Forensic Analysis of Retaining Wall Failure

P. S. Aravind and Neerad Mohan

1 Introduction

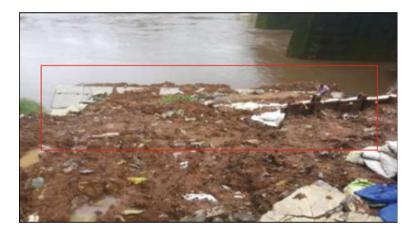
Fig. 2 Collapsed retaining wall

becomes very slushy having very little shear strength after encountering water. Weep holes are provided on the retaining wall but are found to be clogged.

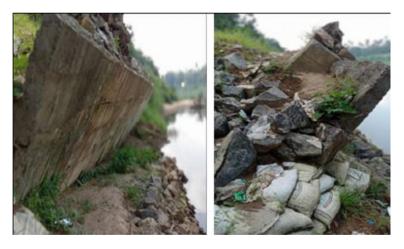
measurements, a maximum vertical displacement of 20 mm is observed at 0.5 m from the bridge abutment. The maximum distress due to lateral movement and vertical settlements is found in the region where the retaining wall joins the bridge abutment. Figure 4 shows the magnitude of distress patterns of lateral deformation. Figure 5 shows visual cracks (more than 60 mm wide) on the inclined slope due to excessive vertical settlement of both backfill and foundation soil beneath the gravity wall. The measured values are compared with deformation values obtained from both displacement analysis and numerical analysis.

Fig. 4 Laterally displaced retaining wall
