Investigation of Long-Term Settlement of Flexible Steel Oil Storage Tanks on Calcareous Sand in UAE

Abstract. Middle East has one of the largest numbers of oil storage worldwide. Most of the tank farms have been built along coastlines of Arabian Gulf and Gulf of Oman. Commonly, the tanks shallow foundations were seated on very dense gravelly gabbro fills, which was laid above a layer of dynamic-compacted calcareous (natural) sand. It has been observed for several cases that different settlements beneath tank bottom annulus after 10-year operation exceeded acceptable limited as per API standard [1].

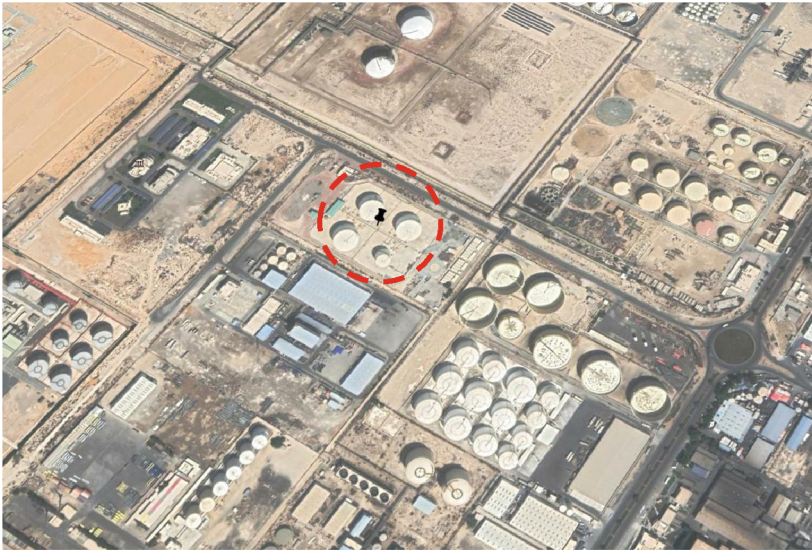
Fig. 1. The investigation site with 4 large oil tanks in a tank farm near a shoreline in UAE. Image from Google Earth Pro, accessed on 04/02/2020

In this paper, we present a geotechnical investigation and assessment to understand the reasons and mechanism to cause the relatively large settlements observed in four oil fixed cover, flexible steel oil – storage tanks. The tank diameters are from 33 m to 40 m, and the tank height is 19 m, constructed in 2008 (Fig. 1). After more than 10 years of operation, the tanks experienced relatively large settlement. Tank settlement inspection as per API-653 [2] reported that the accumulative settlement has exceeded 50 mm (Fig. 2). The excessive settlement can be observed at various locations along the annular plate seating area. The annular plate itself was also deformed, hence the tanks were emptied, and remediation was required.

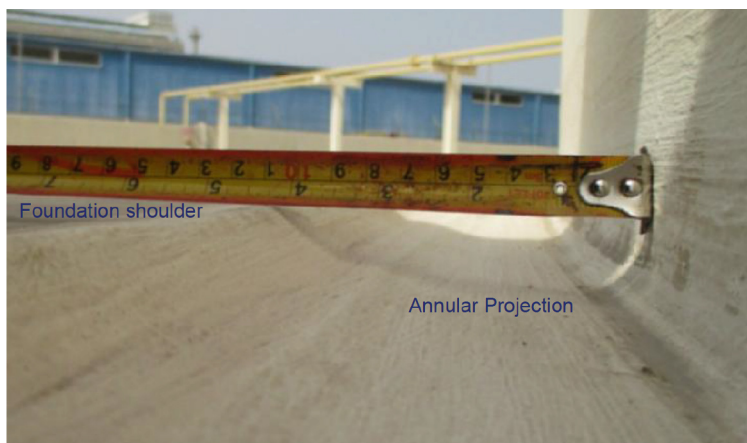
Fig. 2. Excessive oil tank annular projection settlement

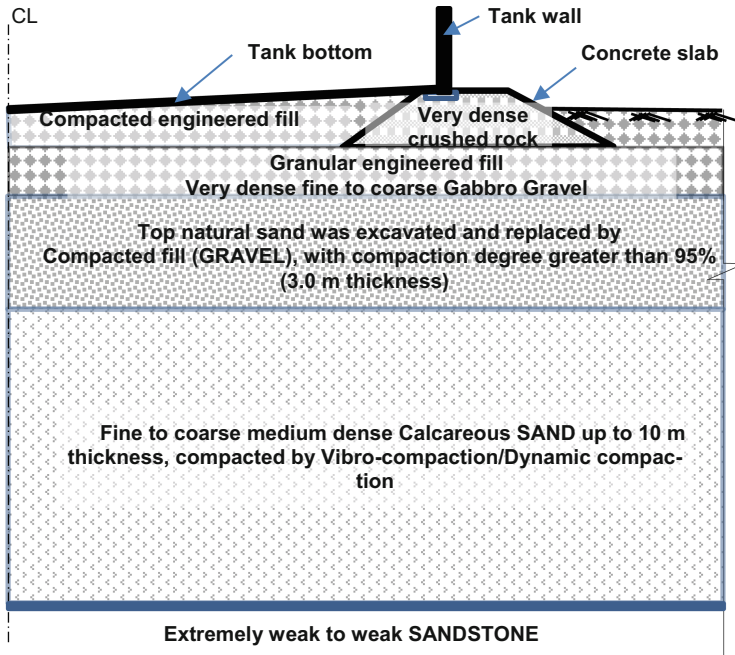
Figure 3 shows a tank foundation seated on dense crushed rock embankment over well compacted granular engineered fill with a total thickness up to 5.0 m. The tank shallow foundation was designed as per API Standard 650 [2]. Beneath the granular engineered fill is a layer of natural calcareous sand, with the thickness up to 10 m. The natural calcareous sand, underlain eventually by sedimentary rock, was compacted by mean of vibro-compaction or dynamic compaction¹.

Fig. 3. Sketch of Tank foundation and soil stratigraphy at the site.

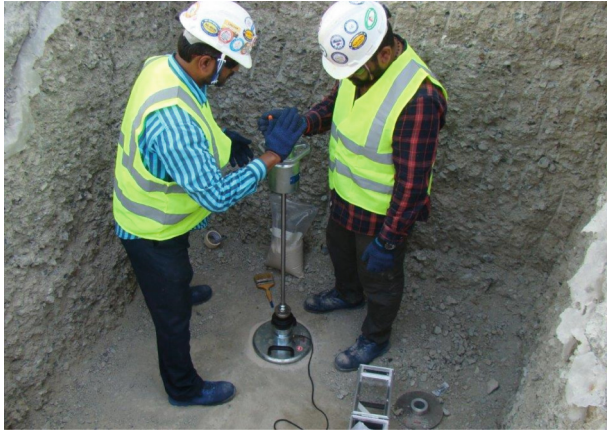
We reassessed the sand density based on the available data obtained from CPT tests conducted previously and also the shear wave velocity measured using MASW technique in this study (presented below). The sand can be classified as medium dense to dense fine to coarse calcareous SAND, with loose/medium dense thin localities. Bedrock of extremely weak sandstone at the site is found at the depth of 15 m below the ground level (bgl). The ground water table at the site is at about 5 m (bgl) with an approximately seasonal fluctuation in range of ± 0.5 m (Fig. 4).

Fig. 4. Trial pit reveals the competent materials beneath the oil tank foundation.

penetration test [8], and dynamic plate loading test [9] were conducted. The measured in-situ dry density varies from 2.01 to 2.19 T/m³. The in-situ test results suggested that the engineered fill was very well compacted with the dry density from 2.01 to 2.19 T/m³ and the degree of compaction more than 95%–100%. Multichannel analysis of surface waves (MASW) was conducted to evaluate the stiffness of the foundation soils up to 28 m (bgl) as shown in Fig. 5.

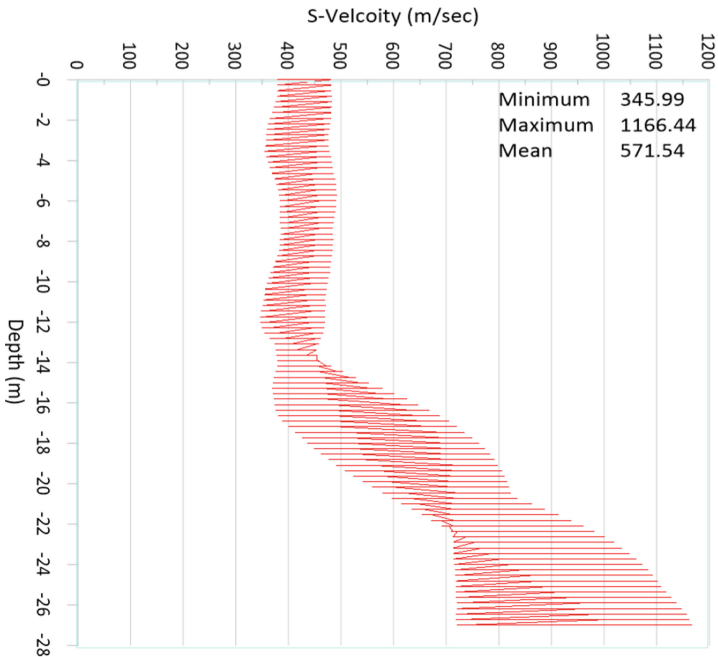
Fig. 5. 2D shear wave velocity images along a survey line obtained from MASW.

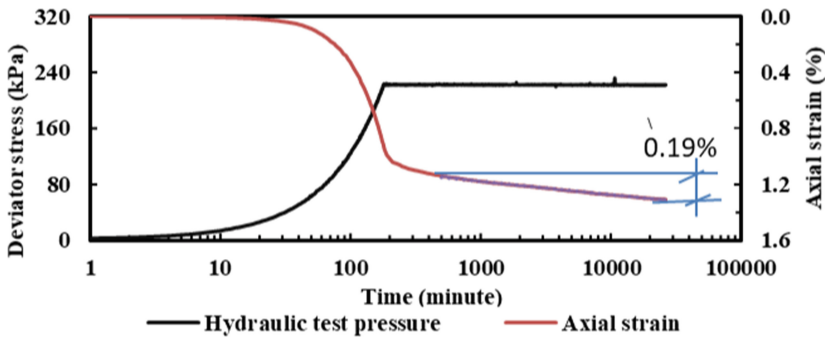
From the trendline for the most linear part of the curve (Fig. 6), the derived creep rate (α) for the calcareous sand is 0.095% per logarithmic cycle. The total creep strain measured in laboratory after 18 days was approximately 0.19% (Fig. 3). The settlement was almost ceased after that as shown by the plateau at the end of the statement curve. This level of vertical strain induced will correspond to 19 mm settlement for a 10 m layer of sand in the field. This measured creep settlement was higher than the value estimated in design of 15 mm. It should be noted that the stress level of 190 kPa applied in triaxial cell is higher than the possible maximum oil pressure during operation (about 170 kPa). The results obtained from the creep test suggest that (i) creep of calcareous sand could contribute to the settlement of the tank under a constant load, however, (ii) creep may not be the major factor causing the tank large settlement.

Fig. 6. Monitoring creep of calcareous Sand in triaxial cell

- The creep rate of dense calcareous sand measured in the laboratory under effective stress of 190 kPa, was 0.095% per logarithmic time cycle, which exceeds the estimates made by empirical relations (e.g. [5, 6]) for 10 years period, whereas residual vertical strain resulted from cyclic loading and unloading is much higher.

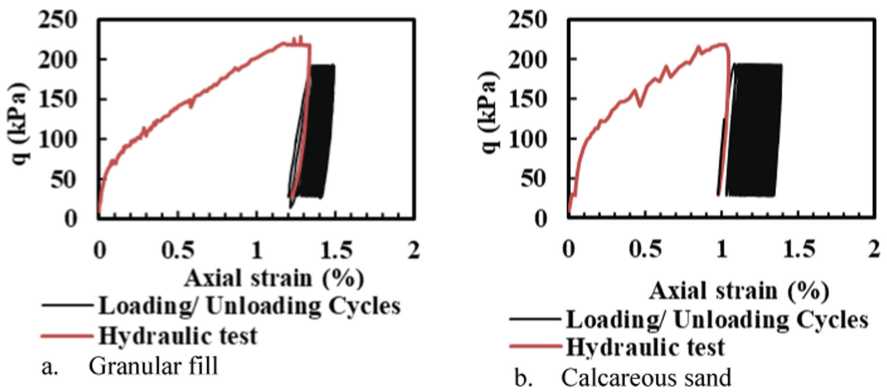
During the cyclic load application, the strain gradually accumulated as shown in Fig. 7 and Fig. 8, and the soils became stiffer thanks to the effects of draining conditions. The residual strain accumulated vs. number of cycles were plotted in Fig. 7. It is observed that when the number of loading cycles exceeded 75 (for granular fill) and 95 cycles (for calcareous sand), the accumulated strains were almost constant, meaning that the settlement could be no longer taking place in the future.

Fig. 7. Stress-strain curve resulted from process of oil 100 filling/emptying cycle

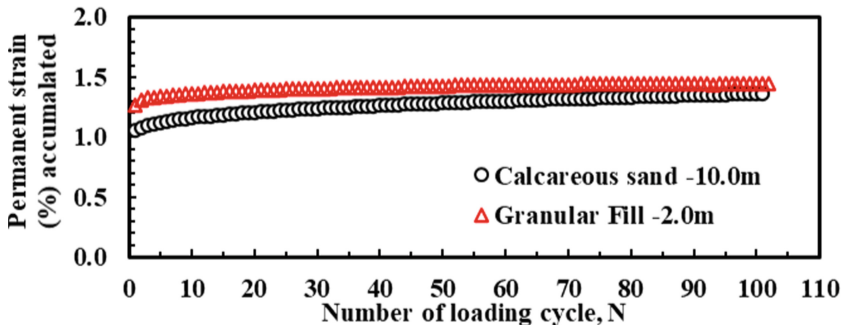
Fig. 8. Permanent strain (settlement) accumulated during cyclic loading

The total accumulative cyclic vertical strain induced was about 0.2% for granular fill and 0.3% for sand (Fig. 8). These cyclic strains are equivalent to 10 mm settlement

for 5.0 m thickness of granular fill, and 30 mm settlement for 10 m thickness of calcareous sand. The total permanent cyclic settlement therefore was up to 40 mm, which was significantly higher than the creep settlement under static load measured above. It should also be noted that the level of accumulated vertical strains illustrated in this study by no means can be deemed as representatives for all calcareous sands in UAE. The accumulated settlement appeared to be terminated after a larger number of cycles for sand compared to granular fill. This can be attributed to the lower relative density and particle crushability of the calcareous sand.

- The process of filling and emptying tank during its operation caused the major excessive settlement with time. This was observed for both dense calcareous sand and very dense granular engineering fill.

- For the studied tanks, it is likely that no further settlement could be taken place in the granular fill and in calcareous sand after 75 and 95 loading cycles, respectively, thanks to the stiffening effects in fully drained condition under cyclic load.
