Ecological Anthropology: Local Perceptions and Their Responses to Changes in Water Environment and Land Use in the Mount Kenya Region

Xiaogang Sun

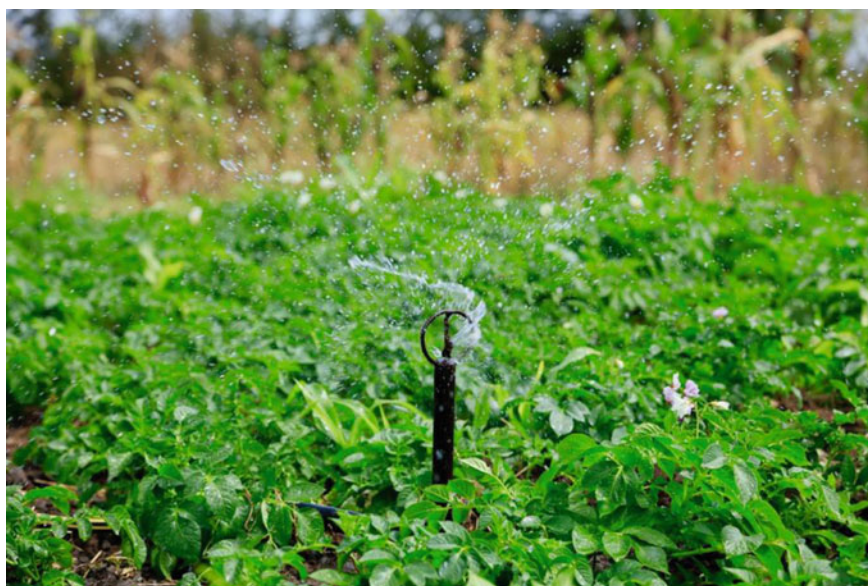
Sprinkle irrigation in farmland in the mid foot zone of Mount Kenya

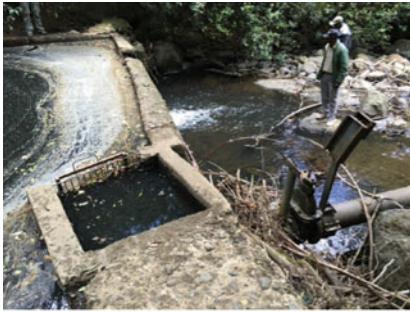
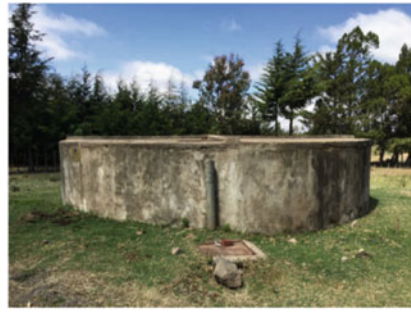
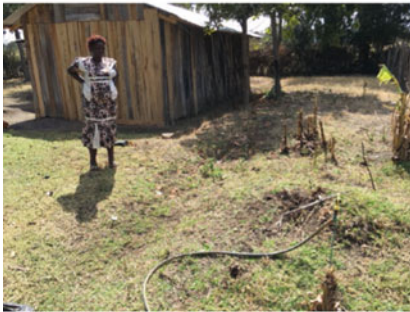
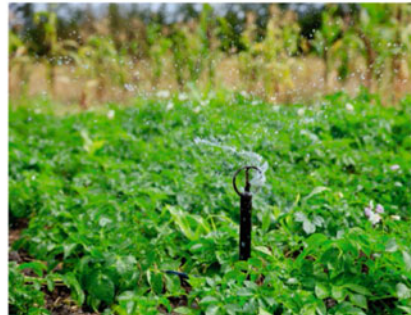
Fig. 4 Typical facilities of a water project

Reservoir dam and intake

Storage tank

Rubber pipe and faucet

Sprinkler on a farm

Currently, nine water projects have been set up to distribute water in the upper and mid foot zones in Naro Moru area. Among them, four projects are connected to the northern branch of the Naro Moru River (locally known as Tereki River), while five projects are connected to the southern branch of the river (locally called the Naro Moru South River). Figure 4 shows the typical facilities of a water project. For example, each project consists of a reservoir dam across the Naro Moru River. The dam has an intake that connects with the main project pipeline (a 6-inch diameter metal pipe). There is a valve between the intake and the pipeline to control the water flow. The main pipeline is connected to storage tanks. Sub-pipes send water to different locations from the storage tank. Each user of the water project is connected to the sub-pipe by a narrow rubber pipe as well as a faucet in their home and sprinklers on their farm. During the rainy season, sometimes the valve has to be closed to avoid overflow of the tank because people only use the project water for drinking, and the crops are irrigated by the rainfall. During the dry season, the valve is opened only at night to fill the storage tanks, which enables people to use water from the tanks from morning until evening. Below are two examples of the water project in action.

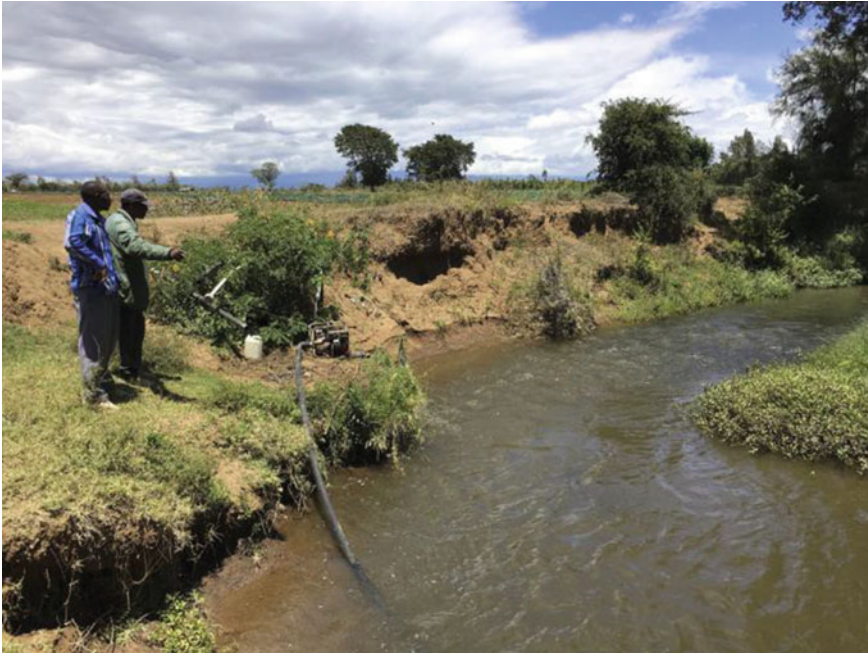
Fig. 9 Collection of water directly from the Naro Moru River using a private electric pump in the lower foot zone

two decades, with an increasing population and higher demands for farmland, new settlers from neighboring areas such as Nyeri and Meru have invested in large-scale and intensive farming along the Naro Moru River. There is no water project in this zone. Individual farmers take water directly from the river using private electric pumps (Fig. 9).

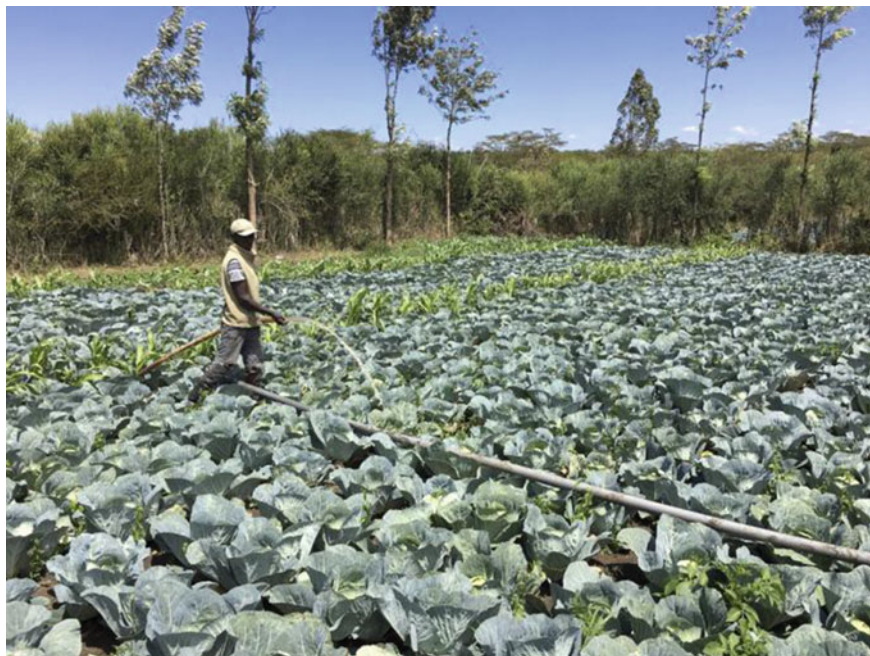
Fig. 10 Irrigation of an intensive cabbage farmland in the lower foot zone
