# Corrosion in Thermal Pipes: An Investigation on Problems and Causes

A. Hari Ganesh, R. D. Mishra, and S. Kar

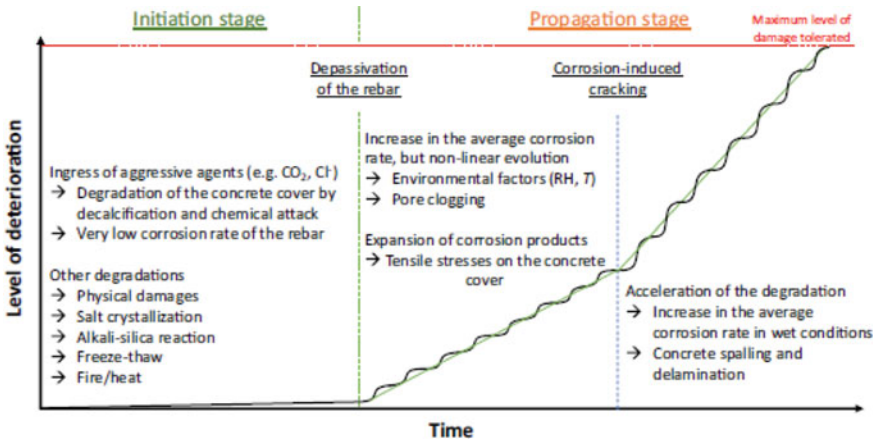
Fig. 1 Schematic representation of RC structures’ service life, adapted from the diagram of Tuutii

The RC systems’ service life can be divided into two significant periods, as indicated by Tuutii [22]: the activation phase and the propagation-phase. It relates to the penetration of aggressive-agents, CO<sub>2</sub> and chloride, into the rebar of concrete material, resulting in passive film’s incremental degradation on the steel surface. Before the degree of corrosion exceeds the maximum failure allowed by construction standard values, the propagation stage is the active corrosion condition. If the current density is less than 0.1mA cm<sup>-2</sup>, and in the active state, if the value is more significant than 1 mA cm<sup>-2</sup>, steel corrosion is typically considered passive. [23]. Other models considered the improvement in the corrosion rate during the service life of reinforced concrete [24–26] based on the Tuutii model or included additional stages in the concept of service life for differentiating rust-expansion, cover-cracking, and spalling/delamination (Fig. 1) [27–29]. However, because the corrosion rate can be increased by concrete cracking and spalling, the degree of deterioration is not sequential, on the other hand the rise of rust materials in broken concrete can pack the pores, therefore falling the corrosion rate.

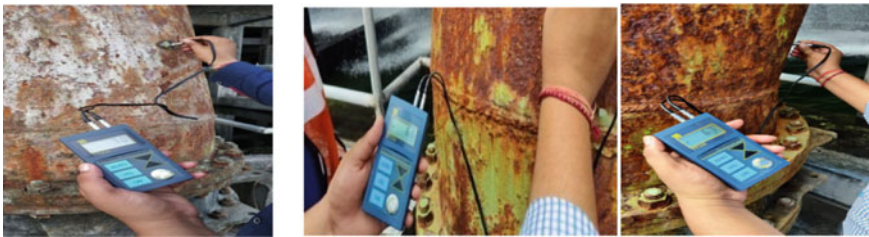
Fig. 3 Pipe thickness measurement

to identify the corrosion level as below (Fig. 4) at cooling water piping in power plant, Karnataka. If thickness falls below 20% of nominal thickness, then pipe need to replace/ repair. Instead of replacement the anti-corrosive coating can be applied

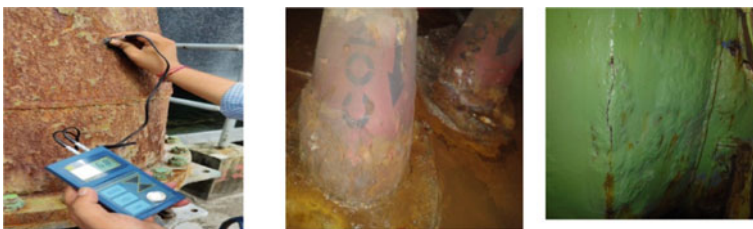
Fig. 4 Pipe thickness measurement

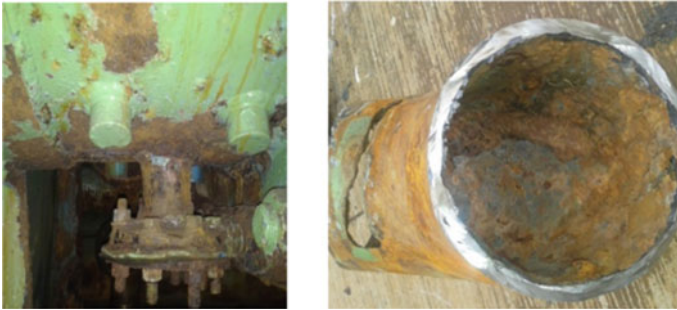
**Fig. 5** Cooling water pipe corrosion at power plant

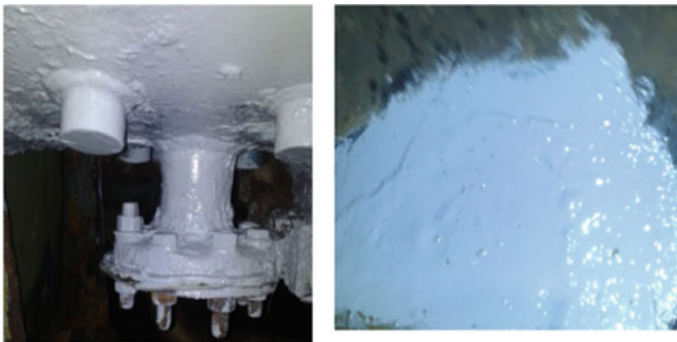
**Fig. 6** After CorroKote application on cooling water pipe

**Product title: Polyglass VEHA (Corrocoat)** Vinyl ester/acrylic glass flake, Type A two-pack, for hand use.

**Surface preparation** Gritblast steel to ISOstandard8501-1 Sa 2.5 near 3/equivalent, priorto usage.

**Application** 2 or above coats of VEHA polyglass can be added when used alone.
