Construction of Cai Mep International Container Terminal

Abstract. Cai Mep International Container Terminal was constructed 80 km southeast of Ho Chi Minh city, Vietnam, where a thick and soft clay deposit was widely found from the top of the ground. To minimize consolidation settlement after construction, soil improvement by PVD was extensively applied. Sand filling including preload up to +11.8 mCD was required on the existing ground of +3.5 mCD. Stability of this sand filling on river side was the first concern in the construction work. According to soil investigation to study shear strength profile of the soft clay, original design of sand filling was revised to maintain stability of the filling on river side. This report presents the original and the revised design, as well as the results of soil investigation.

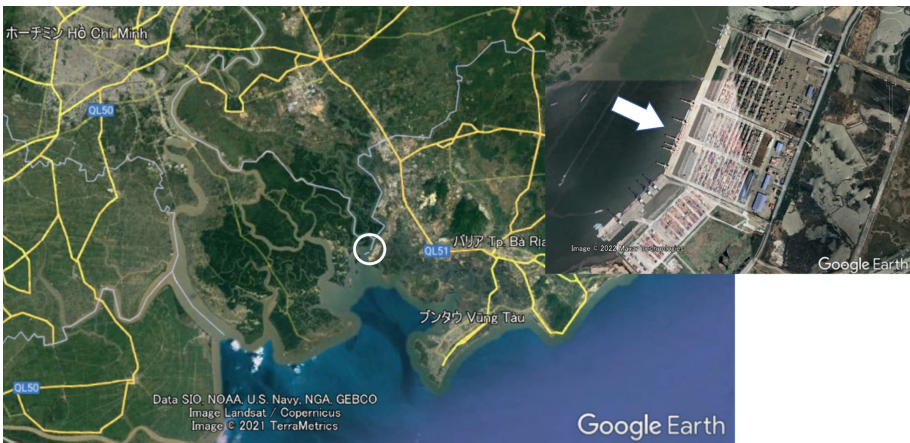
Fig. 1. Location of the site

Figure 1 presents the location of the site by a circle. It is 80 km from HO Chi Minh city and 20 km to Vung Tau city. The container terminal subjected to this report is shown by an arrow in the figure. As can be seen in the figure, the terminal is facing Thi Vai River, and it has the same kind of facilities on both sides. Since the location is very close to the river mouth, water level of the river is affected by the tide of the sea. HWL and LWL are +3.97 mCD and +0.58 mCD, respectively.

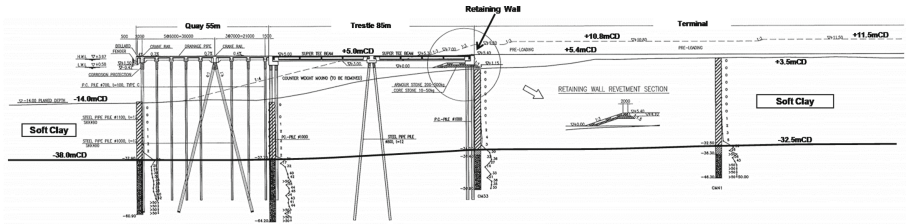
Original design of berthing facilities is presented in Fig. 2. The width of the quay structure is 55 m and the top elevation is +5.0 mCD. Distance from face line of the quay to the retaining wall is 140 m, including 85 m long trestle.

Fig. 2. Cross section of quay structure, trestle and reclamation

The site is widely covered with soft clay deposit (SPT N values are mostly 0 to 2). Figure 3 shows the ground condition of the river bank. A low cliff is formed by a soft clay along river bank. This soft clay deposit continues to the depth of -38 mCD in the river and to the depth of -32.5 mCD in terminal area (24 m thick in river side and 36 m thick in land side), as indicated in Fig. 2.

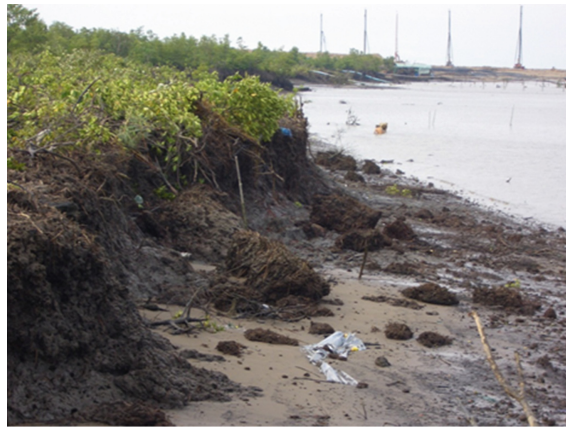
Fig. 3. Condition of river bank

The solid lines in Fig. 7(a) are derived by Eq. (1) from strength profile on land shown in Fig. 7(b). There is good agreement between the lines given by Eq. (1) and measured values. This strongly suggests that the river bank presented in Fig. 3 was formed by erosion, and riverbed soil was subjected to stress release.

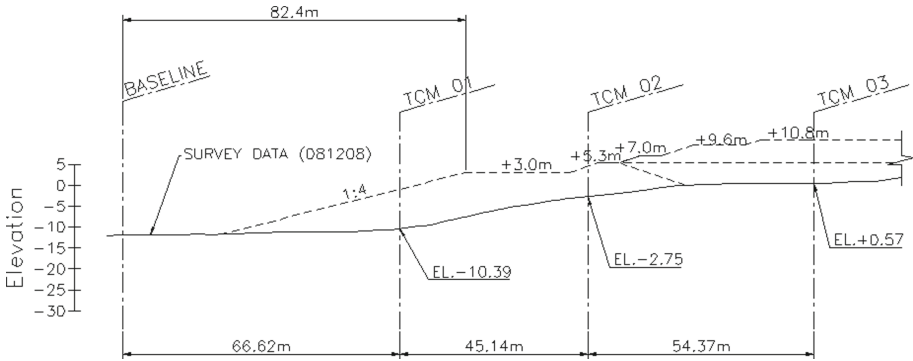
Soil investigation was carried out to study engineering properties of the soft clay deposit and to evaluate stability of sand filling presented in Fig. 4. Boreholes were made on the river bed as presented in Fig. 5, as well as land side boreholes. Undisturbed sampling was performed with hydraulic piston sampler to take soil samples in high quality.

Fig. 5. Boreholes (TCM01 to 03) on the river bed

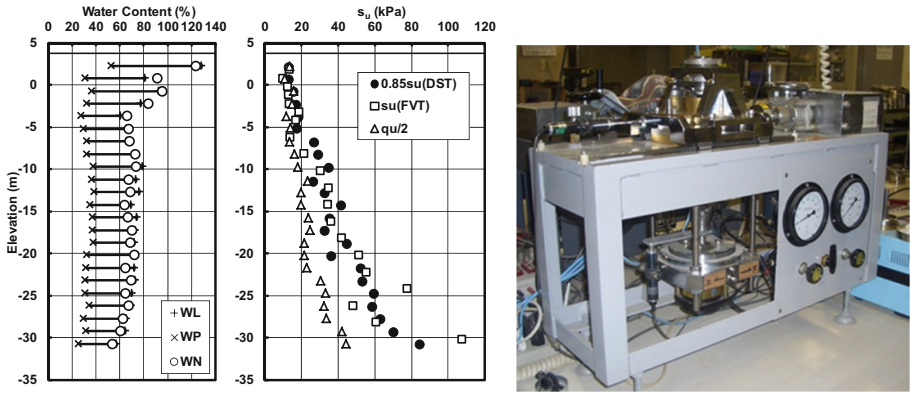
Figure 6 demonstrates water content, Atterberg limits and shear strength profile given by an on-land borehole. Natural water content is very close to or slightly higher

than liquid limit, suggesting that the clay deposit has high compressibility. Direct shear test (DST) was performed with recompression method, in which test specimens (6 cm diameter and 2 cm height) were consolidated at in-situ overburden stress before shear. The factor of 0.85 (Hanzawa, 1992) was applied to consider the effect of deformation speed during shear on strength. The picture on right side of Fig. 5 shows advanced type DST apparatus used for the test. This apparatus can achieve constant volume condition (equivalent to undrained condition) during shear precisely.

The results of field vane test (FVT) in Fig. 6 are almost the same as DST results through the depth. The results of unconfined compression test ($q_u/2$) are smaller than other two tests, except shallow part of the deposit.

Fig. 6. Test results obtained from a on land borehole and DST apparatus used for the study

Asada et al. (2005) studied the effect of release of overburden on shear strength of naturally deposited clay. They used DST apparatus shown in Fig. 6 and found that the effect can be expressed by Eq. (1), where R_{su} is the ratio of s_u after swelling due to stress release to that before swelling, and OCR is the ratio of effective vertical stress before swelling to that after swelling.

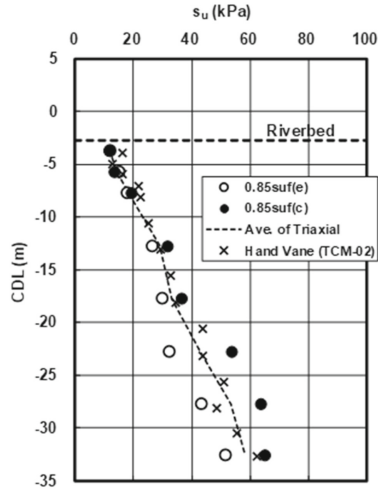
Figure 8 shows reliability of hand vane test. In the figure, hand vane results are compared with triaxial compression and extension test. Specimens for triaxial tests were first consolidated anisotropically, then sheared under undrained condition. As can be seen in the figure, hand vane results (factored by 0.85) are agree with the average strength of compression and extension triaxial tests.

Fig. 8. Comparison of test results from hand vane test and triaxial test

Filling work in the project including counter weight mound and preload was successfully completed without any indication of sliding failure. Since soil data given by direct shear test and triaxial test presented in Figs. 6, 7 and 8 were not available at the time of design revision, shear strength profile of the soft clay applied to stability analysis was slightly smaller than that presented in the figures. This may give some contribution to successful completion of the filling work.

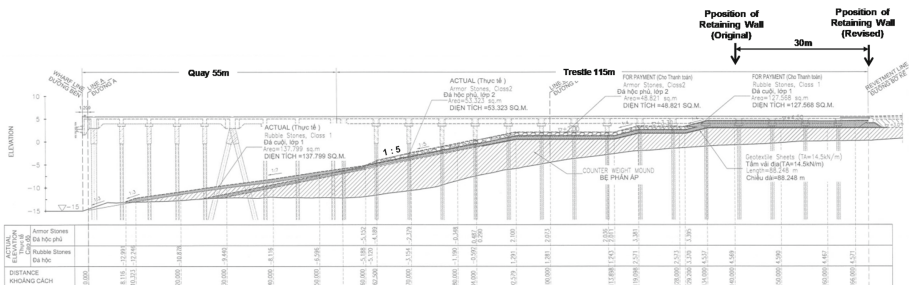
According to the results of soil investigation, many cases of stability analysis were carried out, and cross section of preload fill and counter weight mound was revised as presented in Fig. 9. The slope inclination was reduced from 1:4 to 1:5, and the position of retaining wall was set-back 30 m. Figure 10 demonstrated quay and trestle of the revised design. There is no change in quay structure. The length of trestle was increased from 85 m to 115 m due to a 30 m set-back of retaining wall.

Concrete beam for trestle was also revised at the same time from prestressed concrete to reinforced concrete. Due to this revision, weight of concrete beams became much lighter than the original ones. This change made it possible to use smaller construction machine, of which preparation is much easier in the region than larger one.

Fig. 9. Revised design of trestle
