# Landslides Triggered by Recent Earthquakes in Italy

**Abstract** This document provides a detailed description of seismically-induced landslides and rockfalls that occurred in Italy during the 2016 Central Italy earthquake sequence. Relevant ground motion characteristics for all mainshocks of the sequence are analyzed. The document also provides a quantitative overview of spatial and temporal characteristics of the landslides and rockfalls that occurred during the earthquake sequence which was characterized by three mainshocks: (1) **M**6.1 on 24 August, (2) **M**5.9 on 26 October, and (3) **M**6.5 on 30 October. A relevant fraction of landslides has been caused by the first **M**6.1 mainshock; however, both the following events, especially the third **M**6.5 earthquake, exacerbated the slope instability in many locations and triggered several new and more serious ground failures. The overwhelming majority of the instabilities induced by the sequence are rockfalls in fractured rocks. Details of three selected case histories are described: (1) the Nera rockslide, (2) the Pescara del Tronto landslide, and (3) the Accumoli landslide. Rainfall data during 2016 are also shown and des

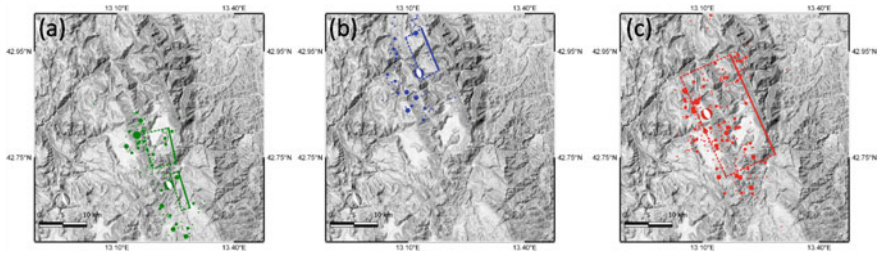
**Fig. 2** Trimmed finite fault model, moment tensor, and epicenter location for the **a** M6.1 on 24 August, **b** M5.9 on 26 October, and **c** 30 October event, along with aftershocks recorded within 24-h periods following each mainshock

Figure 2a shows the surface projection of the trimmed finite fault model for this event. The two-fault systems involved in this rupture are: the Laga Mountains fault system (Amatrice segment) and the Mt. Vettore-Mt. Bove fault system. The number of aftershocks within the 24-h periods following the 24 August mainshock was 121. Most of the aftershock epicenters are not within the surface projection of the hanging wall above the finite fault model, with many south and west of the rupture (Fig. 2a).

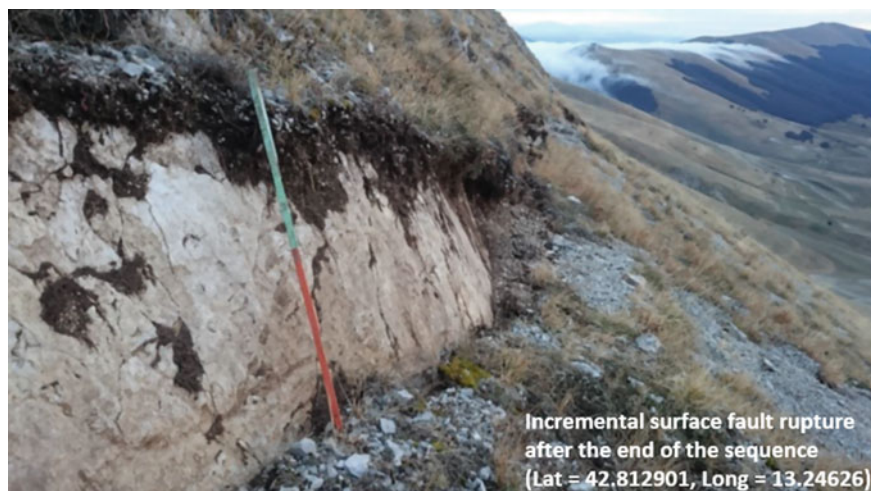
**Fig. 3** Incremental surface fault rupture on the western slope of Mt. Vettore-Mt. Bove fault

Figure 3 shows the cumulative fault offset measurement (70 cm) on the lower or “western” fault trace (Lat = 42.812901°, Long = 13.24626°). A comprehensive overview of the fault surface rupture observed during the 2016 Central Italy earthquake sequence is provided by GEER (2017) and Gori et al. (2018).

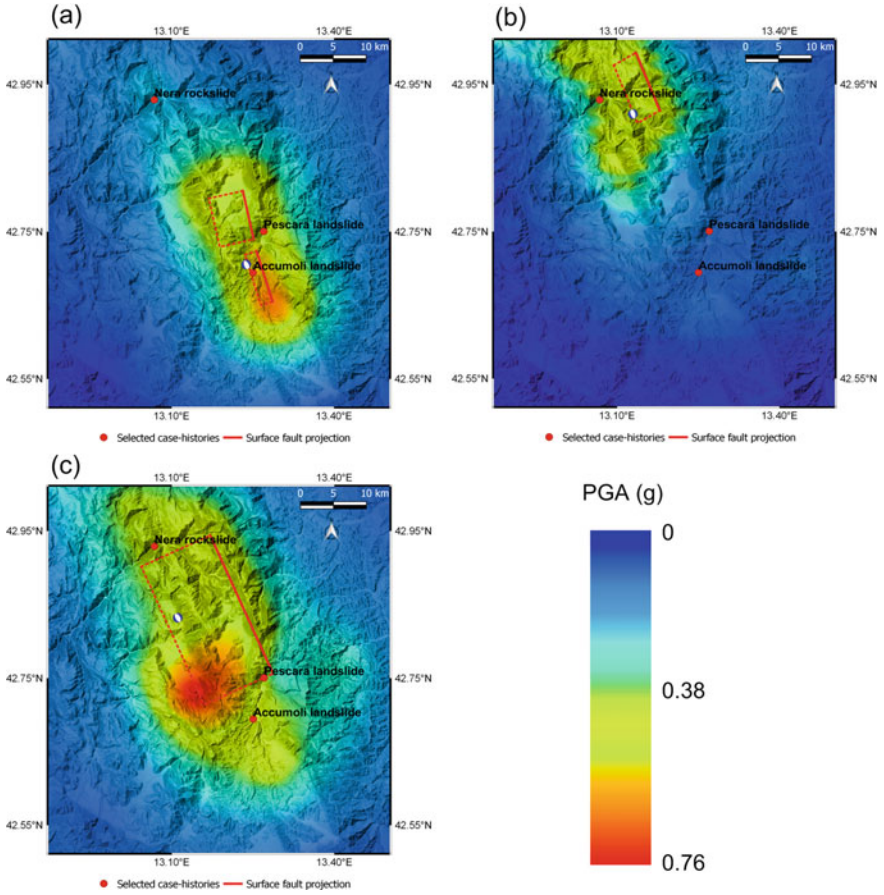
**Fig. 4** Spatial distribution of PGA (in units of g) estimated in the epicentral area for the **a** M6.1 24 August, **b** M5.9 26 October, and **c** M6.5 30 October events

Figure 4 shows the spatial distribution of peak ground acceleration (PGA) in the epicentral area for all three mainshocks. Also shown in Fig. 4 is the location of selected case histories. The measures of the ground motion intensity presented in this figure were estimated using kriging of within-event residuals (i.e., the difference between the recorded ground motions and those assessed by ground motion models for a specific earthquake). After calculating within-event residuals at recording station sites, the spatial distribution of the target intensity measure (e.g., PGA) can be estimated using the Jayaram and Baker (2009) correlation model based on global data. Residuals are equal to zero at recording station sites. The trimmed finite fault models presented in Galadini et al. (2018) were used to calculate source-to-site distances. In this document, within-event residuals were calculated using the average of the Italy-adjusted global ground motion models by Campbell and Bozorgnia (2014), Chiou and Youngs (2014), and Boore et al. (2014). This regional adjustment for Italy is needed to capture a relatively fast attenuation with distance of the ground motion observed in Italian earthquakes (e.g., Stewart et al. 2012 and Zimmaro et al. 2018). Zimmaro and Stewart (2017) recently illustrated the effectiveness of the adoption of global ground motion models with regional adjustments for applications in Italy. More details about the approach used to estimate ground motions used in this study are provided in GEER (2017) and Zimmaro et al. (2018). An estimate of PGA amplitudes at the three selected landslide sites during the 24 August, 26 October, and October 30, 2016, mainshocks is shown in Table 2.

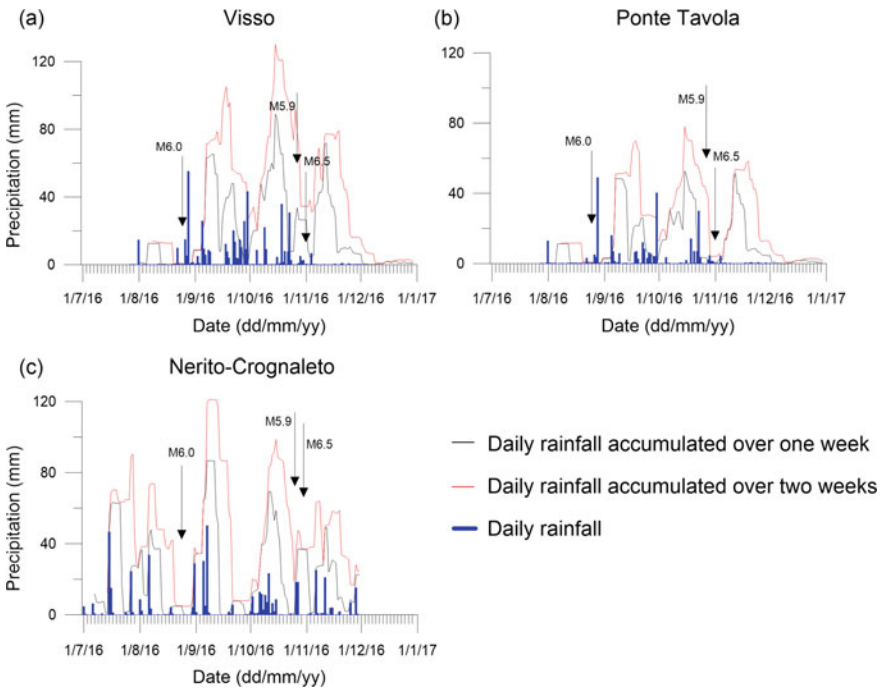
**Fig. 5** Daily rainfall (blue bars) and daily rainfall accumulated over one (black line) and two weeks (red line) recorded by rainfall gauges at **a** Visso, **b** Ponte Tavola (courtesy of Servizio Idrografico—Regione Marche), and **c** Nerito-Crognaleto (courtesy of Servizio Idrografico—Regione Abruzzo) (modified from GEER 2016)

Three rain gauges are operated in the area affected by landslides/rockfalls: Endesa (Visso) and Ponte Tavola (Castelsantangelo Sul Nera) operated by Servizio Idrografico—Regione Marche and Nerito-Crognaleto operated by Servizio Idrografico—Regione Abruzzo. Figure 5 shows the precipitation recordings in these gauges over the time-period of the event sequence (August to December 2016). The analysis of the rain gauge recordings shows that the precipitation that occurred before the 24 August event was not significant. The largest amount of rain was recorded between August and October. However, as further discussed in the remainder of the document, none of the landslide features observed after the October events is related to rain effects.

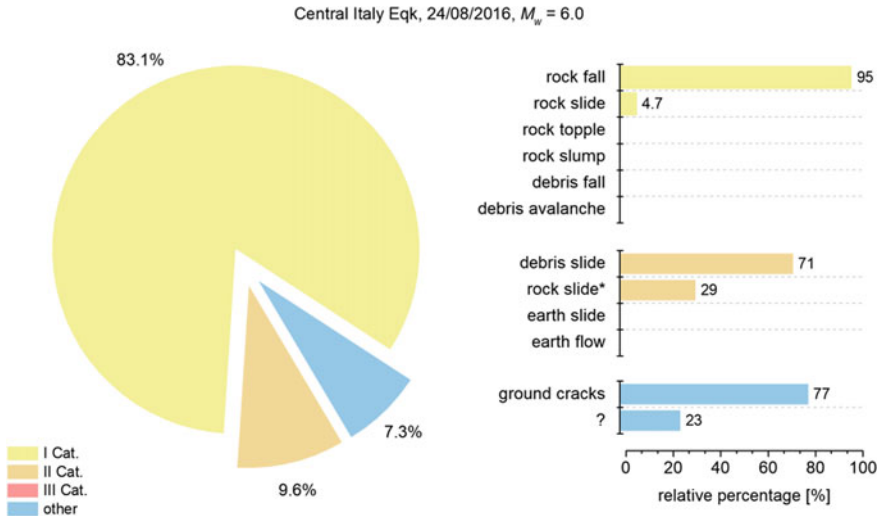
**Fig. 7** Distribution of recognized landslides after the 24 August event

Several landslides were observed following the 24 August mainshock. Figure 6 shows mapped slope instability locations. Table 3 and Fig. 7 summarize the percentage of landslides falling into each category and the different types of landslides for each category, following the 24 August event. Most of the observed phenomena were accompanied mainly by small rockfalls along roadway cuts throughout the earthquake zone. Therefore, they fall in Category I.

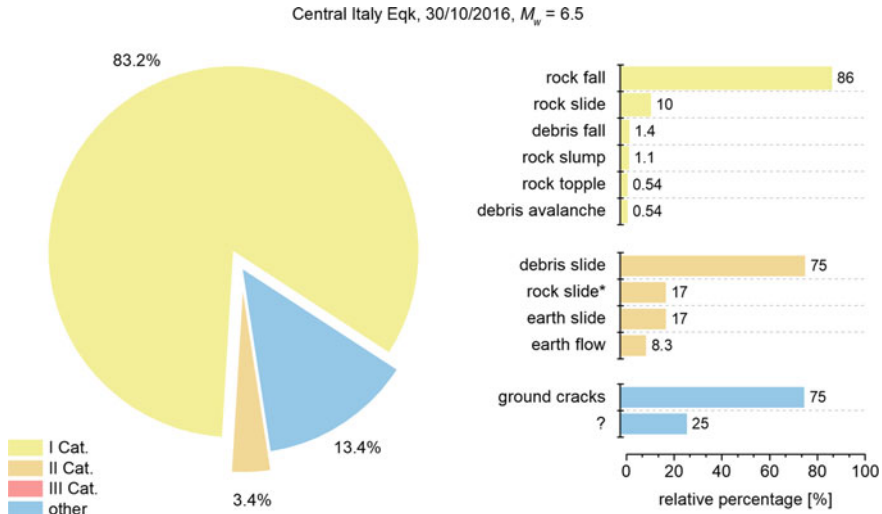
**Fig. 12** Distribution of recognized landslides after the October 30, 2016, earthquake

graphical representation of the same information for the 30 October event. Similarly to what observed after the 24 August event, most of the observed phenomena fall in category I and involve rockfalls.

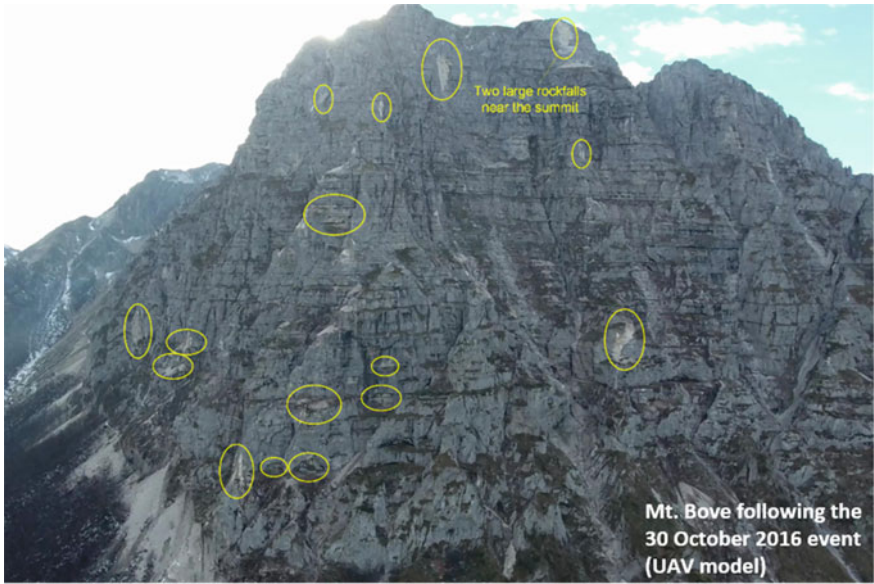
**Fig. 13** sUAS image of Mt. Bove. Suspected rockfall sources are circled in yellow (modified from GEER 2017)

At the top of the mountain, the Calcare Massiccio Formation is overlaid by limestones (Bugarone Formation) with more regular bedding (medium to thick beds). The Mt. Bove massif has been involved in intense Quaternary and ancient tectonics, which has produced faults trending in a strike range from ESE-WNW to N-S. The rock mass has closely spaced joints and persistent joints belonging to the major joint sets. Sever loosening of thick outer parts of the intensely fractured mountain flank could have favored the detachment of large irregular slices under seismic loading (GEER 2017). Figure 13 shows a sUAS-based image of a talus fields visible at the base of Mt. Bove. The same figure also highlights suspected source areas for these talus fields characterized by a lighter coloration of the freshly-exposed unweathered limestone (yellow circled areas in Fig. 13).

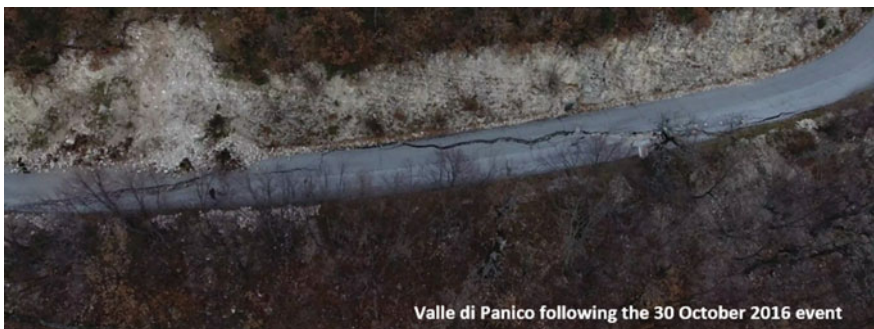
**Fig. 14** Aerial photograph of the Valle di Panico landslide (modified from GEER 2017)

site was a landslide in the soil slope through and beneath the road. Figure 14 shows an aerial photograph of this 55–60 m wide landslide. The GEER team measured a vertical offset on the road pavement ranging between 10 and 70 cm, and horizontal deformation ranging from 2 to 40 cm. The GEER team also created sUAS-based 3D models of this landslide. As shown in Fig. 15a, the eastern portion of the landslide headscarp shows distinct cracks and associated displacements. The western portion of the headscarp appears more gradual and shows pavement cracking (Fig. 15b).

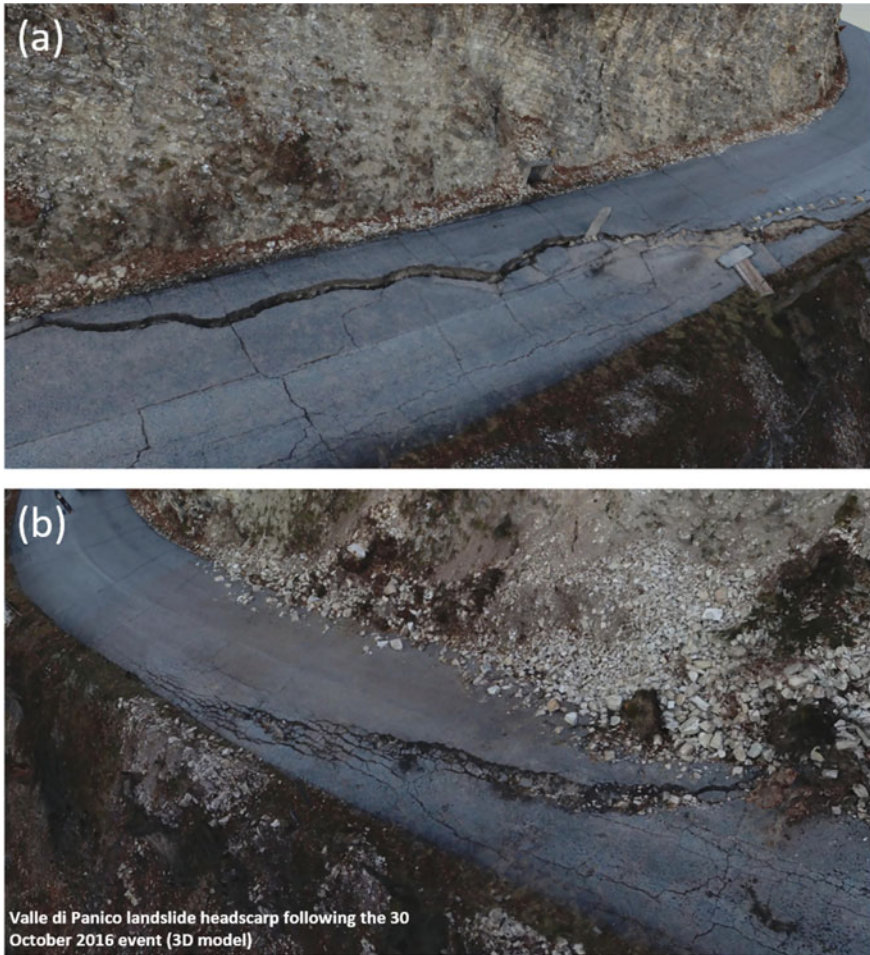
**Fig. 15** a 3D model of the eastern half of the Valle di Panico landslide headscarp; b 3D model of the western half of the landslide headscarp (modified from GEER 2017)

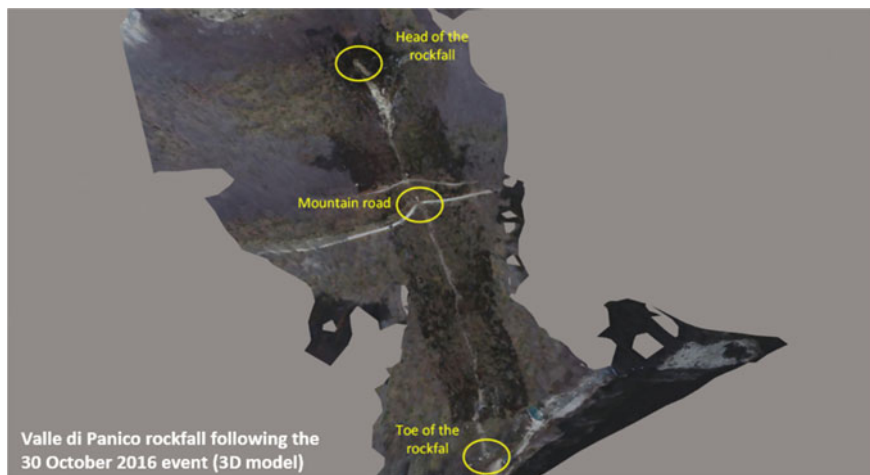
**Fig. 16** sUAS-based 3D model of the Valle di Panico rockfall (modified from GEER 2017)

The second site in the Valle di Panico area is a 420 m-long rockfall along a mountain road. Figure 16 shows a 3D model of the entire rockfall produced by

the GEER team (GEER 2017). The total change in elevation from the source of the boulder to the final resting place on the bottom of the valley is approximately 235 m. The side slope of the valley rests at an angle of 34 degrees from the horizontal direction (1.5 H:1 V). Numerous boulder fragments ranging in diameter from gravel-size to over 3 m were observed and photographed along the entire rockfall length. The largest boulder measures 3 m in diameter. The source boulder is 11.2 m in length and belongs to a formation of heavily weathered and fractured limestone located 91 m above the mountain road (Fig. 17a). Much of the limestone boulder exploded into gravel-sized fragments in the first 90 m of the rockfall. The remaining parts of the boulder broke in larger fragments while tumbling to the bottom of the valley

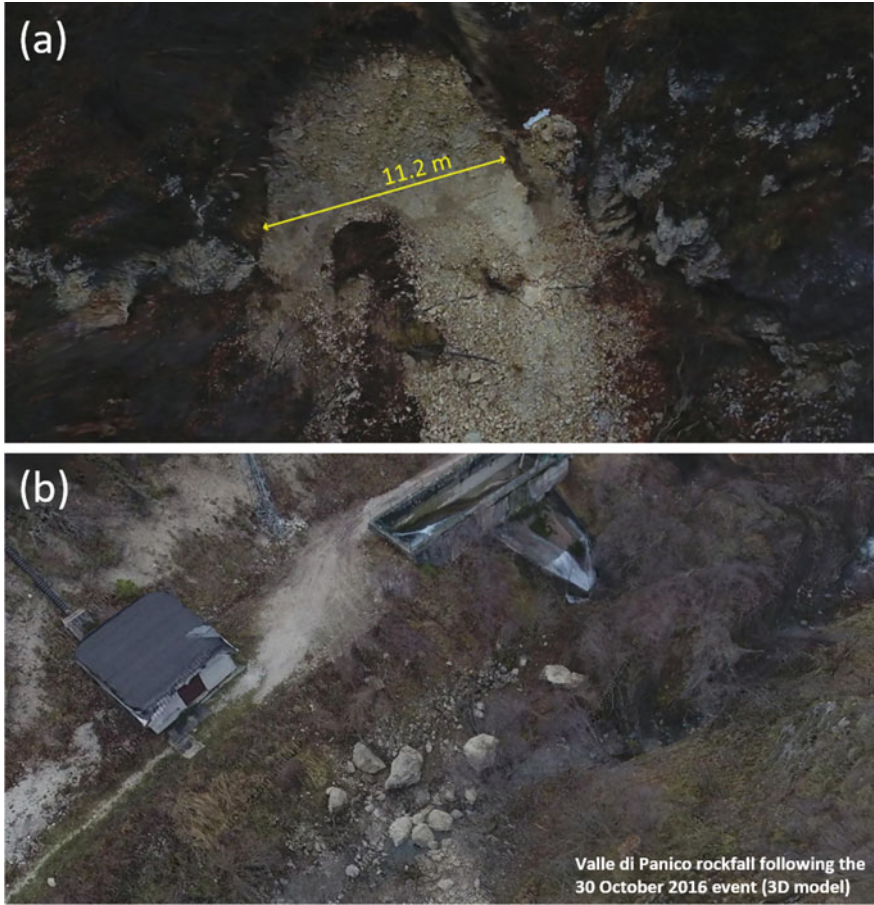
**Fig. 17** **a** 3D model of the source of the Valle di Panico rockfall, located 90 m above the mountain road; **b** 3D model of the boulders and a small power or pump house at the toe of the Valle di Panico rockfall (modified from GEER 2017)

(GEER 2017). At the bottom of the valley, over ten large boulder fragments ranging in diameter from 0.8 to 2.9 m were observed to rest at the valley floor, just 13 m from what appeared to be a small pump or power house (Fig. 17b). Information reported by the GEER team shows that none of the boulders appear to have damaged this small structure (GEER 2017).

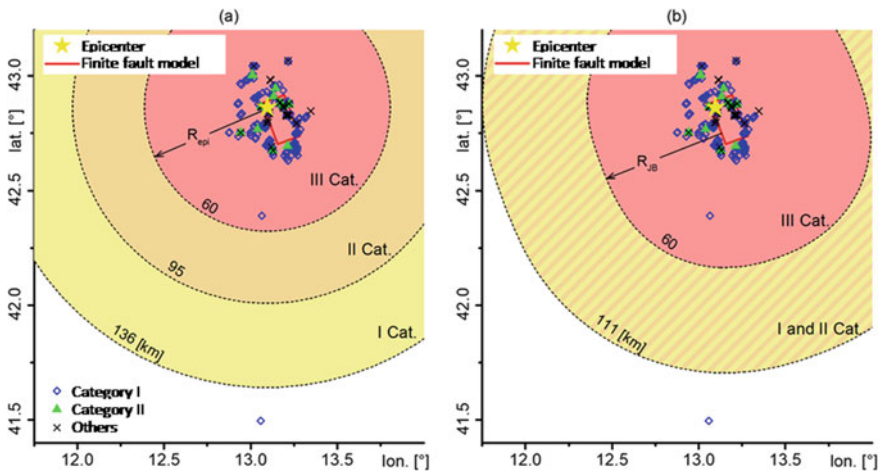
**Fig. 19** Areal distribution of landslide sites following the 30 October event compared with empirical upper-bound loci defined from Keefer (1985) for two source-to-site distance metrics: **a** epicentral distance and **b** Joyner and Boore distance

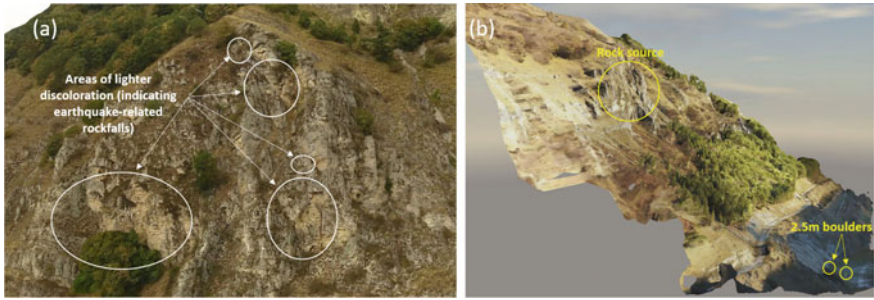
**Fig. 21** sUAS-based 3D models of the Pescia rockfall following the **a** 24 August and **b** 30 October event (modified from GEER 2016, 2017)

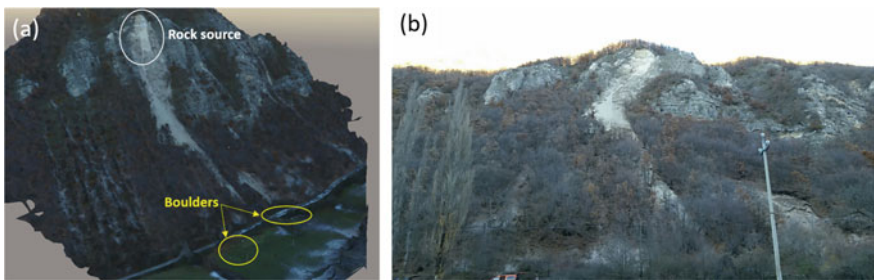
**Fig. 22** **a** sUAS-based 3D models of additional rockfall features observed in the area of Pescia following the 30 October event; **b** source area of the rockfalls with runout damage (modified from GEER 2016, 2017)

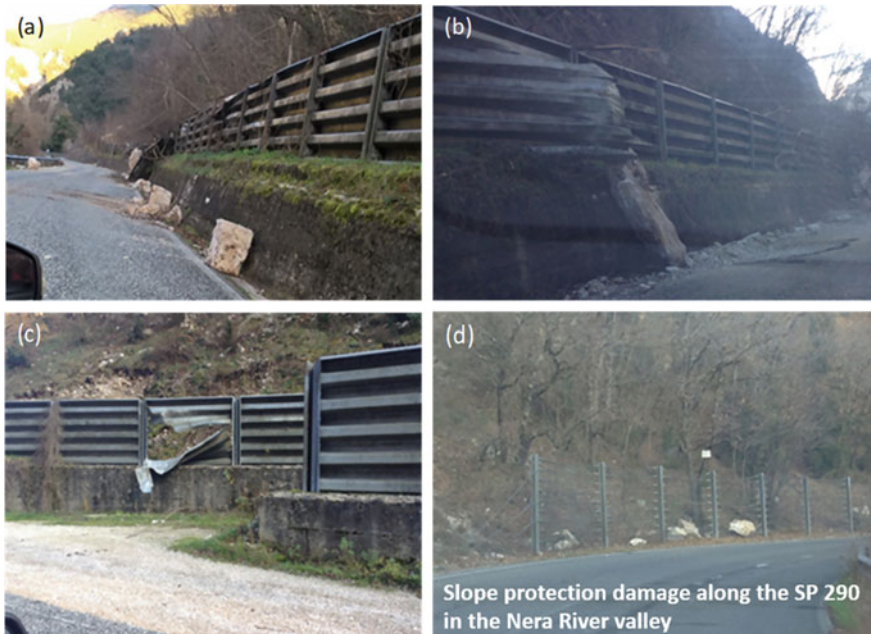
**Fig. 25** Slope protection damaged by boulders and rock-blocks along the regional road SP 290 in the Nera River valley (modified from GEER 2017)

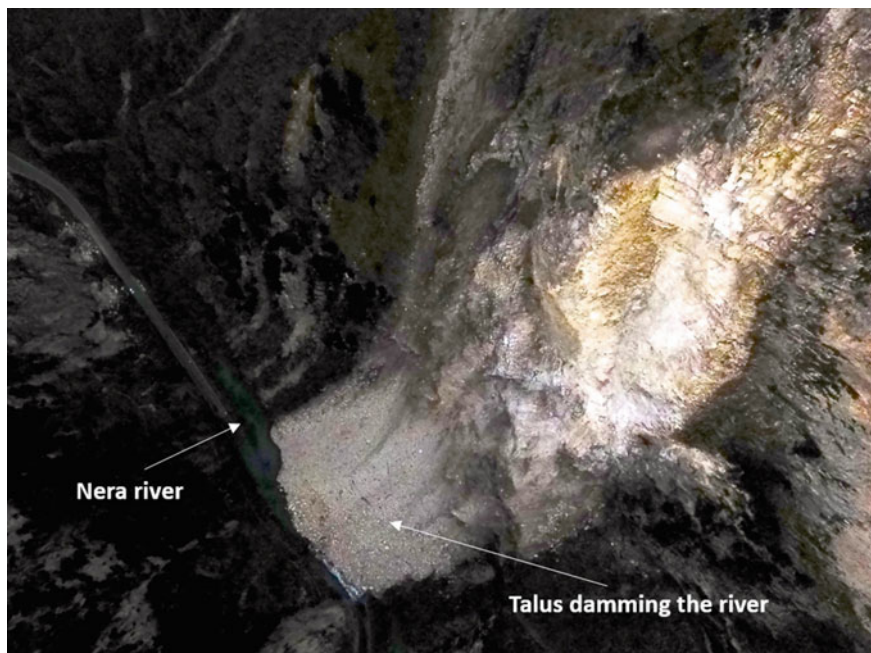
**Fig. 26** Nera rockslide photographed by the GEER sUASat at an elevation of 400 m above Route SP 209. The primary rockfall was a wedge that detached on the right side of the image and disintegrated into talus debris as it fell 330 m to the river valley floor. The limestone bedding is visible in the scar of the wedge detachment (modified from GEER 2017)

The geometry of the rockslide scar and the avalanche deposit were quantitatively measured by photogrammetric reconstruction of images captured by sUAS flights at the beginning of December, 2016, by GEER (2017). The Structure-from-Motion (SfM) computer vision was employed for post-processing and geo-referencing of the acquired sUAS data in order to reconstruct a 3D image (more details in GEER 2017). The resulting 3D model is shown in Fig. 26. Figure 27 shows details of the talus damming the Nera River (Franke et al. 2018). Romeo et al. (2017) have used a TruPulse™ 200 laser rangefinder. The laser sensor was placed on a tripod in order to carry out the measurement of slope distance, horizontal and vertical distance, and inclination, or the calculation of the elevation of any target. Thirty points were installed on the landslide debris that covers an area of about 16,500 m<sup>2</sup>. Furthermore, GIS analysis was defined in ArcGIS 10.1 (more details in Romeo et al. 2017).

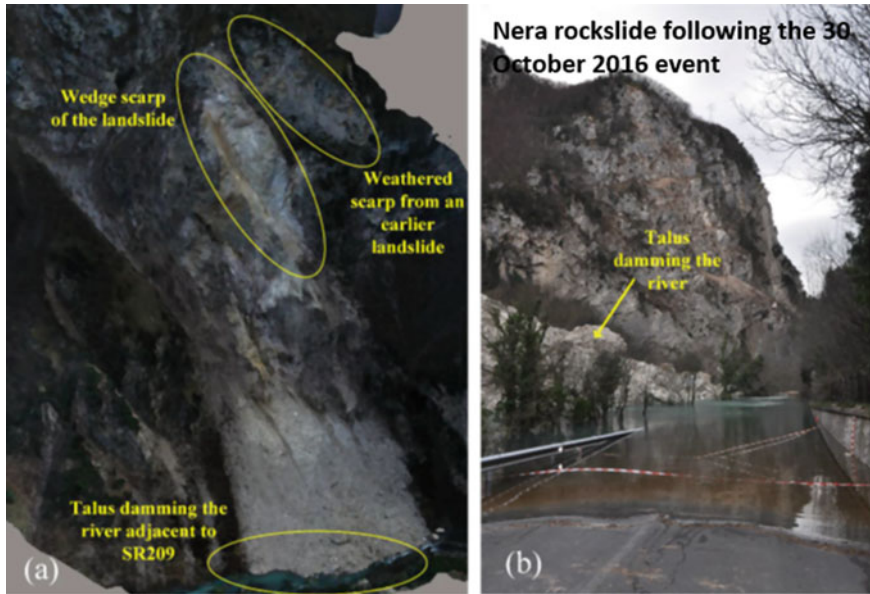
**Fig. 27** **a** 3D model of the Nera rockslide; **b** photograph of the dammed Nera River blocking the road (modified from Franke et al. 2018)

The maximum elevation difference between the rockfall source area, close to the ridge of the slope, and the SP209 road is about 300 m. The slope angle at the detachment area was originally greater than  $58^\circ$ , while after the detachment is between  $75^\circ$  and  $80^\circ$ . The rockslide scar can be approximated by those left by a rock wedge delimited by two persistent joints and the cliff surface, as can be seen in the SfM imagery of Fig. 27. The bedding exhibits an apparent dip of  $20^\circ$ – $30^\circ$  toward the east and appears to be orthogonal to the joints delimiting the failed wedge, thus it did not play a major role in the sliding mechanism. The apron of debris accumulation has a slope angle of about  $27^\circ$  and is not exactly in the perpendicular direction from the source. The accumulation area covers the foot of the slope and has an extent of about  $20,000 \text{ m}^2$ . It is difficult to determine the volumetric ratio of the materials derived from the source area and that from the pre-existing debris along the slope. Romeo et al. (2017) have estimated the total volume (debris originated by the rockfall plus the mobilized pre-existing talus) at about  $70,000 \pm 8000 \text{ m}^3$ , of which about  $50,000 \pm 60,000 \text{ m}^3$  is derived from the new event. This estimate is comparable to the volume of rock detached from the source area (about  $40,000 \text{ m}^3$ ) determined by laser rangefinder, taking into account the considerable uncertainties in evaluating the pre-existing material. Similar conclusions on pre- and post-event talus deposits

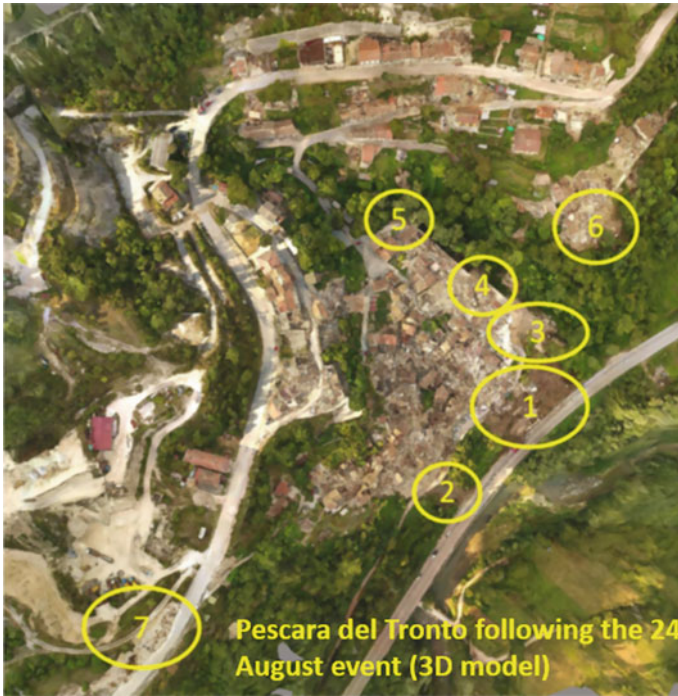
**Fig. 28** 3D model of Pescara del Tronto following the 24 August event. Yellow circles highlight the seven locations discussed in this document (modified from GEER 2017)

After the August events investigation of the 3D models of Pescara del Tronto produced by the GEER team (GEER 2016, 2017) revealed numerous shallow earthquake-induced landslides and retaining wall failures. The remainder of this section summarizes incremental slope instability features observed as a result of the 2016 Central Italy earthquake sequence. This analysis is largely based on multi-epoch observations mainly derived from sUAS-based 3D models. Seven locations of interest within Pescara del Tronto have been identified to carry out cumulative damage analysis (Fig. 28; GEER 2016, 2017).

The largest landslide occurred on the east slope below the city ( $42.75057^\circ$  N,  $13.27223^\circ$  E), directly above Highway SS4 (marked as #1 in Fig. 28). The landslide after the 24 August event was approximately 75 m wide and 30 m high, and was shallow, with only the upper one meter or less of soil sliding downslope. The landslide damaged retaining structures around the city. Significant incremental movements occurred on the landslide above highway SS4 after the two October events as shown in Fig. 29a, b. Limestone boulders greater than 6 m in diameter were detached from the slope and rolled onto the highway.

A second, smaller shallow landslide was located above Highway SS4 (marked as #2 in Fig. 28), just south of the larger landslide #1 ( $42.7501^\circ$  N,  $13.2719^\circ$  E). This landslide was approximately 16 m wide and occurred on a slope 26 m high. Figure 30 shows a comparison between 3D models produced for this feature following the 24 August and 30 October events. This smaller landslide was not observed to change significantly after the 24 August event (Fig. 30a) and the 30 October earthquake (Fig. 30b). In this section, the retaining wall supporting the road appeared to maintain its stability. However, significantly more structural debris from collapsed residences was observed at this location following the 30 October earthquake.

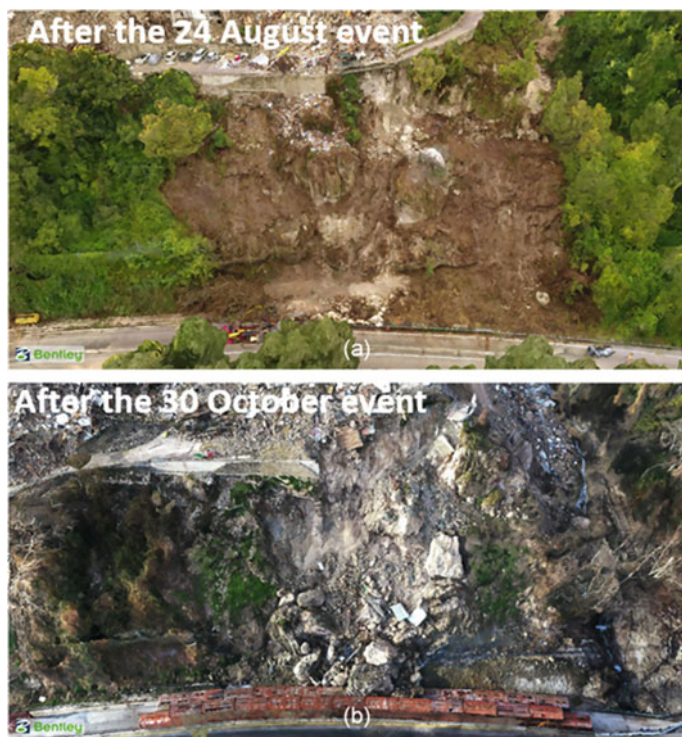
**Fig. 29** D model of landslide #1 in Pescara del Tronto following: **a** the 24 August and **b** the 30 October event (modified from GEER 2017)

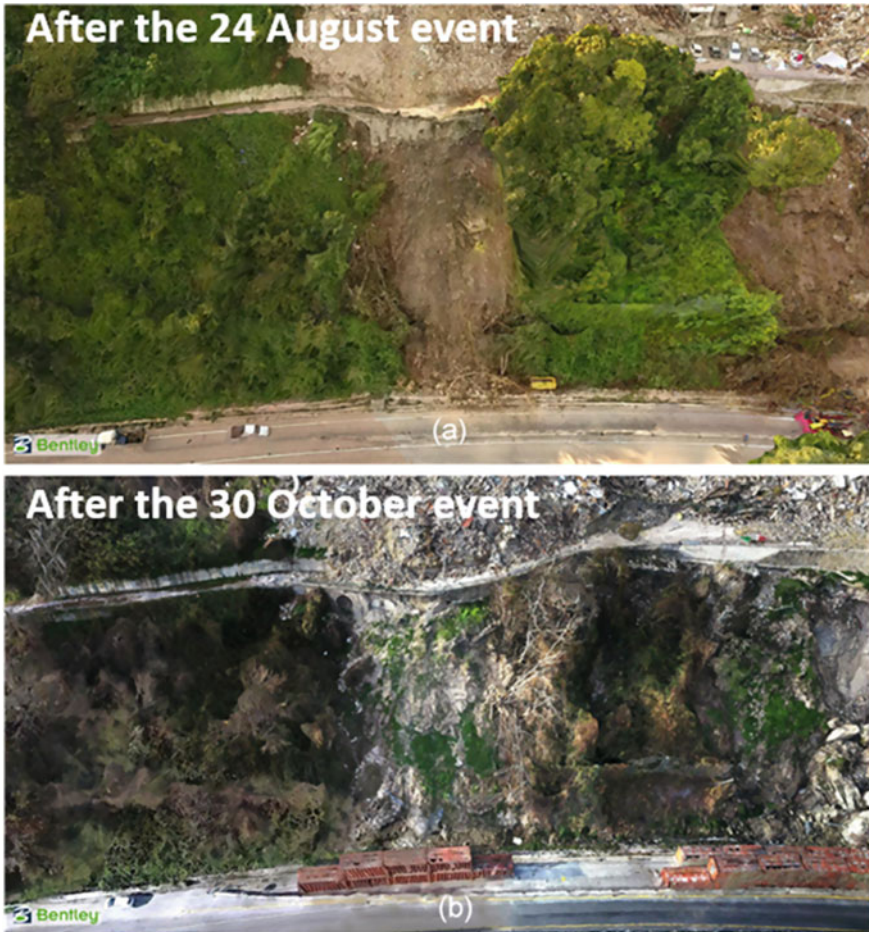
**Fig. 30** 3D model of the landslide #2 in Pescara del Tronto following: **a** the 24 August and **b** the 30 October event (modified from GEER 2017)

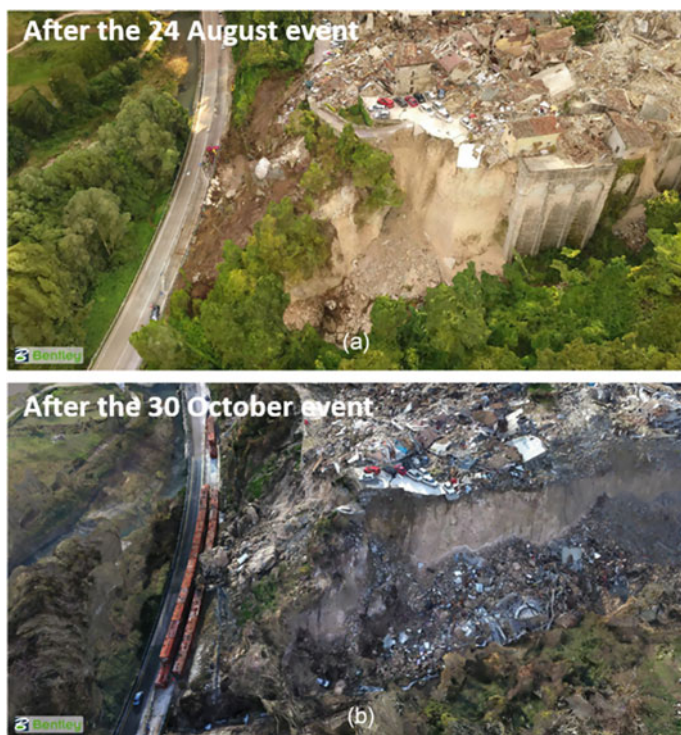
**Fig. 31** 3D model of the failed retaining wall area in Pescara del Tronto (areas #3–4 in Fig. 28) following: **a** the 24 August and **b** the 30 October event (modified from GEER 2017)

A few of the observed slope failures in Pescara del Tronto appear to be related to potential retaining wall failures. The lower portion of Pescara del Tronto was partially supported by a 24 m-tall masonry retaining wall that surrounded the foot of the village. This wall suffered serious damage following the 24 August event (Fig. 31a). Substantial damage accumulation was observed following the October events as shown in Fig. 31b. In Pescara del Tronto, structure debris was so ubiquitous that it was challenging to investigate ground deformation in this zone. Any attempt to directly investigate this zone was not realistic because of the dangerous and unstable nature of the debris field. As a result, sUAS-based imagery constituted the main damage detection and analysis tool, especially after the October events. Moderate to severe damage was found along most of the roads in proximity from the slopes and/or above the retaining walls throughout Pescara del Tronto.

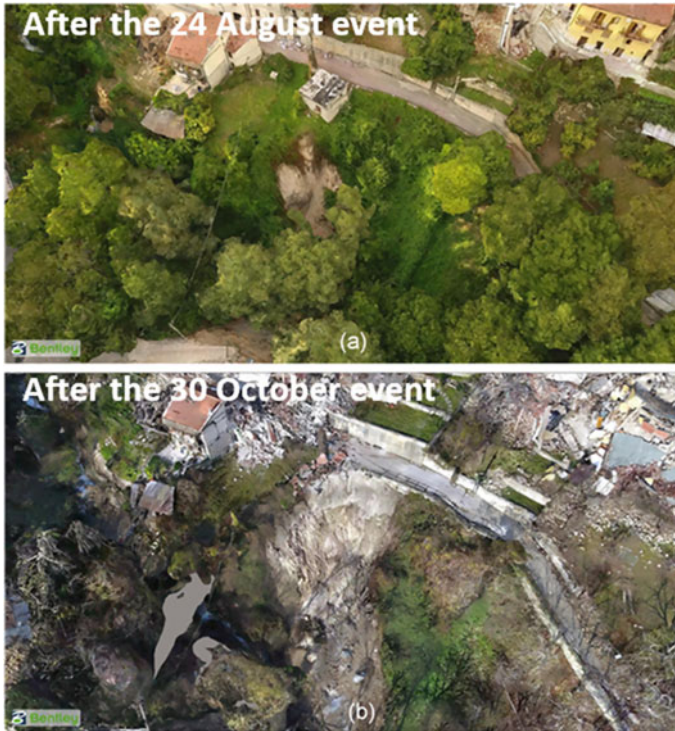
**Fig. 32** 3D model of the failure observed in area #5 in Fig. 28 following: **a** the 24 August and **b** the 30 October event (modified from GEER 2017)

Figure 32a shows a minor sloughing of the gully wall observed following the 24 August event from sUAS-based imagery (feature #5 in Fig. 28). In the same area, sUAS-based imagery captured following the October earthquake events shown that a section of the slope nearly 9 m thick and 20 m wide failed into the gully (Fig. 32b). The remaining scarp is nearly 12 m in height and stands at an angle of 52 degrees, remarkably similar to the same scarp angle that remains behind the failed lower retaining wall (i.e., Areas 3 and 4). A small residential structure that was observed

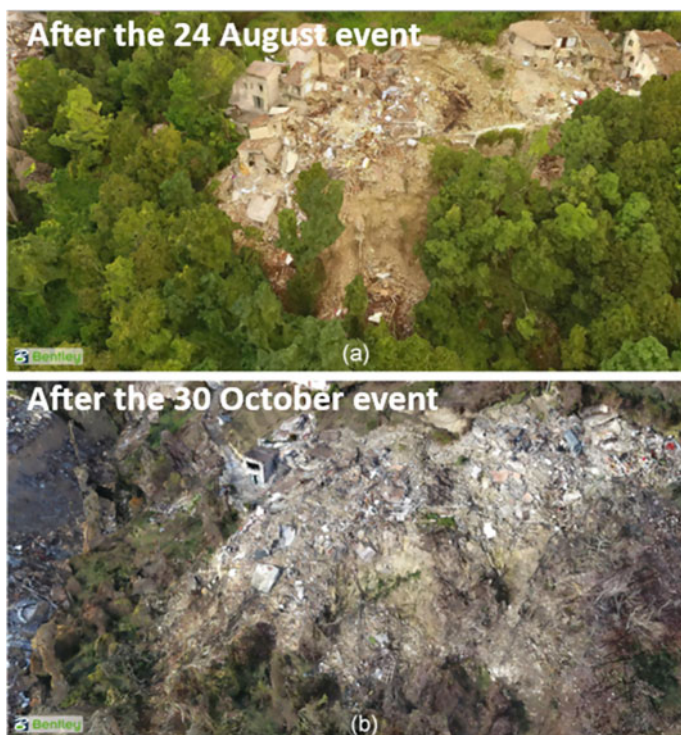
**Fig. 33** 3D model of landslide #6 following: **a** the 24 August and **b** the 30 October event (modified from GEER 2017)

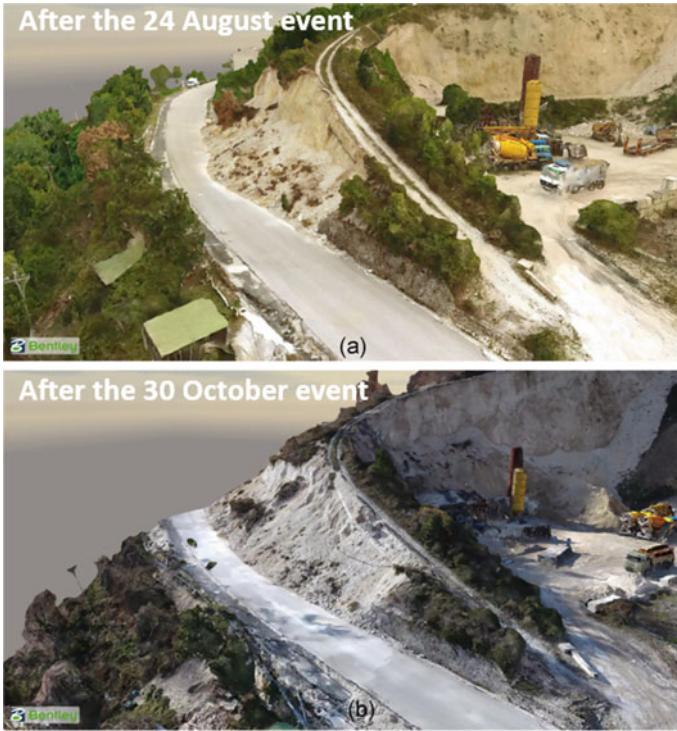
**Fig. 34** 3D model of landslide #7 and exposed pipeline following: **a** the 24 August and **b** the 30 October event (modified from GEER 2017)

The last landslide feature present in the area of Pescara del Tronto is located on the slope bounding the gravel pit on the southern upper portion of the village adjacent to the SP 129 highway (marked as #7 in Fig. 28). Observations made following the 24 August event show that the gravel pit is approximately 70 m by 90 m, and has 2.4 V:1H side slopes comprised of slightly cemented cataclasized limestone blocks interspersed in a gravelly-sandy matrix comprised of angular limestone clasts (Fig. 34a). A dirt haul road extending up and along the edge of the slope is located on

the south side of the gravel pit. The landslide exposed about 15 m of a 50 cm-diameter pipeline that was shallowly buried beneath the dirt haul road. The shape and size of the landslide remained almost unchanged following the October earthquake events as shown in Fig. 34b. However, the slope beneath the haul road degraded slightly more, causing nearly half of the haul road above the landslide to disappear. Approximately 8 more meters of the pipeline became exposed from the additional slope movements, causing the pipeline to apparently sag and bow slightly. Another smaller pipe of a few centimeters' diameter was also exposed and sagging substantially along the scarp.

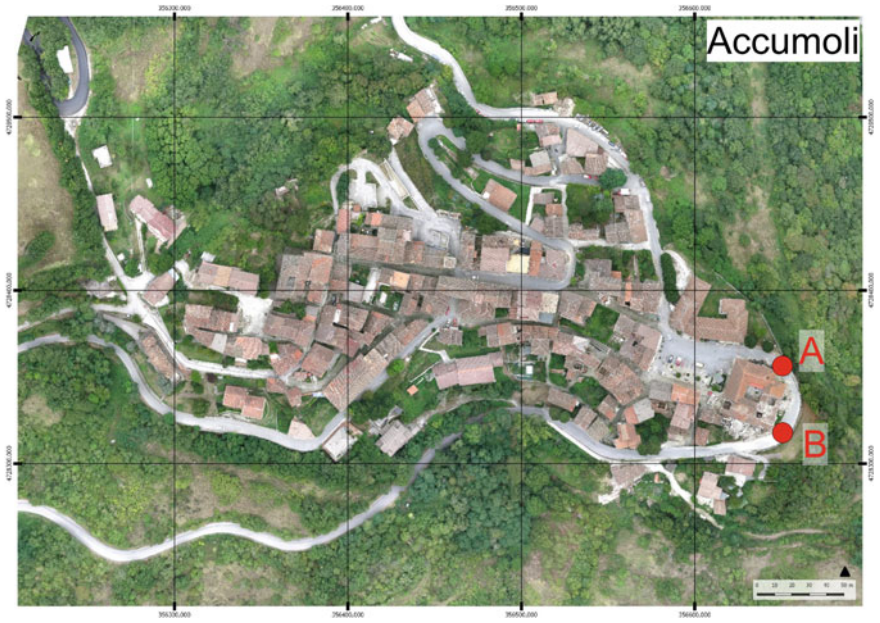
**Fig. 35** Accumoli map with locations of the landslide-related damage observed during the August and October events (modified from Lanzo et al. 2018)

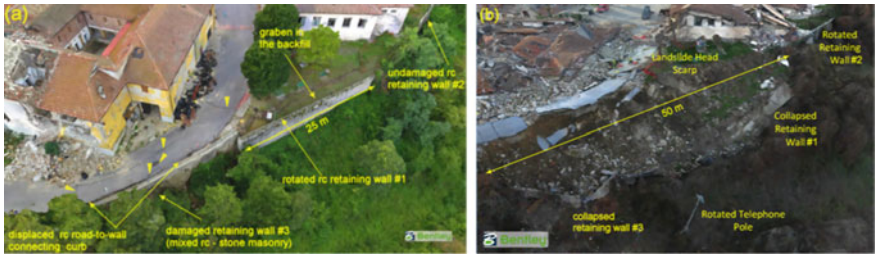
**Fig. 36** 3D model screenshots following: **a** the 24 August and **b** 30 October event (modified from Lanzo et al. 2018)
