Design and Failure Analysis of SAE-9254 Helical Suspension Spring

Abstract Helical suspension spring is used for automotive suspension in vehicles because of its high fatigue, sag resistance, high strength and toughness with fine grain structure. If the suspension spring is failed in service, it results in severe accidents, economic and time loss. The causes of helical suspension spring failure have been mentioned in the literature. The main causes of its premature failure are raw material defects, surface wear, non-metallic inclusions, improper heat treatment and decarburization. In this research work, a helical suspension spring has been designed, which is failed during manufacturing at coiling stage. The real case failed helical suspension spring has been analysed experimentally and computationally to find root causes of its failure. Through experimental results, it is concluded that the spring has been failed due to formation of transverse crack on its cross section. Martensite and bainite was also formed due to variation in surface and core hardness. Decarburization and skin hardness on the outer periphery of spring coil also play a role in the helical suspension spring's cat

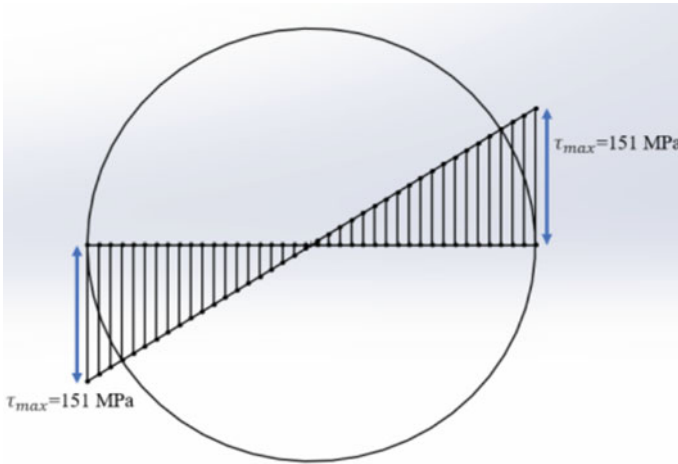
Fig. 1 Shear stress distribution in helical spring

The shear stress distribution diagram of helical spring is shown in Fig. 1. In this diagram, the shear stress at the centre is zero but as we move from centre towards the upper fibre and bottom fibre, shear stress varies linearly and reaches a maximum value of 151 MPa. The load deflection diagram is depicted in Fig. 2. In this figure, load varies linearly with deflection as load increases, deflection also increases. All the parameters of designed helical spring are tabulated in Table 2.

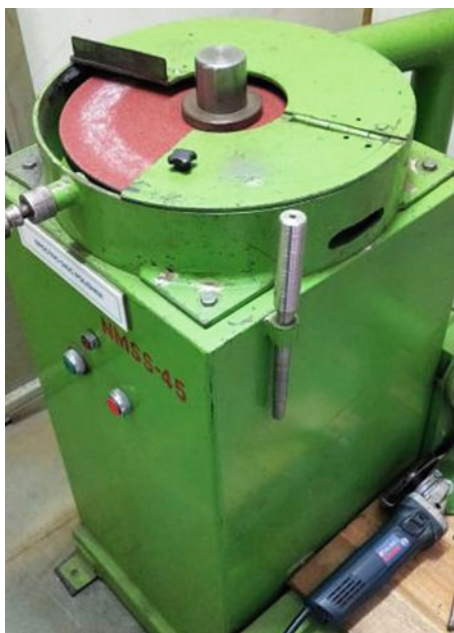
Fig. 4 Standard disc polisher

A real case failed helical suspension spring made up of silicon chromium based high strength steel grade SAE-9254 is analysed experimentally to determine the root causes of its failure. A specimen of about 12.5 mm diameter and 20 mm height is cut from the fractured end of the coil by wire cutting process. Further, the specimen was finely polished on Standard Disc Polisher machine (Fig. 4) and etched with 3% nital solution (3 mL HNO₃ in 97 mL ethyl alcohol) [6]. To determine the chemical composition of material of failed spring, AmeCare X-ray energy dispersive spectrometer (EDS) is used to for testing as shown in Fig. 5. The microstructure of the failed spring specimen and its fractured surface morphology are investigated using Metzer METZ 56 monocular inclined metallurgical microscope (Fig. 6).

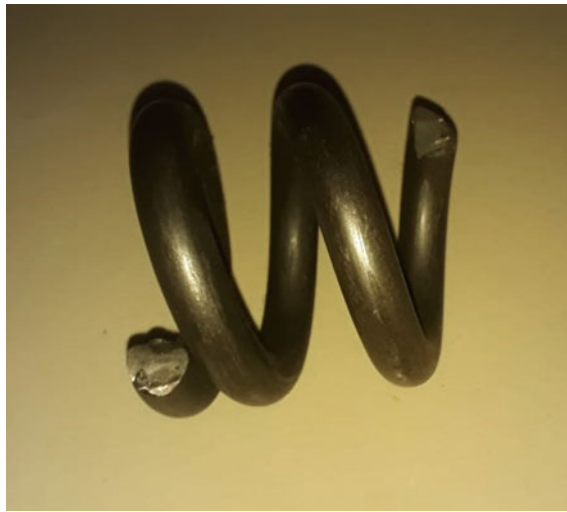
The real case failed helical suspension spring made up of high strength steel SAE-9254 is shown in Fig. 10. On visual examination, it is found that there are longitudinal cracks at the outer periphery of spring coil as shown in Fig. 11. Figure 12 depicts

**Fig. 10** Failed helical suspension spring

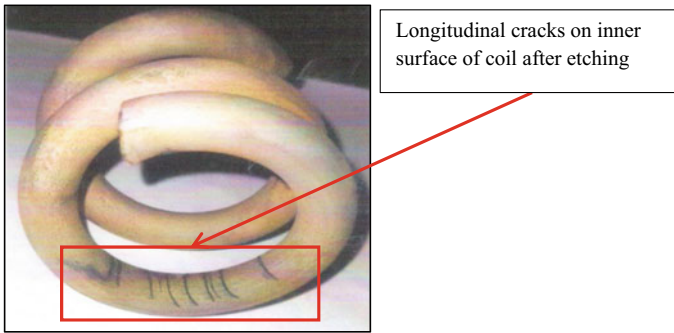
Fig. 13 Longitudinal cracks on inner surface of coil after etching

The failed helical suspension spring is etched with 3% nital solution (3 mL HNO₃ in 97 mL ethyl alcohol) for 1 h duration (Fig. 13), which removed the phosphate layer from coil and revealed multiple longitudinal cracks on the inner periphery of the spring. Further, on examination of outer periphery, skin hardness is found with decarburization that leads to the formation of internal crack during coil forming operation.
