Chapter 5

Sub-structure Strengthening

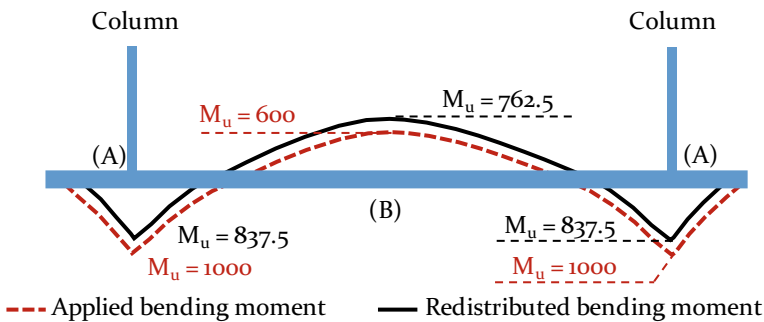
It is recommended to redistribute the bending moment so that sections at the columns, “A”, shall have a bending moment equal to their capacities “837.5 kNm”, while the bending moment at section “B” shall be accordingly increased, as shown in Fig. 5.6. This is mainly since increasing the steel reinforcement at the bottom of the raft is not possible.

Fig. 5.6 Moment redistribution of the raft

The increased bending moment at section “B” = $1000 + 600 - 837.5 = 762.5$ kNm per meter.

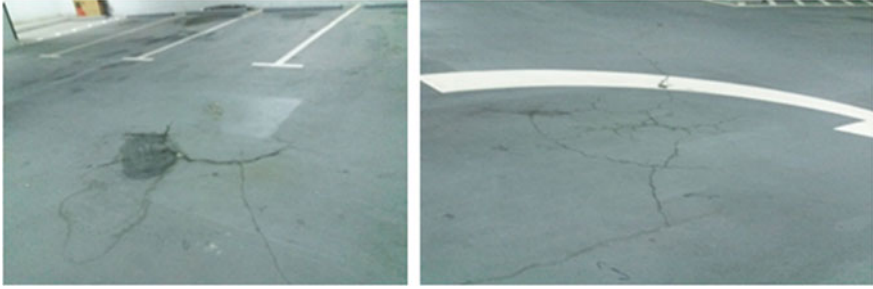
Fig. 5.8 Punching shear cracks in the raft

cracks were due to punching shear of the raft supporting the outer piles. Figure 5.8 shows picture of the punching shear cracks at the top surface of the raft.

The observed crack patterns for two piles in the raft (see Fig. 5.8) clearly draw a map of the pile location and its circumference, which indicates a mode of failure that lies in between the aforementioned failure modes. It is obvious that the failure planes are located along the pile circumference; therefore, any retrofitting scheme should have proper amount of shear reinforcement crossing that plane. Therefore, the concept of the foundation retrofit relied on enhancing its shear capacity by inserting steel reinforcement crossing the existing and anticipated cracks. The repair procedure is summarized as follows:

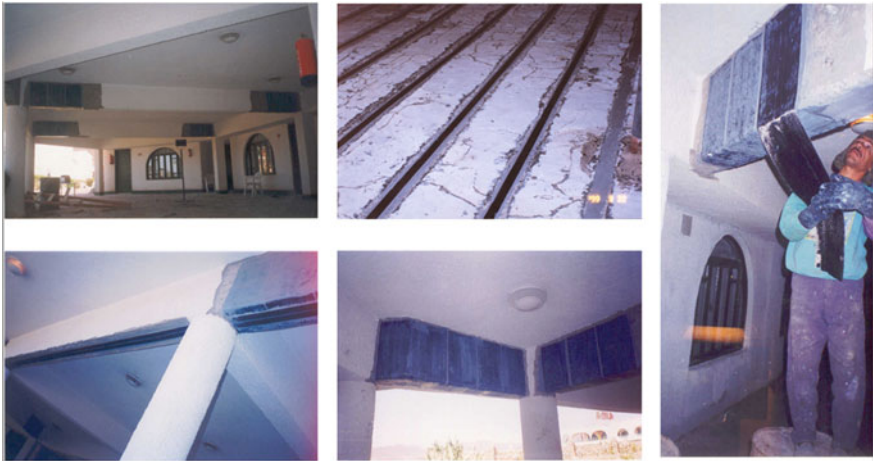
The second phase of the strengthening scheme was to restore the building and increase the structural capacity of both the slabs and beams to resist higher live loads. CFRP strips and laminates were used to strengthen the slabs and beams in flexure and shear, as shown in Fig. 5.16. The measured crack width of the slabs and beams was used to estimate the tensile stress in the steel reinforcement. The required area of CFRP was calculated to allow for double the live load, accounting for the increase in the stress of the steel reinforcement.

Fig. 5.16 Strengthening of the superstructure with CFRP
