Challenges of Earthen Cofferdam in Deep Excavations for Waterfront Structures, a Case Study

Abstract This paper is a case study of an earthen cofferdam, constructed for a deep excavation at intake location in River Aaundha, Maharashtra, India. A 12 m (39 ft) deep excavation was made to construct the intake well. The natural soil profile at this location is clay followed by rock. An earthen Cofferdam of a maximum height of 7 m (23 ft) was made around the periphery of the excavation. Cofferdam embankment and excavation slopes were analysed using the finite element software PLAXIS-2D. Clayey sand was proposed as a filling material during design, but clayey soil was used for the embankment formation during execution. The embankment was built up to 5 m in height in July 2017 and completely submerged due to monsoon. In February 2018, the embankment height was raised to 7 m (23 ft) by filling the soil over the existing submerged embankment. After a few days of completion of the Cofferdam, the inside slope of the embankment had started sliding due to continuous dewatering. The design and execution of deep excavation with earthen Cofferdam for waterfront structures are challenging. The sel

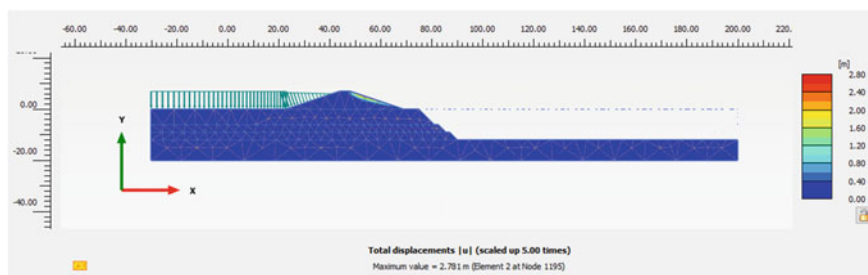
Fig. 1 Critical slip circle in steady-state seepage condition

Cofferdam embankment was analysed considering clayey sand (refer to Table 2) as filling material. Embankment along with excavation was simulated with PLAXIS software for steady-state seepage condition and sudden drawdown condition. Mohr–Coulomb constitutive model and drained shear strength parameters were used in the analysis. The critical slip circle was observed in the downstream side in case of a steady-state condition (Fig. 1), whereas, in sudden drawdown, it was observed in the upstream side (Fig. 2). Minimum factor of safety required for steady-state seepage and sudden drawdown condition was 1.5 and 1.3, respectively, as per IS: 7894. Refer to Table 3 for analysis results (Figs. 3 and 4).

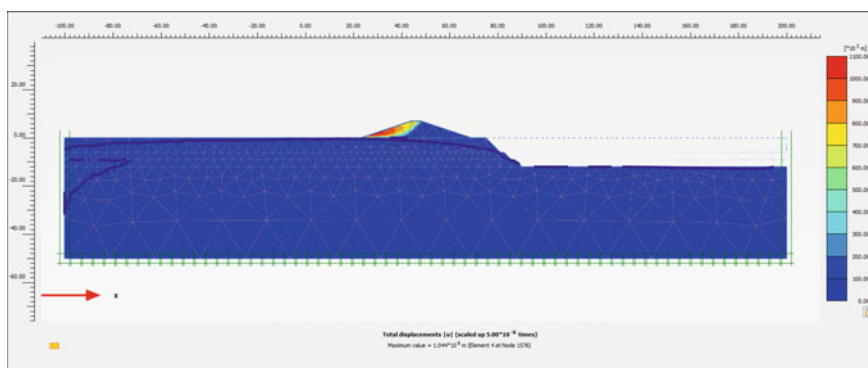
Fig. 2 Critical slip circle in sudden drawdown condition

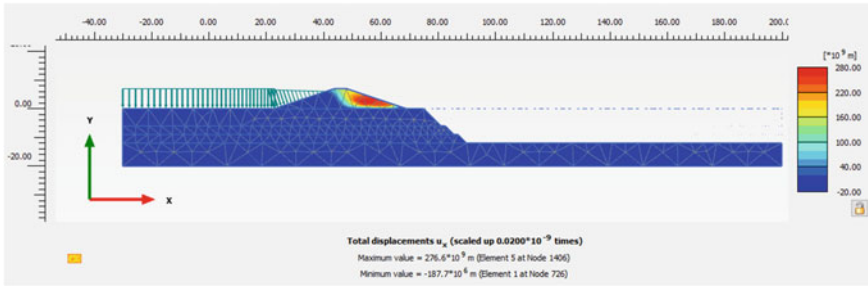
Fig. 3 Critical slip circle in steady-state seepage condition under safety analysis

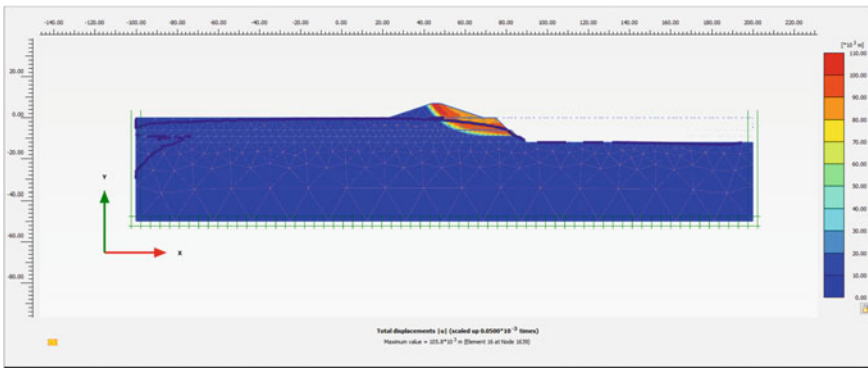
Fig. 4 Critical slip circle in sudden drawdown condition under safety analysis

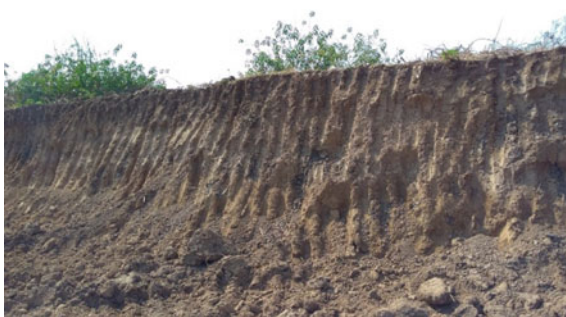
Clayey sand proposed for embankment formation and design was also made accordingly. Project location was surrounded by black cotton soil; hence, the Cofferdam was made with available clayey soil. Borrowed soil for embankment formation is indicated in Fig. 5.

Fig. 5 Borrowed soil for embankment formation

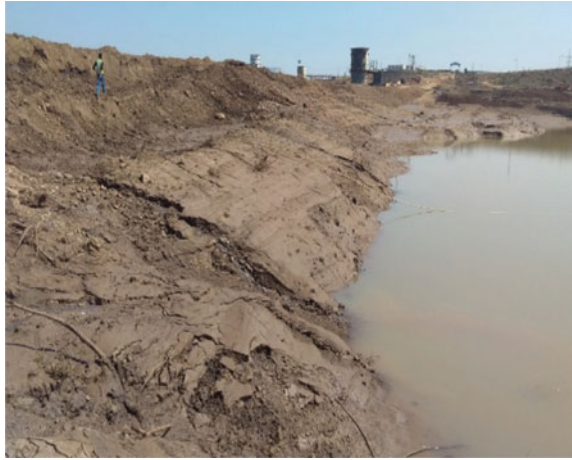
After completion of the embankment formation, immediately dewatering was started with six numbers of 60 HP pumps and the water level in the inside pool was reduced from RL + 587 m to +581 m within 7 days. On the eighth day inside slope, embankment soil had started sliding slowly downstream (Fig. 6).

- (a) The Cofferdam was designed as the proposed fill material such as clayey sand, but the actual Cofferdam was made with clayey soil.
- (b) The embankment was constructed in two seasons, in the first season, it was submerged and in the next season, embankment was made over the existing

Fig. 6 Soil is prone to slide at downstream

submerged embankment. The soil became very soft due to submergence and a weak interface had developed between the submerged embankment and dry embankment.

- (c) Continuous dewatering resulted in sudden drawdown conditions and excessive pore water pressure developed in the embankment, finally led to downstream side soil sliding.

- (a) Dewatering was stopped immediately after the sliding was observed.
 (b) The embankment was strengthened by increasing the top width from 4 m (13 ft) to 7 m (23 ft).
 (c) Proper Compaction was done by Roller (Fig. 7).
 (d) Downstream side soil was prone to slide was removed completely (Fig. 8).
 (e) The excavation was started after 15 days, as the water level reduced on the upstream side due to the summer season has begun.
 (f) The project was completed in the same season and Cofferdam was removed.

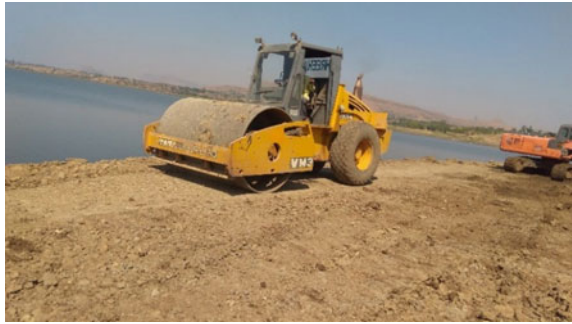
Fig. 7 Roller compaction of soil filled on upstream side

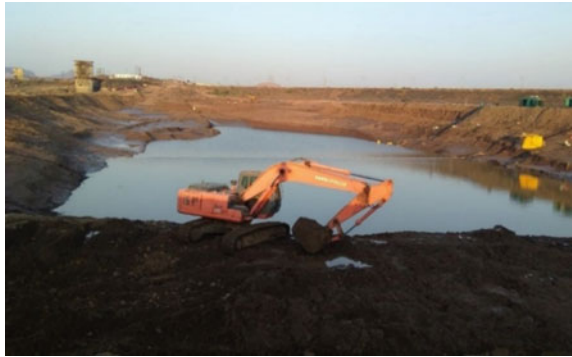
Fig. 8 Removing the soil, prone to slide
