Analysis of the Effect of Vibration from Footfalls on Office Building

Tuan Norhayati Tuan Chik, Shurl Yabi, Nor Azizi Yusoff
and Mohd. Imran Ghazali

Keywords Vibration · Footfalls · Multi-storey · Dynamic analysis

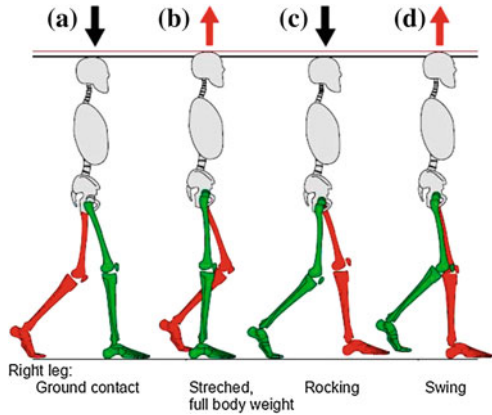
Fig. 1 Phases of legs and feet during walking [4]

Vibration from footfall is induced from the movement phases of legs and feet during walking. Hence, the body weight is transferred to the floor. Figure 1 shows the movement phases of legs and feet during walking.

When the right foot touches the ground with the heel, this is the starting point of the contact forces and when the right leg is stretched, the full body weight is transmitted to the floor. Next, the right foot will rock while the left leg swings forward. This is called “Rocking”. And finally, the left foot touches the ground while the right leg swings forward.

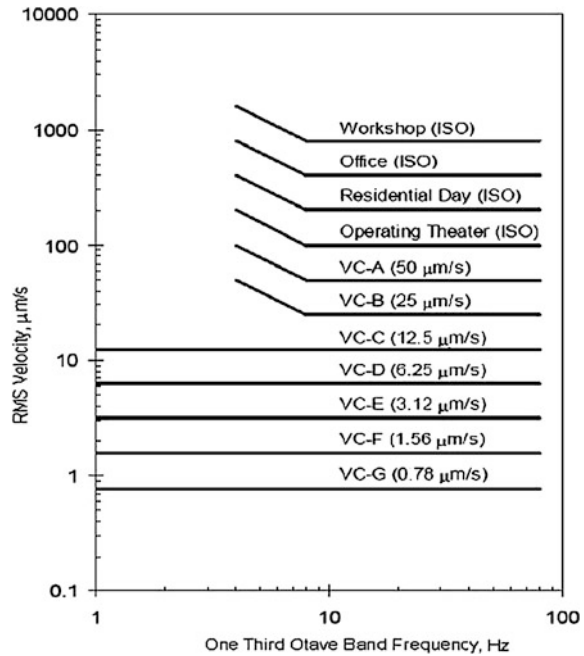
Fig. 2 Generic vibration criteria (VC) curves for vibration sensitive equipment [7]

Vibration criteria curves is important as a guideline in designing facilities such as buildings and instruments that are sensitive to vibrations [4]. Each curve of the criteria are associated with line width or size detail which is a representation of the device capabilities [7] as shown in Fig. 2. The form of the criteria is taken through a

set of one-third octave band velocity where the generic vibration criteria ranges from ISO for the effects of vibration on human occupants in building to VC-G for evaluation only [4].

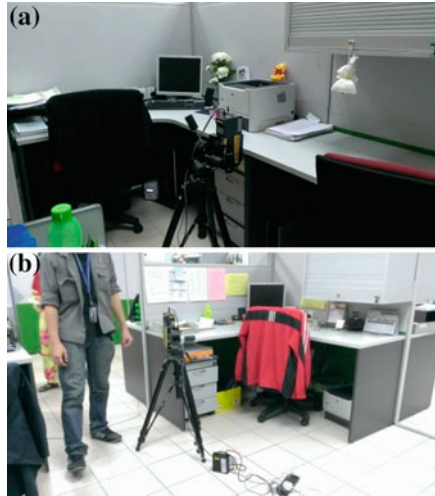
Fig. 3 a Laser Doppler vibrometer (LDV 100). b Measurement at site

Field measurement was conducted to obtain the signal data for this study by using the Vibrometer equipment. The amplitude of the vibration produced by footfalls is measured during office hour on working days. Figure 3a shows the Vibrometer equipment used in this study, Laser Doppler Vibrometer (LDV 100) and Fig. 3b shows the location of the measurement in the office building, while Fig. 4 shows the side view of the Registrar office building.

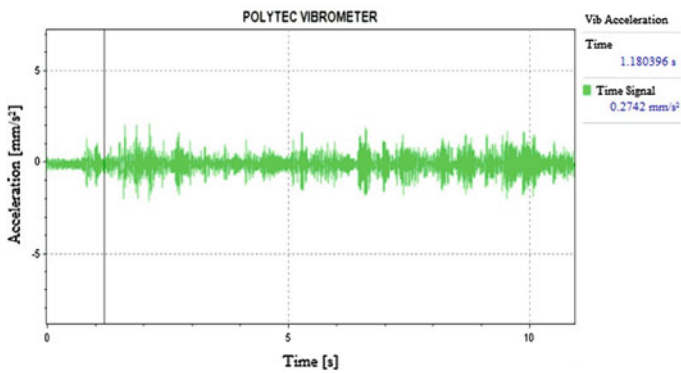
Fig. 5 Vehicles vibration waves measured by LDV 100

The footfall vibration measurement conducted inside the building produced the vibration waves as shown in Fig. 5. Next, this raw data must be processed and analyzed using specific algorithm in Mathematics Laboratory (MATLAB) to obtain

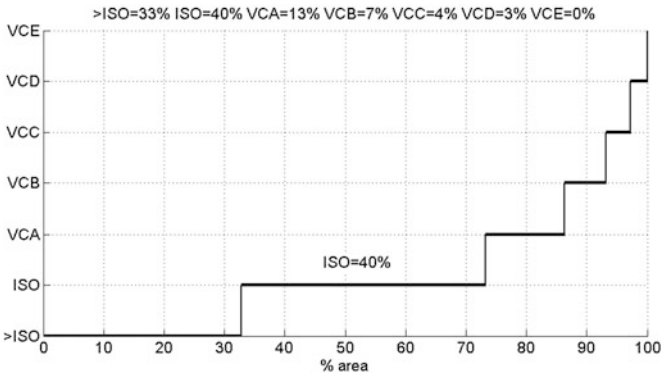
Fig. 10 The vibration criteria value on the third floor of Registrar office building

generic criteria guideline [4], 38 % ISO for first floor, 39 % ISO for second floor and 40 % ISO for the third floor. The vibration response for third floor is shown in Fig. 10.
