Cultural Heritage Science

Shigeo Aoki · Yoko Taniguchi ·
Stephen Rickerby · Michiyo Mori ·
Takayasu Kijima · Su Bomin ·
Fumiyoshi Kirino *Editors*

Conservation and Painting Techniques of Wall Paintings on the Ancient Silk Road

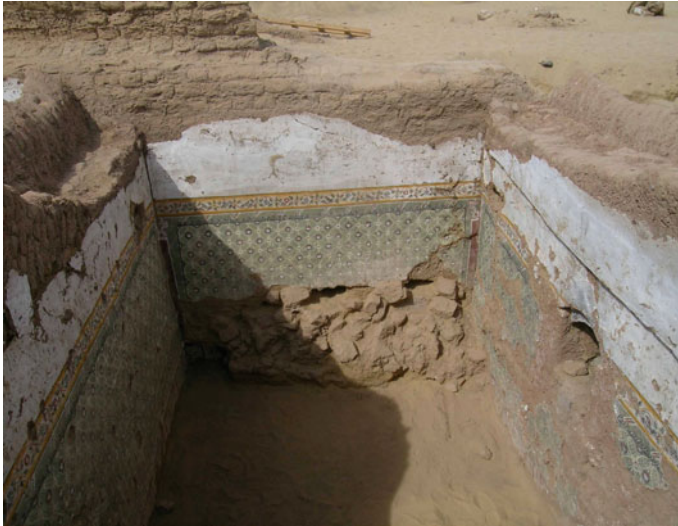
Fig. 1.1 Amheida, Dakhleh Oasis, Egypt, excavated Roman house, first century AD. The room shown here was excavated to reveal its decorative wall paintings for the first time in centuries. The exposure of the original materials (including the mud-brick support) to new environmental conditions led to sudden deterioration, which was addressed by back-filling the site. This example demonstrates how wall paintings are a vulnerable physical interface for environmental deterioration (© *Stephen Rickerby*)

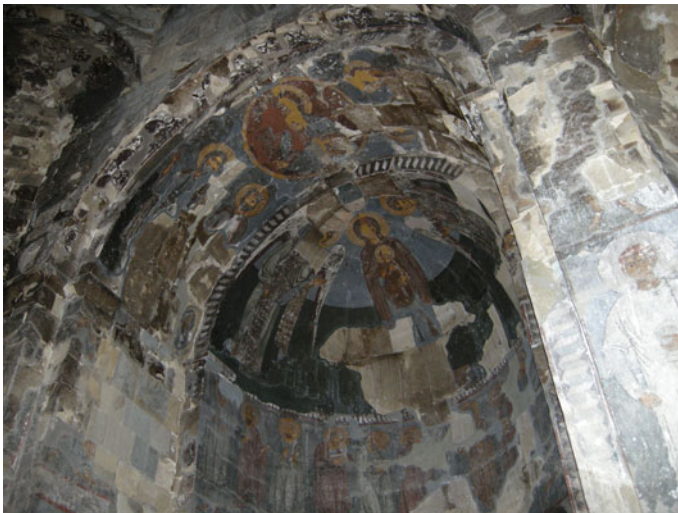
Fig. 1.2 Ateni Monastery, Georgia, eleventh century wall paintings. The scheme here is vast and survives in a discontinuous state. Consequently, it is extremely difficult to make sense of the diverse conditions that are present and to diagnose causes of deterioration. These circumstances are typical of many wall paintings (© *Stephen Rickerby*)

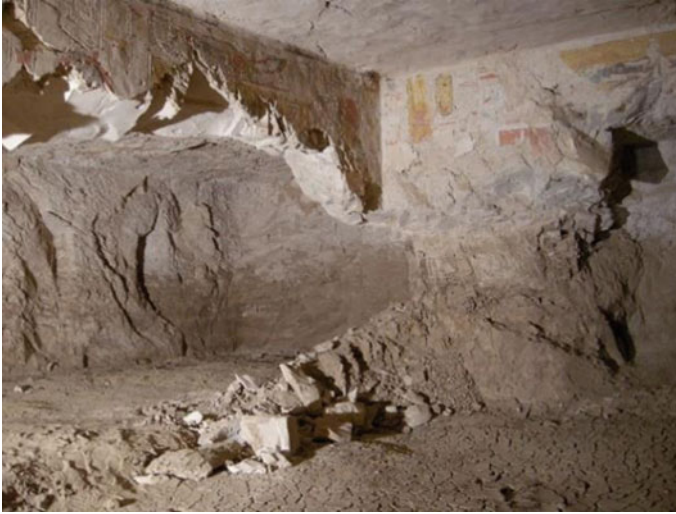
Fig. 1.3 Tomb of Nebattauy (QV60), Valley of the Queens, Luxor, Egypt, 19th Dynasty. Periodic flash floods have had a devastating effect on the expansive clay-rich limestone geology of the tombs in the Valley of the Queens, leading to catastrophic rock collapses and loss of painting, as shown here. Inherent geological issues at wall painting sites such as this often present problems that cannot be eradicated (© *Stephen Rickerby*)

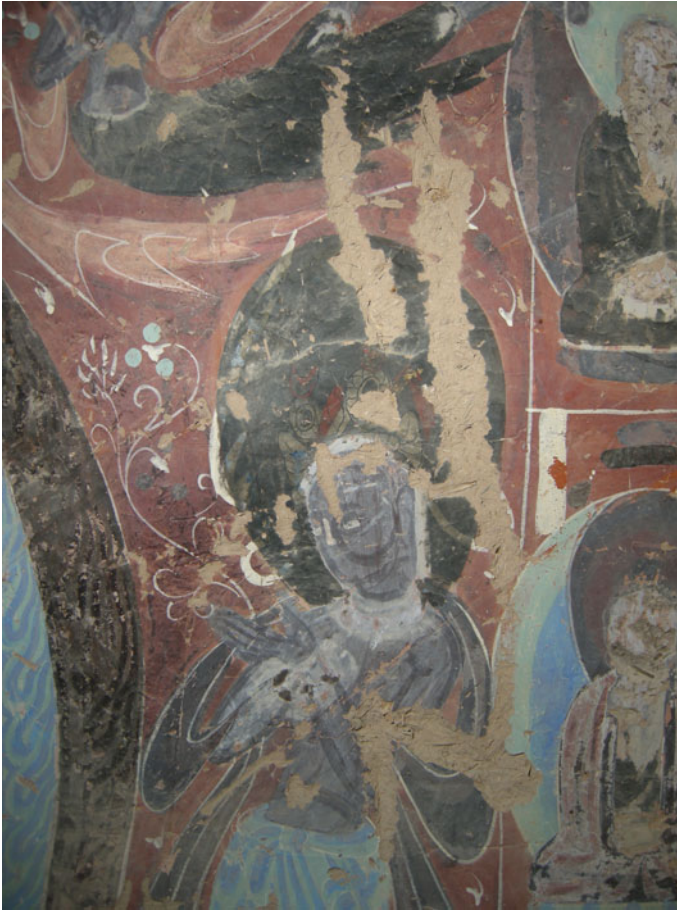
Fig. 1.4 Mogao Grottoes, Dunhuang, China: Cave 260, Northern Wei, c. 525. In this small area of the scheme, the diverse materials of the painting have undergone a wide range of deterioration processes, reflecting aspects of their original technology, the passage of time and circumstances of physical history. Diagnosing these complex changes requires a rigorous scientific approach (© *Courtauld Institute of Art*)

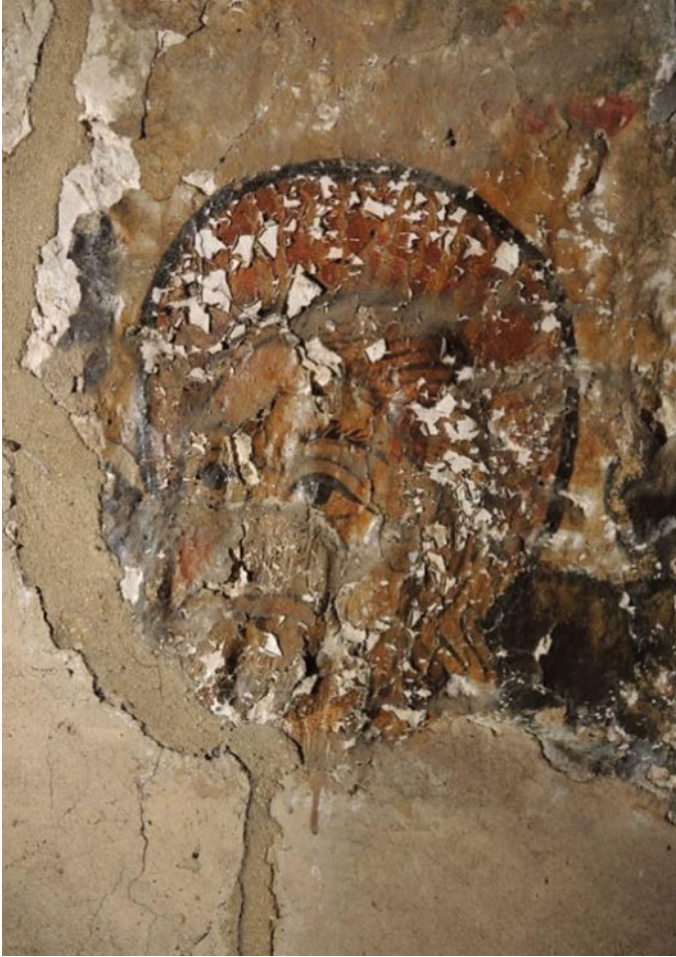
Fig. 1.5 Church of St Mary the Virgin, Cropredy, England, fifteenth century wall painting. This medieval wall painting was coated with an organic varnish, probably in the late-nineteenth or early-twentieth century, in an effort to preserve it. This has badly discoloured and is now promoting severe paint flaking and loss, as this detail shows. Wall paintings very quickly reach states of complete condition breakdown as a result of poor remedial treatment choices (© *Stephen Rickerby*)

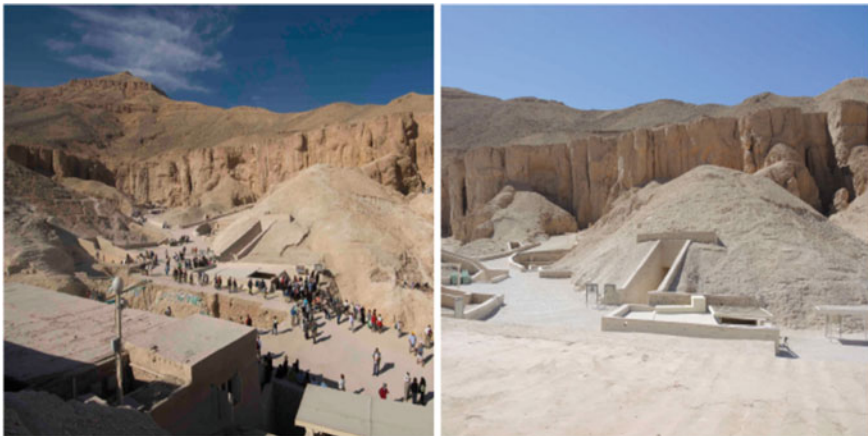
Fig. 1.6 Tomb of Tutankhamen, Valley of the Kings, Egypt, 18th Dynasty. The pressures and expectations associated with mass tourism are a major determinant of conservation outcomes at important cultural heritage sites. But tourism is not a constant. In 2009, a year before Egypt’s ‘Arab Spring’, tourism to Tutankhamen’s tomb in the Valley of the Kings was at record levels (left image). But between 2010 and 2017, this dropped dramatically and only recovered very slowly (right image) (© Stephen Rickerby)

On the other hand, it is also unwise to imagine that tourism is a constant, given economic uncertainties and geopolitical instability (Fig. 1.6). Also, not all projects that select cultural sites for their development focus can be successful: there is not an automatic link between tourism and economic growth and poverty reduction. These contradictions expose the shaky foundations of our confidence in such models. But for now, tourism is a major determinant of conservation outcomes. Wall painting conservation projects incorporate more components related to this than ever before, including tourism infrastructure, environmental mitigation measures and lighting initiatives. While some of these activities may be seen as preventive and passive measures, in the broader context they do not tackle the actual *cause* of our problems, which is tourism itself.

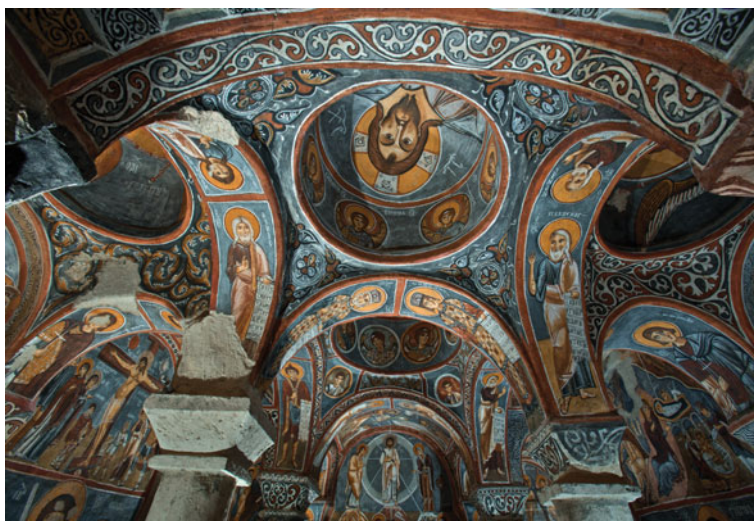
Fig. 3.5 Karanlık Church, Göreme Open Air Museum

Churches in Cappadocia were made by excavating structures into the tuff rock. Carving was made easy by the relative softness of the rock, which facilitated the creation of desired architectural plans. At the same time, great care had to be exercised, as mistakes could not be recovered: if a dome or pillar broke during carving, this could not be rectified (Fig. 3.5).

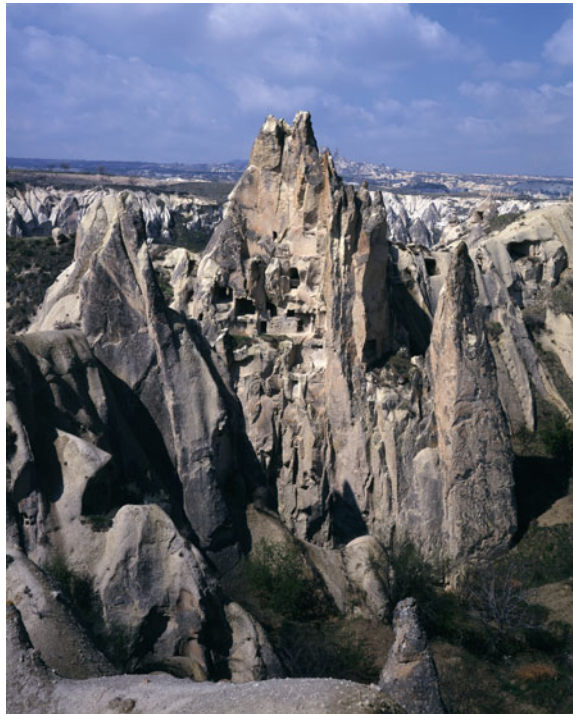
Fig. 3.7 **a** Virgin Mary Church in Göreme Valley.
b Virgin Mary Church in Göreme Valley. Elevation mapping of the structural and macrostructural cracks that have occurred and still occur in the structure of rock churches and other surfaces remove

The rock-cut churches of the Göreme Valley are exposed to various forms of deterioration, and for this reason it was chosen as the primary zone for structural conservation and rescue of the wall paintings (Fig. 3.7a, b). Climatic factors such as wind, rain and frost cause fracturing and cracking of the surface of the tuff rocks. Rainwater dispersed from the surrounding plains runs over the soft rock causing rapid erosion and formation of deep cracks. In winter, water that leaks through these cracks into

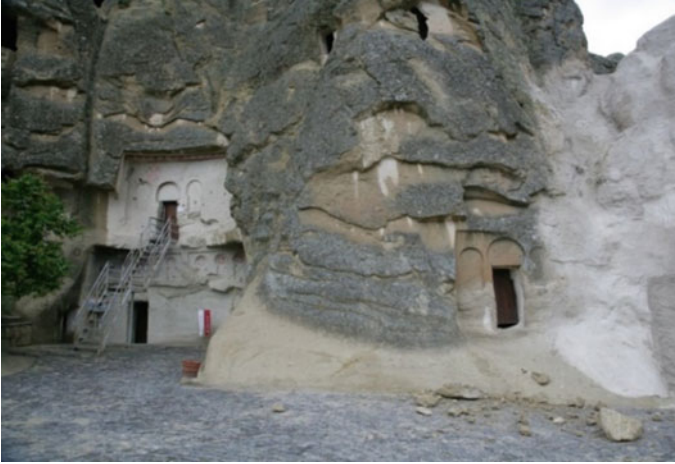
Fig. 3.8 a Çarıklı Church, Göreme Open Air Museum. Climatic factors such as wind, rain and frost cause fracturing and cracking of the surface of the tuff rocks. **b** Çarıklı Church, Göreme Open Air Museum. Loose rock is a potential danger for visitors

deeper grooves and crevices causes tension within the rock, as a result of freeze-thaw cycling (Fig. 3.8a, b).

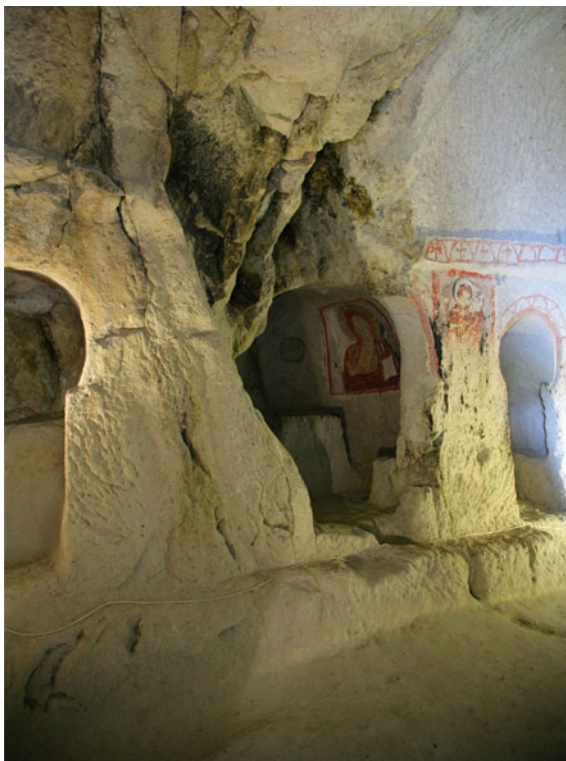
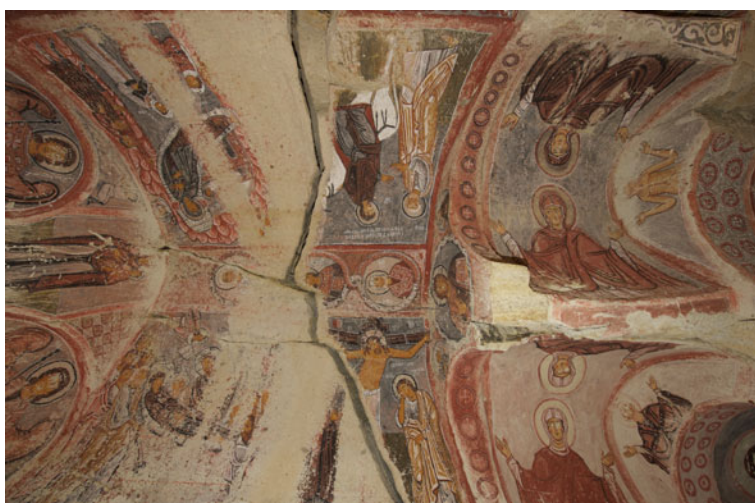
Fig. 3.9 a Environmental deterioration causes the tuff rock to exfoliate, leading to rock collapses from the vaults. **b** Natural cracks are an inherent geological feature of the tuff rock. In the process of carving, they were exposed and made worse. **c** Plan of the Virgin Mary Church, Göreme, showing crack formations, which can extend from the outer surface to the interior

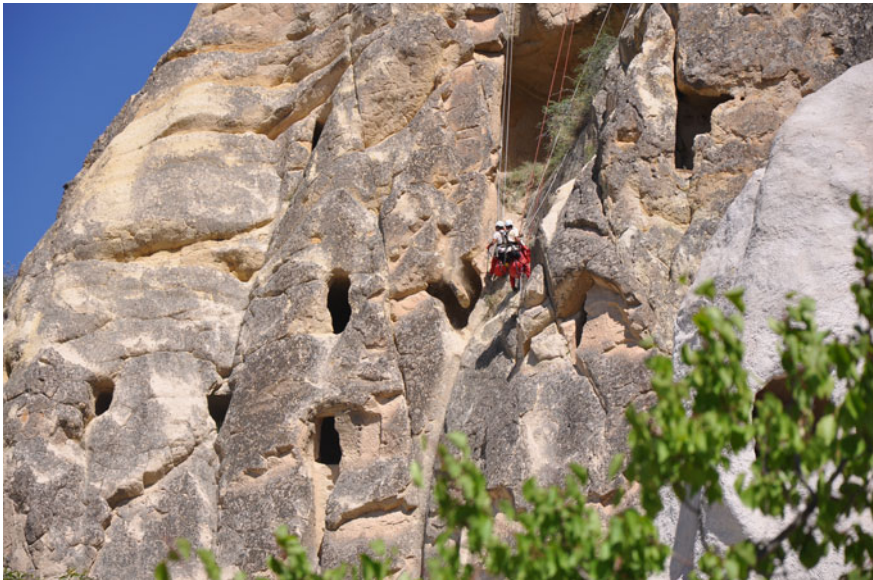
Fig. 3.10 Hidden cracks and loose rocks around the Çarıklı Church complex were completely cleaned by expert mountaineers

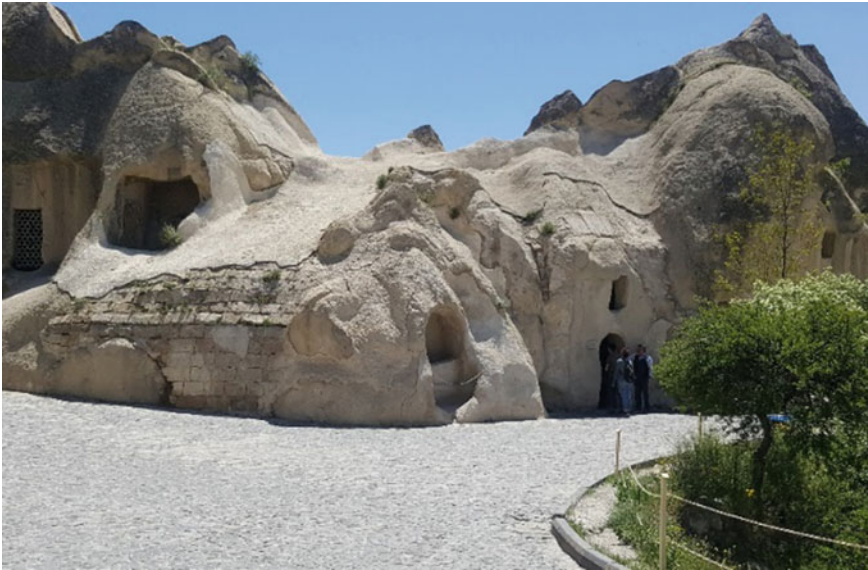
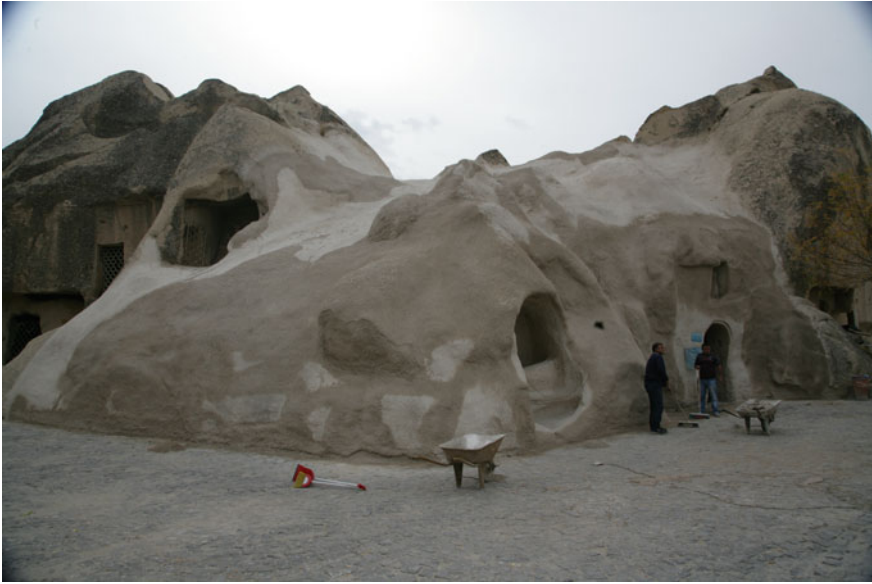
Fig. 3.12 a St. Basil Church, Göreme Open Air Museum. Before recent external treatment. The application of external renders to rock-cut churches in the past has not always been successful. **b** St. Basil Church, Göreme Open Air Museum, after external treatment

A critical issue is how best to protect exterior rock surfaces. The application of external renders to rock-cut churches has not always been successful. Renders of the wrong density that reduce permeability tend to fail, leading to their separation and fragmentation. Within the Göreme Open Air Museum site, several rock-cut structures with eroded ceilings have been protected in this manner (Fig. 3.12a, b). The approach of covering all rock surfaces with a mixture of hydraulic lime, tufa dust

and riverbed sand has not been satisfactory in the long term. Over time, small cracks became larger and deeper, resulting in new deterioration. This occurred to the wall paintings in the Elmalı and Barbara complexes, as rainwater from above infiltrated through deep cracks and crevices in the rock. In subsequent preservation efforts, a different approach has been adopted. Eroded areas on the exterior are first repaired with suitable mortar. Then a wire-mesh is laid over the rock surface to provide a visible control of the depth of erosion. Finally, the top layer is again covered with mortar. This method has had good results in the Church of St. Basil (Fig. 3.13).

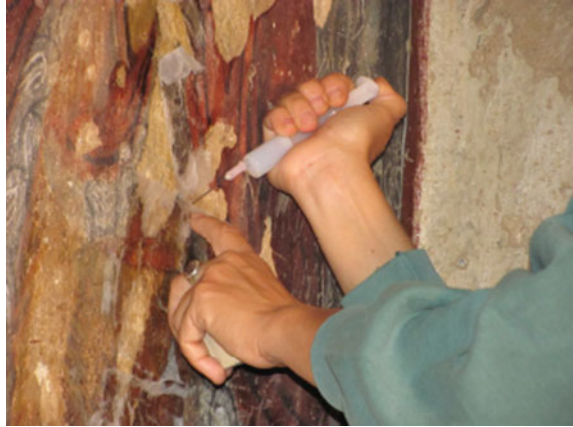
Fig. 3.13 In several churches, natural cracks caused by rain and frost eventually lead to separation and loss of important elements of the rock-cut surfaces. Specialist injection grouting is required, as shown here

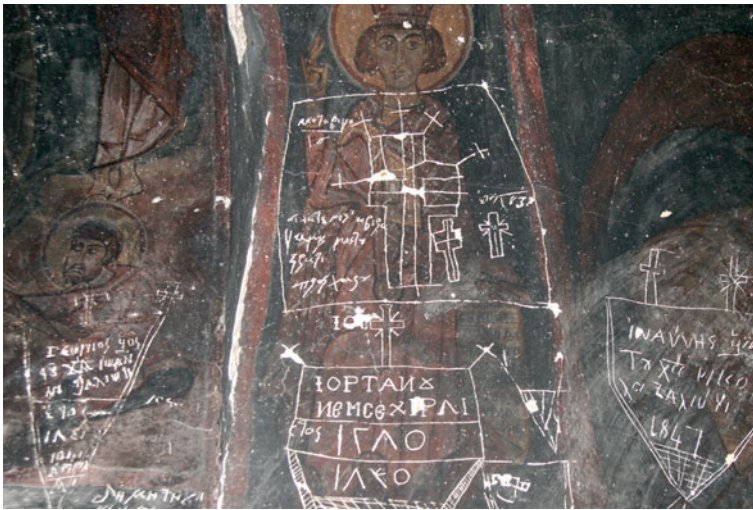
Fig. 3.14 Vandalism is another primary concern. In many cases, contemporary vandalism is encouraged by the presence of historical examples

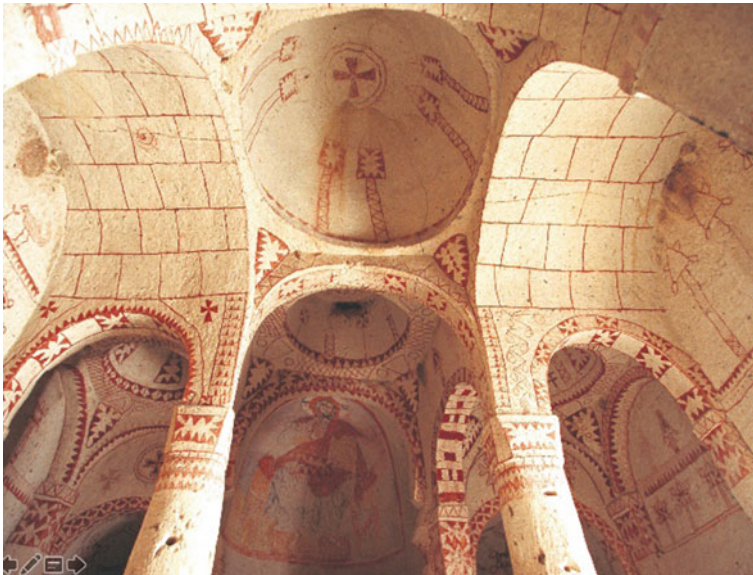
Fig. 3.15 St. Barbara Church. Painting applied directly onto the bare rock without an intervening layer of plaster

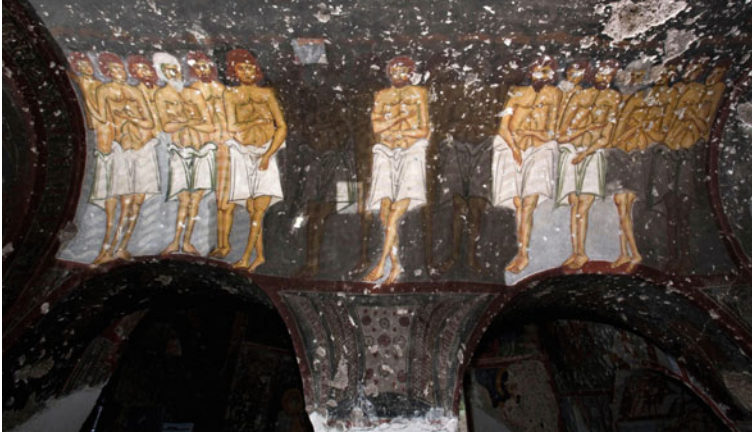
Fig. 3.16 a Restoration of the Forty Martyrs Church near Ürgüp. **Before cleaning.** **b** After cleaning

Restoration of the Forty Martyrs Church near Ürgüp was accomplished between 2009 and 2013, under the leadership of the Nevşehir Museum Administration and the supervision of Prof. Maria Andaloro of Tuscia University [32, pp. 120–135, 33]. The wall paintings were found to be in a very good condition underneath a thick layer of soot from fires, which had provided them with protection. Cleaning was carried out during a comprehensive restoration project (Fig. 3.16a, b). Aqueous and reagent (ammonium bicarbonate) cleaning procedures were employed, applied either directly or through intervention layers, or in cellulose poultices, to address differences in condition and original technology. The timings of the applications were critical for obtaining homogeneous results.

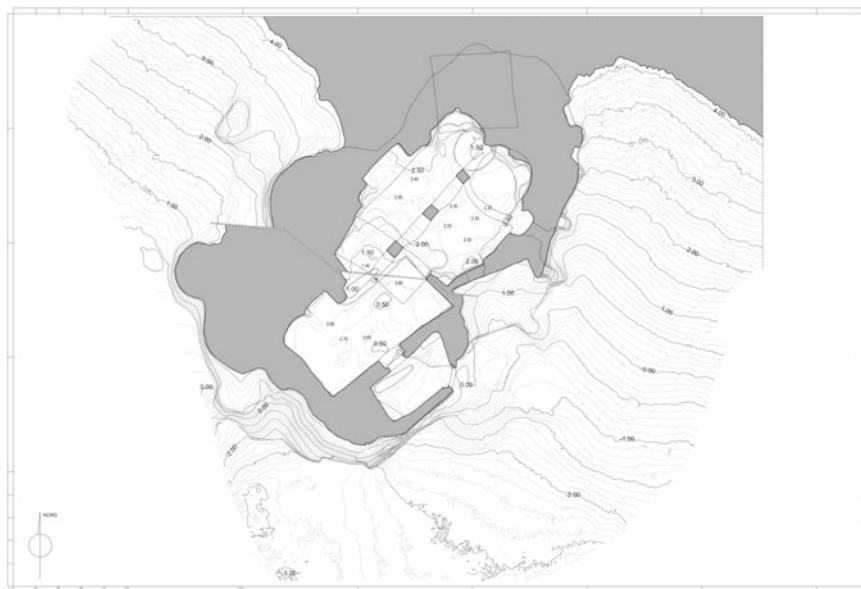
Fig. 4.5 Şahinefendi, church of the Forty Martyrs. Planimetry of the church of Şahinefendi (M. Carpi ceci, Sapienza University)

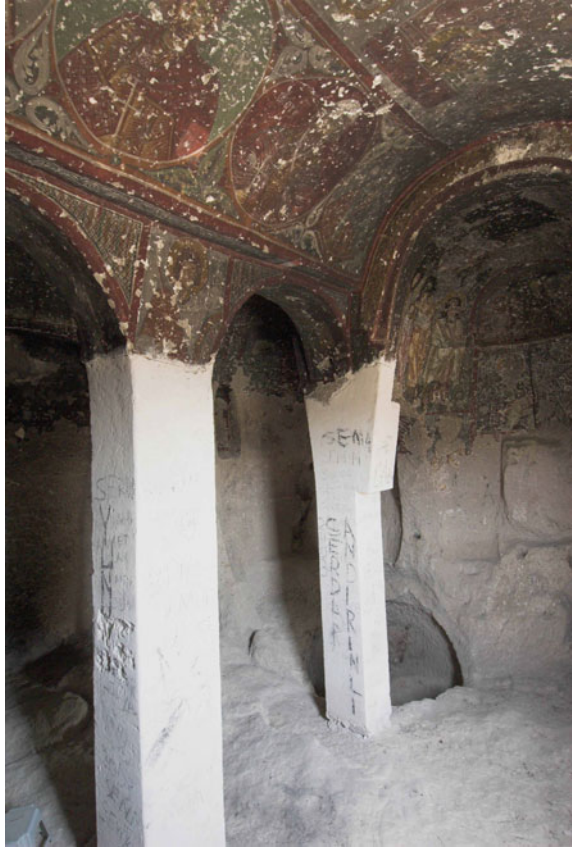
Fig. 4.6 Şahinefendi, church of the forty Martyrs. View of the south aisle and south apse before restoration

At the start of the project in 2006, the entire wall painting programme was concealed by accumulated smoke blackening, produced from fires lit during agricultural re-use of the interior, which impeded legibility of the schemes and concealed their chromatic quality (Figs. 4.6 and 4.7). The cleaning operations restored their intense colour and legibility (Figs. 4.9 and 4.10). During this process, close observation of the paintings from the scaffolding made it possible, as mentioned above,

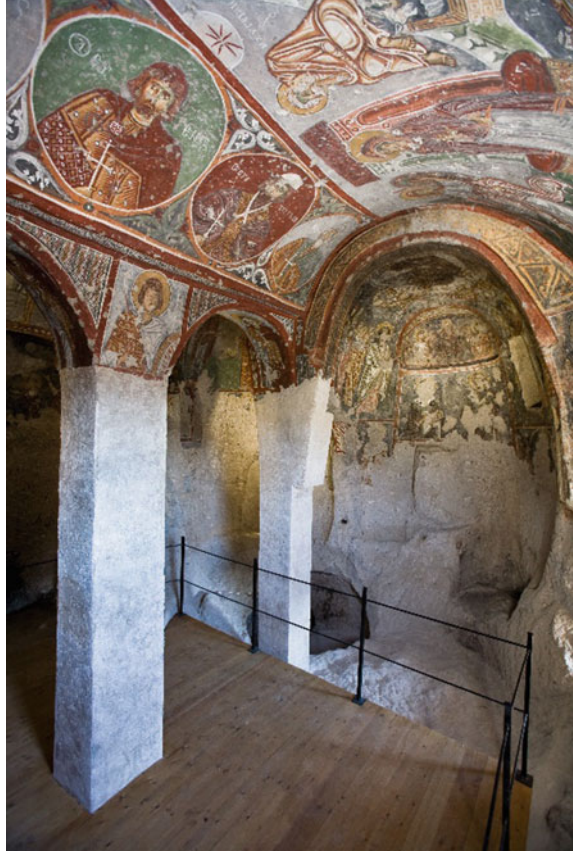
Fig. 4.7 Şahinefendi, church of the Forty Martyrs. View of the south aisle and south apse after restoration

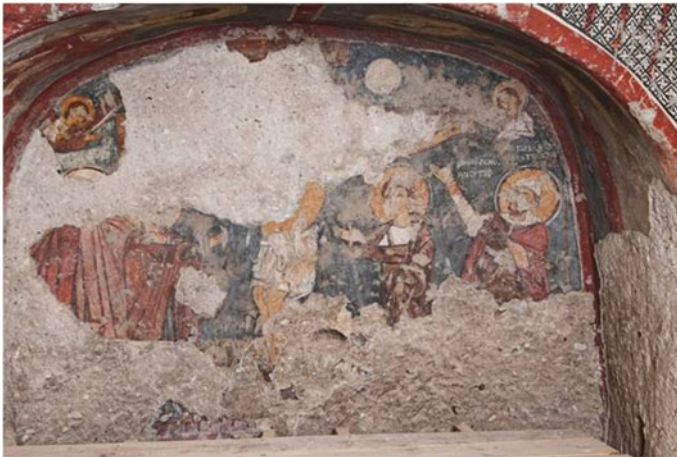
Fig. 4.19 Şahinefendi, church of the forty Martyrs. North nave, niche with the Crucifixion (Phase IV)

The last painting phase at Şahinefendi (phase IV), which is dated to 1216–1217 (Figs. 4.18 and 4.19), differs significantly from the others. It is one of only a few other examples of this painting approach from this era, and from the same area, which also include the Church of the Archangel in Cemil (Figs. 4.33 and 4.34) and the Church of Taşkinpaşa. Compositional and stylistic similarities with the Church of Taşkinpaşa are also marked. The main technical difference, with respect to the previous phases, is due to the presence in the plaster of material extracts from local rocks and very thin vegetal fibres, which were added to improve its working properties and performance characteristics [42]. This phase is also distinguished by the use of specific pigments, such as Jarosite yellow, which have rarely been found in Cappadocian wall paintings.

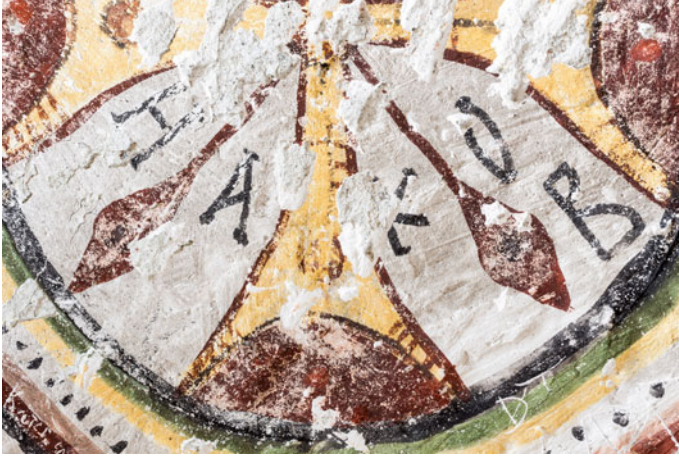
Fig. 4.22 Gomed valley, church of San Basil. Detail of apse painting

(Fig. 4.27), while some shades of yellow combine yellow ochre (goethite) with lead oxide (litharge) (Fig. 4.22) [18, 35, 36].

Preparatory layers are made of thin layers of gypsum-based plaster, mixed free of aggregates. This was a widespread practice in the region and characterizes above all this phase of Cappadocian painting [35, 36]. The brilliant white of the gypsum plaster provides the background for subsequent paint layers. Surface marks left by spatulas and brushes in the plaster provide evidence of working procedures, which was very likely applied as a malleable and dense paste. At almost all the sites from this period analysed, painting schemes comprise two plaster layers: the first layer was spread mainly with a trowel or spatula, so that it would tenaciously adhere to the rocky support; the second layer is thinner and smoothed on the surface with wide brushes. A variant of this practice is found in the decoration of the north apse of the church of Saints Joachim and Anna in the Kızıl Çukur valley (phase II, north apse and narthex) (Figs. 4.24 and 4.25) [38]. Here, impressions in the plasterwork show that the first plaster layer was applied by brush, which was left intentionally rough to support the second plaster layer. Similarly, in the church of Agios Basilios in the Gomedá valley [39], the preparatory layer of the first painting phase in the apse (Figs. 4.26 and 4.27) is made of a white plaster that was spread by brush, in order to follow the topography of the rock as closely as possible. The second layer, which accommodates the painting, is also a thin layer of white plaster spread by brush (Figs. 4.22 and 4.23).

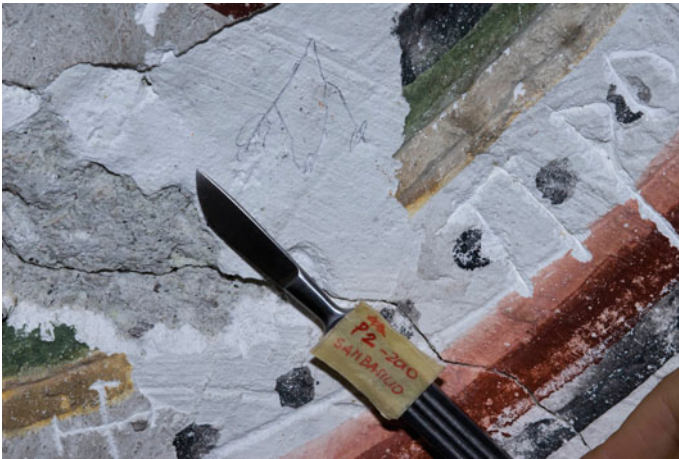
Fig. 4.23 Gomed valley, church of San Basil. Detail of the apse painting showing the overlap of the preparatory layers

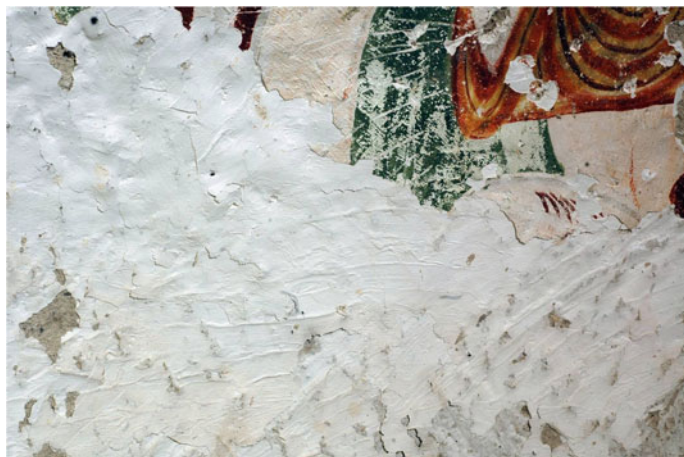
Fig. 4.25 Kızılcukur valley, church of Saints Joachim and Anna. Detail of the apse painting showing the overlap of the preparatory layers

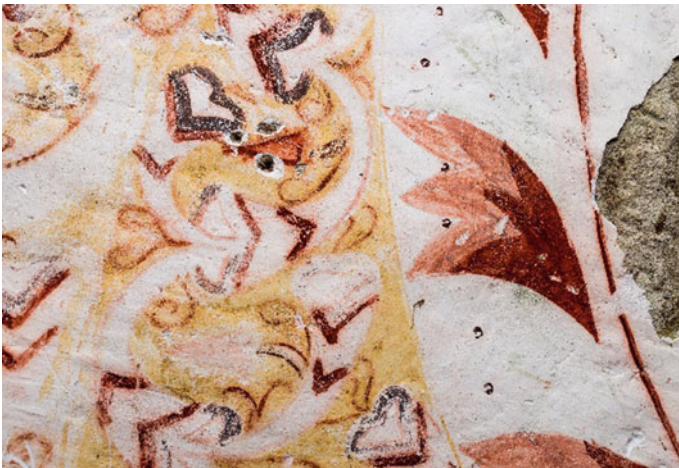
Fig. 4.27 Göreme, church of Karşı becak. Detail of the apse painting showing the use of different red pigments

Phase I of the painting phases (Fig. 4.14) belongs to the period of proto-Byzantine painting, and can be linked to a large group of paintings with shared characteristics, such as at the churches of Agios Basilios in the Gomeda valley near Mustafapaşa (sixth–eighth century) (Fig. 4.20); Agios Stephanos at the Keşlik monastery in Cemil (sixth–eighth century); Saints Joachim and Anna in the Kızıl Çukur valley (sixth–seventh—ninth century); Üzümlü, or of the stylite Niceta, in the Kızıl Çukur valley (late-seventh—early-eighth century); Karşibecak in Göreme (ca. 700); and the Balkan Dere in Ortahisar (sixth–eighth century) [24, 30]. These paintings have in common the fact that they were mostly produced using a *secco* technique with a palette of homogenous colours, made up of reds, yellows, greens, browns and black (Fig. 4.21). Their secondary supports comprise thin layers of white plaster that cover internal surfaces, sometimes in several overlapping layers, following the course of the rock morphology. The palette consists of natural earth colours and more complex pigment mixtures that contain lead-based pigments [35, 36]. For example, the most intense red is obtained by mixing red lead (or minium) and red earth (hematite)

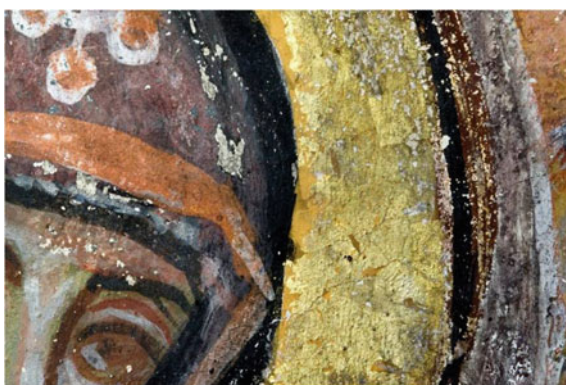
Fig. 4.41 Göreme Open Air Museum, New Tokalı Church, vault. Detail of the gold-leaf used to gild the haloes

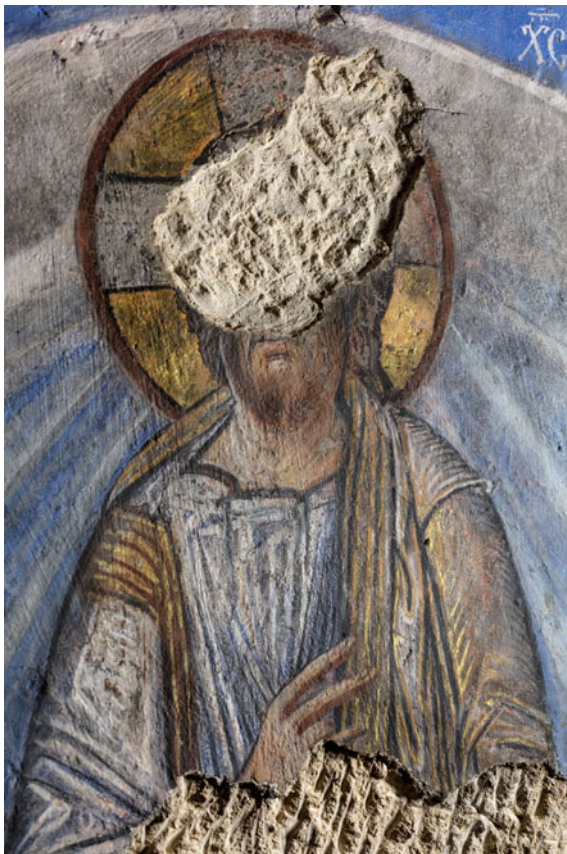
Fig. 4.42 Göreme Open Air Museum, New Tokalı Church, corridor, west wall. Detail showing the use of silver for the highlights of Christ's robe in the scene of Transfiguration

Analysis identified casein as a binder at Tokalı, but physical evidence in the form of small bubbles in the paint surface also suggests that glue was used. The palette includes natural earth red (hematite) and yellow ochre (goethite), carbon black and green earth together with more valuable pigments such as ultramarine blue, and the organic colourant, indigo. The extensive use of ultramarine (lapis lazuli), which covers the blue sky of the scenes with a lighter shade and fills the garments of Christ and the Virgin with a darker violet-blue shade, is remarkable (Figs. 4.39 and 4.40). The modulated darker shading of the garments is achieved by the blue being painted over a light or dark grey background. The meticulous cleaning of the paintings restored vigour to the blue backgrounds and made extraordinary details legible once again. Unexpected complexity is evidenced in traces of gilding in the haloes, which were once covered with thin gold-leaf (Fig. 4.41), and in the use of silver for the highlights of Christ's robe in the scene of the Transfiguration painted in the corridor (Fig. 4.42).

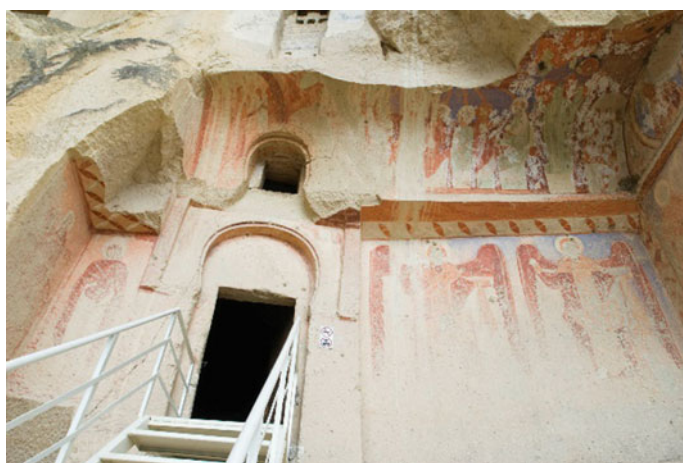
Fig. 4.45 Çavusin, Dovecote church, narthex. The ultramarine blue here is painted on a red background

Painting practices in tenth-century Cappadocia incorporate a multitude of execution methods that are evidenced in a network of workshops active in the valleys between Göreme and Çavusin. Wall paintings produced by these workshops vary in their technical quality, ranging from those in the New Tokalı church, which we have defined as uniquely rich, to other churches that contain more rudimentary schemes using poorer materials. The Dovecote Church in Çavusin (963–969) is chronologically very close to the New Tokalı church [23, 30] (Figs. 4.43 and 4.44). The painting schemes of both churches share the same subject matter, incorporating the Mission of the Apostles and the Ascension, but they differ in terms of their painting materials and execution techniques. In the Dovecote, for example, use of ultramarine blue (lapis lazuli) is found only in the narthex as the background for the figures of the Archangels and in the scene showing the Vision of St. Eustace [35, 36] (Fig. 4.45). Here, the precious pigment is applied over a red preparation, whereas in the New

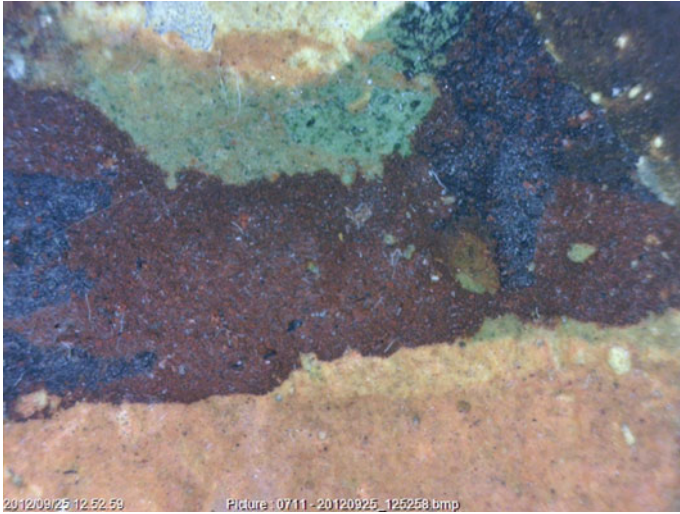
Fig. 4.53 Şahinefendi, church of the Forty Martyrs. Portable microscopy image (50x magnification) showing the overlay of the green shade on the shades of pink

The faces painted in phase III (eleventh century) in the Church of the Forty Martyrs in Şahinefendi were begun with a light yellow base layer, followed by overlapping colours (Fig. 4.52). The main features were drawn with red strokes, while the principal skin tone, which extends from the face to the neck, was blocked in with a very warm pink (Fig. 4.53). Over this, intense pink brushstrokes define the cheeks and the lips, and underline the nasal area, forehead and chin. Once the basic complexion had been established, the shadows were introduced, in greens (Fig. 4.53) and a dark brown tone, and then the features were defined with decisive brown brushstrokes (Fig. 4.54). Lastly, black strokes highlighting the volume of the face were painted (Fig. 4.55), along with white highlights.

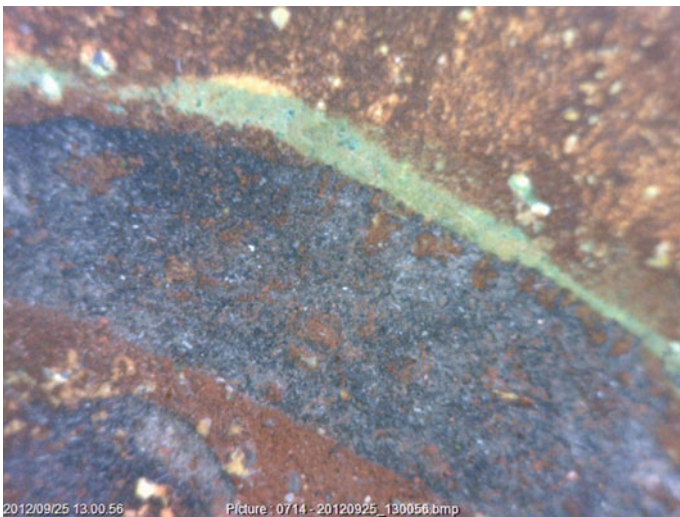
Fig. 4.54 Şahinefendi, church of the Forty Martyrs. Portable microscopy image (50x magnification) showing the features defined with brown brush strokes

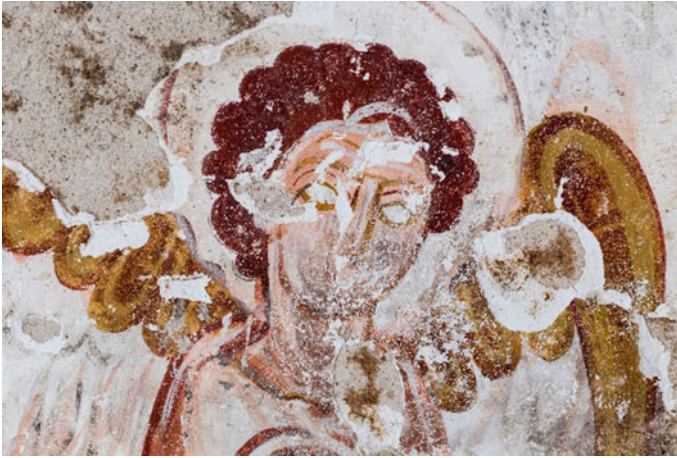
Fig. 4.55 Şahinefendi, church of the Forty Martyrs. Portable microscopy image (50x magnification) showing how the black lines complete the construction of the face

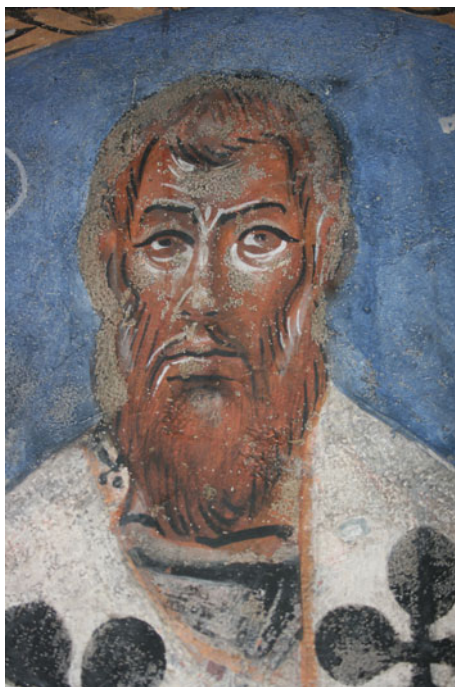
Fig. 4.56 Kızılcık Çukur valley, church of Saints Joachim and Anna. Detail of an angel in the vault

In contrast, the faces of the Marian cycle painted on the vault and walls of the north aisle in the church of Saints Joachim and Anna, in the Kızıl Çukur valley, built approximately two centuries earlier, in the ninth century, have a more schematic structure (Fig. 4.56). A base skin tone of warm pink tending to yellow accommodates subsequent painting. The facial features are then built up in a sequence of brushstrokes applied in red lines followed by white highlights, placed carefully to impart volume,

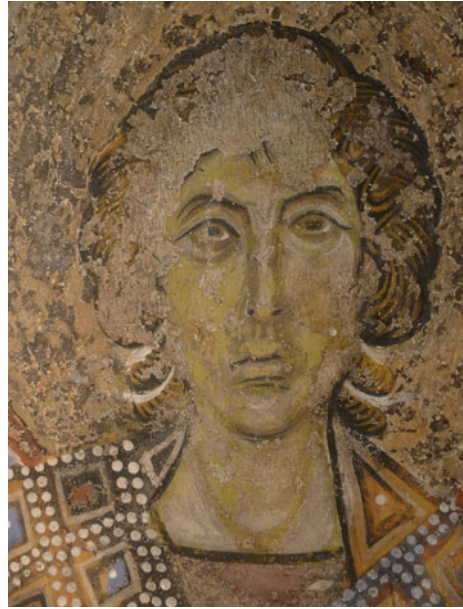
Fig. 4.59 Göreme Open Air Museum, New Tokalı Church, corridor between naos and apsis. Face type II

The faces of the figures in the north apse and in the part of the corridor facing it are part of the second group (Fig. 4.59). They maintain distinctive traits found in the facial painting of the first group (I-b), but employ a different colour range. In particular, they are characterized by the presence of an ochre-green base that is used sparingly to define the shadows. This is also used with a pink skin tone that underlies the lines that define the features. The third group includes the faces of the figures arranged on the south side of the corridor. Here, facial complexions are built up by means of slight and nuanced chromatic shifts, from pink to darker shades, on top

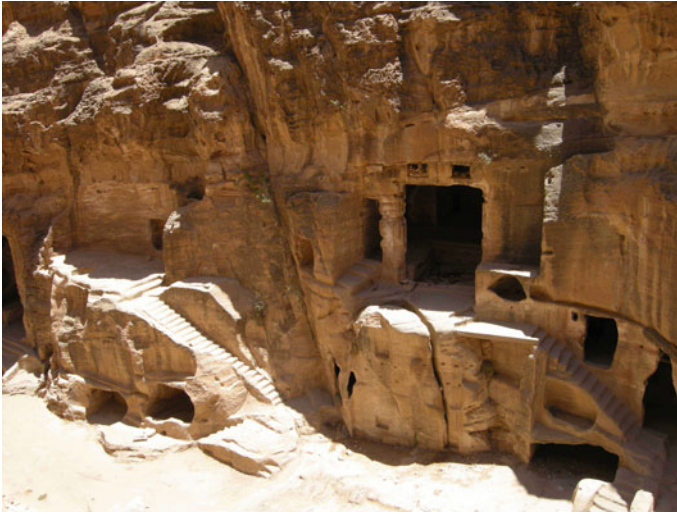
Fig. 5.1 The painted cave complex at Siq al-Barid originally comprised a number of features and elements, some of which survive intact, while others can be inferred from archaeological evidence. A flight of stone-cut steps on the south side of the Siq leads up to a platform in front of a large square chamber, the *biclinium*, which is served by ancillary rooms, cisterns and channels for transporting water (© Petra National Trust and Courtauld Institute)

The site originally comprised a number of features and elements, some of which survive intact, while others can be inferred from archaeological evidence (Fig. 5.1). A flight of stone-cut steps on the south side of the Siq leads up to a platform in front of a large square chamber. This was originally served by a gated entrance, and by a small side door. The chamber is fashioned as a *biclinium*, having two rock-cut benches, on its east and south sides, while a smaller vaulted recess is excavated in

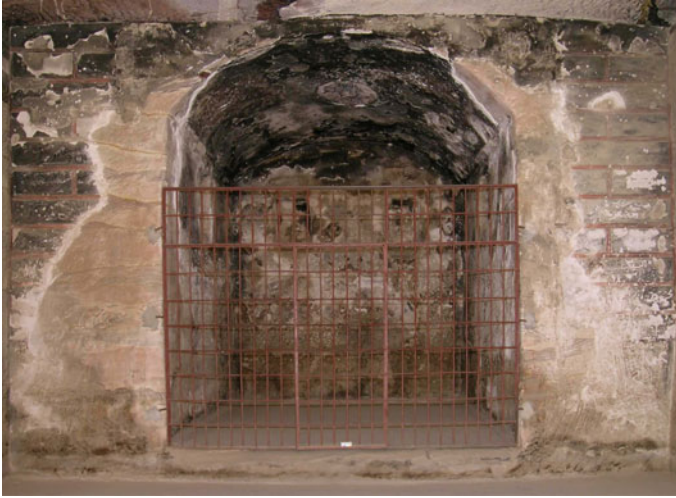
Fig. 5.2 The main chamber (the *biclinium*) has two rock-cut benches, on its east and south sides, while a smaller vaulted recess is excavated in the back, south wall, as shown here. The *biclinium*'s south wall is decorated with painted stuccowork, which consists of an orthostat dado surmounted by fictive ashlar. The vaulted recess is painted in imitation of a bower heavily laden with ripened grapes. This image shows the cave complex before conservation (© *Petra National Trust and Courtauld Institute*)

the back, south wall (Fig. 5.2). The principal chamber is decorated on its south wall with painted stuccowork, which consists of an orthostat dado surmounted by fictive ashlar. Although other examples of this type of architectural decoration survive at Petra, this is the most extensive.

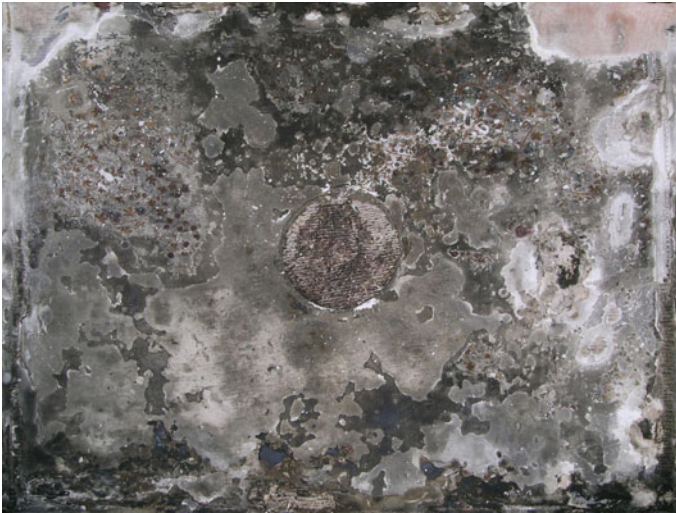
Fig. 5.3 The painted vault in the recess, before conservation. The exquisite decoration of interlocking vinescrolls and flowers, figures, and a variety of birds and insects was obscured and disfigured by smoke blackening, deliberate damage and graffiti (© *Petra National Trust and Courtauld Institute*)

The most stunning painting, however, is found in the recess. Its vault and walls are covered with an exquisite decoration of intertwining vinescrolls and flowers, populated by small winged boys (*erotes*), other figures, and a variety of birds and insects (Figs. 5.3 and 5.4). The *erotes* gather grapes into baskets, wielding pruning hooks and balancing on ladders to do so; others fend off birds with bow and arrow, and spear. The painting was once complemented by richly decorated stuccowork. Remains of an entablature with dentil decoration survive at the springing of the vault, and a stuccowork medallion originally adorned the vault's centre.

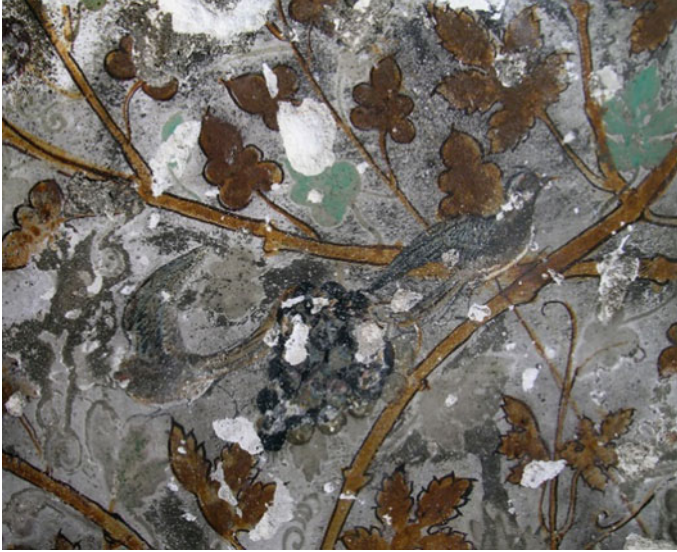
Fig. 5.4 Detail of two birds on the vault, before conservation. The naturalistic depiction of the birds and plants represented in the painting allowed many of them to be identified (© Petra National Trust and Courtauld Institute)

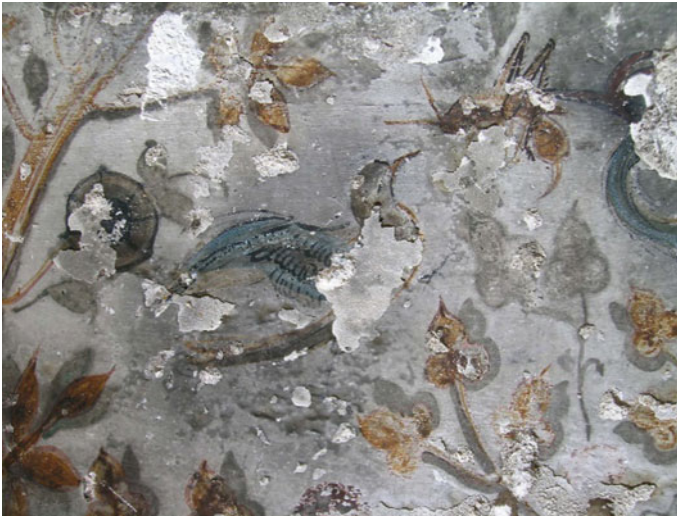
Fig. 5.5 Environmental deterioration included loss of blistering painting, which was gradual but ongoing. Complex inherent paint changes and degradation effects were prominent features of the original painting technology, too (© Petra National Trust and Courtauld Institute)

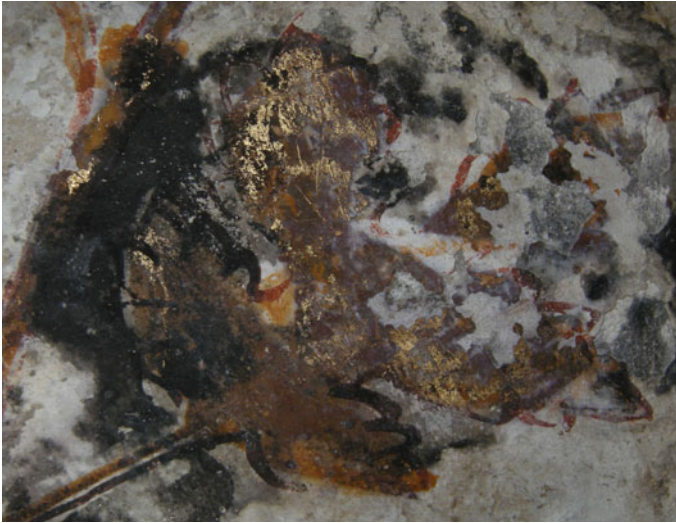
Fig. 5.7 A stunning technological feature is the lavish use of gold. While only minute traces of gold leaf now remain, close examination demonstrated that the autumnal vine leaves and stems were extensively gilded. This detail shows one of the gilded vine leaves (© Petra National Trust and Courtauld Institute)

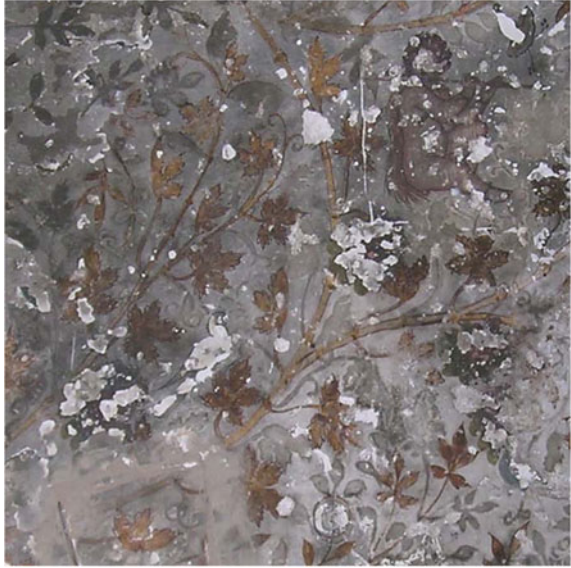
Fig. 5.8 The cleaning of the painting was transformative, allowing it to be fully appreciated as an outstanding work of art. It is now recognised as one of the most precious survivals of wall painting from the ancient world (© Petra National Trust and Courtauld Institute)

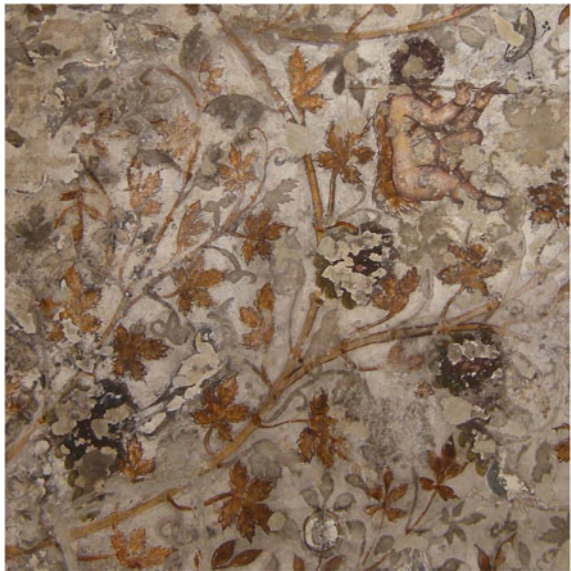
Fig. 5.9 The cleaning of the painting was transformative, allowing it to be fully appreciated as an outstanding work of art. It is now recognised as one of the most precious survivals of wall painting from the ancient world (© Petra National Trust and Courtauld Institute)

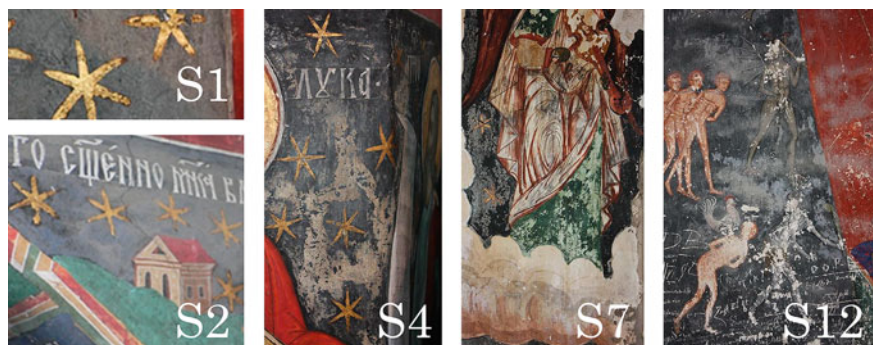
Fig. 6.3 Sampling areas of smalt pigments from Sucevița monastery labelled S1, S2, S4, S7 and S12 (see Table 6.2 for identification)
