Cultural Heritage Science

Shigeo Aoki · Yoko Taniguchi ·
Stephen Rickerby · Michiyo Mori ·
Takayasu Kijima · Su Bomin ·
Fumiyoshi Kirino *Editors*

Conservation and Painting Techniques of Wall Paintings on the Ancient Silk Road

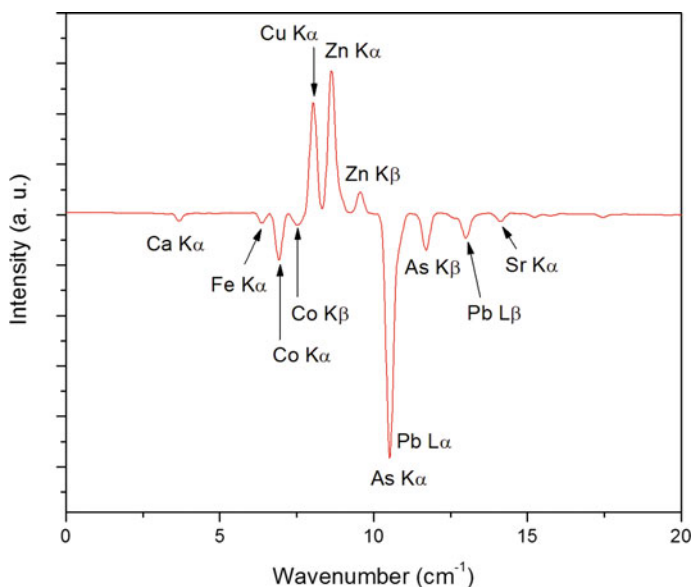
Fig. 6.4 Loading plot of the principal component PC1 for the pXRF spectra of blue samples from Sucevița monastery

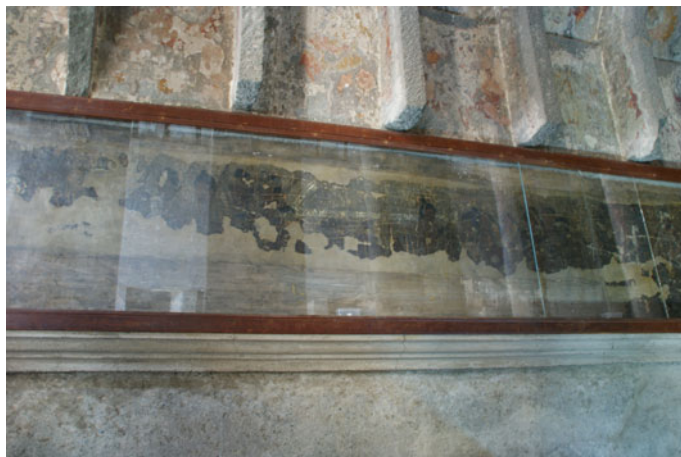
Fig. 8.3 The early painting of Cave 10 covered with glass panels ©ASI/NRICPT

wall paintings in Caves 9 and 10, which are early caves, were painted over in the later period, and are also covered with glass panels for their protection (Fig. 8.3). These conditions make it difficult to carry out detailed investigations of the original materials and techniques of the early wall paintings. The later wall paintings and polychrome reliefs have been investigated and reported on by the Archaeological Survey of India (hereafter the ASI) on several occasions.

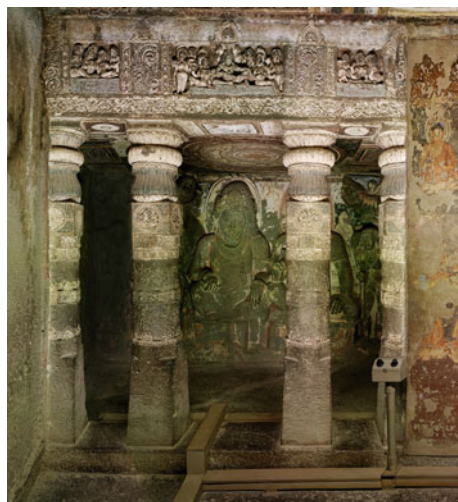
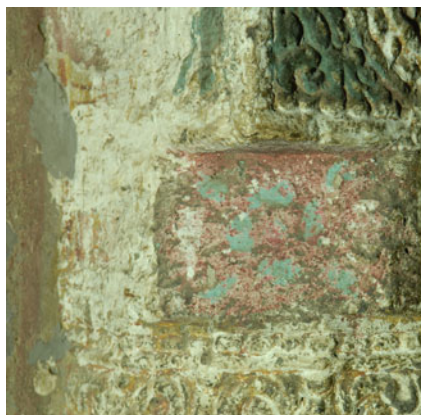
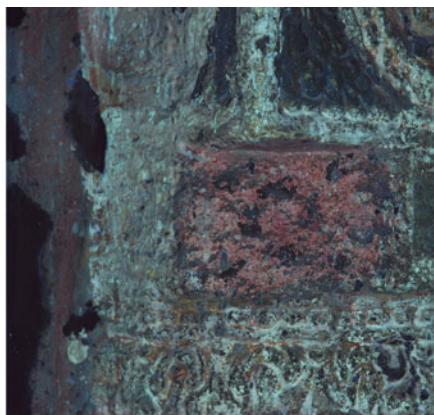
Fig. 8.9 Cave 2, left shrine ©ASI/NRICPT

(a) Front of shrine showing near absence of colour

(b) Detail on the rear of the right column showing red and green paint

(c) Same detail showing red-pink UV-fluorescence in the area of red painting

paint materials (Fig. 8.9). Scientific analysis by HPLC (High Performance Liquid Chromatography) of the red paint detected laccaic acids, proving the use of lac insects (a type of scale insect) as a painting colourant. In cross-section, the lac-containing paint was present as a translucent glaze-like layer, with no observable particles, which precludes the use of a lake form (Fig. 8.10). If purified lac dye powder had been used, the thin paint layer would be either distinctly evident, or dispersed particles of lac dye would be visible in it, neither of which were the case.

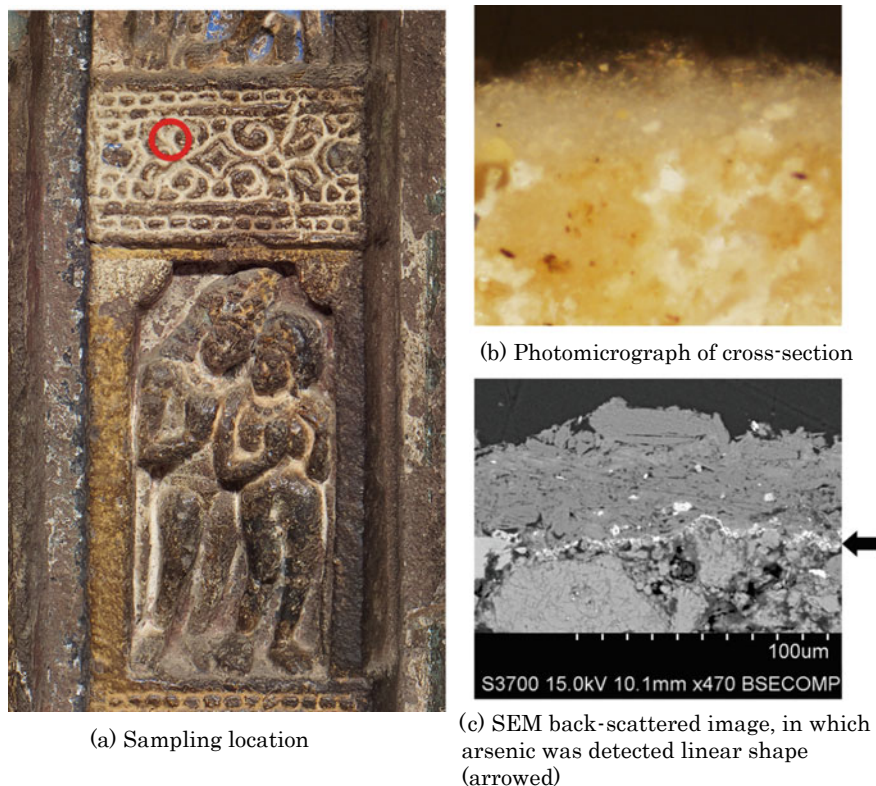
Fig. 8.13 Detection of arsenic in areas of white paint, indicating the presence of altered orpiment
©ASI/NRICPT

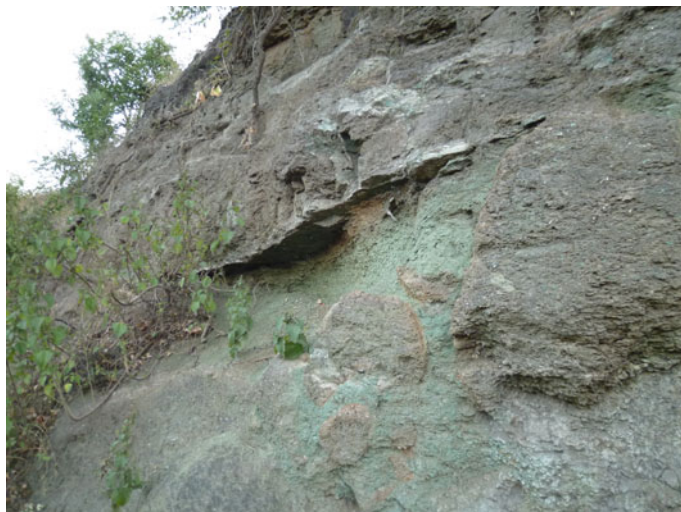
Fig. 8.14 Deposits of green earth in the terrain around the Ajanta Caves

In the Ajanta paintings, the use of green earth is reported from the earliest technical studies onwards. Indeed, geological deposits of green earth are observable around the Ajanta Caves (Fig. 8.14). Two types of mineral have been widely identified as green earth pigments, glauconite and celadonite. Lal thought that the green earth at Ajanta was derived from glauconite, but the ISCR's investigation confirmed the use of celadonite.

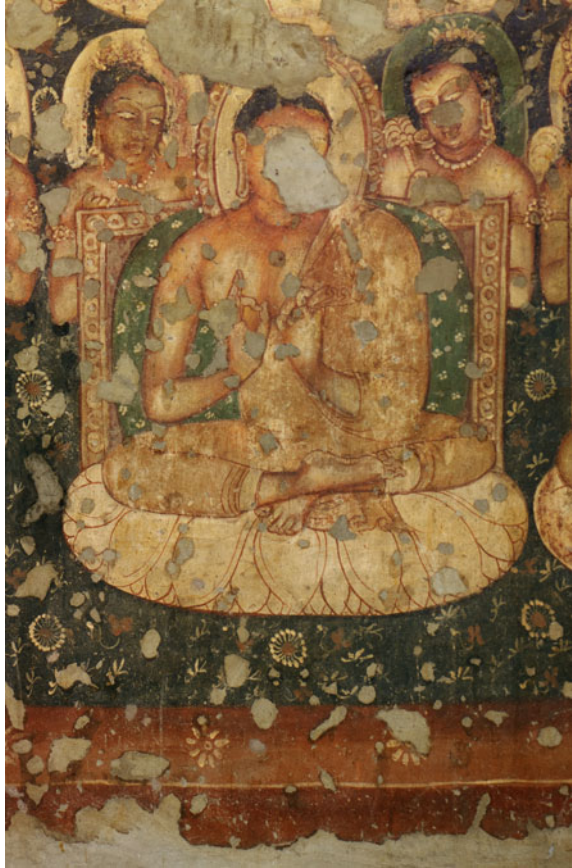
Fig. 8.16 Use of gradations of red colour on the painting inside the Main shrine of Cave 2 ©ASI/NRICPT

In Cave 2, some areas are painted in lighter tones of red or blue, which may indicate that kaolin was added to modify red ochre or ultramarine blue pigments. It is also possible that red paint was diluted with more binder or water and thinly applied over the white ground. To achieve gradations of colour to a lighter tone, such as can be observed in the use of red in the Main shrine (Fig. 8.16), this method of dilution would have been practicable. In contrast, to achieve darker tones, a very small amount of black could be added to the paint.

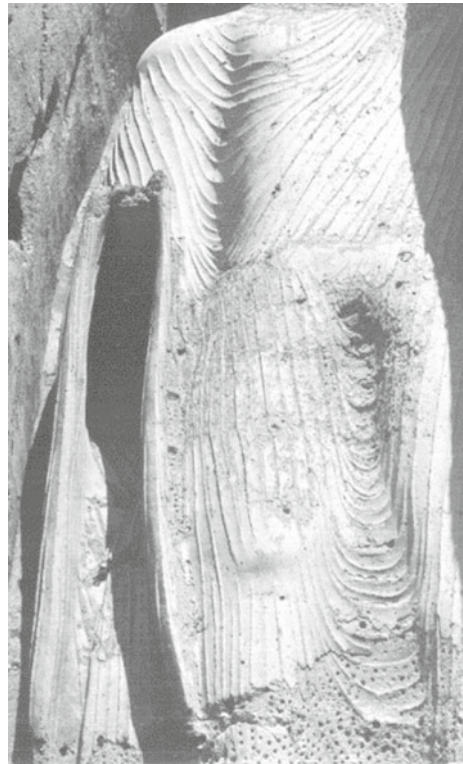
Fig. 9.1 Eastern Buddha: right arm and right leg in the 1950s: the clay modelling of the *sangati* is preserved in large areas Taken by Edmund Melzl in 1955. By courtesy of Erwin Emmering

The Giant Buddhas were roughly cut from conglomerate rock. Since this rock contains coarse inclusions of variable hardness, it does not permit the sculpting of smooth or finely structured surfaces. All rock surfaces were therefore covered with applications of clay, which also completed the three-dimensional shape: smaller details thus are only modelled in clay. To increase the adhesion of the clay layers to the rock, a variety of keying methods were employed. On the smaller Eastern Buddha, numerous holes (about 7 cm wide and deep) were cut into the surface. Before applying the clay, pebbles were pressed into the holes to provide an anchor (Fig. 9.1). On the larger Western Buddha, details such as the garment folds were not carved from the rock. Instead, rows of holes (3.5–4 cm wide, 7 cm deep) were made along the fold ridges with a pointed chisel. Wooden pegs were inserted into the holes, connected with ropes made of an endemic plant (*astragalus coneifolius*)

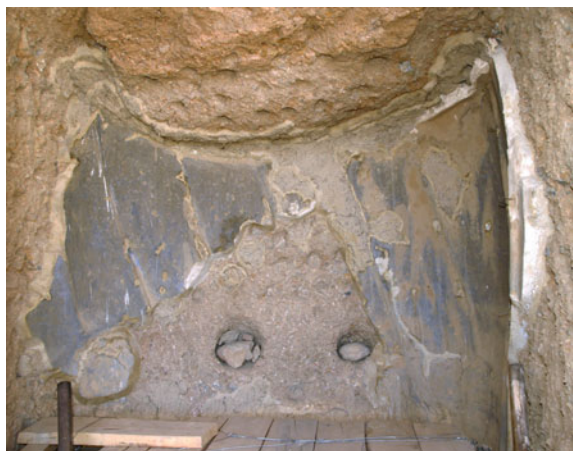
Fig. 9.2 Preserved clay modelling with blue paint layer under the right arm after conservation, October 2008 [© Bert Praxenthaler 2008. All Rights Reserved]

After the destruction in 2001, almost no paint layers were preserved in situ: on the Western Buddha, no original intact surfaces remain; on the Eastern Buddha, small areas of painted clay layers are preserved below the right arm (Fig. 9.2) and next to the left leg, but only to a marginal extent compared with the dimensions of the statue.

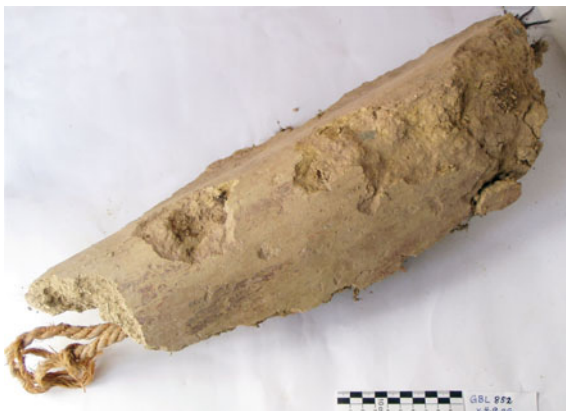
Fig. 9.3 Part of a fold-ridge from the Western Buddha (GBL 852). The paint layer originally was in red hues (fragment ID 48: group 2–4; ID 169: group 2) Taken by Edmund Melzl in 2005. By courtesy of Erwin Emmerling

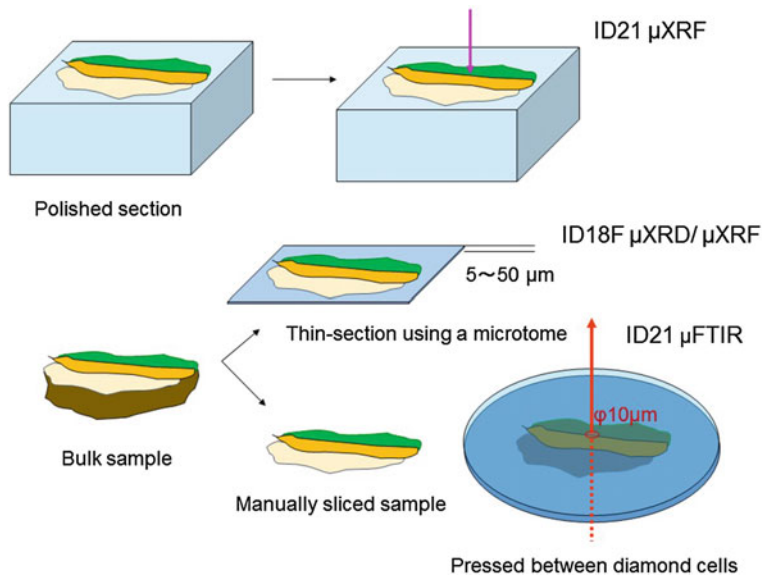
Fig. 10.2 Sample preparations for SR- μ FTIR and SR- μ XRF/XRD (© Y. Taniguchi)

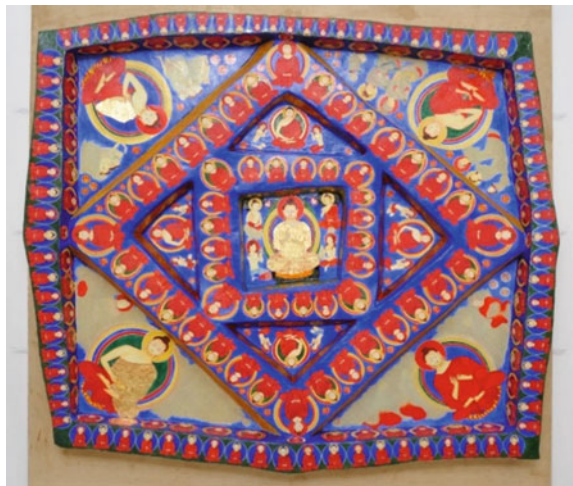
Fig. 10.11 Reconstruction of the ceiling of Cave N(a) by Watanuki Yuki (© Y. Watanuki)

(Figs. 10.6, 10.7, 10.8, 10.9, and 10.10). This is similar to the *mecca* technique, which employs golden yellow resin on tin leaf. In this case, a tin-containing lead-based alloy was used, since the technology did not exist at the time to allow the tin to be extracted from the lead (Figs. 10.6–10.10). Yuki Watanuki created a reconstruction of the ceiling of Cave N(a) using the original vivid palette, which is now in the collection at Teikyo University (Fig. 10.11).

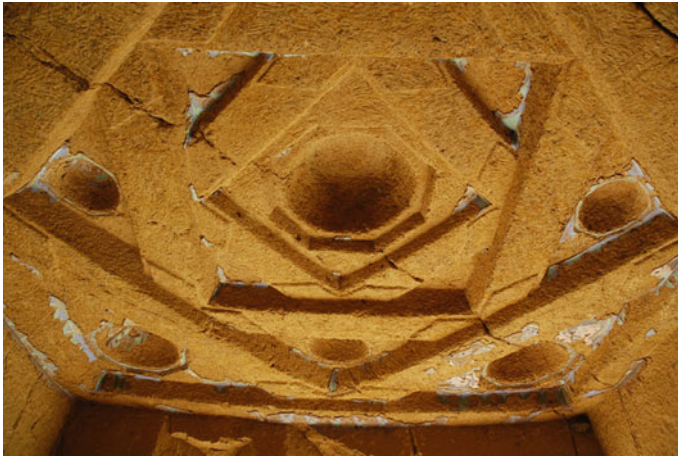
Fig. 10.12 The ceiling of Foladi Cave 4 (© Y. Taniguchi, courtesy of NRICPT)

A sample of paint with a green surface from Foladi Cave 4 was also analysed with Synchrotron radiation (Figs. 10.12 and 10.13). Particular points of absorption within the fingerprint region of FTIR spectra were selected and mapped. Additionally, maps combining SR- μ XRF and SR- μ XRD were created. From this analysis the following stratigraphy was established (from the lower layers): two sizing layers (the first, a natural resin; the second, a proteinous material with polysaccharide content); a white ground layer (lead white), a red layer (minium with red ochre), a further white

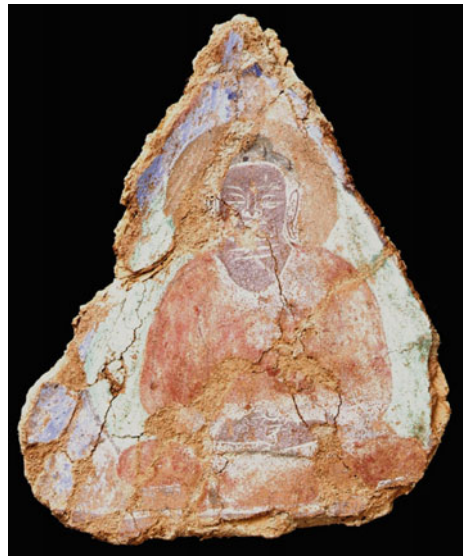
Fig. 10.13 A fragment from Foladi Cave 4 (© T. Kijima courtesy of the Tokyo University of the Arts)

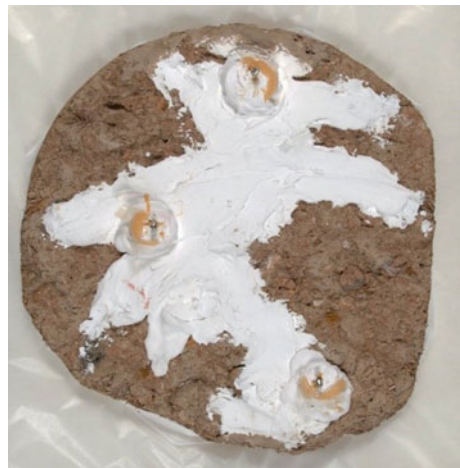
Fig. 11.4 The reverse of the wall painting fragment was fixed with gypsum plaster

Around half of the wall painting fragments had been reinforced from behind, and gypsum plaster thickly applied to attach them to their frames (Fig. 11.4). This type of framing prioritized their aesthetic appearance for sales-related purposes, however, with no consideration given to preservation. As a result, the wall painting fragments were not securely affixed within their frames, making them unstable. In some cases, they had been broken inside the frames and then repaired.

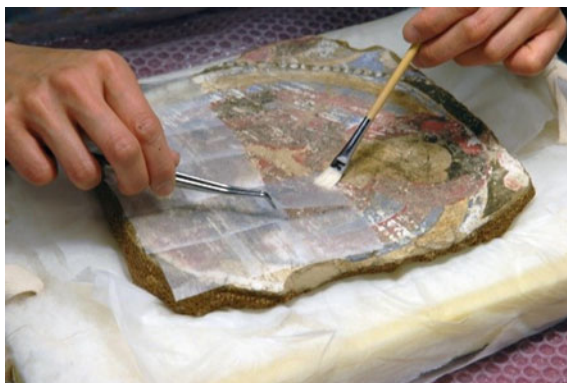
Fig. 11.5 Covering the fragments with Rayon paper and cyclododecane

(3) Surface facing (Fig. 11.5)

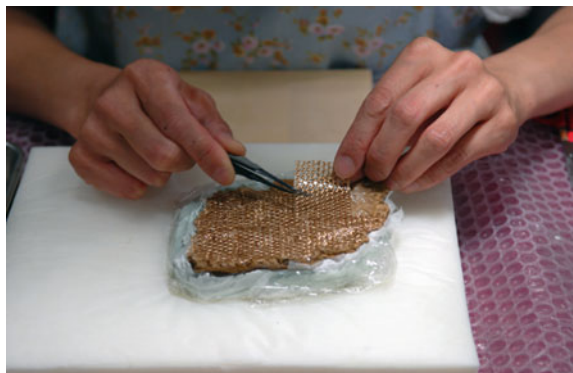
Fig. 11.6 Lining with triaxial woven rayon fabric impregnated with Paraloid B72 to the reverse side

Despite the consolidation of the earthen plaster layers with Primal E-330S, they remained in a fragile state. To provide additional strengthening, triaxial fabric was applied as a facing layer. The triaxial fabric is a textile made from weaving yarn on three axes at an angle of 60°, which disperses its strength and gives it superior protection against rupturing and tearing. With its ability to retain a balanced level of strength in all directions, the fabric does not tend to become twisted in its application, allowing it to retain a stable form and shape for small loads. This fabric was highly useful for the purpose of reinforcing the reverse side of the wall painting fragments, with all of their surface irregularities.

The fabric used was a 32-gauge triaxial woven rayon fiber, which was dyed a brownish-yellow color resembling that of the earthen plasters. Woven sheets of around 15×15 cm in size were impregnated with Paraloid B-72 (15% in acetone), and then allowed to dry. Pieces cut to 3 cm square were subsequently applied using a hot press to the sides and reverse of the earthen plasters, to which 10 wt% Paraloid B-72 in acetone had been previously applied. This lining system provided ample reinforcement of the wall painting fragments.

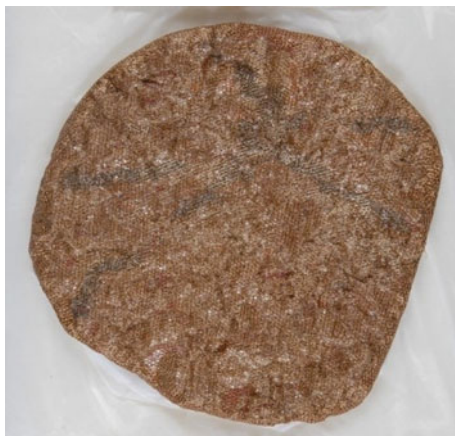
Fig. 11.7 The reverse of the fragment after completing the lining

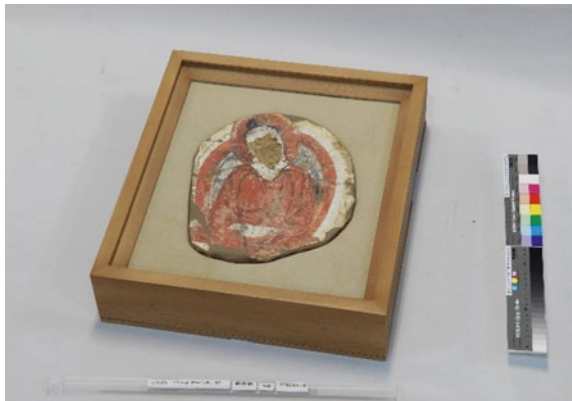
Fig. 11.9 After mounting and framing

The frames have a dual-layered structure, with inner and outer sections. The outer frame incorporated an acrylic sheet to filter out ultraviolet rays, in order to protect the surface of the paintings during exhibition. To ensure ease of viewing when the wall paintings are exhibited in flat display cases, non-acrylic sheets were utilized for the inner frames. The frames can be opened and closed exclusively by means of screws affixed to the sides, which increases the safety of handling due to the ability to

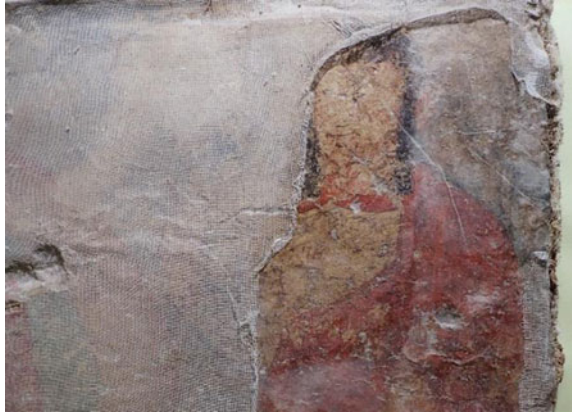
Fig. 11.13 During removal of the gauze

This was accomplished by dabbing acetone-soaked absorbent cotton onto the surface of the gauze, and then slowly dissolving the Paraloid B72 that had penetrated into the wall painting fragment. After the Paraloid had softened, the gauze was

carefully peeled away. To avoid the gauze re-adhering as the solvent evaporated, the best course of action was to cut it away with scissors gradually during the removal operation. Fortunately, since the layer of Japanese paper protected the painting, the gauze did not come into direct contact with the painting layers. The process of gauze removal was therefore relatively easy.

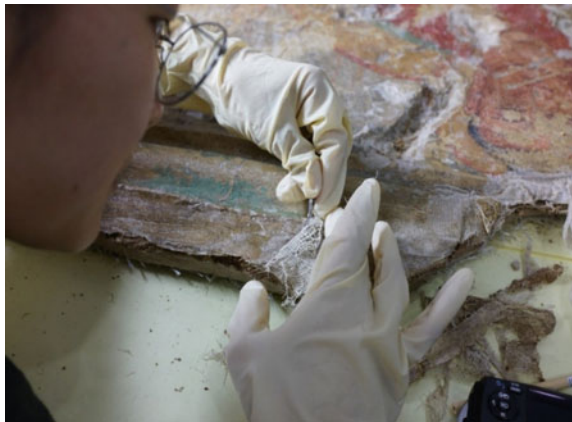
Fig. 11.14 Peeling off the gauze carefully with tweezers

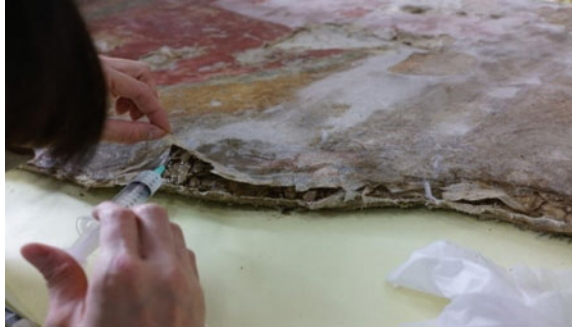
Fig. 11.15 Inserting Primal AC2234 by syringe

After removing the strengthening gauze from the surface of the fragment, a Primal AC-2235 ethanol dispersion (2.5wt%) was injected by syringe to consolidate the painting and earthen layers. This use of ethanol to enhance the penetration of the Primal AC-2235 was based on the experience gained in the treatment of the Bamiyan wall painting fragments, described above.

As well as consolidating the painting and earthen layers, treatment with Primal AC-2235 was also intended to address problems of separated layers within the fragment. Injections were therefore made under the edges of delaminated paint layers. Because the earthen plaster was particularly fragile in these areas, and was also in danger of being lost, the density of the Primal AC-2235 solution was increased from 2 to 5%, and introduced repeatedly but gradually.

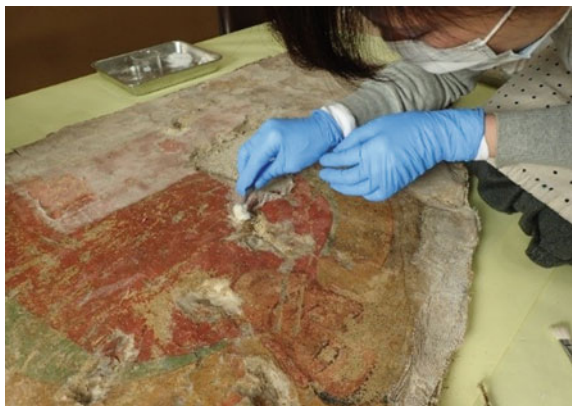
Fig. 11.16 Dissolving Paraloid B72 using absorbent cotton soaked with acetone

of the wall painting fragment after its emergency excavation. Previous efforts to remove the facing materials using large amounts of acetone had resulted in chromatic alterations of the paint surface, especially on the left side of the fragment. When restoration work was initiated, substantial flaking of the paint layer also occurred. To even out the chromatic irregularities in the paint surface and provide further reinforcement, a solution of 5wt% Paraloid B-72 was applied three or four times.

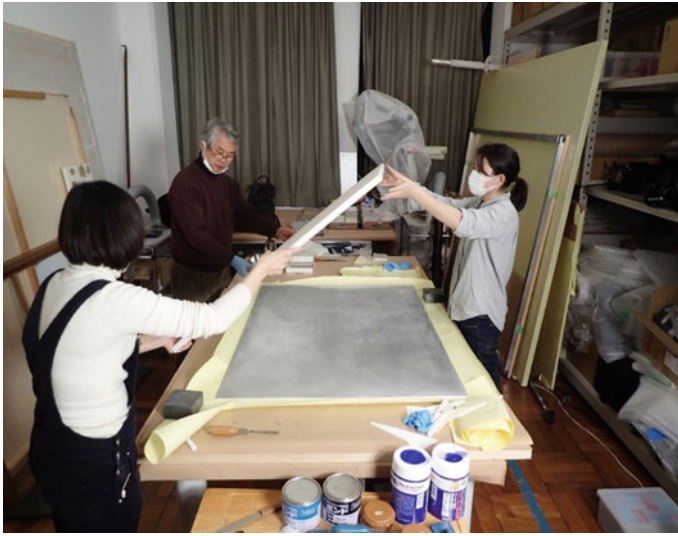
Fig. 11.17 The firmly adhered aluminum bars of previous treatment were utilized for fixing the fragment with mount

0.8), it is also smooth, and has superior heat-resistance and durability. The ROHACELL® was lightly shaped using sandpaper to accommodate the uneven underside of the wall painting fragment. After fixing the mount, exposed parts of the fragment were then finished with a cosmetic mortar. This was designed to be close in configuration and texture as the original plaster, but also easily distinguishable from it. A mixture was created using gypsum dihydrate with Kanuma and Juraku soils. A small amount of methylcellulose was added as a finishing layer to the surface of both the mortar and the filler.

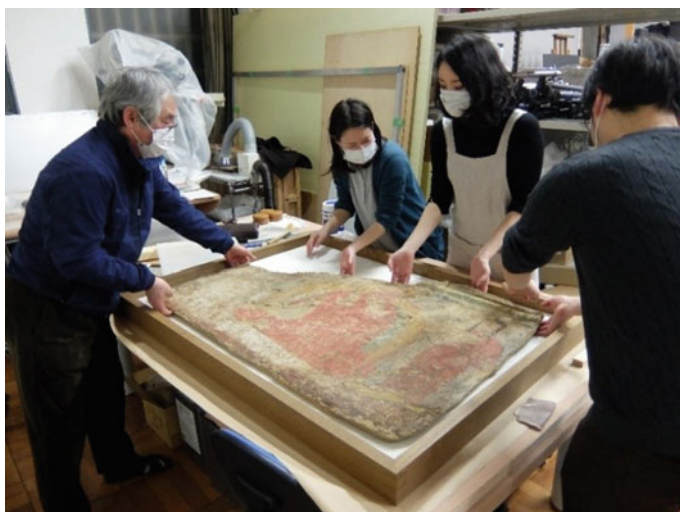
Fig. 11.20 Positioning the fragment on the mount

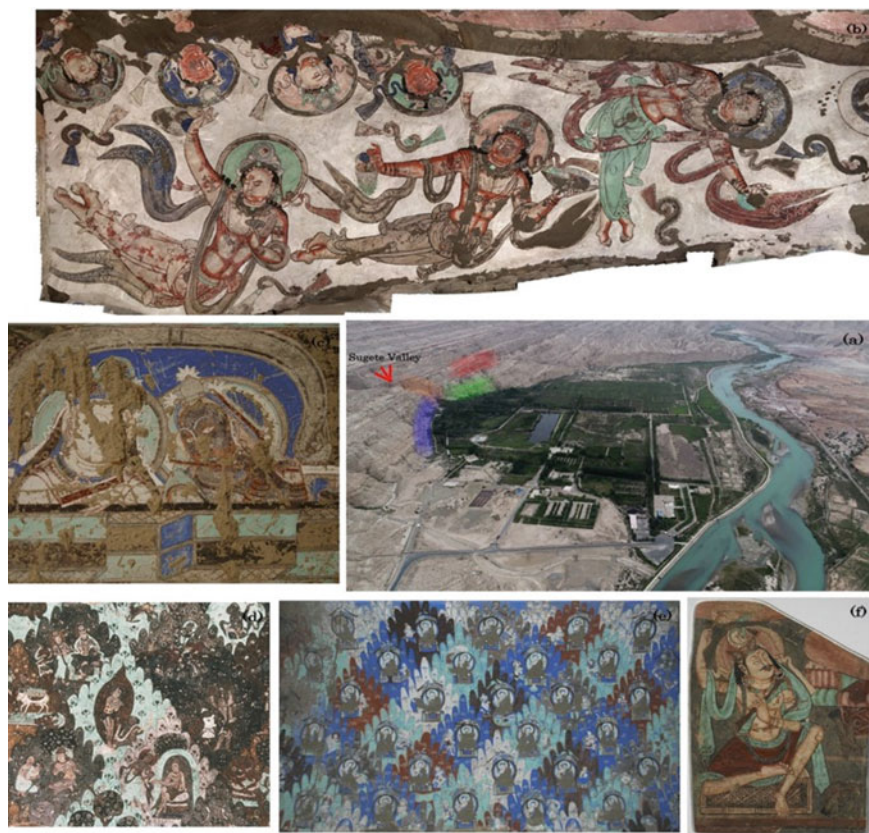
Fig. 13.1 Aerial image of the Kizil grotto site and details of the wall paintings. (a) aerial image of the Kizil grottoes: the Sugete Valley divides the caves into four natural groups: the western ravine (marked with blue), the inner ravine (marked with yellow), the eastern ravine (marked with green), and the rear hill (marked with red); (b) Flying Apsaras from newly-found Cave 1; (c) Musical Apsaras from Cave 38; (d) Śākyamuni story paintings from Cave 114; (e) Śākyamuni story paintings from Cave 171; and (f) painting from Kizil detached by German exploration team

The Kizil grottoes, the largest and most influential of the Kucha grottoes group, is situated in Kizil Town, Baicheng County, Xinjiang, China. The caves are excavated into the cliff face of Mingwutage Mountain in Weigan Valley (named the Muzart River Valley near the caves), and extend from east to west for 1.7 km, scattered on various levels of the cliff (Fig. 13.1). There exist 349 caves dating from the third century to the ninth century containing 5000 square meters of wall paintings, a small number of sculptures, and a number of architectural remains in front of the caves [7, 8].

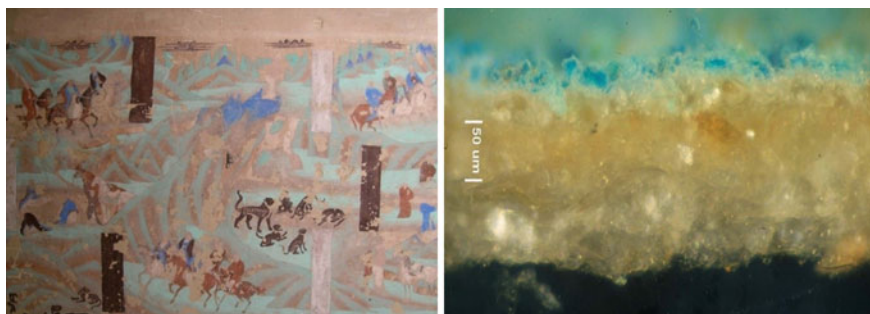
Fig. 14.2 Detail of the Late Tang dynasty painting on the west wall of Cave 85, Mogao Grottoes (left). Cross-section of a paint sample from Cave 85 showing the ground layer beneath the paint

The wall paintings of the Mogao Grottoes are composed of multiple layers applied to the conglomerate rock support. These comprise earthen plaster layers, sealants and ground layers, paint layers and glazes, coatings and surface decorations (Figs. 14.1, 14.2, and 14.3). Local earth deposits, and added sand and plant fibers are the three basic components of the plaster layers. Evidence indicates that alluvial deposits from the river in front of the grottoes were the main source of the earth (“Dengban soil”), which principally contains illite and chlorite in its clay fraction, matching the mineral composition of plasters that have also been analyzed. Generally two layers of plaster were applied to the conglomerate rock walls: the lower layer, varying in thickness from approximately 2–3 cm, is usually a coarse mixture of the local earth and a relatively low amount of added sand, with wheat straw, reeds and other coarse plant fibers; the upper finer layer, ranging in thickness from 2–5 mm, appears to have

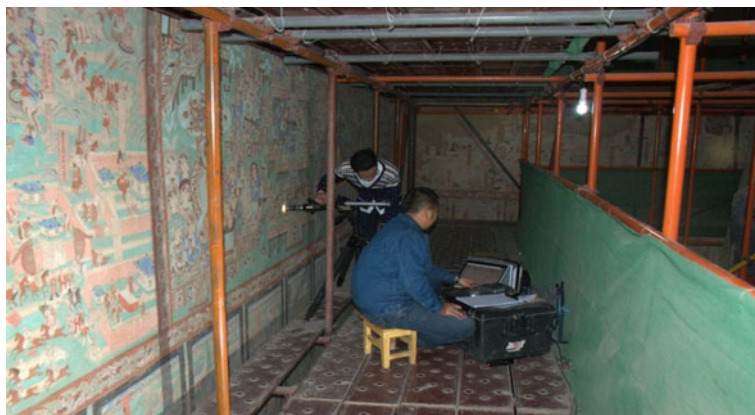
Fig. 14.6 Examination of the wall paintings in Cave 98 using a portable digital microscope

Technical investigations and analyses were carried out on the ceiling, the four slopes, and the east wall, south and north walls of the main chamber of Cave 98. Non-destructive in situ methods and procedures included visual examination, hyperspectral imaging, portable microscopy (Fig. 14.6), portable XRF, NIR-Reflectance spectroscopy, and Raman Spectroscopy. Laboratory-based procedures included XRD and cross-section analysis.

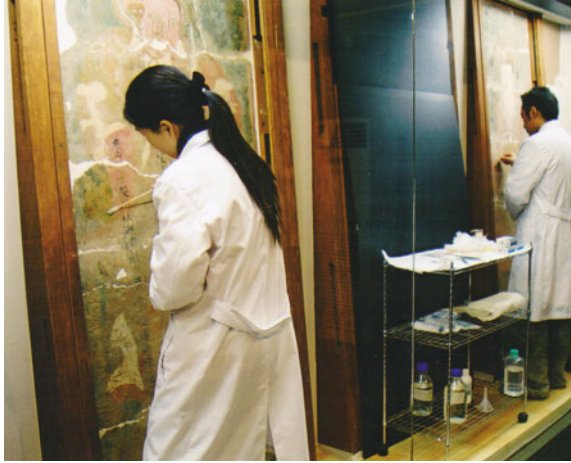
Fig. 15.3 Treatment of the painting in 2002

In 1985, the wall paintings housed in Muryangsujeon Hall were transferred to storage at Bojanggak and underwent conservation treatment under the auspices of what is now the Cultural Heritage Administration. The conservation treatment comprised salt-reduction procedures, cleaning (Fig. 15.3), and consolidation to reinforce the painting layers. For removing salts from the surface of the wall paintings, poulticing techniques developed in Florence, Italy were tried. For consolidation, the acrylic co-polymer, Paraloid 72®, was applied in concentrations varying from 1.5 ~ 25% [3]. Following their treatment in 1985, maintenance of the wall paintings was almost non-existent, resulting in damage to some of the paintings, and the accumulation of dust and contaminants on their surfaces. To address this situation, their display environment was improved in 2002 by changing the lighting conditions and introducing temperature/humidity controls. Some remedial treatment of delaminated areas of painting was also carried out. The wall paintings were then transferred to a newly built museum at the temple complex in 2010, and displayed in their current exhibition cases (Fig. 15.4). A recent survey identified serious physical damage to the wall paintings [4]. A principal problem is transverse cracking in the plasterwork, but more particularly damage is also concentrated in areas where gypsum plaster was

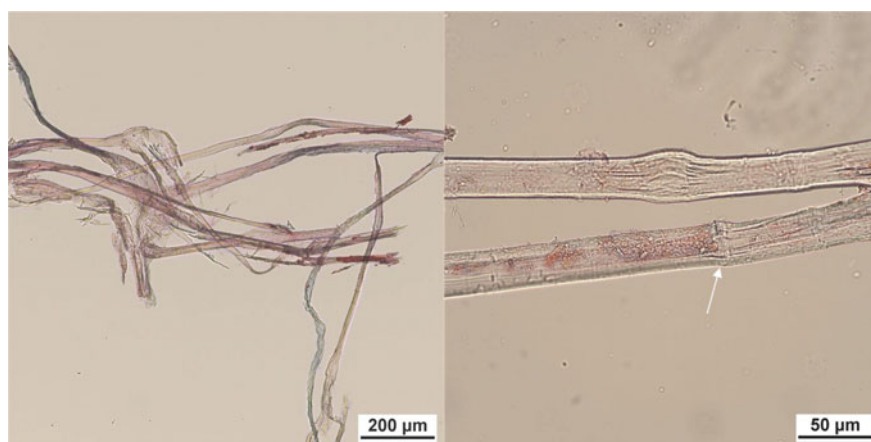
Fig. 15.9 Microscopic examination of fibres from the finishing plaster layer (left: dissociated fibre, right: fibre node)

no epidermal cells but fibre cells, which classified them primarily as bast fibres. Longitudinal streaks, nodes and fibre distortions were also observed, classifying the fibres as hemp. Fibre widths ranged from 12.8–46.0 μm , with an average of 26.6 μm , which is also consistent with hemp identification (Fig. 15.9). Although

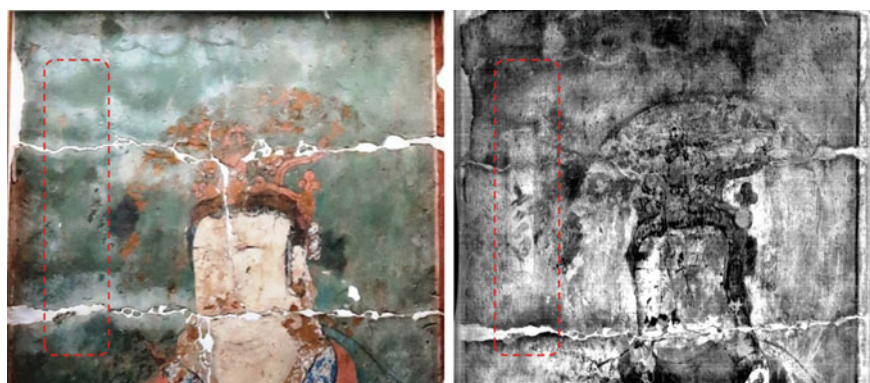
Fig. 15.22 Hyperspectral imaging at 1600 nm to reveal concealed ink-lines in the Indra wall painting

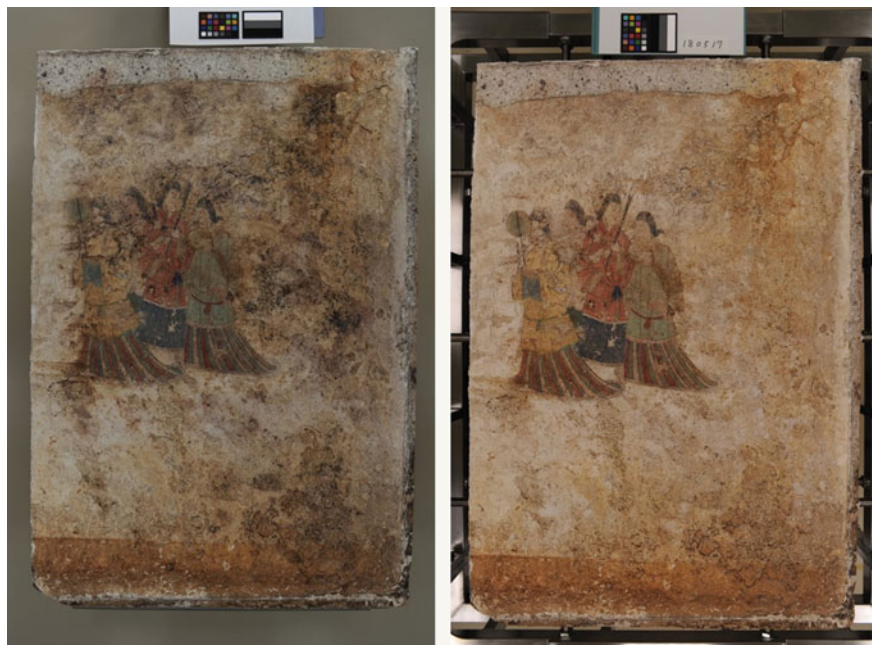
Fig. 16.7 Condition of the painting of the female figures from the Takamatsuzuka tumulus in 2007 (left) and in 2018 (right)

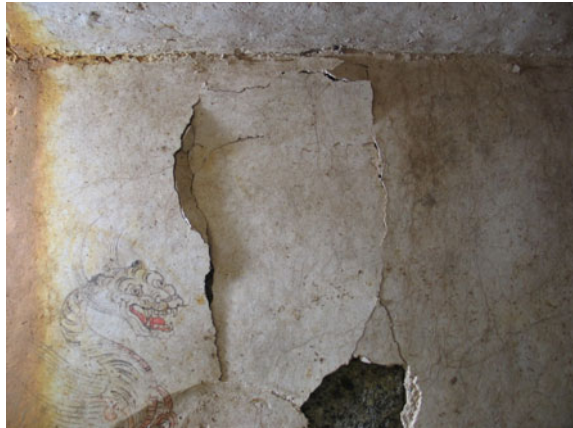
Fig. 16.8 The condition of the west wall in the Kitora tumulus in Kitora tumulus in 2004

The excavation of the Kitora tumulus, which was begun in February 2004, clarified the extent and nature of the surviving wall painting, confirming the presence of large areas of separated plaster that were at risk of collapse (Fig. 16.8).

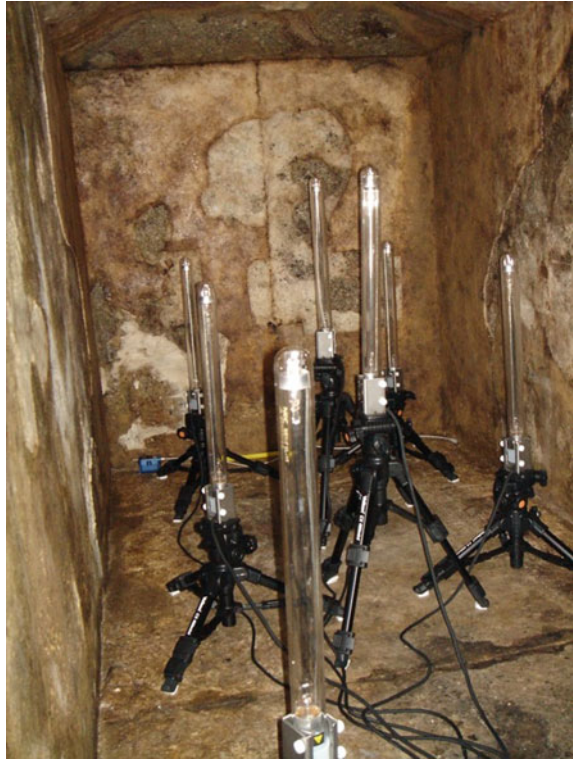
Fig. 16.9 Use of germicidal lamps in the Kitora tumulus in 2004 after removal of the plaster

Since only areas of plaster preserving painting were selectively removed, a considerable amount of unpainted plaster was left inside the stone burial chamber. As there was no need to consider effects on paint materials, biodeterioration risks were managed through periodic irradiation with germicidal lamps, to suppress the outbreak of microorganisms. Regular inspections were made, which demonstrated that this method was effective (Fig. 16.9).

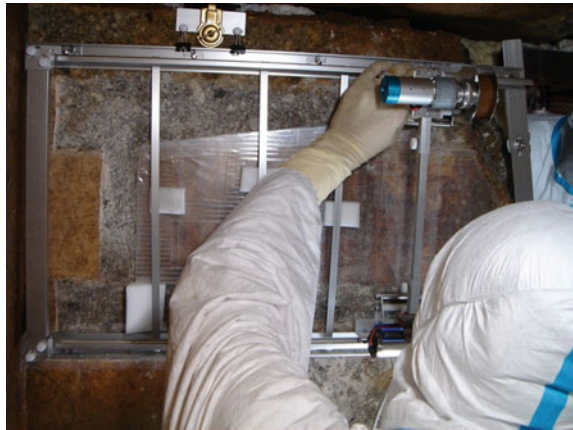
Fig. 16.10 Removing the painting of the Vermilion Bird from the Kitora tumulus with a diamond-wire saw

The first areas of separated painted plaster that were removed at the start of the project were relatively thick and easy to cut, and a variety of spatulas and tools were used to achieve this. Later, however, the plaster was found to be in a variable condition, with some areas being very thin and brittle. A diamond wire-saw was developed to respond to these conditions, so that the plaster could be cut in a controlled and uninterrupted way, even through bonded areas, while also minimizing losses at the edges. A further

aim was to remove the plaster and its immediate substrate at a uniform thickness. The surface of the plaster was uneven, as was the stone support. Various trials were carried out, including on replica wall paintings. Eventually it became possible to remove the Vermilion Bird, which was painted onto a relatively thin plaster layer of about 3 mm thickness (Fig. 16.10).

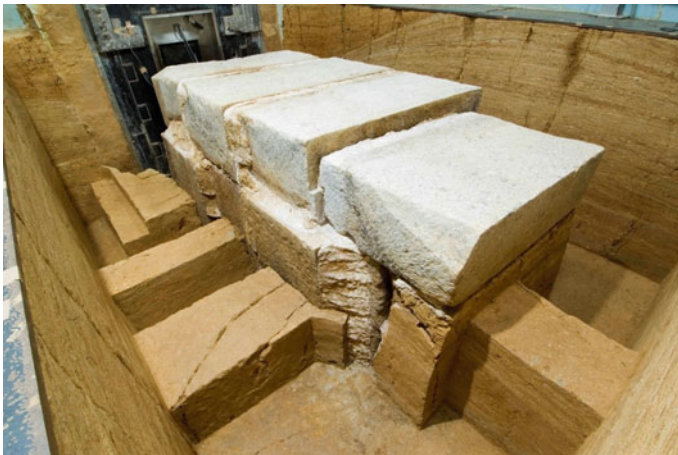
Fig. 17.3 The excavated stone chamber

Excavations were made in the tumulus to remove the stone chamber efficiently and safely, adopting the latest techniques and procedures (Fig. 17.3). Archaeological information revealed during this process, including evidence of historic damage, was carefully recorded. For example, numerous signs of earthquake damage were detected in the rammed earth tumulus. Construction evidence in the form of compressed layers of earth and the impressions left by ramming poles was also discovered [6].

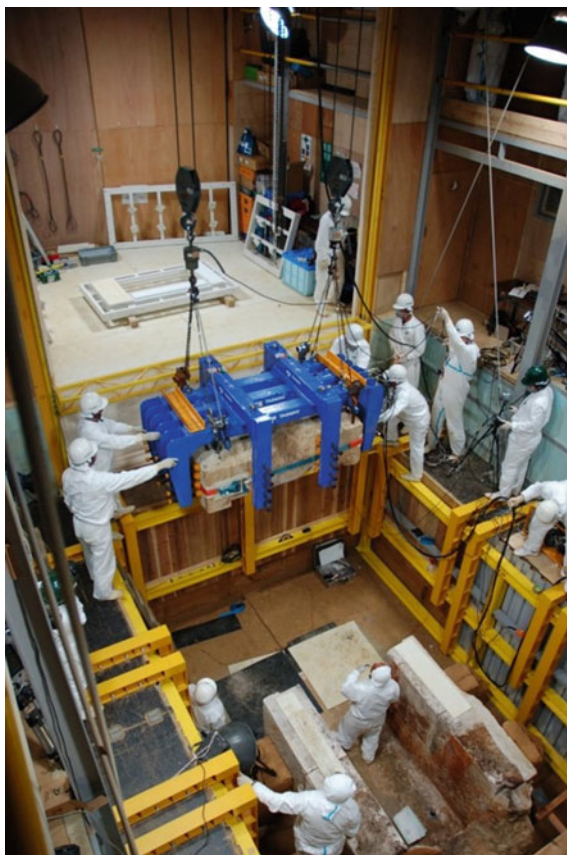
Fig. 17.4 Work to remove the ceiling stones

In April 2007, work to remove the stone chamber began (Fig. 17.4). The chamber was taken apart stone by stone to minimize adverse impacts on the paintings. They

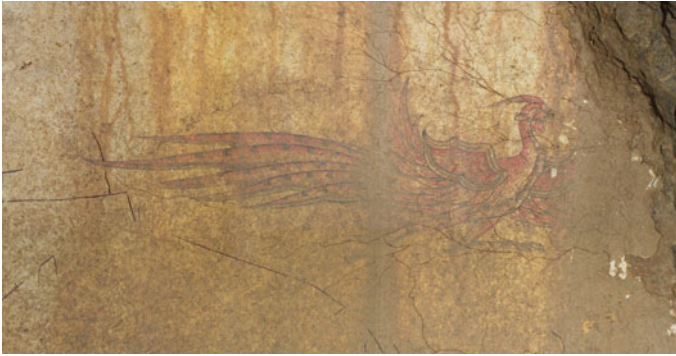
Fig. 17.6 Kitora tumulus: south wall painting showing the red phoenix

The inner surface of the stone chamber was covered with plaster, and paintings survived on the four walls and the ceiling. They depicted, from the east wall counter-clockwise, the Four Guardians: the Azure Dragon, the Vermillion Bird (Fig. 17.6), the White Tiger, and the Black Tortoise. Under each of these Four Guardians were paintings of three of the 12 Earthly Branches. Each of the Earthly Branches was depicted with the head of its representative animal and the body of a human, wearing a wide-collared kimono wrapped to show the right side on top, and holding weapons and other objects in their right hand. The wall paintings were arranged clockwise around the room, with the Rat in the middle of the three animals on the north wall. The compositions were transferred onto the walls using a method involving *nenshi* (paper similar to carbon paper). The transferred designs show evidence of both incised lines and red outline drawing. A constellation of stars was depicted on the ceiling, and the east and west slopes showed the sun and moon. This subject matter is based on the theory of the cosmic dual forces and the five elements, and in the stone chamber the scenes were deliberately arranged in a logical way to emphasize their relationships with each other.

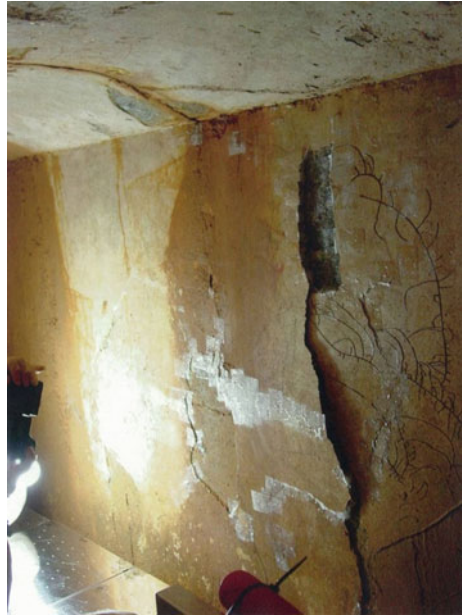
Fig. 17.7 Kitora tumulus:
east wall painting of the blue
dragon

An investigation of the interior of the stone chamber carried out in 2004 showed that the plaster, which is only about 3–5 mm thick, was separated by about 3 cm from its stone support in the areas of the Azure Dragon on the east wall and the White Tiger on the west wall, creating a very dangerous situation (Fig. 17.7). Furthermore, tree-roots had grown behind the separated plaster, and many pieces of plaster had already fallen down. It was decided that re-attaching the plaster to the stone and conserving the murals in situ was impossible. This led the 'Investigative Research Commission for the Protection and Utilization of the Special Historic Site Kitora Tumulus [10]' to decide at its 7th session in September 2004 that all of the wall paintings would be removed.

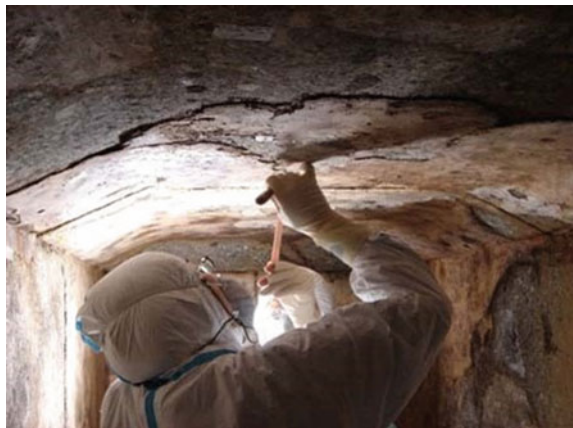
Fig. 17.8 Kitora tumulus:
the astronomical ceiling
during its detachment

Before removing the wall paintings, their condition was studied and recorded. Then the surface of the paintings was protected from unforeseen accidents or vibrations in a process known as *omoteuchi*. For this, a thin rayon sheet and hydroxypropyl cellulose (HPC) or methylcellulose (MC) diluted to a concentration of about 2% in an aqueous solution was used. Then, special tools were employed to carefully remove the murals (Fig. 17.8). For the painting of the Vermillion Bird on the south wall, and some other wall paintings where the thin plaster was well bonded to the stone, a diamond wire-saw was used for the removal process (Fig. 17.9). Among these

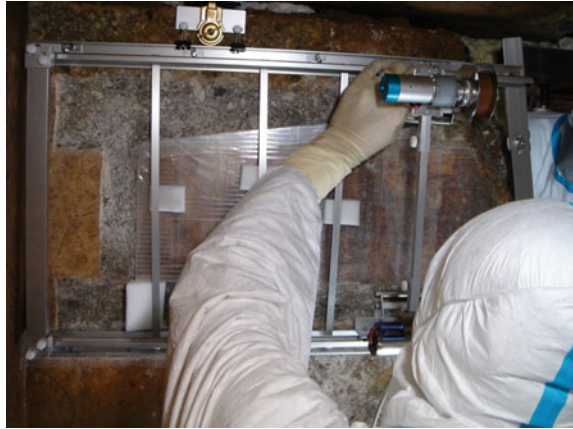
Fig. 17.9 Kitora tumulus:
removal of wall painting
using a diamond wire-saw

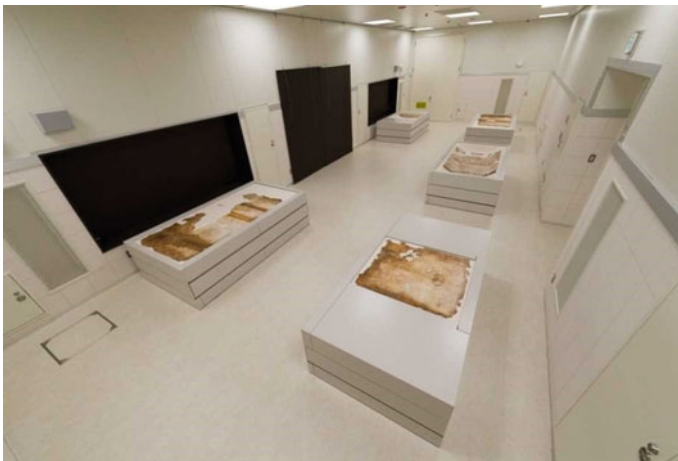
Fig. 17.10 Kitora tumulus: storage room for the detached wall paintings
