Analysis and Evaluation of the Slope Stability of K49 + 800 Section of S207 Road in Shizong County

Keywords: Highway Slope · Stability Evaluation · Treatment Measures

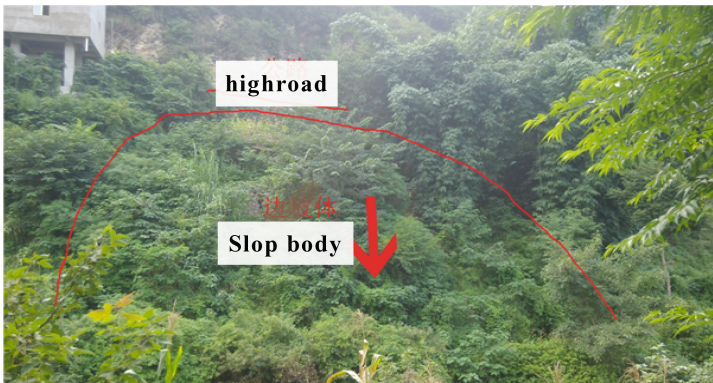
Fig. 5. Slope body

With the construction of Gaoliang Township, limited by geographical conditions, houses had to be built on the top of steep slopes. The formerly fragile geological environment is worsening. At the same time, in order to meet the traffic needs, the provincial road is built on the top of the slope, which forms a lot of excavation and filling, and the rock mass of the slope is broken, which affects the stability of the slope even more (See Fig. 5).
