# Geotechnical Lessons Learnt—Building and Transport Infrastructure Projects

Proceedings of the 2021 AGS Sydney  
Annual Symposium

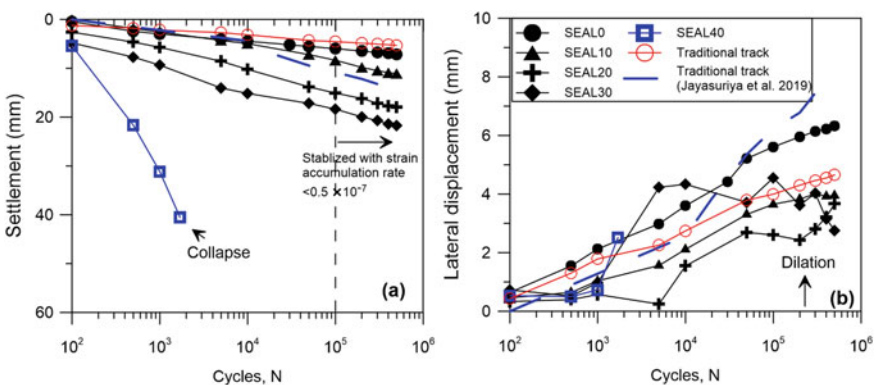
**Fig. 4** Deformation behaviour of the track specimen with SEAL mixture having different RC contents: **a** settlement and **b** lateral displacement (modified after Qi and Indraratna [40])

Figure 4 shows the settlement and the lateral displacement of the track specimen with traditional materials and SEAL having different rubber contents. It is observed that the settlement increases with loading cycles, and except for the one with 40% rubber the settlement of most of the test specimens stabilises with minimal strain rate ( $<0.5 \times 10^{-7}$  mm/mm/cycle). As expected, more rubber is included in SEAL, more settlement is observed for the track specimen (Fig. 4a). When 40% rubber is

added, the track specimen collapses with extensive settlement (more than 40 mm) within 2000 cycles. In terms of lateral displacement, adding 10% rubber in SEAL reduces the lateral dilation, but when more rubber is added, the lateral movement is increasing with fluctuation (unstable) (Fig. 4b). This may be because that when more rubber is included, the skeleton of SEAL tends to be taken by rubber materials, hence the SEAL mixture behaves like rubber which shows a bounce effect under dynamic loading [40, 41]. When compared with the track specimen with traditional materials, the track specimen with SEAL having 10% rubber shows a comparable settlement and less lateral movement, suggesting 10% rubber is a suitable amount to be included in SEAL for superior track deformation behaviour.

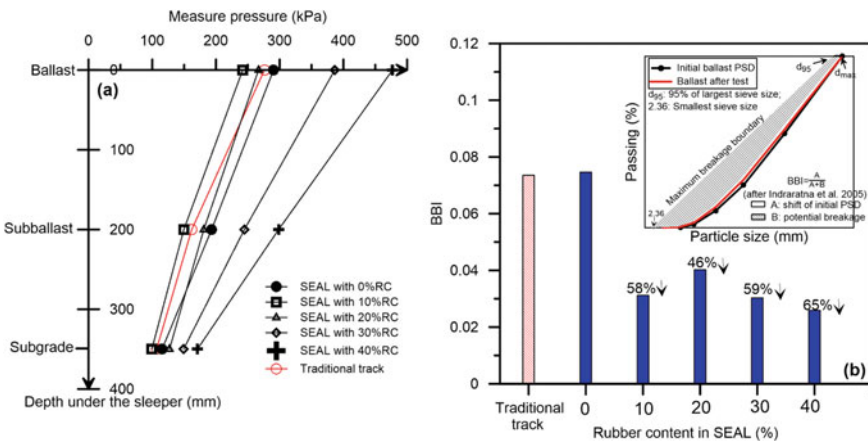
**Fig. 5** Test result of the track specimen with SEAL: **a** measured pressure on top of ballast, subballast and subgrade, and **b** BBI (modified after Qi and Indraratna [43])

Figure 5a shows the maximum stress measured on top of the ballast, subballast and subgrade layer. Noted that as the load distributes along with the depth of the track specimen, the measured stress decreases as the depth increases under the sleeper. Under dynamic loading, the actual stress subjected by the track substructure is usually higher than the applied load due to the dynamic amplification effect. Suppose the rail and sleeper are rigid, the applied maximum deviator stress on top of ballast should be 230 kPa, but due to the dynamic amplification effect, the measured actual stress on top of ballast for the track having 40% rubber is more than double. The specimen with 10% rubber shows the minimum dynamic amplification effect as the measured stress is around 240 kPa. The same trend can also be observed for other layers (i.e. subballast and subgrade). This indicates with a proper rubber content (10%) in SEAL, the dynamic amplification effect can be reduced, while too much rubber will adversely intensify the effect. Further investigation on the effect of rubber contents in SEAL on the track performance is related to the ballast breakage, as shown in Fig. 5b. Ballast breakage index (BBI) is used to evaluate the ballast degradation. It is proposed by Indraratna et al. [42] based on the particle size distribution curves of ballast before and after the test (Fig. 5b). BBI of the track specimen with traditional materials is similar to the track specimen with SEAL having 0% rubber. The addition of rubber will significantly reduce the ballast breakage index (46–66%). Having 10% rubber inside the SEAL seems sufficient to reduce ballast breakage as only a minimal change in BBI is observed when more rubber is added.

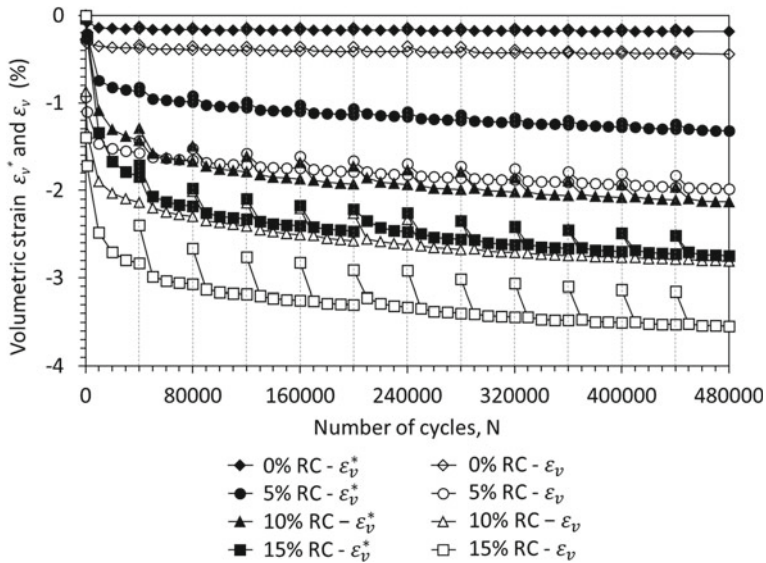
**Fig. 7** Void volumetric strain and total volumetric strain of CW-RC mixtures (modified after Tawk et al. [39])

The void volumetric strain ( $\epsilon_v^*$ ) and the total volumetric strain ( $\epsilon_v$ ) are shown in Fig. 7. In general, a rebound behaviour is observed during the rest period when rubber is added to the mixture for the void volumetric strain and the total volumetric strain. When no rubber is added to the mixture, the difference between the void volumetric strain and the total volumetric strain is minimal. This indicates that the CW particles experience negligible deformation. However, when rubber is added to the mixture,

a significant difference between the void volumetric strain and the total volumetric strain is observed. This proves that rubber particles experience a change in their volume, thus contributing to the total volumetric strain as expressed in Eq. (2).

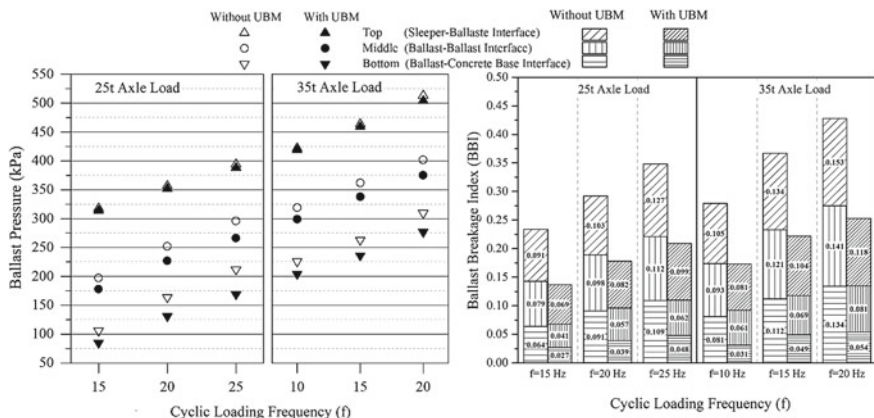
**Fig. 12** Ballast pressure variation and ballast breakage index (BBI) with and without UBM (modified after Navaratnarajah and Indraratna [26])

Figure 12 presents the profiles of pressure and BBI. The results confirm the increase in stresses in the layer due to the increase in axle load and frequency. A UBM layer at the top of a concrete base contributes to a notable decrease in pressure, especially at the concrete base–ballast and middle portion of the layer. Stress distribution due to a rigid base is now within about 1–1.5, 5–10 and 10–20% at the ballast–sleeper, ballast–ballast and ballast–concrete base, respectively. As expected, higher BBI is

observed at the top portion due to greater inter-particle contact stress and this reduces at the greater depths. Using UBM underneath the ballast layer can considerably reduce particle breakage. The UBM decreases the degradation by more than 40% on average. For each sub-layer, the reductions are 22% at the top, 40% at the middle and 55% at the bottom layers.

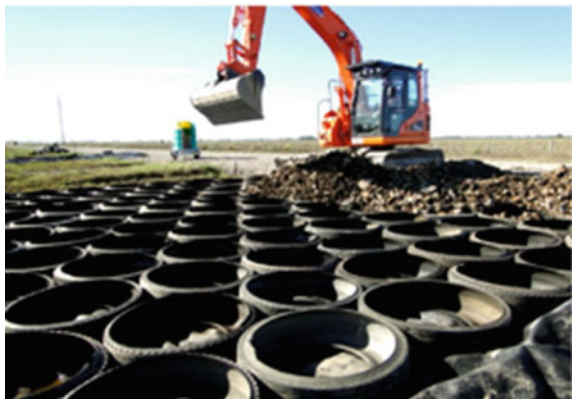
**Fig. 13** Placement of tyre cells in the field application

In this technique, the standard subballast layer of the railway track is replaced with waste rubber tyres having compacted infill materials. The waste rubber tyre is used after removing one of its sidewalls (the resultant herein referred to as “tyre cell”). The infill material is added to the tyre cell, and this unit cell is repeated throughout the width and length of the required track segment (Fig. 13). This method has the additional benefit of utilizing the 3D cylindrical geometry of the tyre cells along with the energy absorption characteristics of the tyre rubber. As a result, the infill material is more tightly contained, hence increasing the track’s bearing capacity.

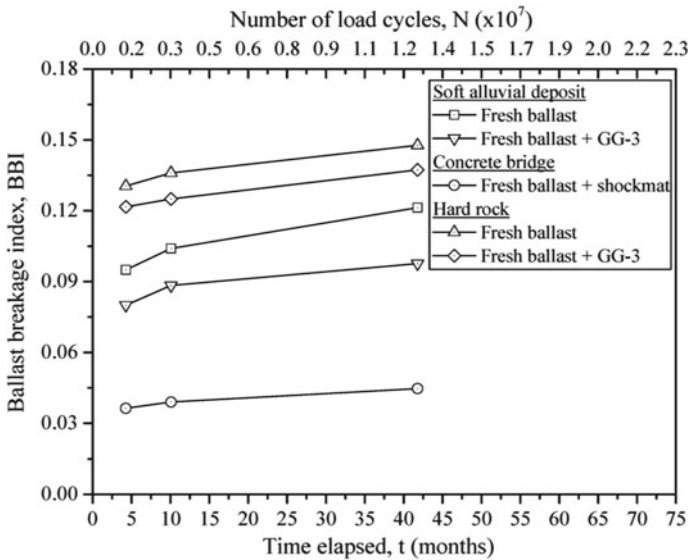
**Fig. 21** Ballast breakage index of the track section with and without geogrid and shockmat (modified after Indraratna et al. [27])

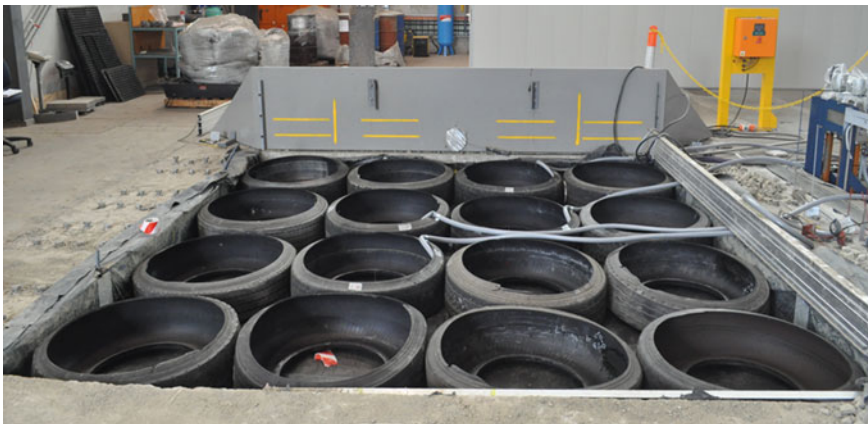
**Fig. 23** Tyre cell assembly placed for the preparation of capping layer

cell (Ecoflex). The tyre cells are then filled with the compacted infill materials. The placement of the tyre cells to prepare the capping layer is shown in Fig. 23. A typical cross-section of the track is being designed using the method proposed by Indraratna and Ngo [54] to obtain approval (Fig. 24). It is expected that the track performance can be enhanced and track maintenance costs can be minimised by reducing the deterioration of ballast aggregates and decreasing excessive settlements of the formation layers (i.e. capping and structural fill layers).

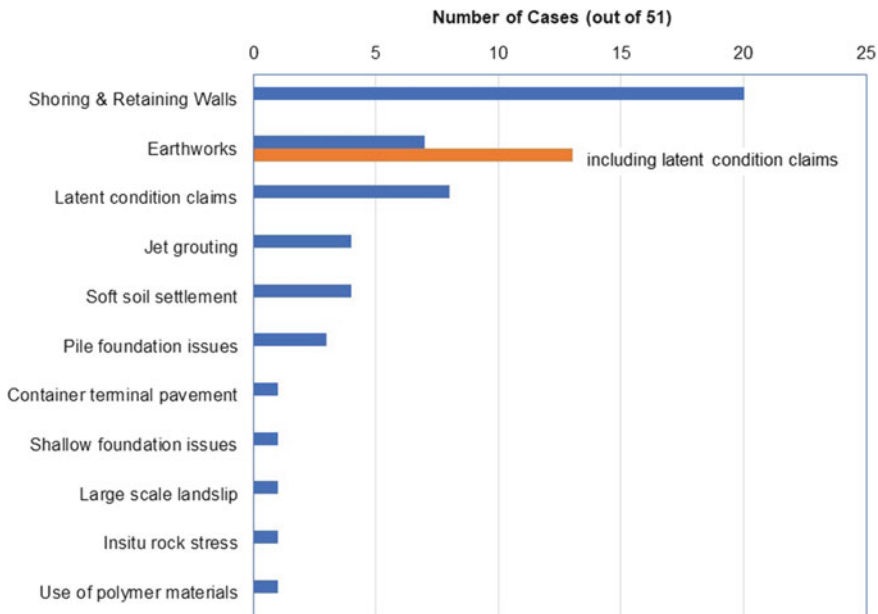
Fig. 1 Frequency of geotechnical problems (Author’s Experience)

Latent condition claims come next with 8 out of 51 cases or about 16%, and 6 of the 8 cases of latent condition claims are related to earthworks.

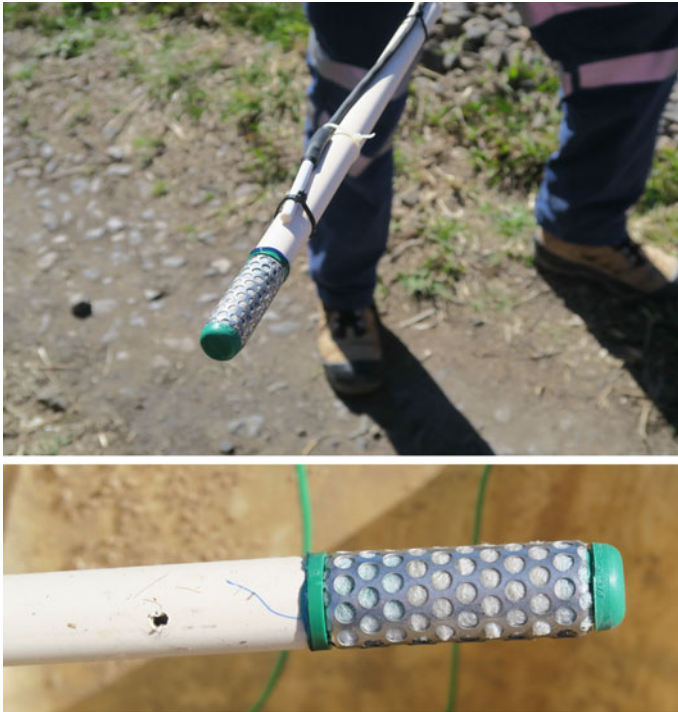
**Fig. 3** Watermark 200SS sonde prepared for installation, (top) with temperature monitor attached to outside of PVC conduit in proximity to the sonde and (bottom) the recommended hole in casing just above instrument

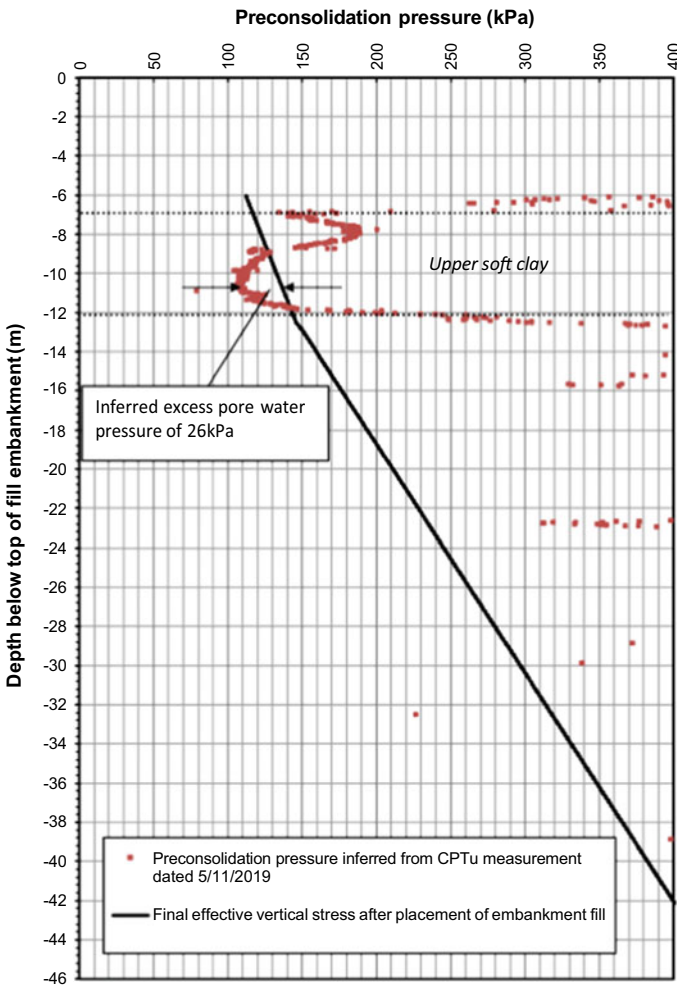
Fig. 4 Typical plot of assessed  $\sigma'_p$  and  $\sigma'_{v \text{ final}}$  with depth

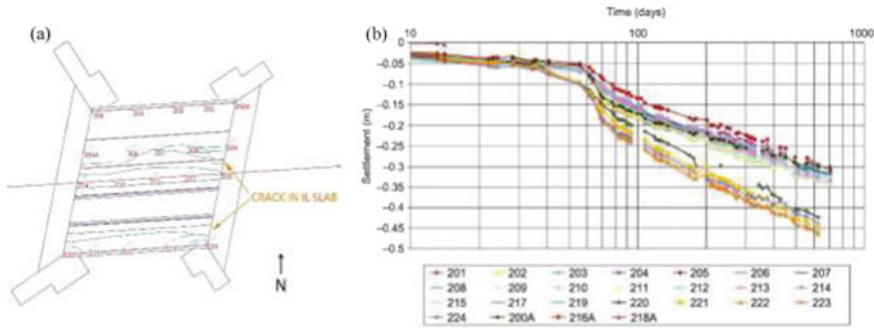
**Fig. 8** a Location of survey points on culvert base slab b Box culvert settlement monitoring results

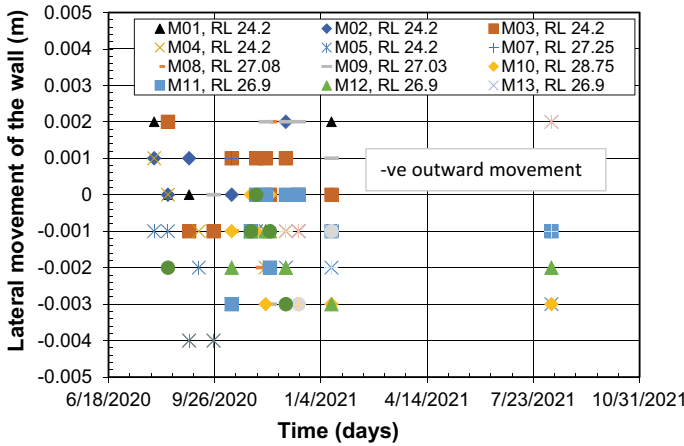
Fig. 9 Wall movement monitoring results using wall tags

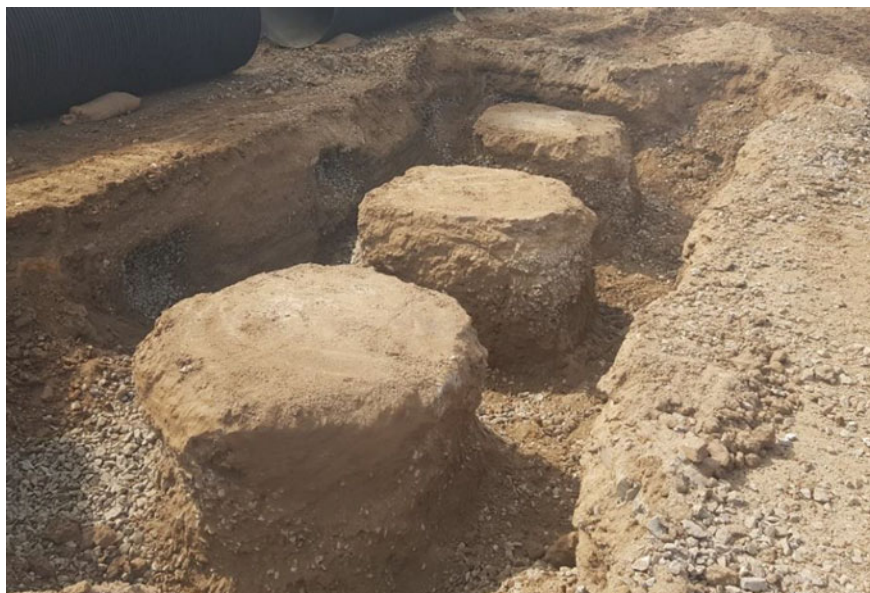
**Fig. 16** Exposed column head of WSM columns at 1.1 m depth

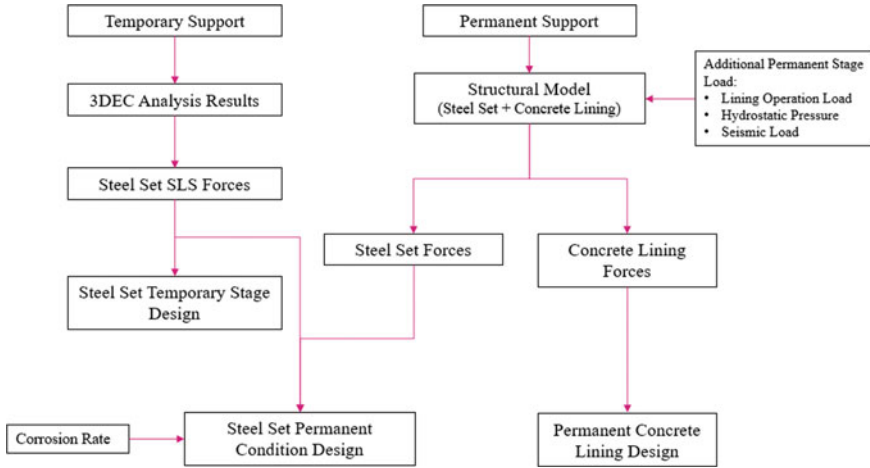
Fig. 9 Work flowchart of structural design check

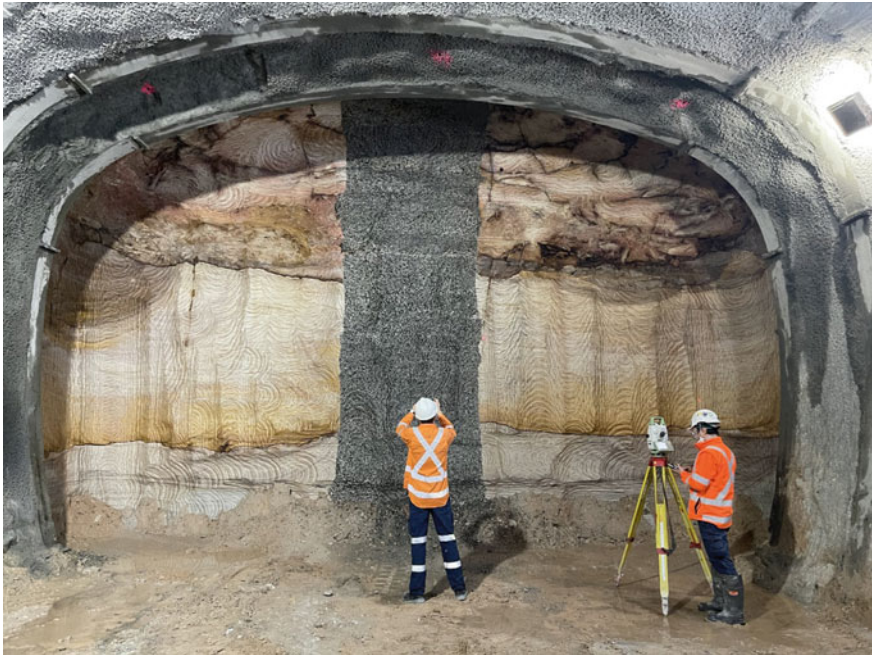
**Fig. 12** Initial advance below C10 showing MCB extending below tunnel invert

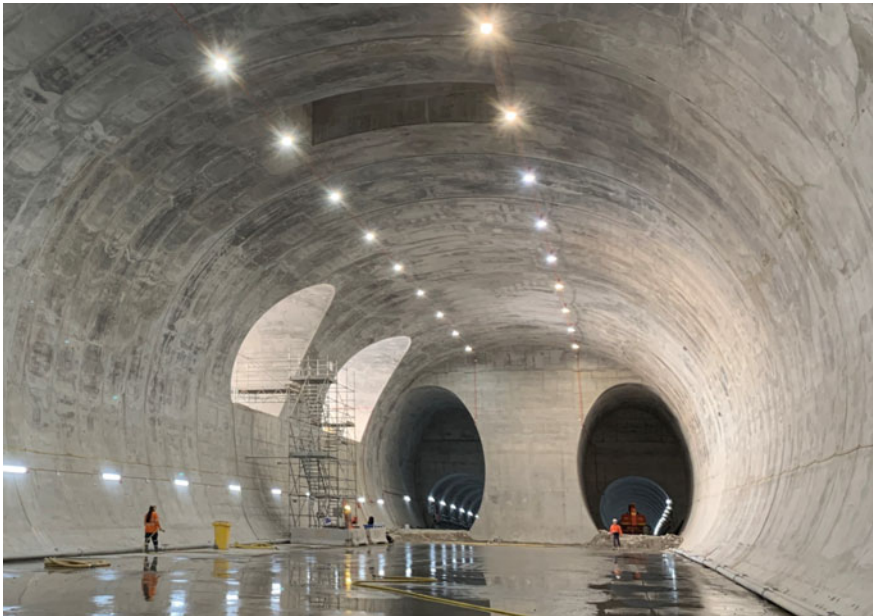
**Fig. 9** Completed permanent lining with lift shaft opening evident in the crown (9 November 2020)

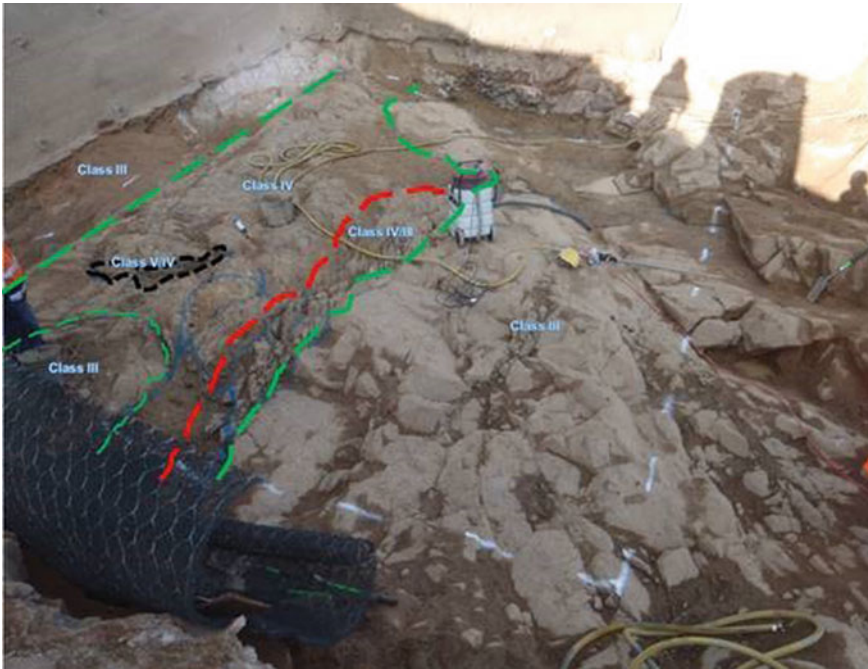
Fig. 16 Exposed rock at elevation of RL 849 m at Pier 2
