# Geotechnical Challenges in Design and Construction of Bridge Foundations and Approaches in Hilly Granite Formation

**Abstract** This paper presents a case study of geotechnical design and construction challenges of bridge foundations and approaches in a hilly granite formation in northern New South Wales, Australia. Firstly, the geological formation and existing cut slope conditions which have high risks of rock fall will be described. The original design was based on the available geotechnical information and assumed construction methodology. Reinforced concrete cantilever retaining walls founded on mass concrete were adopted for the bridge southern approach to resolve constructability issues over hilly terrain. The design considered retaining wall block sliding stability while overturning and internal stabilities were satisfied. Slope treatments using a rock fall fence together with individual boulder stabilisation or removal were also considered. It was found during construction that the actual ground conditions were different to that originally inferred and modifications to pad footing designs were deemed necessary. Additional investigations were undertaken, and the subsurfa

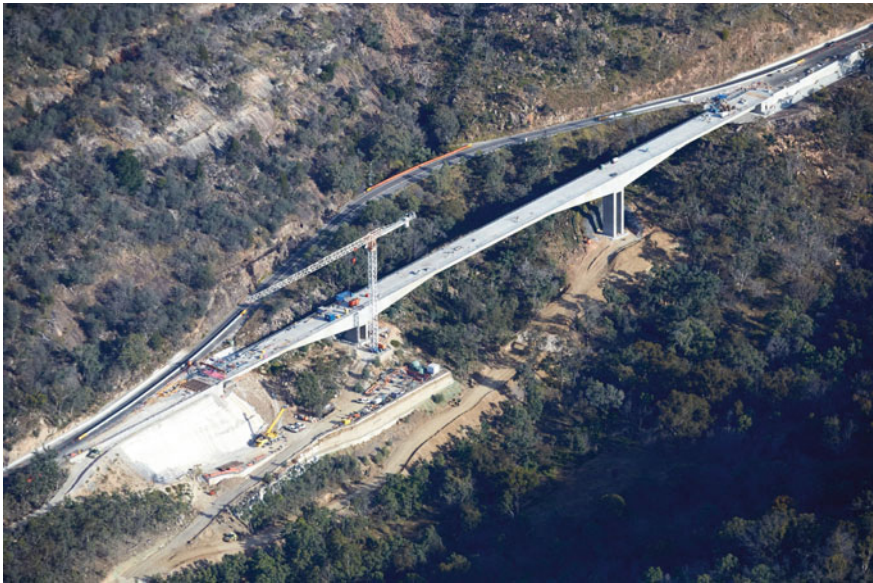
Fig. 2 Aerial view of the bridge near completion

Figure 2 shows the 3D view of the proposed bridge close to completion of construction with respect to the existing road. The redundant section of highway is being retained for use as an access road for bridge maintenance.

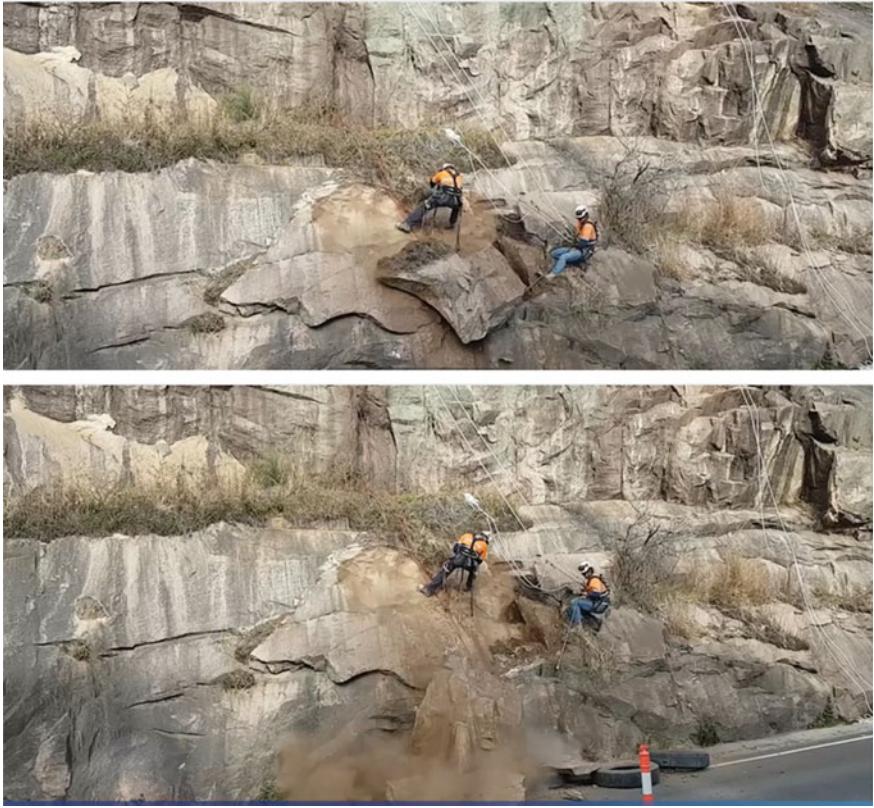
Fig. 7 Removal process of a potentially unstable rock block (after TfNSW website)

After awarding the contract the contractor engaged an independent geologist to carry out an assessment of the rock fall risks to both road users and the construction crew down slope. It was apparent that the attitude to the uncertainties in risk rating to the road user and construction workers were different. The Contractor’s responsibilities under WHS legislation drove a robust approach to worker safety (considering what is reasonably practicable to achieve) whereas the basis of the RMS slope risk assessment guidelines is safety of road users who are exposed to risk for merely seconds as they pass through the hazardous zone. Therefore, a greater emphasis was placed on safety for construction crew down slope, leading to increased upslope treatment measures including using rock fall mesh. Figure 7 shows the removal process of a potentially unstable rock block above the road as part of upslope stabilisation works.

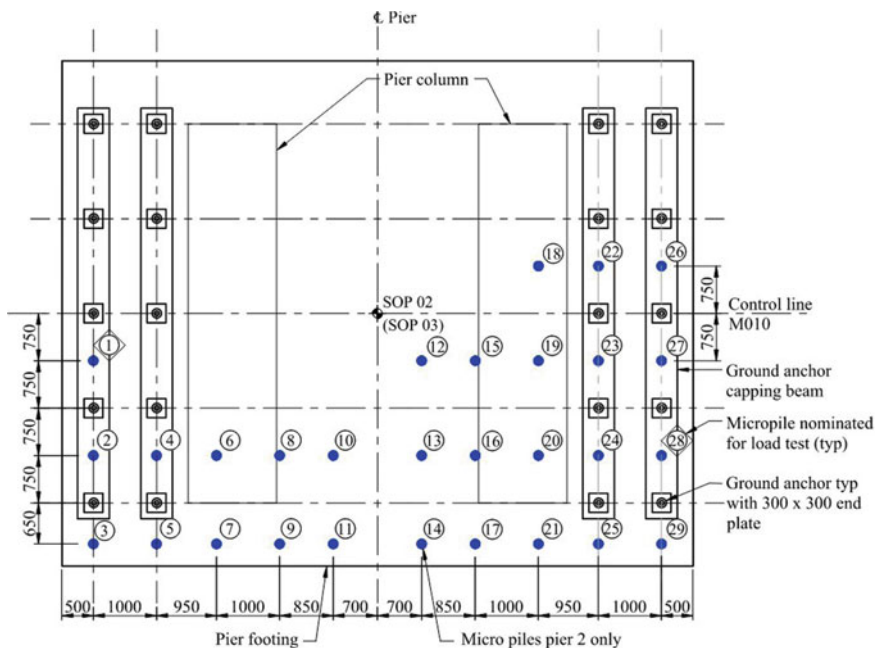
**Fig. 12** Layout plan of 29 micropiles of varying lengths at Pier 2

A total of 29 micropiles, as shown in Fig. 12, were considered for the identified “weak” zone of Class V or Class IV rock inferred from the available cored borehole data.

The micro piles were taken to form an overall ground improvement and stiffening of the Class IV/V layer allowing the majority of loads to be transferred to the more competent Class III layers below. Structurally the micropiles were assumed to transfer these bearing loads in axial compression. An allowance for vertical tolerance of 1/100 has been included in the design in accordance with AS2159, however, up to 4/100 has been assessed to demonstrate the impact of the surrounding rock confinement on limiting induced moments.

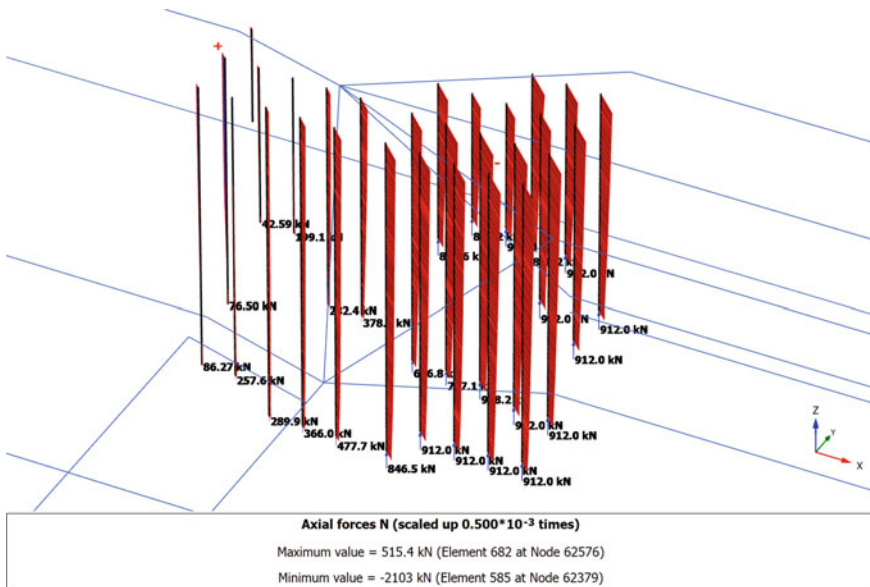
**Fig. 14** Axial loads in micropiles from Plaxis 3D model—Case B

The results of the Plaxis 3D modelling for these three cases are summarised in Table 4, with the axial forces for Case B presented in Fig. 14. Note that the values shown at the bottom of each pile are loads at the tip of pile.

Pile geotechnical capacity assessment in accordance with [1] LRFD indicated that approximately 4 m of socket into Class III rock was required (when ignoring the casing to rock bond over the plunge length). For each location/area the pile length was adjusted to achieve the required geotechnical and structural capacity. In general, the length of the piles will be varying between approximately 5 and 11.5 m.

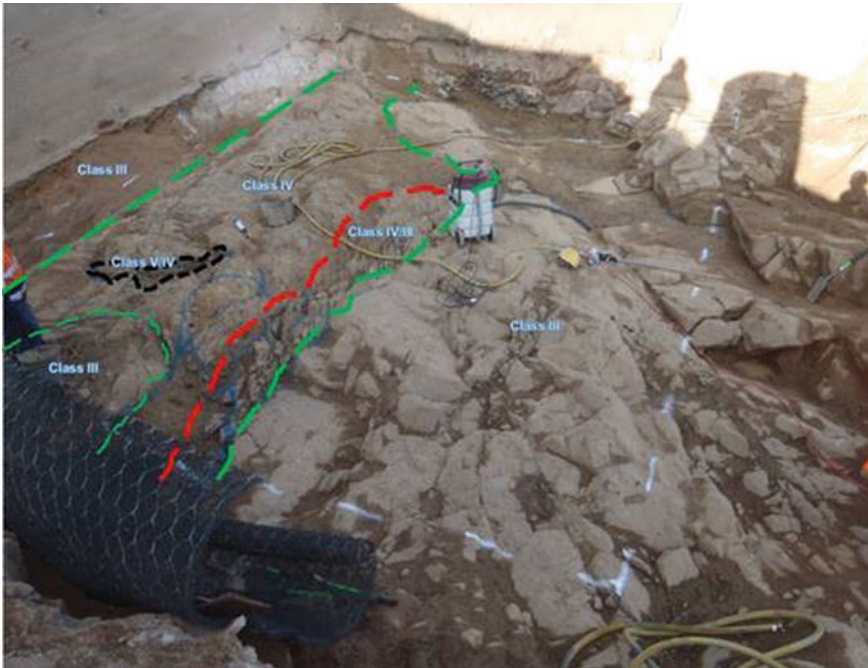
Fig. 16 Exposed rock at elevation of RL 849 m at Pier 2

When the excavation of pad footing was carried out down to RL 849 m the exposed rock surface was assessed by an engineering geologist prior to pour of concrete. Figure 16 shows the approximate extent of mapped classes of rock mass at the founding level beneath the pad footing at Pier 2.
