# Crack Growth Life Prediction in API 5L X46 Grade Steel Pipes Subjected to Cyclic Internal Pressure

S. Vishnuvardhan, A. Ramachandra Murthy, M. Saravanan, and P. Gandhi

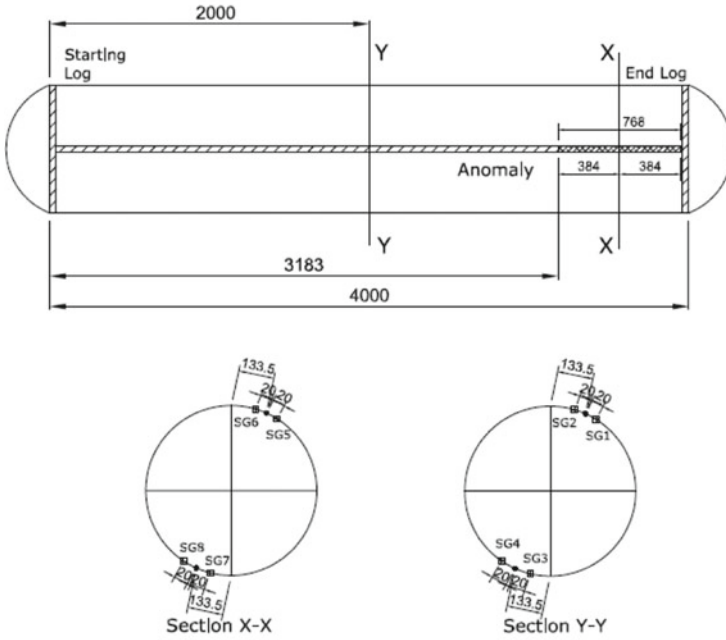
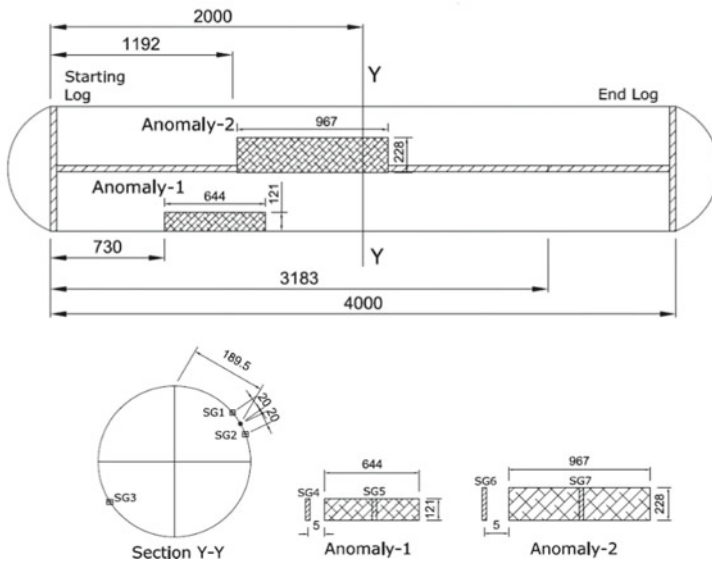
**Fig. 1** Details of pipe specimens, defect details and location of strain gauges

The pipe specimens were welded with curved blind flanges at both the ends. Two threadolets were provided in the pipe specimens at a distance of 200 mm from the weld centre. Threadolet is an opening given in the specimen with threads inside and a bolt is used for opening or closing it. This provision was used to fill the specimen with hydraulic oil and apply the desired internal pressure. The pipe specimens were instrumented with two element rosette strain gauges to study the variation of strains during cyclic pressure test. Strain gauges were mounted on the pipe specimen at two different cross-sections along the length of the pipe viz, centre of defect location and middle of pipe specimen. In the case of pipe specimen containing lamination defect, strain gages were also mounted at the edge of defect. Figure 1 shows details of pipe specimens, defect details and location of strain gauges.

(a) Specimen with longitudinal seam crack

(b) Specimen with lamination defects

The pipe specimens used in the present studies were made of API 5L X46 Grade steel conforming to API 5L [16]. The pipe specimens of 4.0 m length with different defect profiles cut removed from in-service pipe line were used. The nominal outer diameter and thickness of the pipe specimens were 14" (355.6 mm) and 7.14 mm respectively. Based on the intelligent pigging measurements carried out in the field, one pipe was detected to contain a longitudinal seam crack of 32 mm length and 2 mm depth and the other pipe was detected to contain two lamination defects of different sizes. Length and width of one lamination was 644 mm and 121 mm respectively. Length and width of the other lamination was 967 mm and 228 mm respectively.

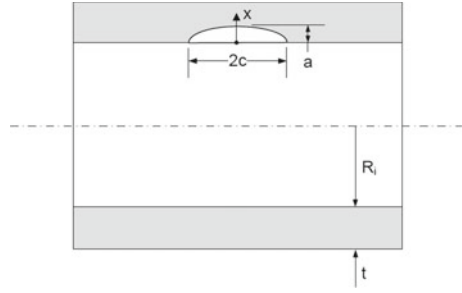
**Fig. 4** Mode I stress intensity factor for a cylinder subjected to internal pressure with longitudinally oriented semi-elliptical surface crack

As per API 579-1/ASME FFS-1, the Mode I stress intensity factor for a cylinder subjected to internal pressure with longitudinally oriented semi-elliptical surface crack (as shown in Fig. 4) can be computed by the following equations:

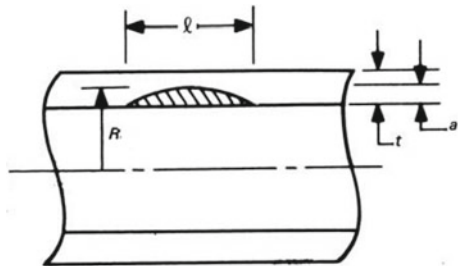
**Fig. 5** Mode I stress intensity factor for a pressure vessel with semi-elliptical surface crack

From paragraph H-4221.2 under Article H-4000 Screening criteria in ASME Boiler and Pressure Vessel Code (Section XI), Mode I stress intensity factor for a pressure vessel with semi-elliptical axial flow (as shown in Fig. 5) at the internal surface is given by the following equation:

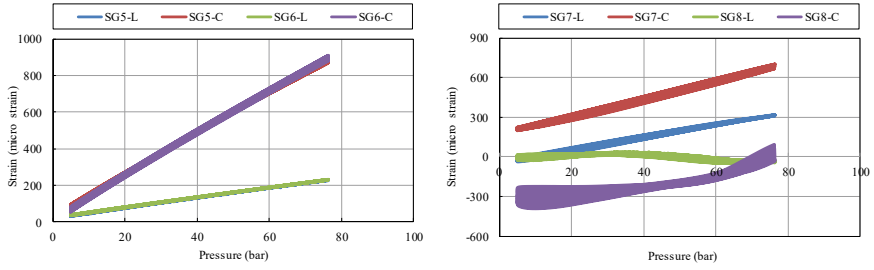
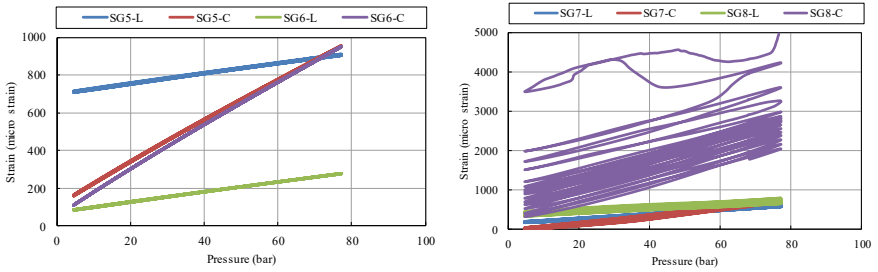
Fig. 7 Strain versus pressure curves for pipe specimen with longitudinal seam crack

(a) cycles 31 - 50

(b) cycles 1372 - 1392

Figure 6 shows typical strain versus time curves and Fig. 7 shows typical strain versus pressure curves for pipe specimen with longitudinal seam crack. Figure 8 shows typical strain versus time curves and Fig. 9 shows typical strain versus pressure curves for pipe specimen with lamination defects. It is observed that strain in the circumferential direction was higher compared to the longitudinal direction at a given location. The strain values are observed to be almost constant till the initiation of through-wall crack. It can be observed that the strain values close to the crack location increased rapidly just before the appearance of through-wall crack. In the case of pipe specimens with longitudinal seam crack, the existing crack had become through-wall and the specimen failed after completion of 1412 cycles indicating 3.87 years of remaining service life. Figure 10 shows close-up view of failure of pipe specimen with longitudinal seam crack. The pipe specimen with lamination defects has developed a through-wall crack and failed after completion of 2010 cycles indicating 5.51 years of remaining service life. Figure 11 shows close-up view of failure of pipe specimen with lamination defect.

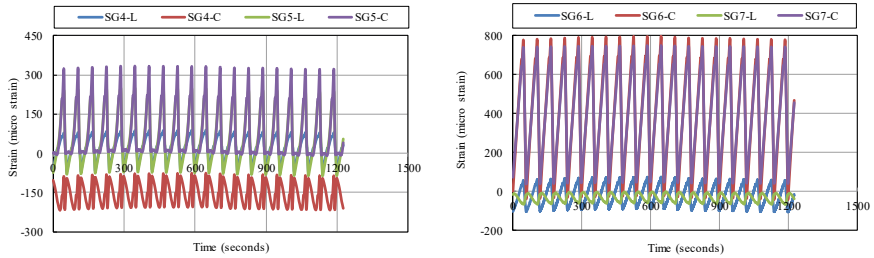
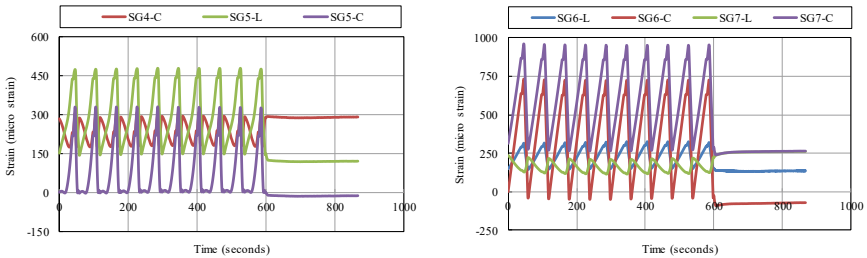
Fig. 8 Strain versus time curves for pipe specimen with lamination defects

(a) cycles 1501 - 1520

(b) cycles 2001 - 2010

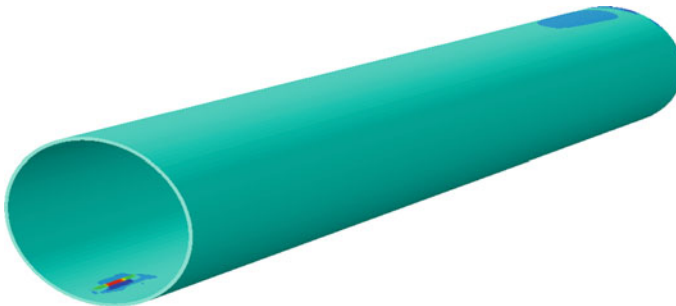
**Fig. 12** Stress distribution ahead of crack tip

Figure 12 shows stress distribution of ahead of crack tip. It was observed that the SIF is higher for the crack tip located nearer to the support than for the crack tip located away from the support due to the geometrical constraint effect of the crack position. Figure 13 shows SIF versus crack depth. As expected, SIF increased with increase in crack depth. Both the axial and von-Mises distributions are exhibited the fracture behaviour based on the material yield zone. It was observed that the crack tip located nearer to the support reached the yield first than the crack tip located away from the support, which could be due to the geometrical constraints and the boundary conditions.

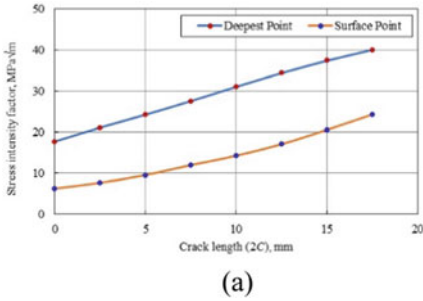
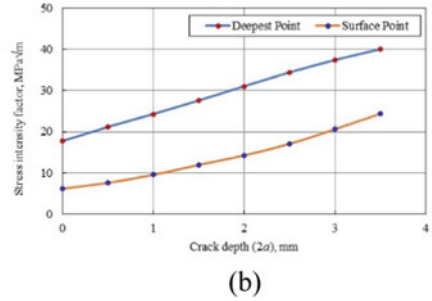
**Fig. 14** SIF prediction using API 579/ASME FFS-1

Figure 14a shows SIF for different values of crack length and Fig. 14b shows SIF for different values of crack depth obtained using API 579/ASME FFS-1 for the pipe specimen with longitudinal seam crack. Figure 15 shows comparison of SIF obtained using API 579/ASME FFS-1 and ASME B&PV Code Section XI Division I. SIF value obtained at deepest point of crack was always higher compared to surface point

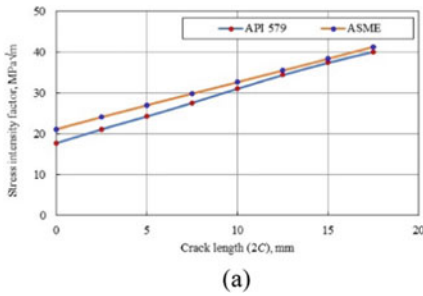
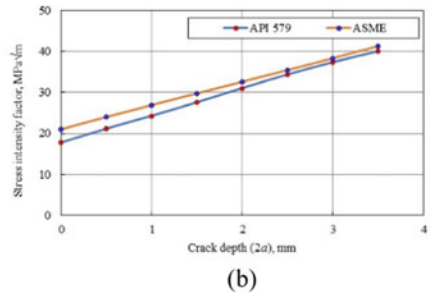
**Fig. 15** Comparison of SIF obtained from API 579/ASME FFS-1 and ASME B&PV Code Section XI Division I

of crack. SIF values predicted using ASME B&PV Code were slightly higher than the values predicted using API 579/ASME FFS-1 both at the deepest and surface points of crack. Employing Paris' crack growth model and crack growth constants available in the literature, number of cycles to failure was predicted. The values of Paris's crack growth constants  $C$  and  $m$  used in the present studies were  $3 \times 10^{-8}$  and 2.615 respectively. The number of cycles predicted using API 579/ASME FFS-1 and ASME B&PV Code Section XI were 5264 and 1691 respectively. The number of cycles predicted with the SIF values obtained from both the approaches were un-conservative. Tiku et al. [7] compared fatigue crack growth rates obtained from full-scale tests with the existing BS 7910 and API 579 formulations. The comparison confirmed that the BS 7910 approach results in very conservative estimates of fatigue crack growth rates for axial flaws. The BS 7910 stress intensity factor formulation overestimated the bulging correction for axially oriented flaws.

the crack tip located away from the support due to the geometrical constraint effect of the crack position. SIF for different crack depths was also evaluated analytically using the expressions available in API 579/ASME FFS-1 and ASME B&PV Code Section XI Division I. SIF values predicted using ASME B&PV Code were slightly higher than the values predicted using API 579/ASME FFS-1 both at the deepest and surface points of crack. Employing Paris' crack growth model and crack growth constants reported in the literature for API 5L X46 grade steel, number of cycles to failure was predicted and the results are compared.
