Influence Analysis of Damp Defect of Composite Insulated Zinc Oxide Arrester Based on Finite Element Calculation

Abstract Composite insulated zinc oxide arrester is important electrical equipment in power systems, and is prone to insulation failure during operation. For a case of abnormal leakage current and heat generation of zinc oxide arrester, the cause of the abnormality was identified as internal dampness through testing and disintegration analysis. The finite element analysis method was used to study the effects of zinc oxide valve plate moisture, insulating sheath moisture and insulating sheath cracking on the voltage distribution of arrester. The results show that when the resistivity of the arrester varistors and sheaths drops to a certain extent, it will lead to a significant change in the voltage distribution on the varistors, and the overall change trend is that the voltage of the varistors around the object is reduced, and the voltage of the other varistors is raised. It plays a certain a certain reference role in the analysis and disposal of the insulation moisture abnormality of the composite insulated zinc oxide arrester.

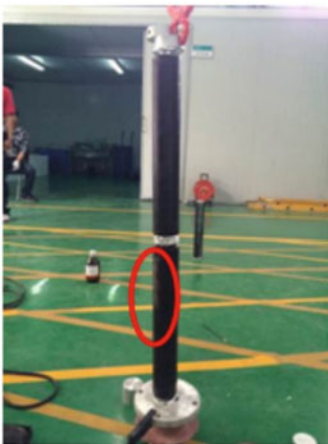
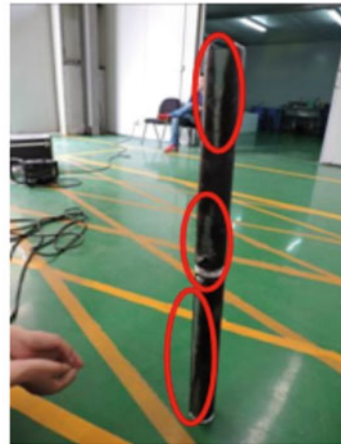
Fig. 3 The appearance of insulated sheath

The B-phase arrester was disassembled, and it was found that the upper section valve plate group had high resistance during the disassembly process, and the insulation sheath cracked and deformed many times. The upper section of the A phase with normal test data was disassembled, and it was found that the valve plate group was taken out smoothly, and the outer insulation sheath of the valve plate group was intact and there was no abnormality. The appearance of the upper insulating sheath of the A-phase and B-phase arresters is shown in Fig. 3.

(a) A-phase arrester section above

(b) B-phase arrester section above

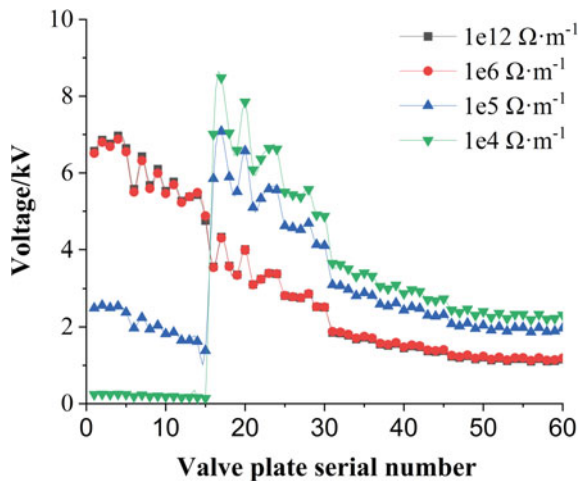
Fig. 5 The voltage distribution under different electrical resistivity of zinc oxide varistor

When the resistivity of the 1–15 valve plates of the upper section arrester from top to bottom is set Separately to $1e12$, $1e6$, $1e5$ and $1e4 \Omega \text{ m}^{-1}$, the voltage distribution of the arrester is shown in Fig. 5.

It can be seen from Fig. 5 that due to the comprehensive factors of its own capacitance and stray capacitance, the potential distribution of the arrester resistance valve plate is uneven. In the absence of pressure equalization measures, the potential distribution is characterized by high voltage sharing of the upper valve plate and low voltage sharing of the lower valve plate, which makes the charge rate of some valve plates high. When the resistivity of the 1–15th valve plate changes in the range of $1e6$ – $1e12 \Omega \text{ m}^{-1}$, the overall voltage distribution of the arrester does not change significantly, but when the resistivity of the 1–15th valve plate drops to $1e4 \Omega \text{ m}^{-1}$,

the bearing voltage of the single valve plate with the decrease in resistivity decreases significantly, from a few thousand volts to hundreds of volts, while the voltage of other valve plates rises significantly, resulting in uneven voltage distribution.

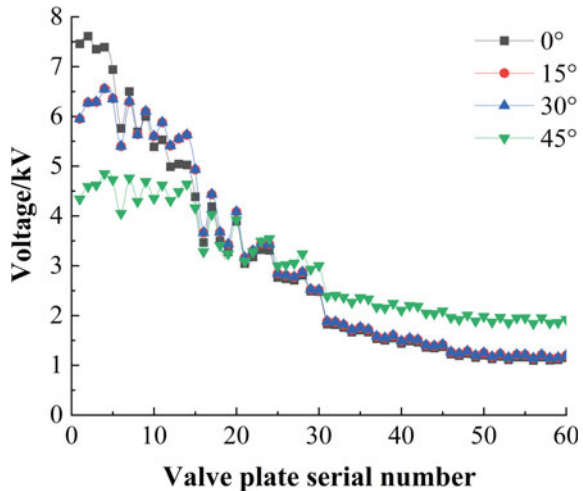
Fig. 6 The voltage distribution under different cracked angles of insulated sheath

Under the condition that the cracking angles of the outer sheath of the 1–15 valve disc from top to bottom are 15°, 30° and 45°, the voltage distribution of the arrester valve plate is shown in Fig. 6.

It can be seen from Fig. 6 that in the absence of moisture in the insulation layer, the cracking of the sheath has a great effect on the voltage of the lightning arrester valve near it, and the voltage change of the lightning arrester valve piece far from the cracking position of the sheath is not obvious. Compared with the case that the sheath is not cracked, after the sheath is cracked, the bearing voltage of the top resistive valve plate dominated by the 1–6 pieces decreases, and the withstand voltage of the middle and lower resistive valve plates increases slightly, that is, the voltage distribution of the upper arrester valve plate tends to be uniform.
