# Effects of Climate Change on Landslide Slope Stability and Case Studies

**Abstract** In recent years, disasters caused by torrential rains and floods that exceed the planned scale are occurring in Japan due to climatic change. In response to it, Japan has been improving and reinforcing existing infrastructure to withstand more severe disasters. For example, in river projects, widening river width through channel excavation to increase flow capacity, and in road projects, lane widening and reinforcement of existing embankments to enhance the traffic network during disasters are occurring. At these project sites, there is concern that artificial topographic modification (changes in stress conditions due to excavation and embankment), which was conducted as a countermeasure, will affect potential weak surfaces in the ground, which, combined with the effects of increased rainfall caused by climate change, will destabilize the existing slopes and cause new slope changes (Kaneko in A collection of papers from the China Branch of Geotechnical Society, pp.161–168, 2018). In this wise, the demand for the assessment of landslide slope stability associated with increased rainfall caused by

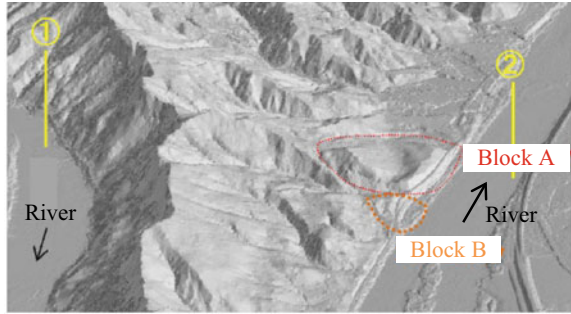
**Fig. 1** Bird's-eye view of topography

In the target area, when a landslide occurred in Block B (length 126 m, width 138 m) shown in Fig. 1 during the construction to widen the river in the past, the head soil removal work was conducted. In the adjacent Block A (length 380 m, width 295 m), no landslide deformation was observed in visual and field observations, but two water collecting wells were installed to improve safety and maintain stability. However, the widening of the river was required to increase the water flow of the river, and the countermeasure was pending issue.

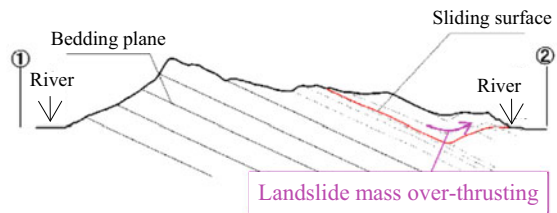
**Fig. 2** Schematic cross-sectional view

As shown in Fig. 2, Block A of the landslide shows a characteristic landslide topography in which the bedrock of the monoclinical structure (cuesta landform) bent in the middle and rose at the end. Since the crushing of the bedrock consisting of the landslide mass was localized, differentiation of the landslide block was not approved, and no clear deformation was observed in the field monitoring, it is now considered to be a primary landslide in an inactive condition. The geology of the subject area consists of Neogene Miocene tuff (mudstone, tuff, and alternating layers of tuffaceous

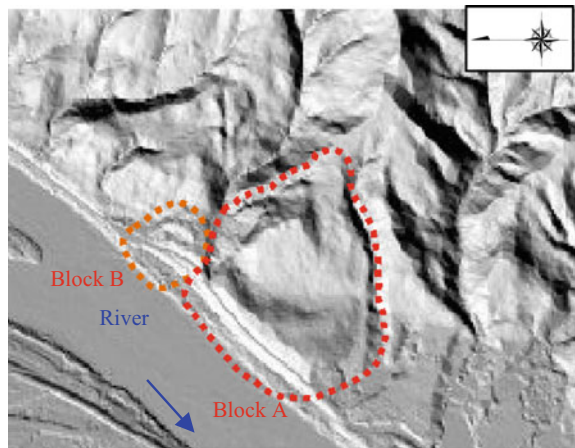
**Fig. 3** Topographic shadow diagram

sandstone and mudstone) distributed with north–south strike and gentle west-dipping monoclinic structure in the west area and steep cliffs in the east area, and the direction of the movement is 25° oblique to the river direction (Figs. 3 and 4).

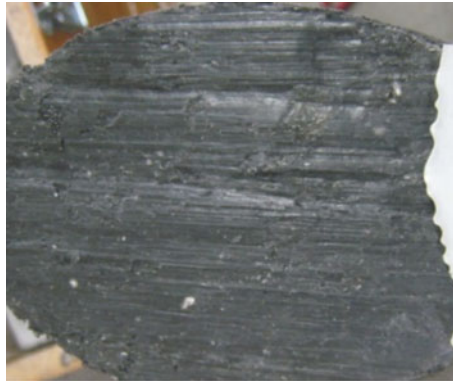
**Photo 1** Slickensides and striations

A geological survey was conducted to identify the geologic stratigraphy and the inclination direction of the geologic boundary, and the clay layer was extracted as a slip surface. Then, based on the presence or absence of mirror skin and striations, and the inclination angle, the slip surface was defined by the method shown in Photo 1 and Fig. 5.

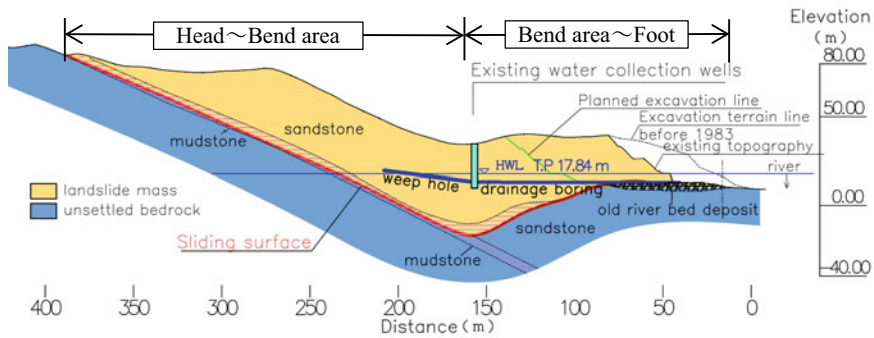
**Fig. 6** Schematic diagram of landslide cross-section

a primary slip caused by external factors such as an earthquake with large movement, and it was judged to be in a state of arrested movement at present (Fig. 6).

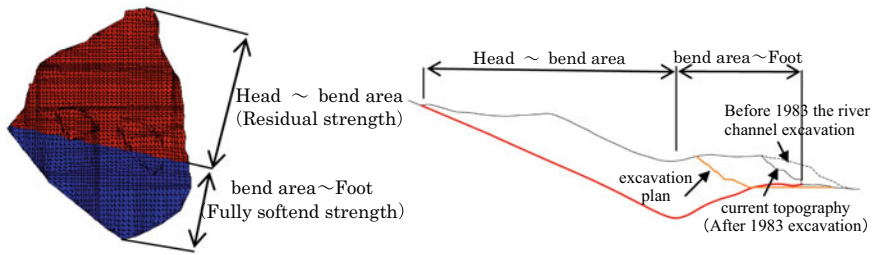
**Fig. 7** Planar and longitudinal sectional maps of slip surface strength

From the head to the bend in the landslide mass, the slip surface is straight and completely clayed by the large shear displacement during the initial landslide. The strength of the slip is judged to be equivalent to “residual strength” because a slickenside and striations are observed. The area from the bend to the end of the landslide shows hard clay mixed with gravel, which indicates that the moving soil mass rode up on the immovable ground and riverbed during the initial landslide and was crushed and clayed, and then reconsolidated by soil overburden load or horizontal compressive force. Although slickensides and striations are recognized in some parts, no clear separation surface is recognized as a whole, and therefore, its strength is judged to be equivalent to “full softened strength” (Fig. 7 and Tables 2 and 3).

3D stability analysis [4] was used to determine the factor of safety of the landslide slope at the highest observed water level. For the case of total residual strength,  $F_s = 0.93$ , which is inconsistent with the absence of landslide movement in Block A. For the total complete softening strength,  $F_s = 1.34$ , which is inconsistent with the situation where Block B collapsed due to past river channel excavation and Block A has no margin. Compared to the safety factor when the strength is set by the inverse

method, the safety factor is the same for the current topography and before the past excavation, but the safety factor is calculated as 10% lower for the future excavation plan due to zoning. It is considered that the zoning set the slip surface strength at the time of excavation to the full softening strength and excavated the area of higher resistance, resulting in a greater degree of reduction in the safety factor. From the above, it is judged that the strength setting by zoning is an appropriate method that reflects the local landslide conditions.

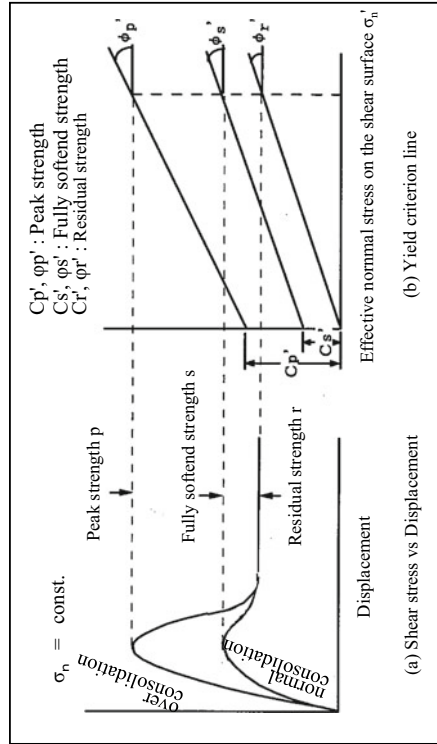
Concept of shear strength obtained from soil tests

Soil features	Clay (soft). There are slickensides and slickenlines	Gravel-bearing clay (reconsolidation). There is no slickenside and slickenline

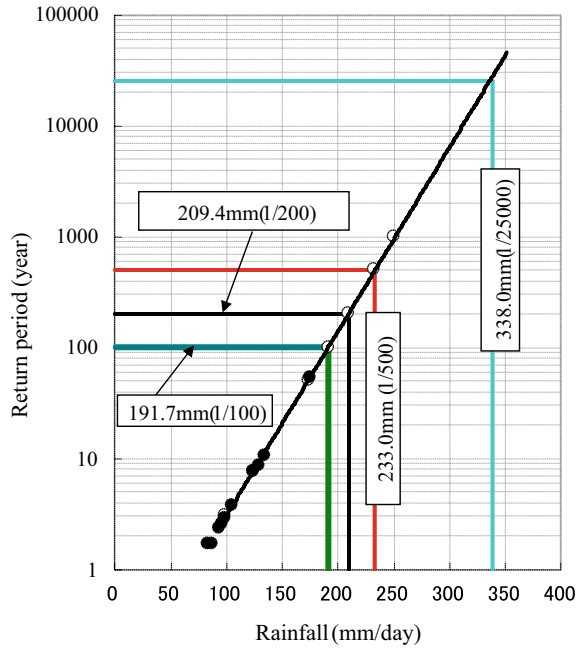
**Fig. 10** Chart for calculating probable rainfall precipitation using the Iwai method

The rainfall waveforms input to the seepage flow analysis were stretched from existing observation waveforms to an arbitrarily set maximum daily rainfall, and rainfall probabilities were calculated using the widely used “Iwai equation” (Fig. 10)

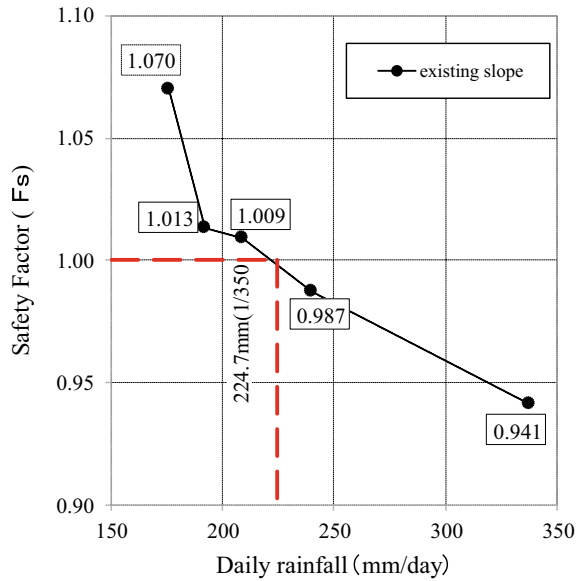
**Fig. 11** Chart for calculating the critical rainfall that maintains slope stability

[6]. Based on this rainfall waveform, groundwater levels were predicted by quasi-3D seepage flow analysis, and stability was evaluated by 3D stability analysis. This resulted in a predicted critical daily rainfall of 224.7 mm (1/350), which was sufficient to maintain stability (Fig. 11).

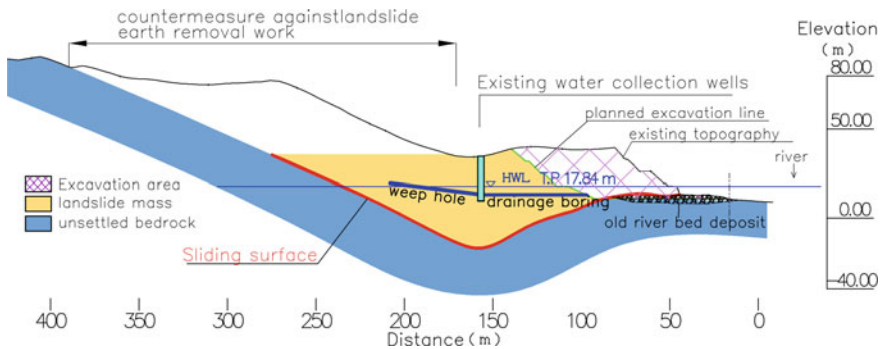
**Fig. 12** Landslide prevention work for river widening

The slip factor of safety for existing slopes (Table 4) showed a significant degree of decrease with increasing rainfall, reflecting the increase in the groundwater level of the landslide soil mass as rainfall increases. On the other hand, the safety factor was less than 1.0 in the river widening plan to improve the flow capacity of the river, as shown in Table 3. Therefore, sediment removal works with a safety factor of  $F_s = 1.05$  or higher were considered, and the results of rainfall and safety factors are shown in Table 4. Since most of the landslide soil mass was removed (Fig. 12) and there was little room for the groundwater table to rise, it was determined that there was an upper limit to the decrease in the factor of safety with increasing rainfall and that the stability of the slope could be improved.
