DECAY OF SANDSTONE IN URBAN AREAS CORRELATED WITH ATMOSPHERIC AEROSOL

Abstract. The decay of sandstone in urban areas has been investigated. Patterns and composition of the damage layers sampled on monuments and historical buildings are described. The elemental concentrations of black surface crusts are reported. Enrichment factors in relation to the sandstone and crustal rock composition have been calculated in order to point out the component due to atmospheric deposition. The presence of anthropogenic aerosol and its role in the process of damage is evidenced.

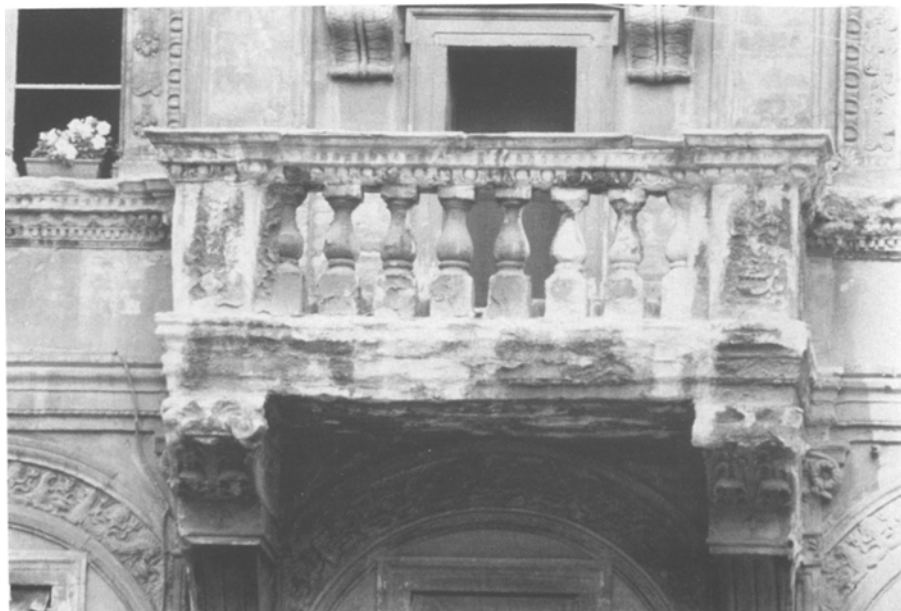
Fig. 2. Black patterns as can be observed on the surface of porous natural stones, such as calcarenites and sandstones.

al., 1983). On considering the color and appearance of the surface of sandstones and calcarenites, the blackening is observed on the whole surface independently of its geometry or exposure to rain water (Figure 2). The damage layer presents an inhomogeneous structure, consisting of a thin black crust at the surface and a thicker underlying layer white-beige in color with a crumbled powdered consistency (Figure 3a). Where the black crust has come away, part or all of the powdered layer is removed, laying bare the underlying rock. In this case a loss of material of the order of one centimeter is observed and the unaltered sandstone is exposed to a new cycle of weathering (Figure 3b). Thus, the blackening can affect the whole surface of a monument; the color of the original rock is shown, only where the black crust has fallen off.

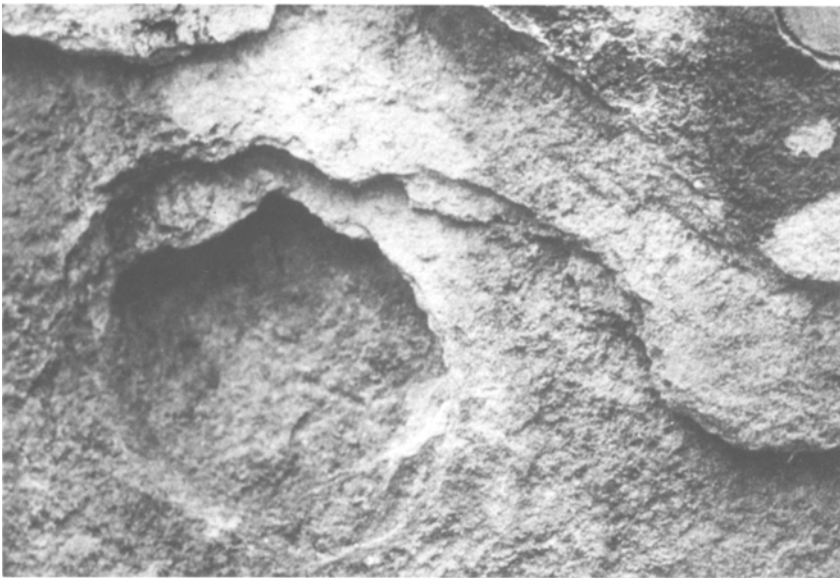
Fig. 3. (a) An example of sandstone damage: the black surface crust (layer *A*) is clearly shown; where exfoliation occurs, the underlying powdered layer (*B*) is lost within a short time, exposing the undamaged rock to a new cycle of chemical weathering. (b) The decayed sandstone surface shows exfoliation revealing concentric cracks which have been produced by dissolution of the calcium carbonate, the soluble portion of the rock.
