Pollution of limestone aquifer due to urban waste disposal around Raipur, Madhya Pradesh, India

Abstract During the rainy season deterioration in the quality of water, supplied through dug wells and tube wells, near an abandoned limestone quarry was reported. The abandoned quarry is now being used as an urban waste disposal site. The problem was further complicated by hospitalization of several inhabitants who were using this water for domestic purposes. Looking into the consequences, chemical analysis of water from the quarry, dug wells and tube wells was carried out. The water was found to be contaminated. The transportation of pollutants from the quarry to the groundwater system was facilitated by karst features. Furthermore, four major sources—domestic waste disposal, water conservation structures, landfills, and water wells—contributing to pollution were identified. This case study is an attempt to provide an understanding of how the karst features facilitate groundwater contamination. It will help us answer a few questions such as why karst hydrogeology deserves special attention in urban expansion and what protective measures should be planned in view of rapid urbanization.

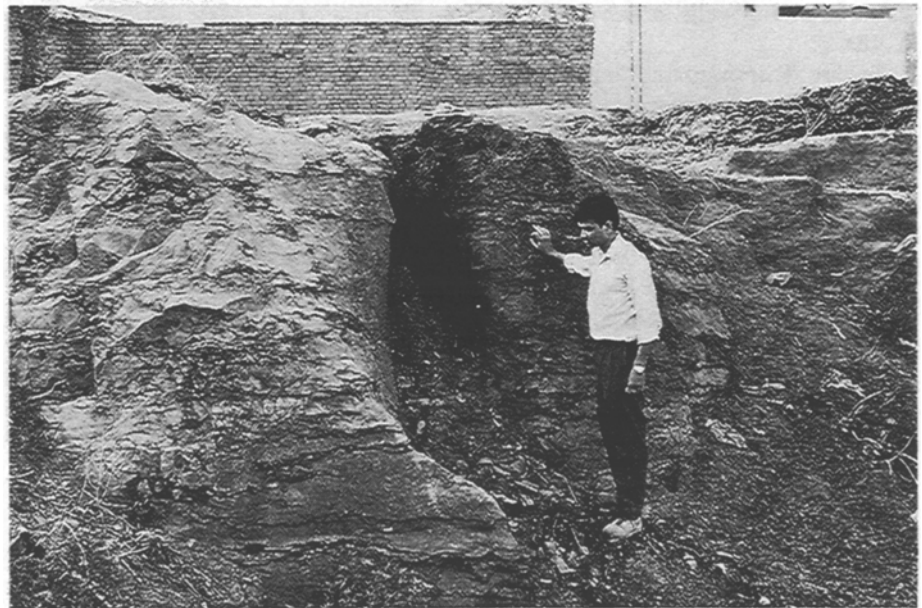
Fig. 5. Solid waste dump in solution enlarged joint

The Chandi limestone of the Raipur Group is the major aquifer that provides fresh water to Raipur city. It is covered with soil or laterite. The thickness of this cover varies up to 10 m. The laterite that is overlying limestone is highly porous (Fig. 3). The major joint patterns observed are vertical (NE–SW, NW–SE) and subhorizontal joints. Various karst features identified are grikes, klints, kareens, dolines, sinkholes, and solution-enlarged joints (Figs. 4 and 5). These karst features act as conduits and provide

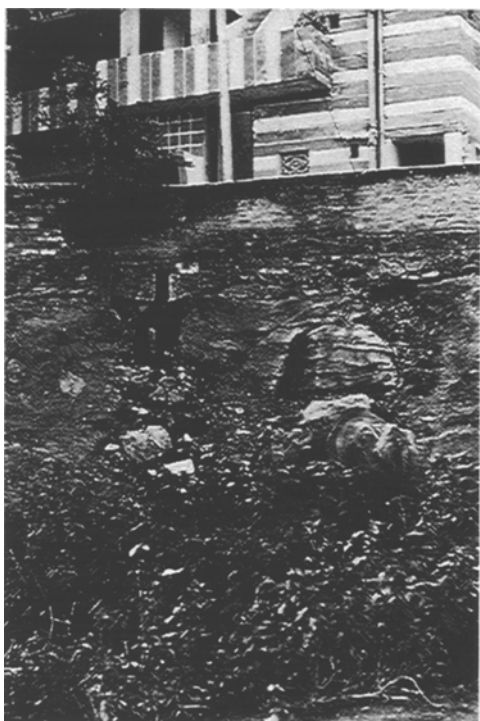
Fig. 6. Direct disposal of domestic sewage into karstified limestone

also potential contamination sources (Fig. 6). In all these systems, bacterial action digests the solid materials and the liquid effluent is discharged into the ground. Excessive concentrations of detergents, nitrate, and organic chemicals, bacteria, and viruses present the greatest threat to groundwater quality.

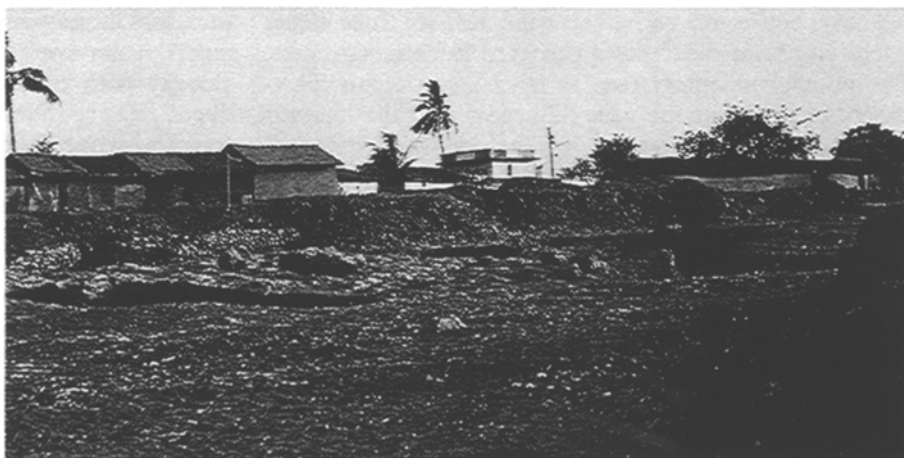
Fig. 7. Garbage disposal as landfills in an abandoned limestone quarry

3. Landfills: There are more than 25 active and abandoned urban waste disposal sites in Raipur. At places, the disposal of waste is by dumping of garbage as landfills with incineration of combustible refuse in abandoned limestone quarries (Fig. 7). The current annual urban waste output exceeds 10 million tons. Along with the residential refuse, industrial, agricultural, demolition, and incineration waste are used as landfills. The landfill material includes paper products, food wastes, construction debris, septic tank sludge, plastic, glass, and chemicals.
