J. M. James

Burial and infilling of a karst in Papua New Guinea by road erosion sediments

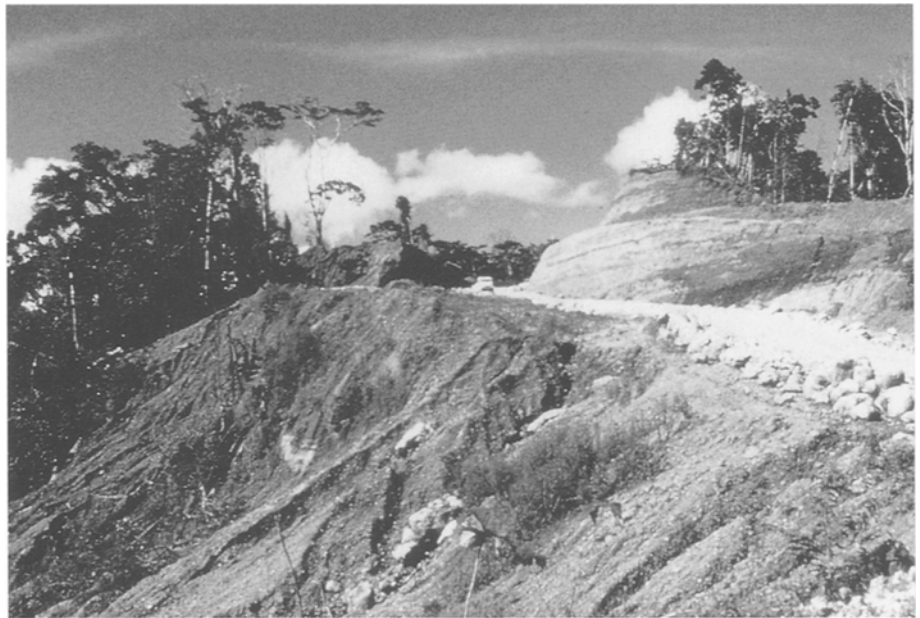
Fig. 4. Erosion of the Lukwi road embankment, May 1985

The access road (Fig. 3) was placed high on the easily excavated Era beds by clearing a wide track of primary forest. The road was bulldozed in, either on or just below the crest of the ridge, with no effort being made to move or consolidate the excavated vegetation, soil, and rock. The road was not sealed and its surface was finished with crushed limestone; immediately after construction, runoff began to cause considerable erosion of the roadway and its embankments. Figure 4 shows the degree of erosion of the road embankments in May 1985. In July there was considerable growth of natural vegetation on the embankments and some enterprising Papua New Guineans had already assisted their consolidation by planting vegetable gardens.

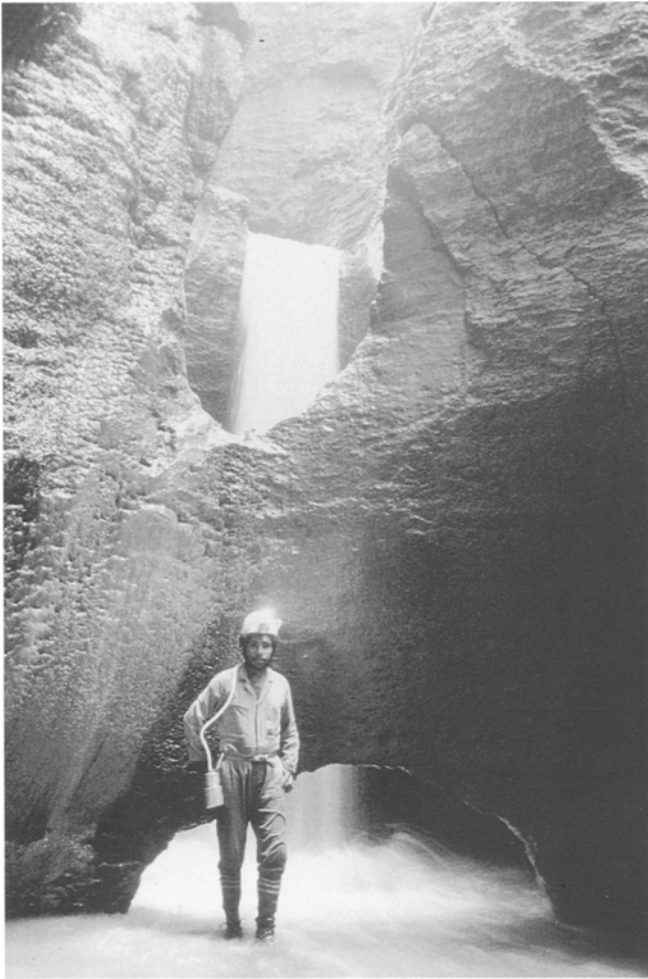
Fig. 5. The waterfall entrance to Ok Bedda Cave. Sediments eroded from the Lukwi road were cleared efficiently through this steep section

In Ok Bedda Cave, road erosion sediments, logs, and other vegetal debris were spread throughout the large, horizontal trunk passage. Depth of the sediments varied daily; during the hours of low flow they built up, and when the rains brought high flow, they were removed again. The depth of the plunge pool of a 5-m waterfall at the sink (Fig. 5) varied from 1.5 m to 0.25 m. In contrast, a tributary passage of Ok Bedda Cave that drains a small catchment isolated from any road sediment influx had clean-washed scalloped walls and remained completely free of sediment. During a dry period in May 1985, a fan of sediment could be observed extending 5 m out into, 10 m up, and 20 m down the Ok Ma at its junction with the Ok Bedda creek.

Before the construction of the road, the drainage system of the east bank Lukwi karst would have been one with large turbulent flows under gravity passing through caves to springs. At that time, the karst would have had negligible water-storage capacity. The Ok Bedda Cave retained these characteristics throughout the period of sediment invasion despite having the greatest length of the road in its catchment (Table 1). This can be attributed to its possessing a comparatively straight, direct route between the sink and the spring, to the uninterrupted large dimensions of its principal passages and to the frequent occurrence of large discharges (more than two cu. meters per second). Such discharges, when confined within a cave passage, are expected to maintain excellent scouring capacity, and this was confirmed by the continuous clearance of sediments through this cave.
