## Technical Note

# Application of the Distinct Element Method for Analysis of Toppling Observed on a Fissured Rock Slope

T. Ishida, M. Chigira and S. Hibino

Central Research Institute of Electric Power Industry, Abiko City, Chiba, Japan

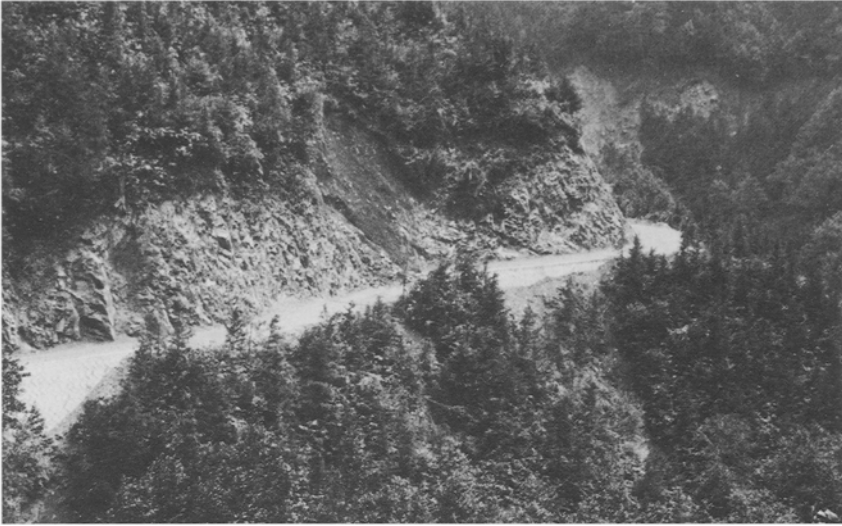
a)

Fig. 2. Photographs of outcrop *A*.

(a) Distant view of outcrop *A* as seen from the north; (b) Failure of rock plates on a bending surface; (c) Close-up photograph of outcrop *A*, which shows the change of the structure from the base rock region through the weakly toppling region to the toppling region

The structures formed by toppling were found at the two outcrops *A* and *B* (Fig. 1) which have about the same structure. The structure of outcrop *A* can be observed more clearly than that of outcrop *B*, because the observed section of outcrop *A* trends east to west and is almost normal to the most dominant joint set trending north to south. Therefore, the structure of outcrop *A*, shown in the photographs in Fig. 2 and in the sketch in Fig. 3, is discussed in the following.
