Flood Control Failure: San Lorenzo River, California

ABSTRACT / The San Lorenzo River on the central California coast was the site of a major US Army Corps of Engineers flood control project in 1959. By excavating the channel below its natural grade and constructing levees, the capacity of the river was increased in order to contain approximately the 100 year flood. Production and transport of large volumes of sediment

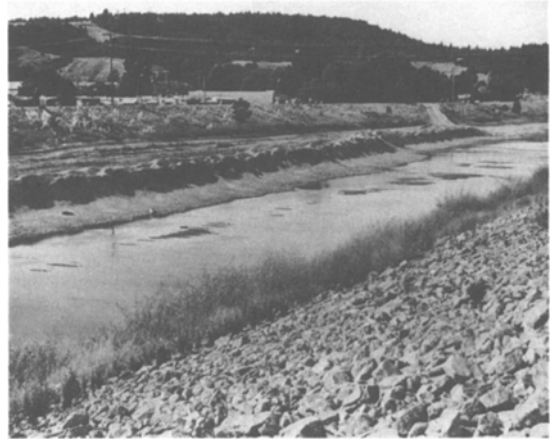
Figure 5. San Lorenzo River channel immediately upstream from the Water Street bridge showing efforts by the City Department of Public Works to pile up sediment in hopes of flushing by high flows.

the channel over the last four years, (again hoping for winter scour to remove the sand—Figure 5), and also started to remove sediment on a small scale. (As of December 1981 less than $76,000 \text{ m}^3$, [$100,000 \text{ yds}^3$] had been removed). However, the city is now unable to finance the removal of the accumulated sediments, which has been estimated to cost as much as \$3 million initially and at least \$200,000 annually to maintain. These are considerably different figures (even allowing for inflation) than the Corps estimated in 1959 (\$25,000/yr). As a result, the city is concerned both about the cost of removing the sediment and the potential flood hazard of leaving the sediment in the channel.

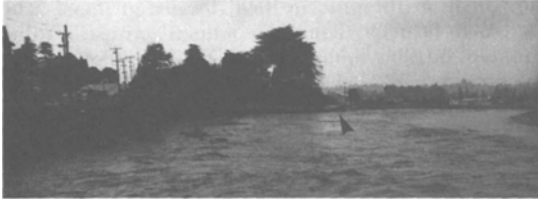
Figure 8. San Lorenzo River looking upstream from the Riverside Avenue Bridge at 1:00 P.M. January 4, 1982. Overflow actually occurred at Arrow, and much of the old roadway along left side of photo was undercut.

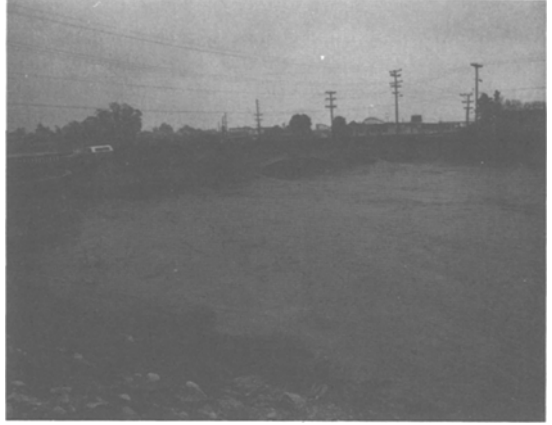
Figure 10. The Riverside Avenue bridge nearing capacity. River stage peaked about 2 feet above this point. Although no overflow occurred, the bridge foundation was damaged by scour.

down the river piled up at bridges, but prompt action by the City with heavy equipment prevented damming and flood water back up. Maximum discharge capacity beneath the Riverside Avenue bridge was reached, but no overflow occurred (see Figure 10). Cracking of the bridge, perhaps from scouring, did lead to its closure. Severe scouring around bridge piers did lead to collapse of one span of the Soquel Avenue bridge (see Figure 11). Unfortunately half of Santa Cruz' telephone circuits passed beneath the span and were severed when collapse occurred. Bridge repairs are estimated at \$1.75 million.

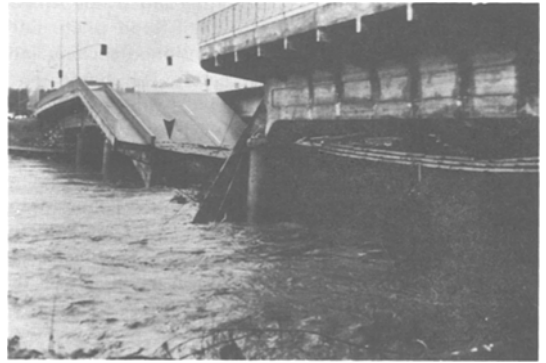
Figure 11. Failure of one downstream span of the Soquel Avenue bridge. Note high water mark. Scour led to settling of an older pier supporting the down stream span.
