Weathering and Weathering Rates of Natural Stone

ERHARD M. WINKLER

ABSTRACT / Physical and chemical weathering were studied as separate processes in the past. Recent research, however, shows that most processes are physicochemical in nature. The rates at which calcite and silica weather by dissolution are dependent on the regional and local climatic environment. The weathering of silicate rocks leaves discolored margins and rinds, a function of the rocks' permeability and of the climatic parameters. Salt action, the greatest disruptive factor, is complex and not yet fully understood in all its

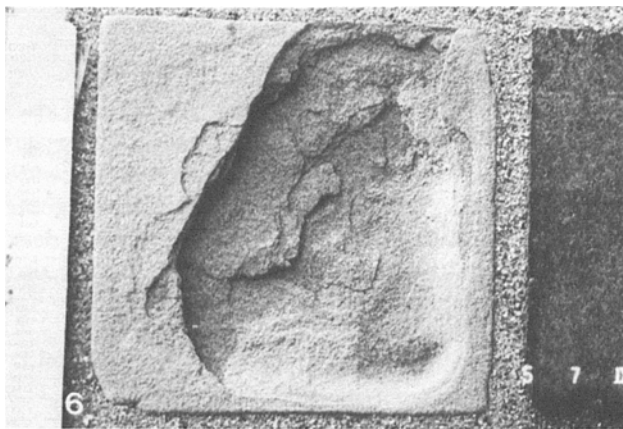
Figure 6. Weathering of sandstone by scaling. Migration of grain cement from inside to the surface, migration also from mortar joint. Specimen is 10 cm long. National Bureau of Standards Stone Test Wall.

idly increases beyond $\text{pH} = 9$ (Fig. 5B). Silica as grain cement in sandstones is susceptible to dissolution near a hot and sundrenched alkaline desert floor, and also on buildings where silica can migrate from inside the rock and stone outward toward the stone surface, leading to scaling of a thin hardened crust while crumbling occurs beneath (Fig. 6).

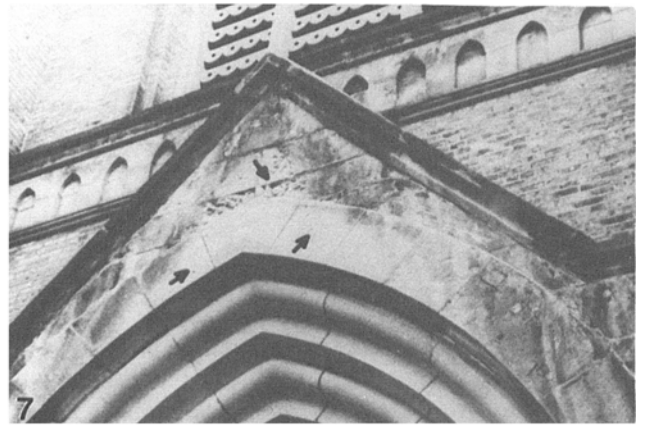
Figure 7. Honeycombs and efflorescence of de-icing salts developed in fine-grained quartz sandstone. South entrance to Sacred Heart Church, Notre Dame, Indiana.

Honeycomb formation is based on the relocation of calcite and/or silica toward exposed surfaces while the stone behind the surfaces, now deprived of a part of its grain cement, crumbles away, often a process accelerated by salt action. At Sacred Heart Church, Notre Dame, Indiana, siliceous sandstone making up columns is crumbling beneath the overhang with the help of salt used for de-icing at the south entrance (Fig. 7). Honeycombs have developed above the arched entrance by a combination of solar exposure on the south side of the building, alkaline solutions, and salts.

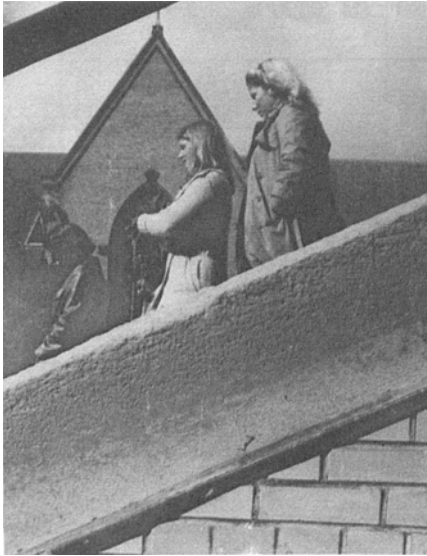
Figure 10. Balustrade of fossiliferous Indiana limestone showing strong corrosion in upper portion by combination of salt fretting by de-icing salt and acid rain attack. Hygroscopic retention leaves the wetline permanently visible. South entrance to Main Building, University of Notre Dame, Indiana.

throughout the entire year. Figure 10 shows a balustrade of Indiana limestone composed of even-sized small fossil shell fragments; it is visibly corroding above the wetline; the result is a combination of salt fretting and dissolution by acid rain. The degree of hygroscopic attraction by halite was quantified by Vos and Tammes (1969) on brick masonry (Fig. 11). The vertical distribution of rising damp and soluble salts on buildings was well analyzed by Arnold (1982).

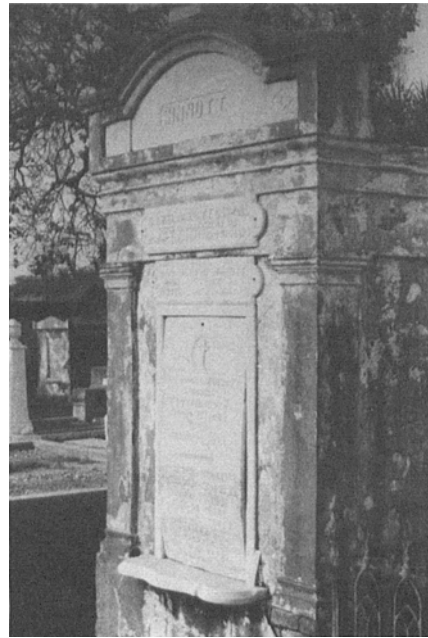
Figure 12. Slab of fine-grained Italian White marble, weathered and warped after exposure of about 100 y to 2000 mm precipitation and high relative humidity of New Orleans, Louisiana.

Rapid disintegration of some fine-grained marbles of the Carrara type, known as Italian White Marble, has often puzzled the architect. The process is commonly associated with warping if the slabs are thin. High precipitation and relative humidity in the Gulf Coast area permit the rapid introduction of moisture into the marble slabs, as initial cracks tend to develop along the grain boundaries and propagate inward, a phenomenon known as *corrosion cracking* in metals and plastics (Whalley and others 1982). Bowing of marble slabs and internal disintegration are believed to be caused by a combination of stress relief of locked-in stresses from the geological past loading history of the stone and expansion-contraction cycles of moisture

entrapped in the narrow capillary system, leading to warping and cracking, followed by volume expansion (Fig. 12) (Winkler 1982).

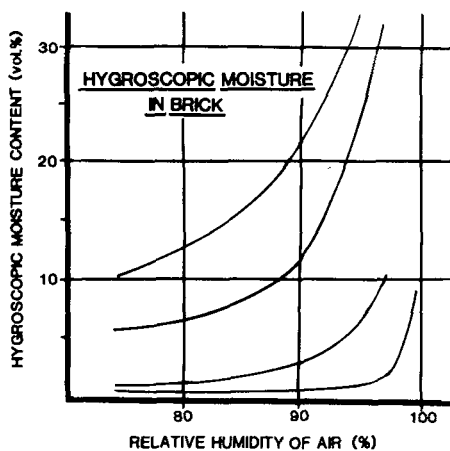
Figure 11. Hygroscopic moisture retention in brick masonry depending on salt content and relative humidity. After Vos and Tammes (1969).

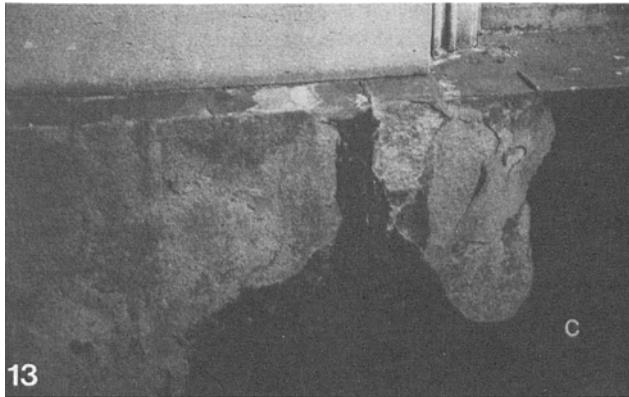
Figure 13. Spalling of thin slabs of granite in several layers. Base of Tweed Courthouse, Lower Manhattan, New York.

Tentlike spalling of thin, even slabs of granite at the base of buildings near the ground level is common in urban areas. The phenomenon is similar to the natural process at the outcrop, a combination of stress relief formed many kilometers beneath the earth's surface but now exposed, and expansion-contraction of entrapped moisture and salt action of de-icing salts from streets and sidewalks. Figure 13 shows spalling of exposed fine-grained Massachusetts granite along the base of the old Tweed Courthouse, peeling in several even layers superimposed on top of each other. The blistering is probably enhanced by the process used to polish granite surfaces in the mill, which added stresses to the already locked-in natural stress. Thin surface spalls are common on granite surfaces in natural outcrops, mostly near the ground surface.
