# Mortar deterioration of the masonry walls in historic buildings. A case history: Vanvitelli's Mole in Ancona

*The utilization of data from advanced techniques, such as enhanced pattern treatment of x-ray diffraction analysis, combined with data from historical sources as well as environmental information, has been applied to diagnose the complex deterioration mechanism of a historic construction. A case history is provided dealing with a famous Italian construction in Ancona designed and erected by the Neapolitan architect Luigi Vanvitelli during 1733–1743, where both jointing and rendering mortars deteriorated very seriously. It has been found that the original lime–pozzolan mortar deteriorated due to physical events (rain water leaching, thermal changes, freezing–thawing, etc.), whereas Portland cement mortars, used to repair damaged walls, deteriorated by chemical sulfate attack.*

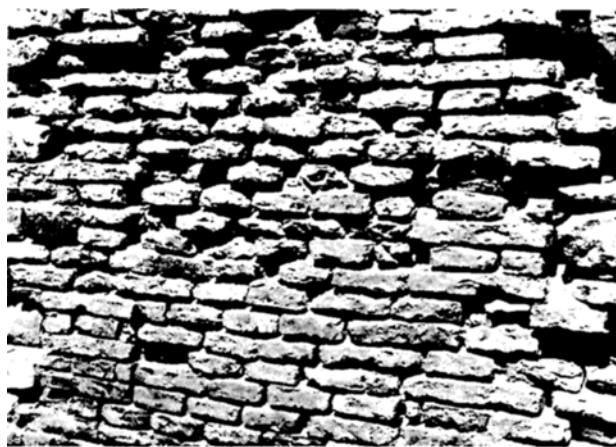
Fig. 2 Deterioration of bricks and jointing mortars.

Because of the extensive state of deterioration of both the bricks (Fig. 2) and the mortar (Fig. 3) of the masonry walls, a survey specifically devoted to the materials used in the building has been carried out. The deterioration survey includes sampling the materials (bricks, mortars and efflorescences) for examination using chemical, mineralogical, physical, and mechanical tests. In addition to these laboratory tests, some *in situ* examinations, such as flat jacks, endoscopies and foundation inspection, have been carried out. Finally, all the results of these laboratory and *in situ* tests have been correlated with supplementary information concerning the environment, the climate, the history and the architecture of the building. In the present paper, for reasons of brevity, only the results concerning mortar deterioration will be examined.

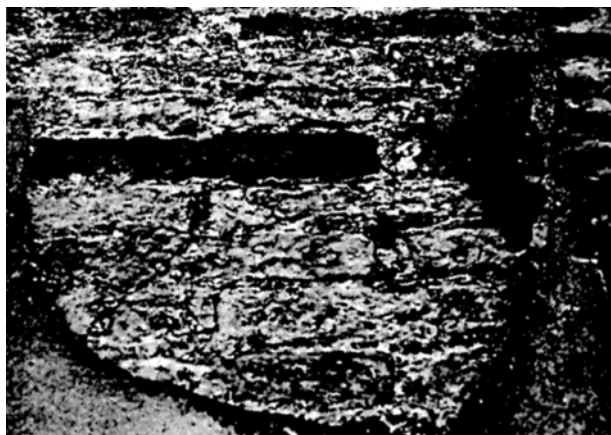
Fig. 3 Deterioration of rendering mortar.

The presence of traces of  $C_3S$ ,  $C_2S$ ,  $C_3A$  and  $C_4AF$  in some areas of the rendering mortars (documented by a treated XRD pattern similar to that shown in Fig. 6) is clear evidence that an unsuccessful repair has already been tried using Portland cement: significant detachment of this repairing mortar is observed almost everywhere (Fig. 3). Besides the gypsum formation and the subsequent ettringite and/or thaumasite production, other physical events, such as salt crystallization, and thermal changes, cannot be excluded as responsible for the deterioration of the rendering mortars.

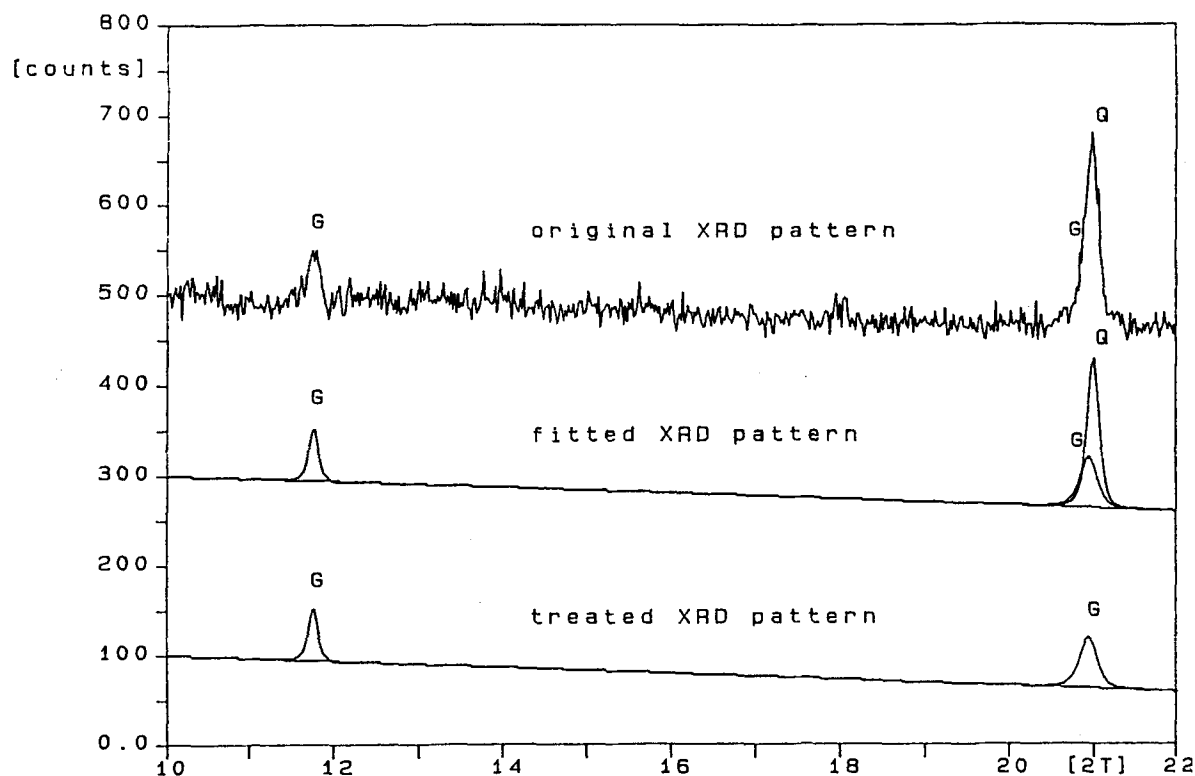
Fig. 4 XRD patterns (original, fitted and treated) of an interior jointing mortar with traces of gypsum (G) and large amounts of quartz (Q).

Indeed, through the 'profile fitting' technique the original XRD pattern can be treated in order to enhance very weak peaks belonging to products which may be present even in traces. For instance, Fig. 4 shows the original unmodified XRD pattern and the fitted one as well as the treated one of a lime-pozzolan mortar which contains large amounts of limestone-quartz based sand and only traces of gypsum.

Traces of gypsum (Fig. 4) as well as other sulfate salts have been detected by XRD. The amount of gypsum is so small that its presence cannot be ascribed to the utilization of a gypsum-based mortar. Therefore, gypsum must have been formed by water soluble sulfate salts, coming from bricks or sea water capillary rising and reacting with lime:

The presence of  $\text{SO}_2$  as a pollutant in the area of the Vanvitelli's Mole has been confirmed by an environment survey (see Section 2): the busy car traffic in the streets, the ferry boats in the harbour area, and a neighbouring industrial factory cause the environmental  $\text{SO}_2$  content near Vanvitelli's Mole to be much higher than the legal limit in force locally. Therefore, gypsum formation [5–7] by sulfation process 5 cannot be excluded where significant amounts of gypsum have been found. Moreover, the fact that gypsum has been found clearly in the mortar facade jointing samples exposed to polluted air (Fig. 7) and only in traces in interior mortar samples (Fig. 4) would indicate that sulfation of calcite (see 5) is the process responsible for gypsum formation.

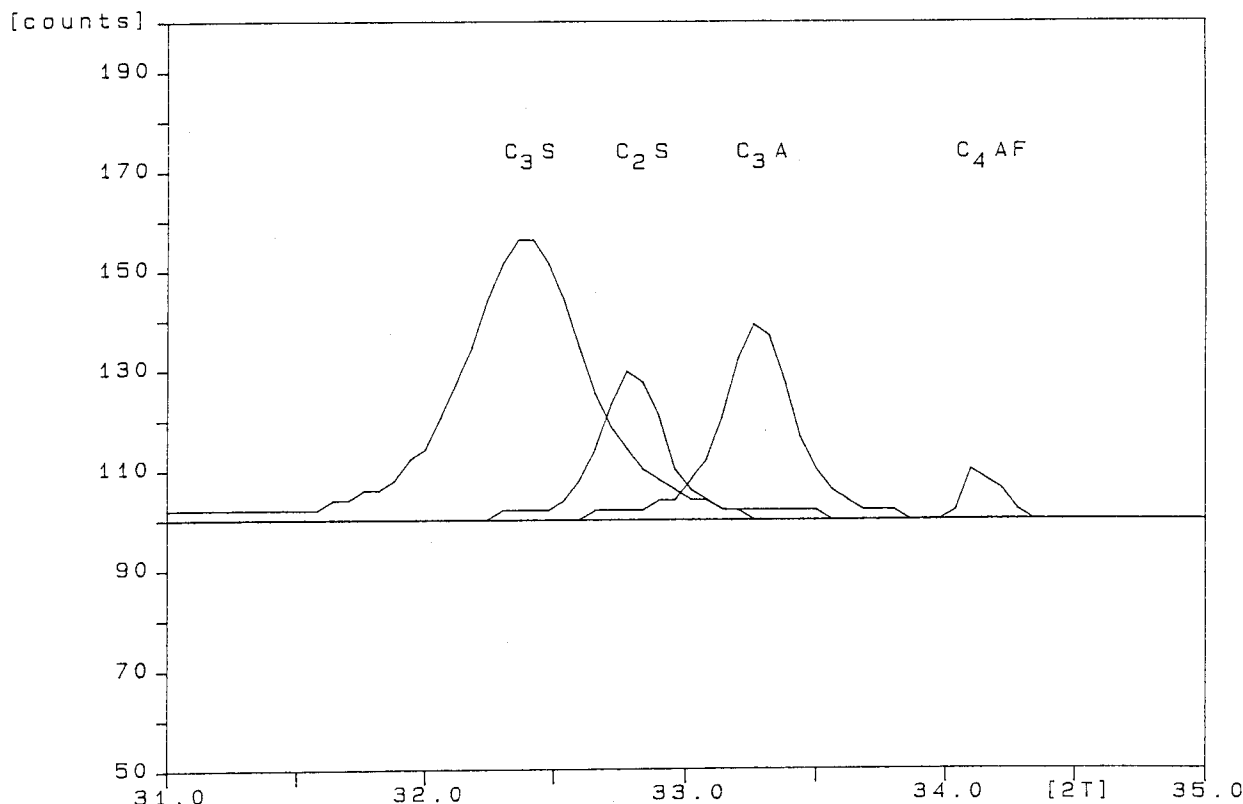
Facade jointing mortars have been examined as a potentially different material from the interior jointing mortar (Fig. 5), mainly because of different colour and/or appearance. The XRD analysis has confirmed this hypothesis. Indeed traces of  $\text{C}_3\text{S}$ ,  $\text{C}_2\text{S}$ ,  $\text{C}_3\text{A}$  and  $\text{C}_4\text{AF}$  ( $\text{C} = \text{CaO}$ ,  $\text{S} = \text{SiO}_2$ ,  $\text{A} = \text{Al}_2\text{O}_3$ ) have been found (Fig. 6) in three available samples of facade jointing mortar. This means that some joints, for example like those of Fig. 2, have been repaired by filling the hollow outside space (20–30 mm) with a Portland cement mortar, clearly a long time (at least one century) after the original building construction (18th Century).

Fig. 6 Treated XRD pattern of a facade jointing mortar showing the presence of trace quantities of cement compounds.

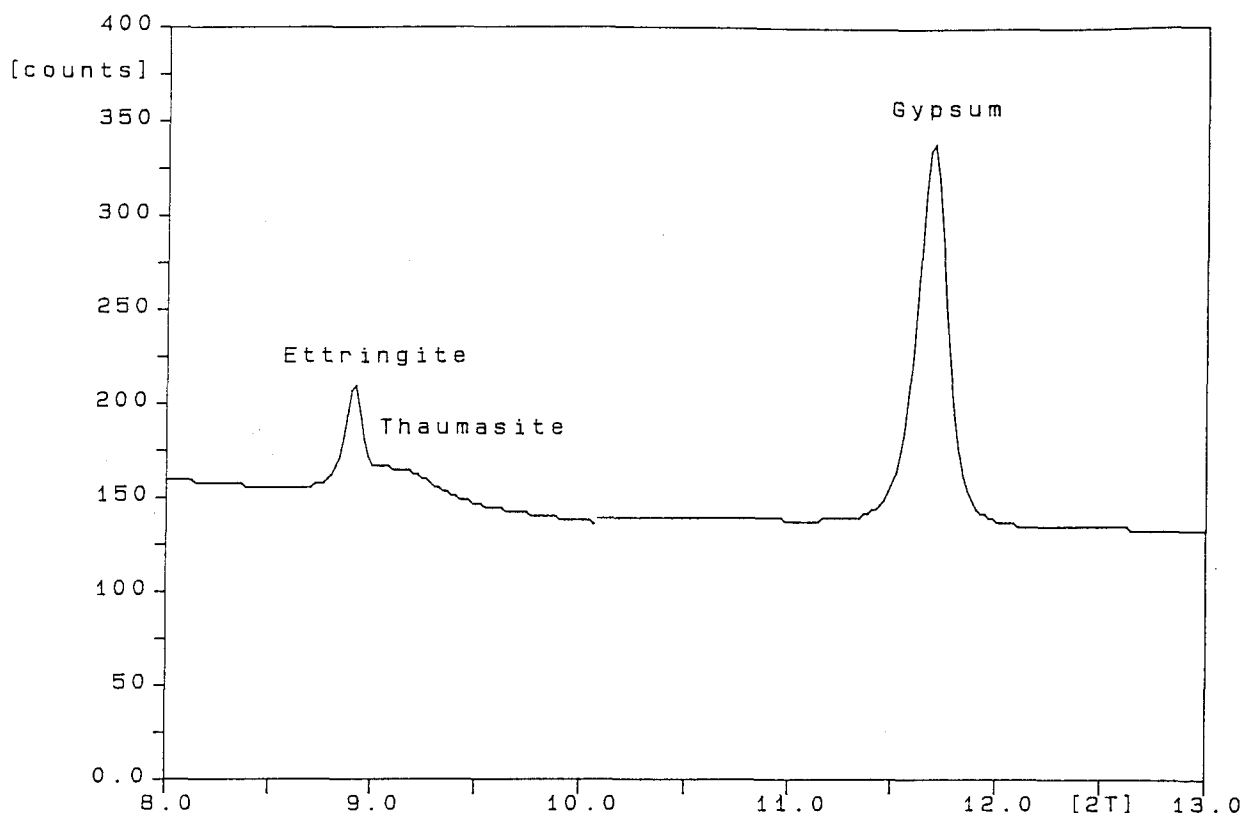
Moreover, detectable traces of ettringite and thaumasite, as well as a significant amount of gypsum, have been found in all the available samples of this repairing jointing mortar (Fig. 7). Gypsum production, and its subsequent transformation into ettringite ( $\text{C}_3\text{A} \cdot 3\text{CaSO}_4 \cdot 32\text{H}_2\text{O}$ ) and thaumasite ( $\text{CaSO}_4 \cdot \text{CaCO}_3 \cdot \text{CaSiO}_3 \cdot 15\text{H}_2\text{O}$ ):

Fig. 7 Treated XRD pattern of Portland cement based mortar sample to repair consumed facade jointing mortar.

could be ascribed to the formation process 2. Potential sulfate ion sources are (a) sulfate salts from bricks and (b) sea water capillary suction. In addition to these sources, gypsum could be formed by sulfur dioxide oxidation and subsequent sulfation of calcite [5–7], which is present both in the cement paste and in sand:

Therefore, in the repair mortar of Vanvitelli's Mole, all the three requirements for ettringite and thaumasite production [2] have been documented in the present work: (a) calcium aluminate or silicate hydrates produced by hydration of Portland cement used to repair the surface of jointing mortars; (b) gypsum formation by reaction of environmental  $\text{SO}_2$  with lime; and (c) presence of water produced by sea water capillary suction or capillary condensation of water vapour in humid air.

crystallization, etc., appear to be responsible for the deterioration of this mortar. A Portland cement based mortar has been used in the past to repair the deteriorated jointing mortar as well as the rendering mortar. This repairing mortar appears to have been damaged by ettringite/thaumasite formation, as local humidity and sulfate sources are available to react with calcium aluminate/silicate hydrates produced by Portland cement hydration. Environmental  $SO_2$  appears to be the main source of sulfate salts in addition to those coming from brick impurities or sea water capillary rise. For future repair work, cementitious materials should be tested and proved to be resistant to sulfate attack before their utilization in this historic building.

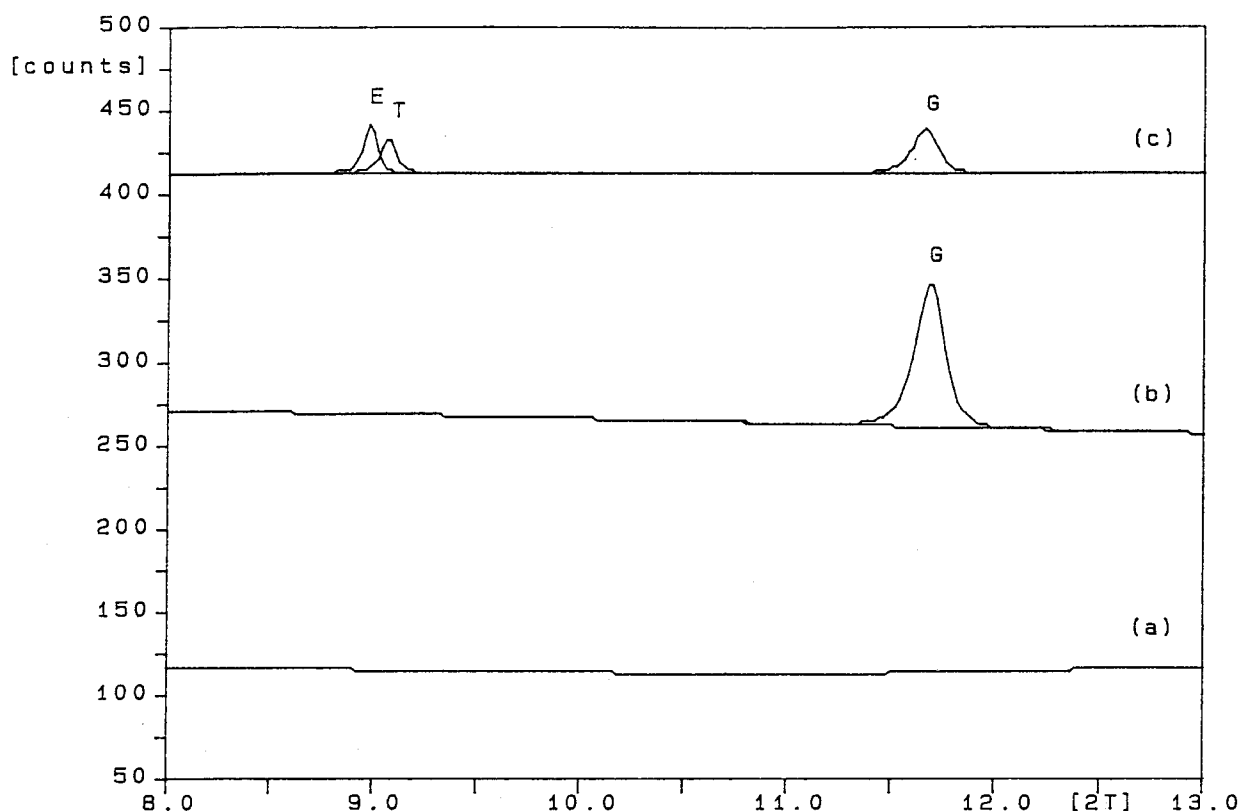
By XRD analysis, the five samples of rendering mortars have been separated into two types: (a) three samples based on lime-pozzolan mixes which do not contain any trace of gypsum, ettringite and thaumasite (Fig. 8a); and (b) two samples based on Portland cement mixes with traces of  $\text{C}_3\text{S}$ ,  $\text{C}_2\text{S}$ ,  $\text{C}_3\text{A}$  and  $\text{C}_4\text{AF}$  still present. In these

Fig. 8 Treated XRD patterns of three rendering mortars: A, without gypsum and ettringite or thaumasite; B, only gypsum (G); and C, gypsum (G), ettringite (E) and thaumasite (T).

two samples, two different situations have been found: in one sample a significant amount of gypsum is present without ettringite/thaumasite (Fig. 8b); in the other sample a significant amount of ettringite/thaumasite is present with a lower amount of gypsum (Fig. 8c). In the latter, it can be assumed that reactions 3 and 4 occurred, for some reasons, to a much higher extent than in the former: for instance, local humidity could have been higher in one area of the rendering mortar than in the other one, so that the degree of gypsum transformation into ettringite or thaumasite has been controlled by the local availability of water in the rendering mortar.
