# Landslide Damage to Buildings

**DAVID ALEXANDER**

**ABSTRACT** / Landslides are a significant and expensive hazard in urban areas, however, a universal methodology for

classifying the damage to buildings has not been adopted. This article proposes an intensity scale for structural damage caused by subsidence, compression, or extension of the ground during landslides and offers a checklist of site observations that could be made by planners, engineers, architects, surveyors, geologists, or geomorphologists.

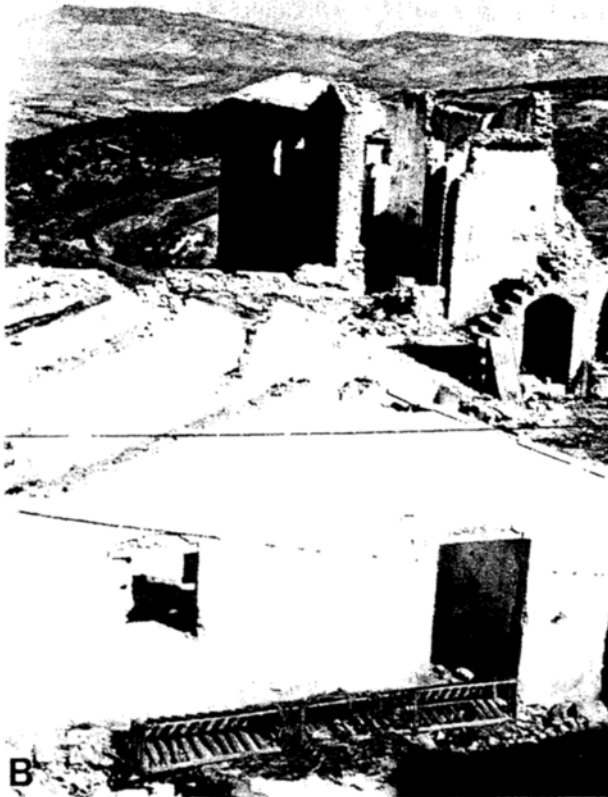
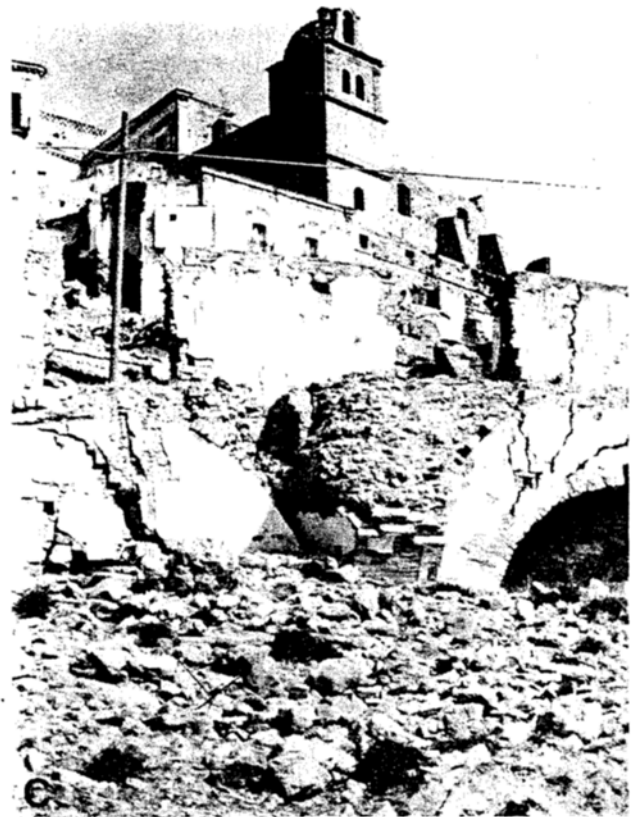
**Figure 1.** Landslide damage of grades 5, 6, and 7 in Italy: **A.** Hospital in reinforced concrete, Ancona (grade 5). **B.** Houses in rubble masonry, Tricarico, Matera (grade 6). **C.** Total destruction of the urban environment, Craco, Matera (grade 7).

central Italy, which involved 3.41 km<sup>2</sup> of land and about 475 buildings (Alexander 1984), and by adapting post-earthquake building inspection forms used in Italy (Lagorio and Mader 1981, GNDT 1984). Figure 1 shows three examples of landslide damage, which can be related to the severer parts of the scale.
