RESERVOIR-INDUCED LANDSLIDES

SCHUSTER R. L., U. S. Geological Survey, Denver, Colorado, U. S. A.

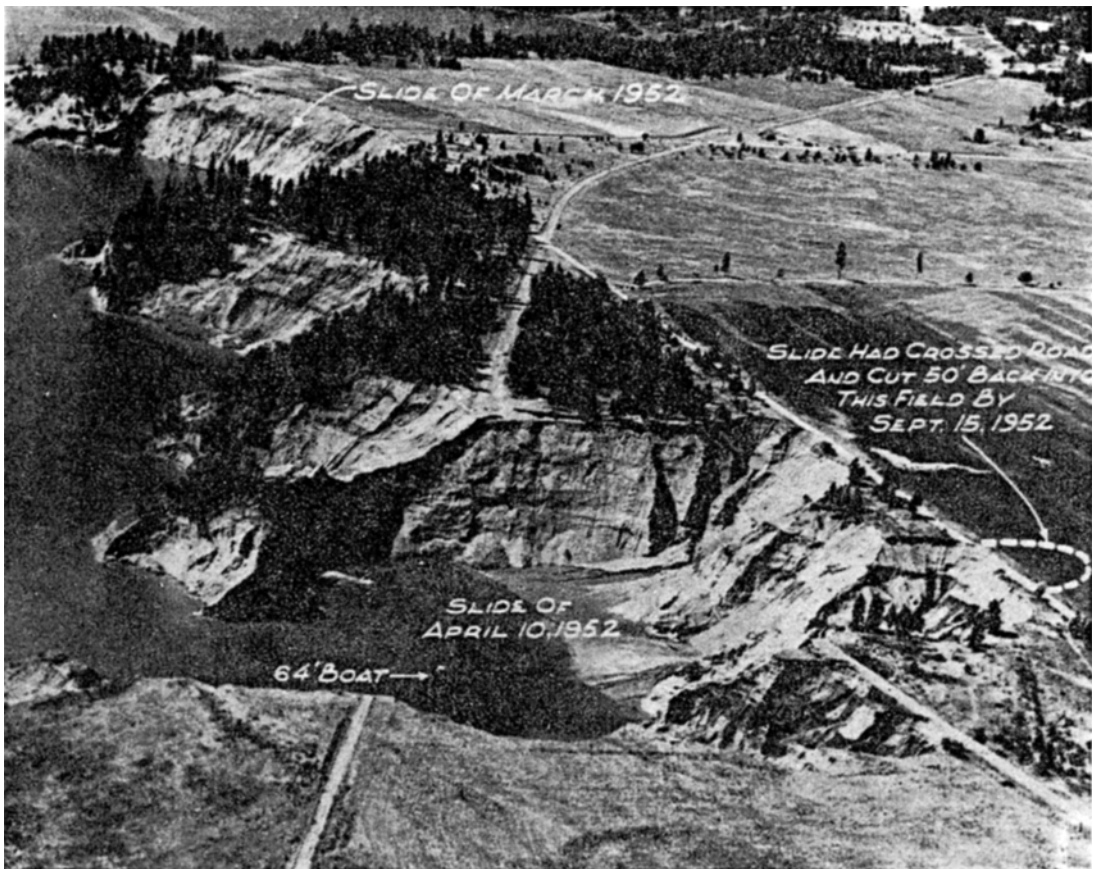
Fig. 13: Shoreline of Figure 12 as it looked on August 1, 1952. The landslide of April 10, 1952, involving about 11 million m^3 , took place by progressive slumping, liquefaction, and flowing of Pleistocene glaciofluvial sediments through a narrow opening (from Jones et al. 1961; Varnes 1978). (Photograph by F. O. Jones, U. S. Geological Survey.)

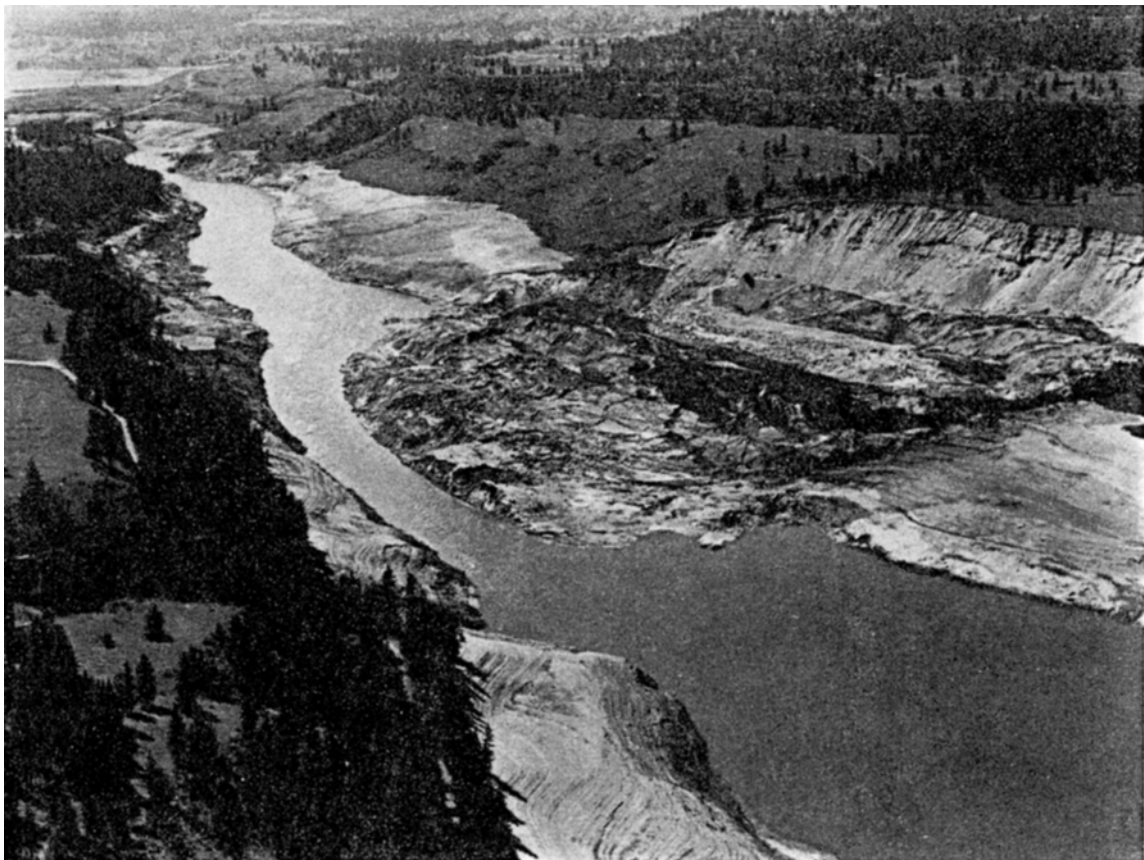
Fig. 14: Jackson Springs slide on the Spokane arm of Roosevelt Lake. This earth slump, which had a volume estimated at over 11 million m^3 , occurred on March 26, 1969, on a terrace consisting of alternating beds of lacustrine clay, silt, and sand. The slump occurred during a period of extreme drawdown necessitated by excavation for a forebay dam preliminary to construction of the Third Powerplant at Grand Coulee Dam (U. S. Bureau of Reclamation 1969). (Photograph courtesy of U. S. Bureau of Reclamation.)

One of the best examples of sliding caused by the large drawdowns in this period was the Jackson Springs Slide (Fig. 14), which occurred during the period of extreme drawdown in 1969. An example of a large recent landslide that apparently was not related to these extreme drawdowns was the estimated 3 - 4 million m³ reactivation of the Hughes Slide along the east bank of the San Poil arm of the reservoir in February 1978. This slide probably was caused by melting of 30 - 50 cm of snow, which resulted in saturation of the lacustrine silt, clay, and sand in the slide area.

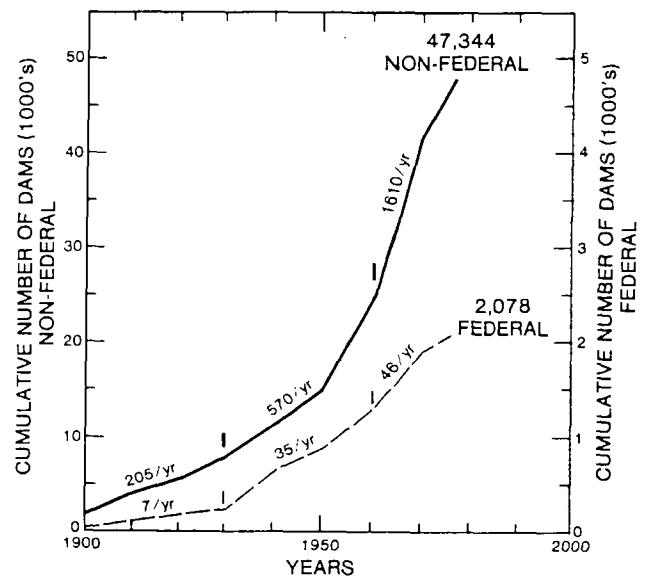
Fig. 17: U. S. growth rate trends for Federal and non-Federal dams, 1900 – 1977 (Federal Coordinating Council for Science, Engineering, and Technology 1977).

As noted in Fig. 17, only about 2000 of the dams in the United States are classified as Federal dams, i. e., they are owned and operated by agencies of the Federal Government, such as the Corps of Engineers or the Bureau of Reclamation. However, these Federal dams constitute a high percentage of the large dams in the nation; their reservoirs also are large, and, in some cases, these reservoirs are subject to landslides. Thus the Federal dam-building agencies are well aware of the problems of landslides related to reservoirs and have taken actions to reduce the danger therefrom. The most formal program of study of such slides is the Bureau of Reclamation's "Landslide Surveillance Program", the essential features of which include landslide classification, an automatic data-processing program for computerized listing of landslides, and requirements for inspection, monitoring, and remedial measures (U. S. Bureau of Reclamation 1973). The purpose of the program is to register

As shown in Fig. 17, nearly 48,000 of the approximately 50,000 dams in the United States in 1977 were non-Federally owned dams, a great percentage of these being small dams. The Corps of Engineers has designated that 9000 of these non-Federal dams present high hazard to downstream life and property if failure should occur (U. S. Department of the Army 1978). On November 28, 1977, President Carter directed the Department of the Army to immediately begin inspecting these 9000 high-hazard non-Federal dams. These dams are being inspected according to the Army's Recommended Guidelines for Safety Inspection of Dams (U. S. Department of the Army 1976) which, in relation to stability of reservoir shorelines, specifically directs that "The landforms around the reservoir should be examined for indications of major active or inactive landslide areas and to determine susceptibility of bedrock stratigraphy to massive landslides of sufficient magnitude to significantly reduce reservoir capacity or create waves that might overtop the dam." During the first year of inspection, 1793 of the 9000 high-hazard dams were inspected and 354 were determined to be unsafe; however, the records indicate that none of these were threatened by landslides related to the reservoirs (U. S. Department of the Army 1978).
