# **The 1959 and 1960 eruptions of Kilauea volcano, Hawaii, and the construction of walls to restrict the spread of the lava flows.**

GORDON A. MACDONALD

Senior Professor of Geology and Geophysics, Institute of Geophysics, University  
of Hawaii. Hawaii Institute of Geophysics Contribution No. 42.

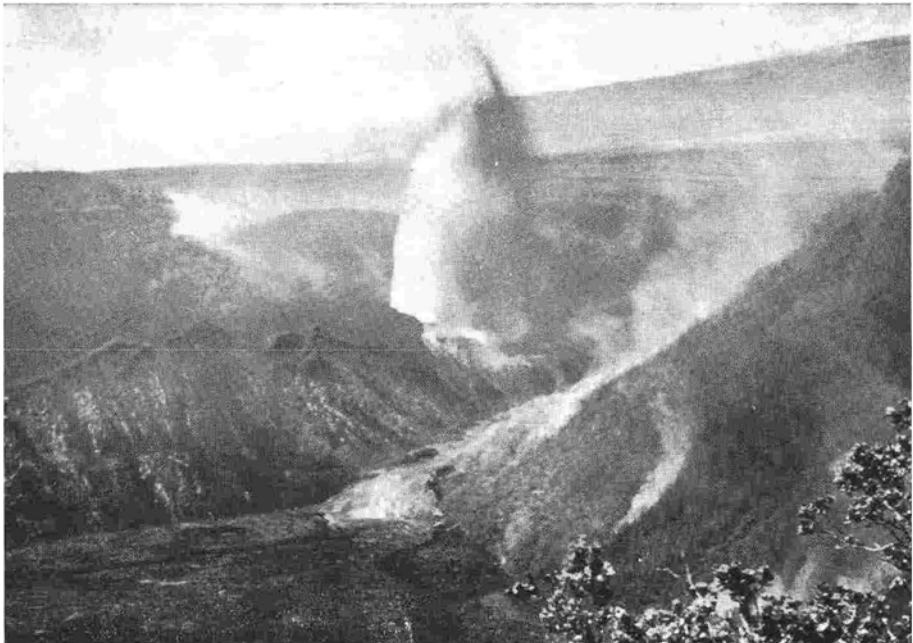
Fig 2 - Lava fountain, and stream of lava cascading westward into the main part of Kilauea Iki crater, Nov. 18, 1959. The main crater has been filled almost to the level of the « mezzanine » (Compare pl. 1, fig. 1).

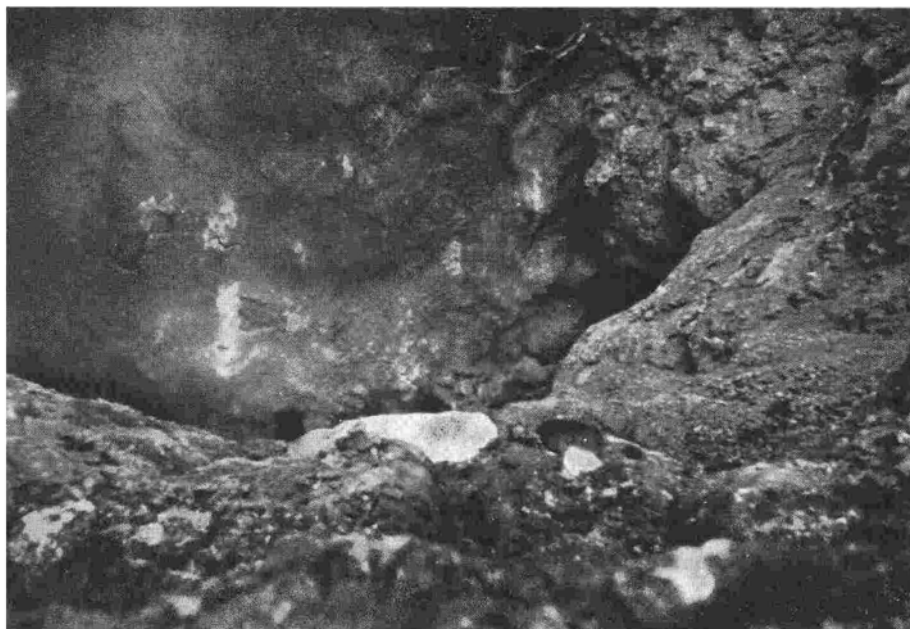
Fig. 3 - Looking into the vent between eruptive phases 2 and 3, on the morning of Nov. 28, 1959. In the foreground a stream of brightly incandescent liquid lava is pouring into the vent about 10 meters below the level of the surface of the lava pool in Kilauea Iki crater.

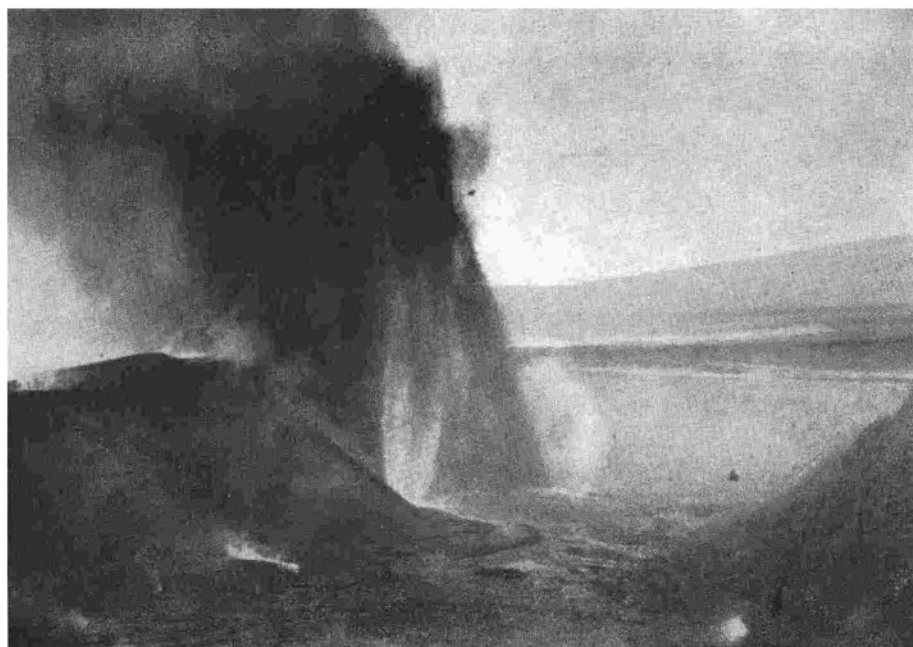
Fig. 4 - Lava fountain and dark cloud of pumice, Nov. 29, 1959. The lava pool has risen not only above the level of the « mezzanine », but also above the level of the original vents (Compare pl. 1, fig. 2).

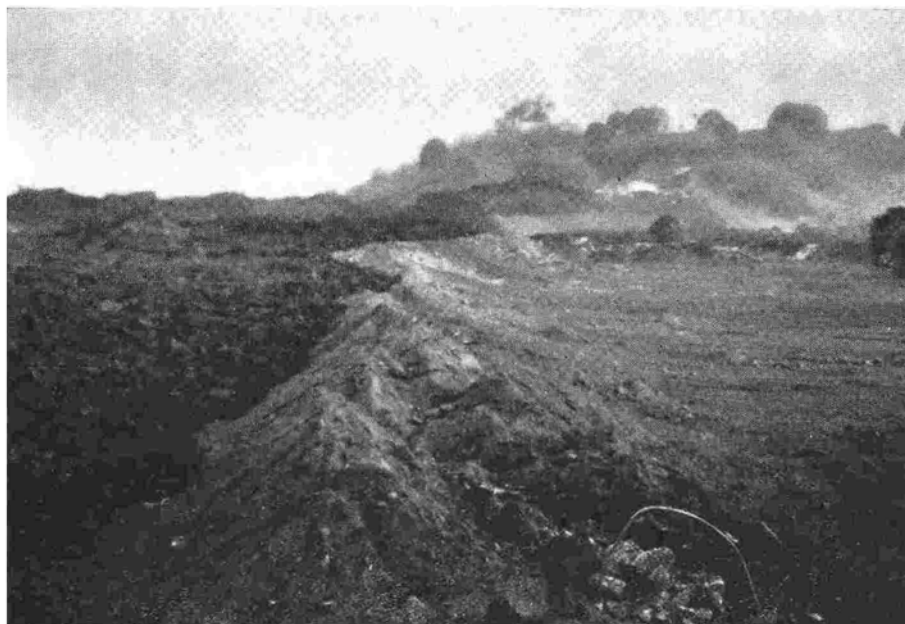
Fig. 16 - Wall 5, seen from the western end, Jan. 28, 1960. Lava is standing against the wall in the foreground and middle distance. In the far distance, at the base of Puu Kukii, the end of the wall has been elevated by faulting, and a lava flow is pouring from a vent at the south base of the wall and spreading to the right of the wall.

7.9 meters, but was not broken, and save for a minor amount of tumbling down of loose rock fragments from the lower part of the southern slope it was not even deranged.

The opening of a vent south of the wall was not, and could not have been, anticipated. The outpouring of lava from it south of the wall in no sense represents a failure of the wall.
