The Effect of Defects on the Fatigue Crack Initiation Process in Two P/M Superalloys: Part I. Fatigue Origins

J. M. HYZAK and I. M. BERNSTEIN

Two high strength P/M nickel-base superalloys, AF-115 and AF2-1DA, with different defect populations, were tested to determine the effect of preexisting defects on the fatigue crack initiation process. Strain controlled continuous cycle fatigue tests were performed at room and at elevated temperature; these were followed by fractographic examination to characterize both the location and character of the fatigue origins. In most cases, particularly at elevated temperature, the initiation process was associated with a large pre-existing defect, either a pore or a nonmetallic inclusion. There was also a change in the location of the crack that caused failure as the strain range varied: at high strain ranges initiation occurred at or near the specimen's surface, while at the lower strain ranges the failure originated in the specimen's interior. The initiation mode for both alloys at room temperature was different than at elevated temperature. At room temperature, Stage I crystallographic cracking at or near the surface dominated the process in

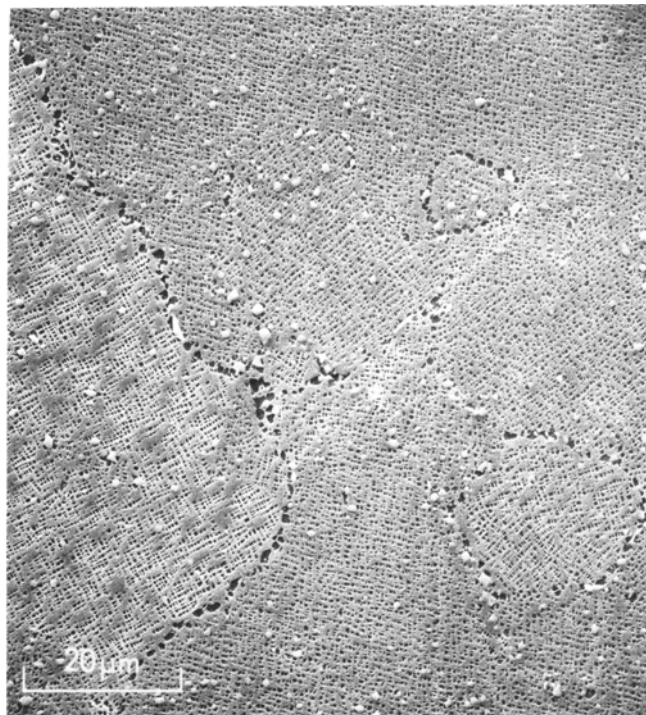
Fig. 2—SEM micrograph of the AF2-IDA microstructure showing the morphology of the grain boundary γ' and cooling γ' , as well as the carbide distribution.

The AF2-IDA microstructure also had three sizes of γ' precipitate with the larger two resolved in Figure 2. The irregular shaped primary γ' (1 to 3 μm) decorated the grain boundaries while cuboidal cooling γ' (0.25 μm) and fine aging γ' (0.06 to 0.08 μm) were contained within the grains. The grain diameter was approximately 200 μm .

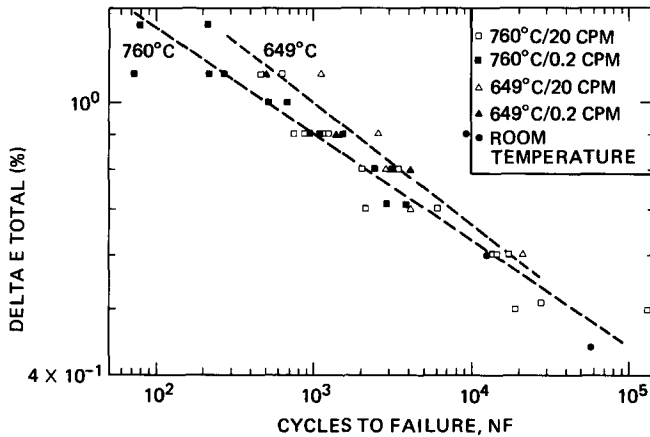
Fig. 5—Continuous cycle fatigue data for AF-115.

The fatigue data for AF-115 are shown in Figure 5; fatigue life exhibits a nearly linear relationship with total strain range. This type of relationship has been predicted previously by Wells and Sullivan⁹ for superalloys that deform heterogeneously. There was no appreciable effect of cyclic frequency found on fatigue life although the tests at 0.2 cpm were practically limited to the higher strain ranges (shorter lives). The best fit lines through the data also show that there

The room temperature fatigue tests for AF-115 (as-HIP condition), although limited in number, clearly show a large increase in life compared to the elevated temperature results for the test at 0.9 pct $\Delta\epsilon_t$. However, the scatter for these tests preclude any more definitive conclusions being drawn.

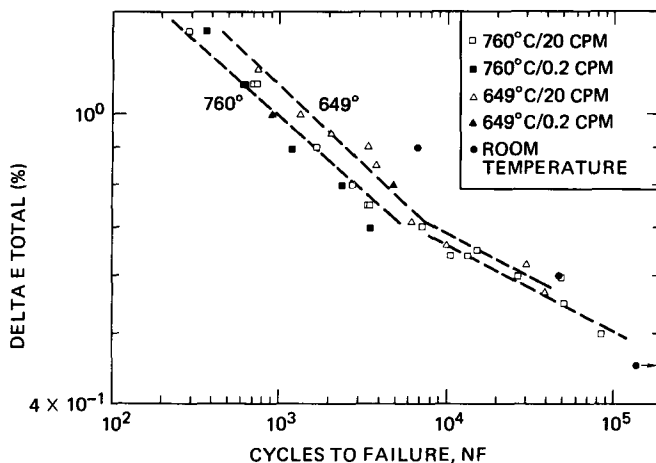
Fig. 6—Continuous cycle fatigue data for AF2-1DA.

The fatigue test results for the AF2-1DA alloy are presented in Figure 6. Again, the data are represented by linear relationships with total strain range, but they now appear in two separate regimes. This representation was chosen since it not only better describes the data than a single straight line, but the change in slope can be correlated with a change in initiation mode, to be discussed in detail in the accompanying paper.⁷ Figure 6 shows that there was a small reduction in life when the temperature was raised from 649 °C to 760 °C. As with AF-115, however, there was no appreciable frequency effect over the strain ranges tested. The room temperature tests also show a large increase in life at 0.9 pct $\Delta\epsilon_t$, but again no conclusions can be drawn because of the limited number of tests.

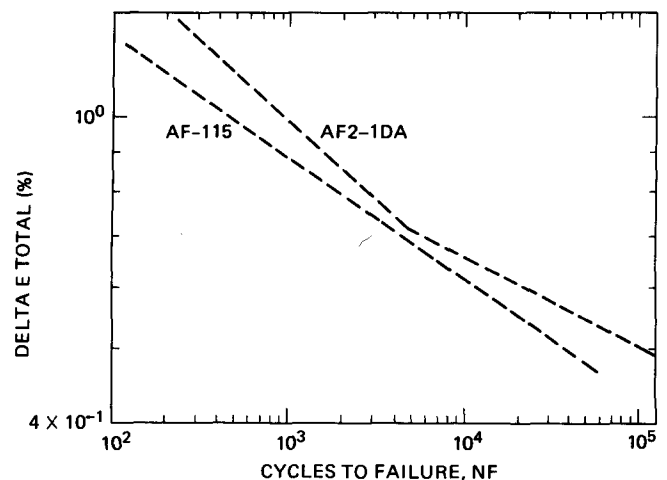
Fig. 7—Comparison of the fatigue behavior of AF-115 and AF2-1DA at 760 °C and 20 cpm.

The 760 °C, 20 cpm data for AF-115 and AF2-1DA are compared in Figure 7. The results show that in both the high and low strain range regimes, the AF2-1DA alloy had a greater fatigue life than the AF-115 alloy. These results are somewhat surprising in that it would be expected that the superalloy with the greater yield strength would exhibit superior fatigue properties when the alloys are compared at equal total strain ranges.^{10,11} This result suggests that the higher defect concentration of the AF-115 alloy causes a reduction in fatigue life through its influence on crack initiation and propagation.

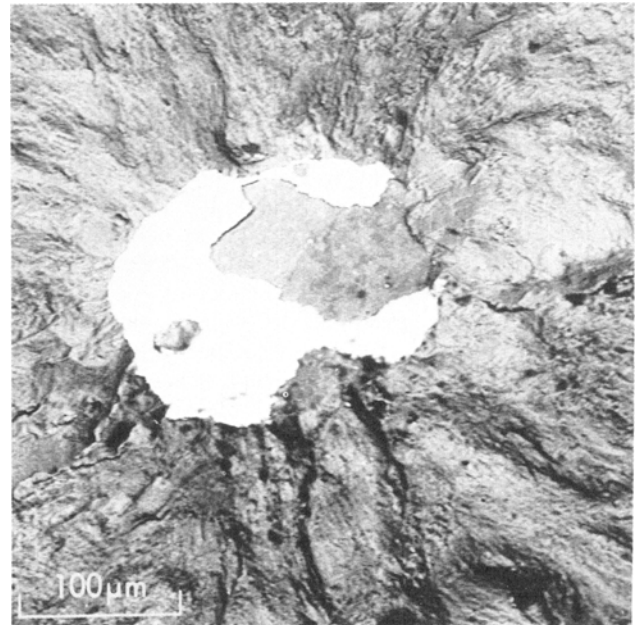
Fig. 11 — (a) Subsurface initiation site on the fracture surface of an AF-115 specimen; (b) SEM back scattered image of the fatigue origin.

B.2. AF-115—Low $\Delta\epsilon_i$. Below 0.7 pct total strain range, the dominant fatigue cracks in AF-115 initiated at subsurface hafnium oxide inclusions. Figure 11a shows the location on the fracture surface of one such origin, well below the specimen's surface. At higher magnification, the backscattered SEM image indicated a high concentration of the heavy element hafnium at the origin (Figure 11b).

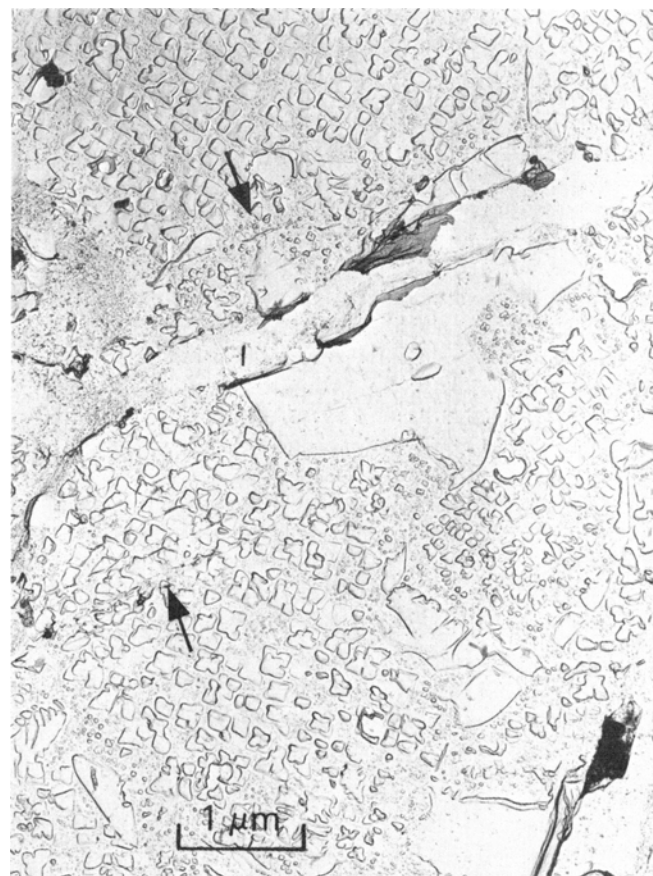
Fig. 20—(a) Cross sectional view of a Stage I crack originating at a near surface pore in AF-115; (b) TEM replica image of the cracked region between the pore and the surface edge in the accompanying micrograph showing planar slip bands parallel to the Stage I crack.

Three fatigue tests were performed on AF-115 at room temperature; the cyclic strain ranges were 0.9 pct, 0.6 pct, and 0.44 pct. In all cases the dominant fatigue cracks initiated along planar slip bands adjacent to a near-surface pore. On the fracture surface, crystallographic cracking was evident around those pores which were the fatigue origins (Figure 19). At higher magnification, the Stage I planes appeared similar to cleavage facets as in AF2-1DA. Metallographic sections revealed further details of the Stage I initiation process. Figure 20a shows a near-surface pore with cracks emanating along planes of maximum shear strain at an angle of approximately 45 deg to the tensile axis. TEM replica examination of this pore showed intense slip traces parallel to the main crack (Figure 20b), as evidenced by cutting of the γ' precipitates.
