The Cooperative Relation between Temper Embrittlement and Hydrogen Embrittlement in a High Strength Steel

KENICHIRO YOSHINO AND C. J. McMAHON, JR.

A sample plate of HY 130 steel (5 pct Ni-0.5 pct Cr-0.5 pct Mo-0.1 pct V-0.1 pct C) was found to be quite susceptible to temper embrittlement. Step-cooling produced a shift in transition temperature of 583 K (310°C). In the step-cooled condition the plane strain stress intensity threshold for crack growth in 0.1 N H₂SO₄ was about 22 MNm^{-3/2} (20 ksi √in.) and the fracture mode was intergranular, whereas in the unembrittled condition the threshold for a 1.27 cm (½ in.) plate (not fully plane strain) was around 104.5 MNm^{-3/2} (95 ksi √in.) and the fracture mode was mixed cleavage and microvoid coalescence. The interaction between the impurity-induced and the hydrogen embrittlement is discussed in terms of Oriani's theory of hydrogen embrittlement.

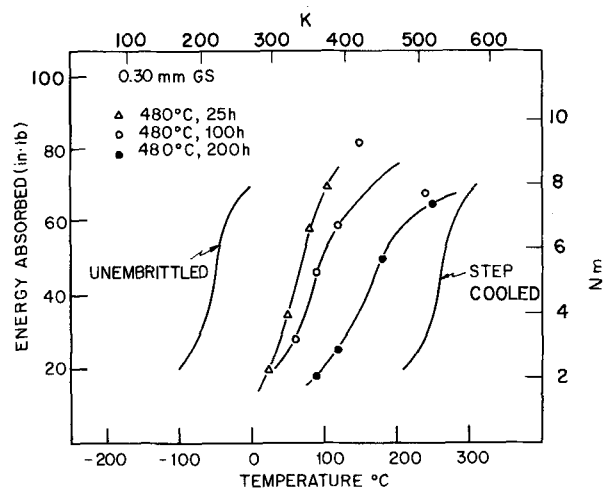
Fig. 3—Shifts in transition temperature due to isothermal embrittlement at 753 K (480°C).

When isothermal embrittlement at the arbitrarily selected temperature of 753 K (480°C) was carried out, the transition temperature shifted upward with time, as shown in Fig. 3, but it reached only 443 K (170°C) in 200 h, as compared with 533 K (260°C) transition temperature produced by the 168 h step-cooling treatment. The progress of embrittlement can be seen in the fractographs shown in Fig. 4 from specimens fractured on the low temperature side of the ductile-brittle

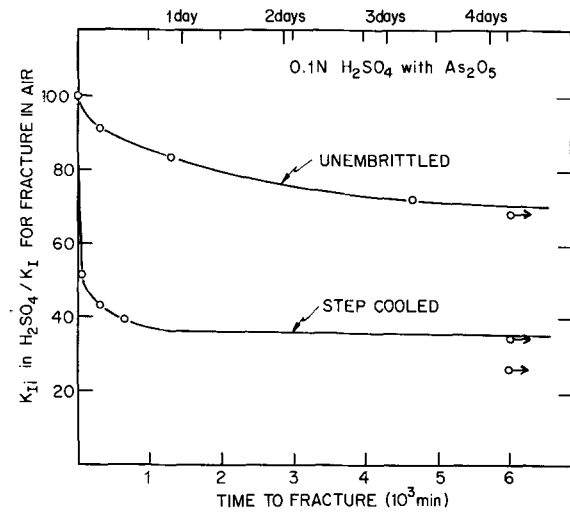
Fig. 7—Data of Fig. 6 plotted in terms of the K_C values in air.

When the precracked cantilever bend specimens were tested in the 0.1 N H_2SO_4 in the unembrittled and the step-cooled conditions, it was found that the impurity-induced embrittlement has a profound effect on the resistance to crack growth in this hydrogen-producing environment. The initial K_I values are plotted against time to fracture in Fig. 6, and the same data are shown normalized to the K_C values in air in Fig. 7. It can be seen that the K threshold for hydrogen embrittlement is lowered from about 104.5 $\text{MNm}^{-3/2}$ (95 $\text{ksi}\sqrt{\text{in.}}$) in the unembrittled case to about 22 $\text{MNm}^{-3/2}$ (20 $\text{ksi}\sqrt{\text{in.}}$) for the step-cooled condition. The unembrittled threshold would presumably be lowered if thicker specimens had been used to develop a fully constrained plane strain fracture, but the step-cooled specimen almost meets the K_{IC} requirement of 1.40 cm (0.55 in.) thickness for a K_C of 63.8 $\text{MNm}^{-3/2}$ (58 $\text{ksi}\sqrt{\text{in.}}$) and a yield stress of 848 MN/m^2 (123 ksi), and the threshold of 22 $\text{MNm}^{-3/2}$ (20 $\text{ksi}\sqrt{\text{in.}}$) therefore is probably the minimum that would be observed for this condition of embrittlement.

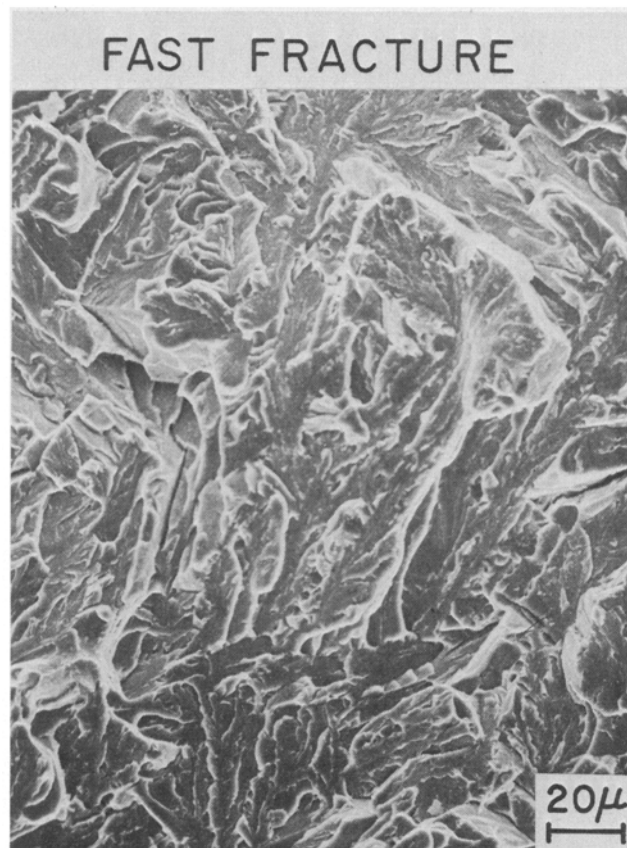
Fig. 8—Fracture surfaces of unembrittled specimens tested as in Fig. 6 showing: (a) initiation, (b) slow hydrogen cracking, and (c) fast cracking regions.

The fracture mode in the H_2SO_4 for the unembrittled case is shown in Fig. 8. At the onset of slow crack growth some intergranular fracture could be observed (Fig. 8(a)), but this soon shifted to a mixture of cleavage and microvoid coalescence (Fig. 8(b)) and then to fully cleavage in the fast-fracture region (Fig. 8(c)). It can be seen from Fig. 9 that the hydrogen-produced crack propagated faster in the central portion where the triaxial stress state was more fully developed.

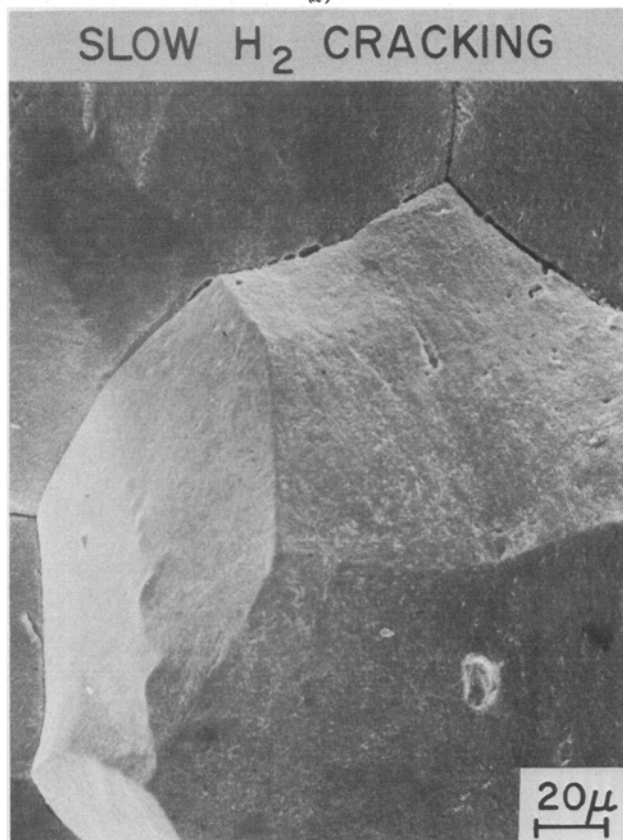
Fig. 11—Fracture surfaces of step cooled specimens tested as in Fig. 6 showing (a) initiation region and (b) and (c) slow hydrogen cracking regions.

from the point of initiation (Fig. 11(a)), through the slow growth region (Fig. 11(b) and (c)), and the fast growth region.

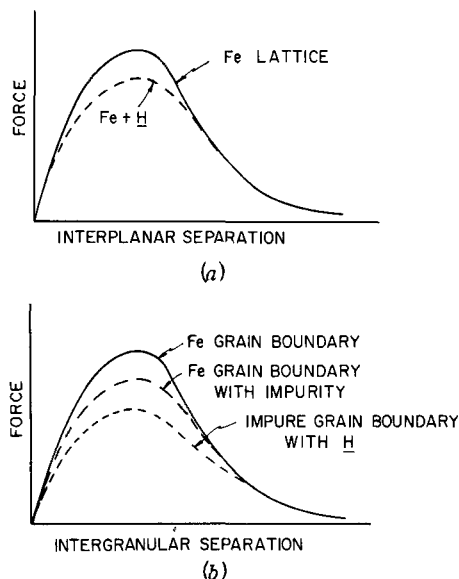
Fig. 12—(a) Schematic plot of cohesive force vs separation of atomic planes in an iron lattice in the absence of hydrogen (solid curve) and with a certain concentration of hydrogen present in the vicinity of the crack tip (dashed curve), after Oriani, Ref. 11. (b) Similar plot to 12(a) showing the proposed additive effect from the superposition of the impurity effect and the hydrogen effect.

The cooperative effect of the impurity-induced embrittlement and the hydrogen-producing environment can be understood qualitatively in a straightforward manner by extending the recent theory of Oriani.¹¹ Under the triaxial constraint at the tip of a sharp crack in a thick body a large component of stress normal to the crack plane can build up without relaxation by plastic flow. In addition, this region of hydrostatic tension expands the iron lattice and thus lowers the chemical potential of dissolved hydrogen in the vicinity of the crack tip,¹² thereby creating a sink for hydrogen. There are compelling reasons to postulate that, as the hydrogen concentration builds up, the maximum cohesive force of iron is decreased.¹¹ The latter can be depicted schematically by a lowering of the binding energy curve for the alloyed iron, Fig. 12(a). In the unembrittled case the resultant mixture of cleavage and microvoid coalescence signifies that hydrogen-induced cleavage cracks form ahead of the main crack and are joined by plastic failure.

For the embrittled state a large body of experimental evidence leads us to make a similar postulate that the maximum cohesive force along prior austenite grain boundaries is lowered by the buildup of segregated impurities, as can be schematically illustrated in Fig. 12(b). From the present results we conclude that the presence of collected hydrogen can lower this cohesive strength still more, so that crack growth can occur along these grain boundaries at very low values of stress intensity, hence with very small attendant plastic zones and, therefore, small amounts of ab-
