# Fatigue Behavior and Failure Mechanisms of Modified 7075 Aluminum Alloys

J. S. SANTNER AND D. EYLON

The effects of purity level and dispersoid type on the fatigue behavior of 7000 series alloys were investigated. Ten different compositions based on the 7075 alloy were produced with five levels of Fe + Si and either Cr or Zr dispersoids. Notched axial fatigue specimens were tested at room temperature and the fatigue life did not correlate with either purity level or dispersoid type. Specimens failed by three macroscopic modes designated as: slant, vee, or flat fracture. Sectioning analysis showed that the slant, vee, and flat fractures resulted from single, double and multiple initiation, respectively. Both initiation and propagation in all three modes of failures were dominated by slip related fracture on the {111} planes inclined at 35 deg to the tensile axis of the textured material. The same failure mechanisms were observed in smooth fatigue specimens.

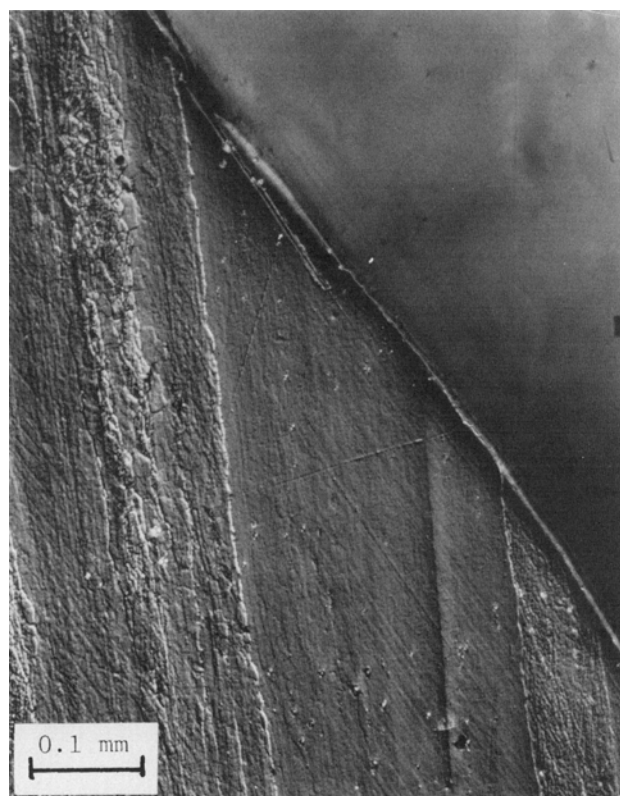
Fig. 6—Slip band formation directly below the fracture surface: (a) in a notched specimen and (b) in a smooth specimen. Note that the slip lines are parallel to the fracture surface.

Higher magnification photomicrographs from the vicinity of the fracture surface (Fig. 6), show intense slip bands parallel to the fracture surface. This indicates that the fracture plane is related to the inhomogeneous planar slip bands. A SEM investigation was conducted to identify these slip planes. The planar fracture throughout the specimen, as evidenced in Figs. 4 and 5, indicates that the unidirectional rolling introduced strong crystallographic texturing.

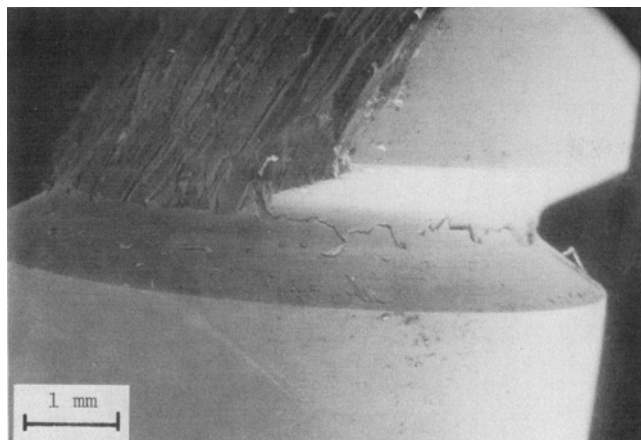
Fig. 7—Multiple initiation in the notched area of a specimen which failed by the slant fracture mode.

The SEM image of the notch area in a slant fracture specimen (Fig. 7) shows that the notch provides many initiation locations. In the case of the slant fracture only one initiation location developed to a full size crack. The vee shaped failures are the result of two opposing initiation sites. A high magnification view of the flat fracture (Fig. 8) shows that the apparent flat appearance at low magnification is made of many slanted segments which are also inclined at approximately 35 deg to the tensile axis.
