# Mechanical Stability of Retained Austenite in Tempered 9Ni Steel

C. K. SYN, B. FULTZ, AND J. W. MORRIS, Jr.

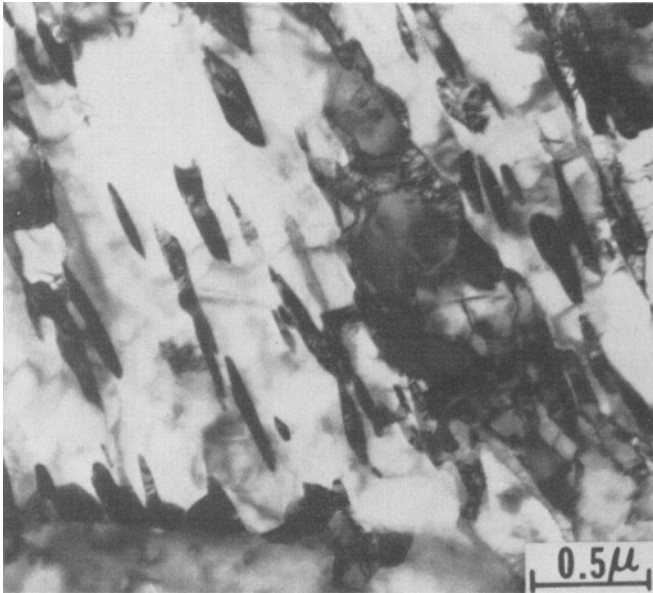
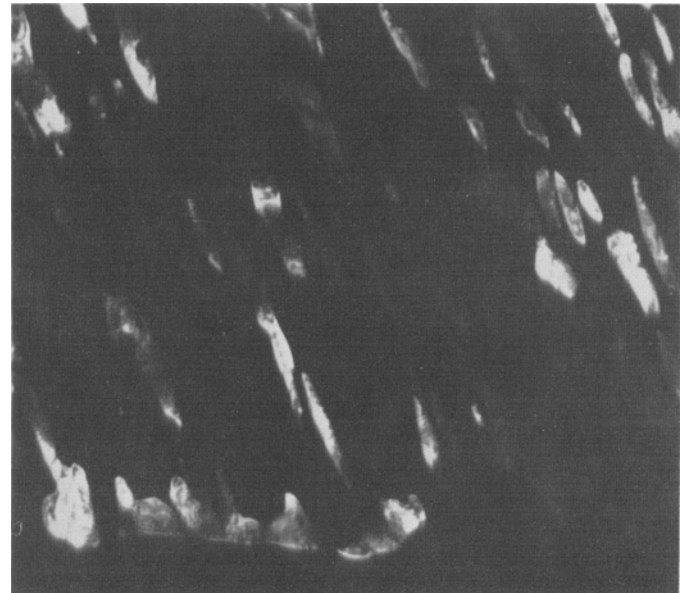
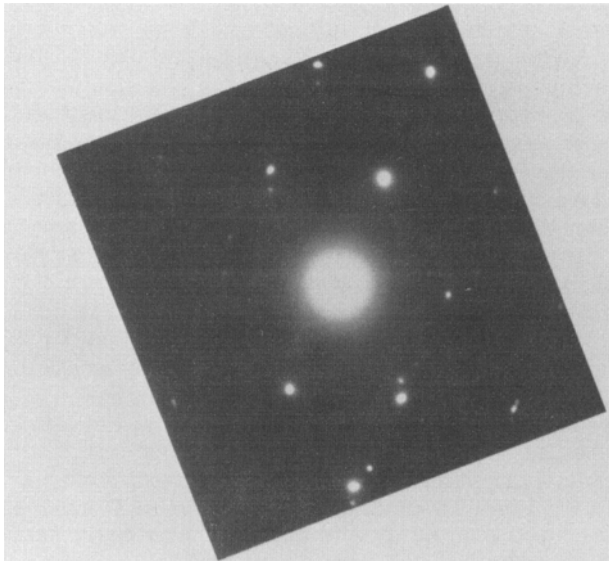
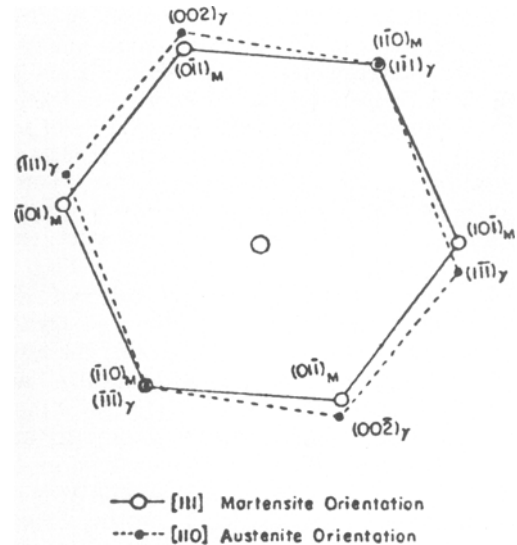
Fig. 1—Transmission electron micrographs of retaining austenite in grain refined and tempered 9Ni steel. (a) bright field, (b) dark field taken from  $(00\bar{2})\gamma$  diffraction spot in (c).

position is given in Table I. Compact tension fracture toughness specimens were cut out of the plate. To insure that these specimens would fail in a ductile manner at 77 K the as-received microstructure was erased by annealing at 900°C for two h, and the specimens were given the grain refinement treatment shown in Fig. 2. After grain refinement the specimens were tempered at 575°C for one h and water quenched. The final microstructure of the specimens is illustrated in Fig. 1. Previous work<sup>11</sup> has shown that this grain refinement plus tempering treatment

fact that features which morphologically resemble the retained austenite present in the undeformed alloy are common. Examples of austenitelike features are circled in Figs. 6 and 7; they are comparable to the retained austenite particles present in the dark field micrograph in Fig. 1. The TEM study hence supports the conclusion from Mössbauer analysis that there is complete transformation of the austenite near the fracture surface.

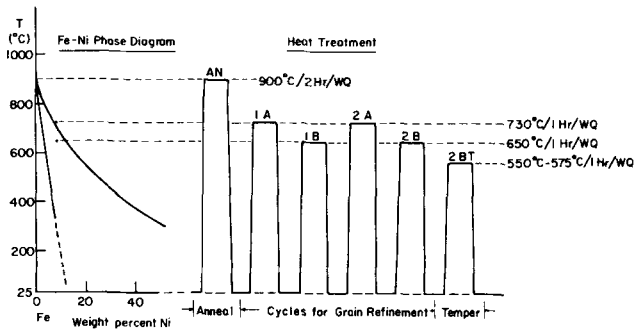
Fig. 2—Thermal cycling and temper procedure for grain refinement in 9Ni steel.

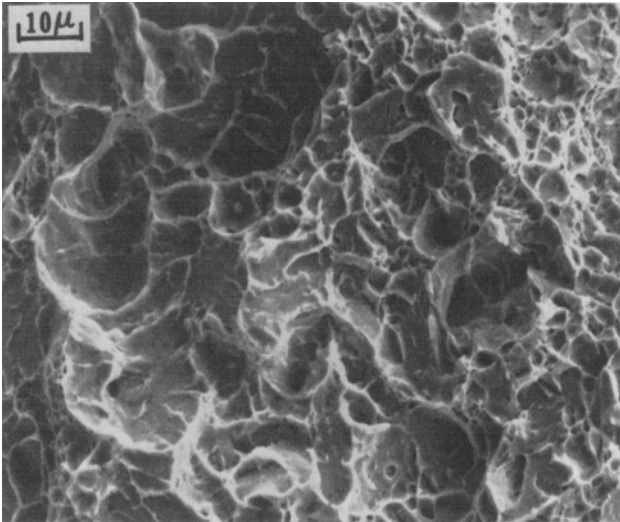
Fig. 3—Scanning electron microscopic (SEM) fractograph. Tempered (575°C/1 h/water quench) after grain-refinement and fractured in the compact tension test at 77 K.  $K_{IC}$  estimated to be 300 ksi  $\sqrt{\text{in.}}$  (330 MPa  $\sqrt{\text{m}}$ ).

suffices to reduce the ductile-to-brittle transition temperature of 9Ni steel to below 6 K. Fracture toughness tests were conducted on these specimens in liquid nitrogen (77 K) with the result that the specimens failed in a ductile manner (Fig. 3) with a fracture toughness ( $K_{IC}$ ) estimated to exceed 300 ksi  $\sqrt{\text{in.}}$  (330 MPa  $\sqrt{\text{m}}$ ), in agreement with earlier results.

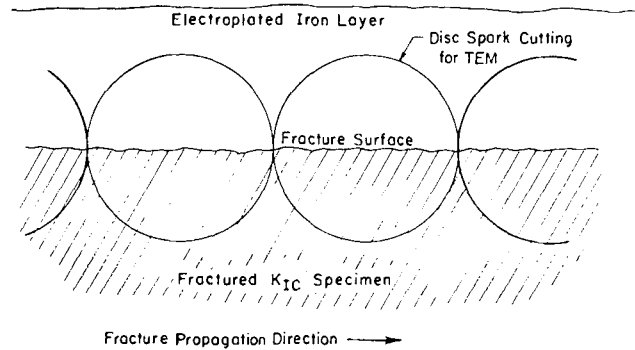
Fig. 4—Schematic diagram of disc preparation from the boundary area between the fractured 9Ni steel and the electroplated iron layer.

One of the two matching parts of a specimen fractured at 77 K was used for Mössbauer spectroscopy. The fracture surface of the other piece was electroplated with pure iron to a thickness of more than 2 mm using the Fischer-Langbein type solution.<sup>12</sup> The plated piece was sliced along the direction of the fracture crack propagation and perpendicular to the fracture surface. These slices, ~500  $\mu\text{m}$  thick, were chemically and mechanically thinned to a thickness of ~40  $\mu\text{m}$ . Discs of 3 mm diam were then spark cut from the slices in such a way that the boundary lines between the plated iron layer and the fractured 9Ni steel lay approximately along a diam of the disc (Fig. 4).

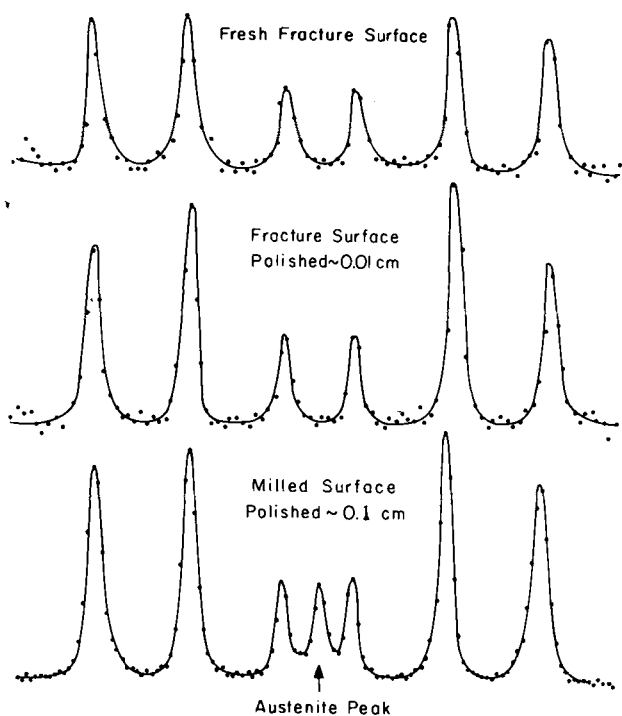
Fig. 5—Conversion electron Mössbauer spectra from the fracture surfaces. Solid curves were hand-drawn through datum points.

The results of the Mössbauer analysis are presented schematically in Fig. 5. The undeformed specimen surface shows a clear austenite peak corresponding to a retained austenite content of 8 pct by volume. This peak is absent in the spectrum obtained from the fracture surface suggesting an essentially complete transformation of the austenite over the region (to

$\sim 0.1 \mu\text{m}$  below the fracture surface) from which the data is taken. The austenite peak was also absent from the spectrum taken from the fracture surface after electrolytic etching to a depth of  $\sim 1 \text{ mm}$ . This result suggests a general transformation to a significant depth within the plastic zone associated with the fracture, whose radius is estimated to be  $5 \text{ mm}$  for this particular case.

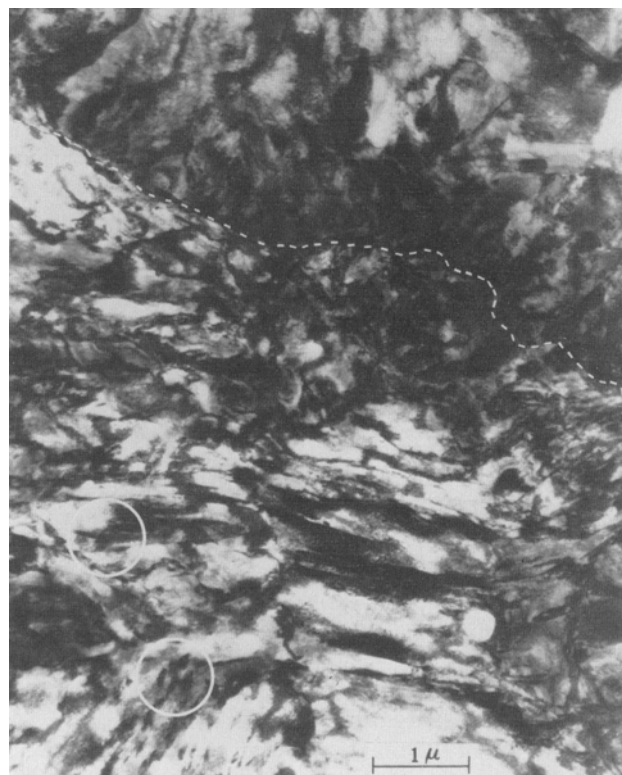
Fig. 6—Transmission electron micrograph and diffraction pattern of the fracture surface layer. The boundary between the electroplated iron layer (above) and fractured 9Ni steel (below) was marked by a dashed line. The circled areas show retained austenite-like particles.

The profile fractographic samples prepared for this study permitted examination of the region below the fracture surface to a depth of  $\sim 20 \mu\text{m}$  in a transmission electron microscope operated at  $650 \text{ KeV}$ . Typical bright field micrographs are shown in Figs. 6 and 7. The fracture surface is easily located by the abrupt change in microstructure between the electroplated iron layer (above) and the deformed 9Ni steel (below) and is marked with a dashed line and arrows respectively. The severe deformation of the alloy immediately below the fracture surface is visually apparent. Figure 7 includes a selected area diffraction pattern taken from the central region of the micrograph immediately below the fracture surface. The spread of the diffraction spots along each diffraction ring is indicative of the severe deformation of the subsurface material; as shown in Fig. 1 the selected area diffraction from the undeformed material yields a well-defined spot pattern. No extra spots attributable to retained austenite are present in the diffraction pattern.

The TEM evidence argues, however, that the transformation of the austenite is in this case to a dislocated martensite rather than to a twinned martensite as suggested by earlier work.<sup>8</sup> In a careful structural survey of the subsurface region no example of internally twinned martensite was found. In particular, the martensite particles which were tentatively identified as transformed austenite on morphological grounds were dislocated rather than twinned. Examples include the circled regions in Fig. 6.

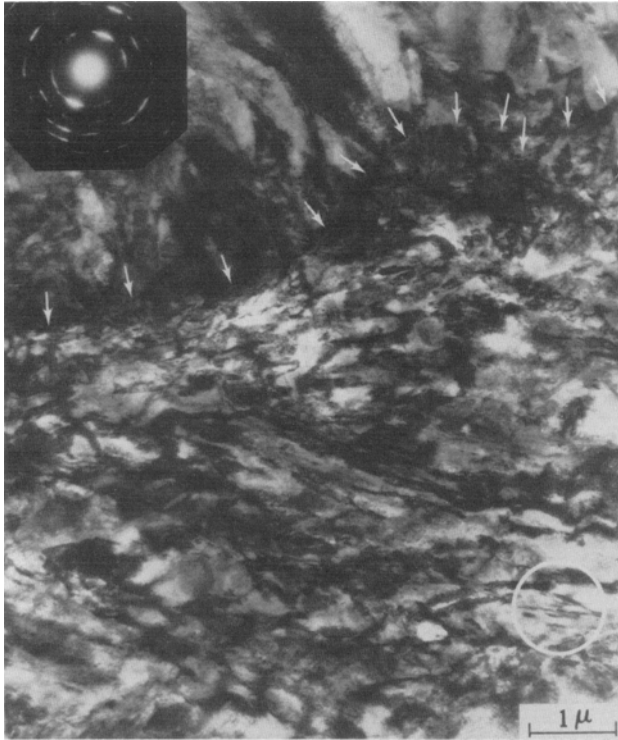
Fig. 7—Another TEM picture of the fracture surface layer (the boundary indicated by arrows). The diffraction pattern was taken from the central region right below the boundary line. The circled area shows retained austenite-like particles.
