Hydrogen Assisted Cracking of Type 304 Stainless Steel

C. L. BRIANT

This paper reports a study of hydrogen assisted cracking in type 304 stainless steel. It shows that the most detrimental effect in increasing the susceptibility of the material to hydrogen cracking is the formation of martensite upon deformation. This is particularly damaging if the martensite is localized at the grain boundaries. With martensite present intergranular impurities such as phosphorus play a secondary role. As martensite becomes more difficult to form, the importance of impurities increases.

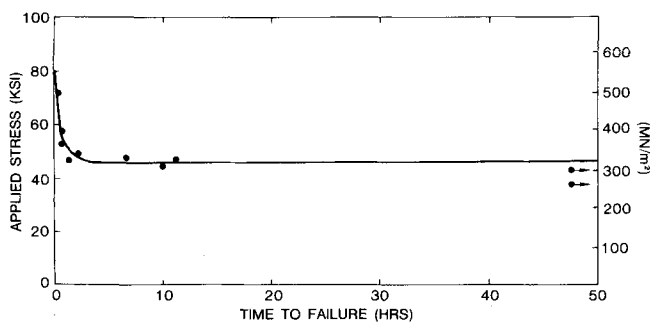
Fig. 1—A typical time to failure curve for a commercial heat of 304 stainless steel sensitized at 650°C for 24 h. The time to failure is plotted as a function of the initial applied stress.

Two types of tests were employed to study hydrogen cracking. One was a time to failure test. In these tests smooth bar tensile samples (gage diam of 1.52 mm) were mounted in a charging cell and an initial stress was applied. The samples were then cathodically charged with hydrogen throughout the test and the time to failure was measured. The charging solution was 0.1 N H₂SO₄, containing 500 mg/l of sodium arsenite. The current density was 40 mA/cm². Initially tests were run for one week, and if a sample had not failed within that time the test was terminated. However, after many such tests it became clear that samples usually failed within the first 12 h of the test and always within the first 48 h of the test, or not at all. Figure 1 shows the experimental evidence for this. The data shown in this figure are for the commercial heat of 304 stainless steel studied in Ref. 15. The heat treatment for these samples was 1100°C for 1 h plus 650°C for 24 h. As can be seen on this figure, the time to failure suddenly shifts from less than 10 h to longer than 48 h as the initial applied stress is decreased. Based on this the termination time for this test was shortened to 48 h. Therefore, the measure of susceptibility to hydrogen cracking, as determined by this test, is the minimum stress required to cause failure within 48 h.

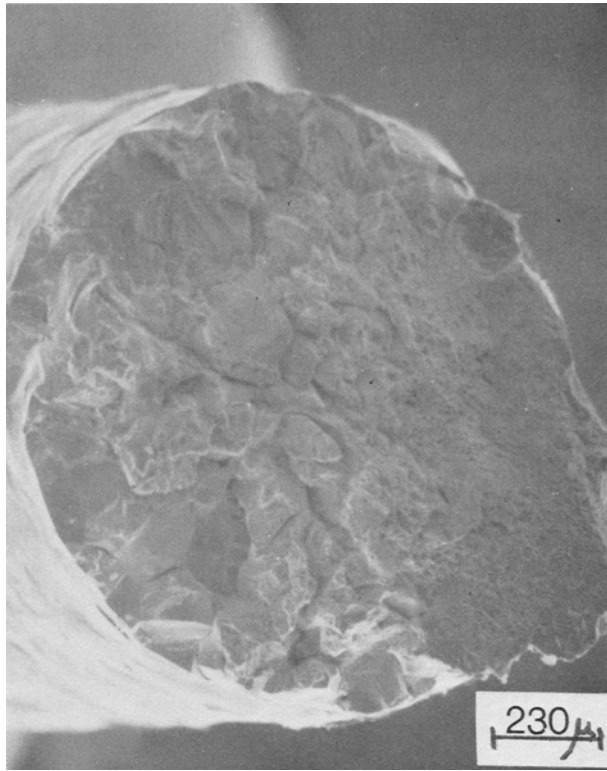
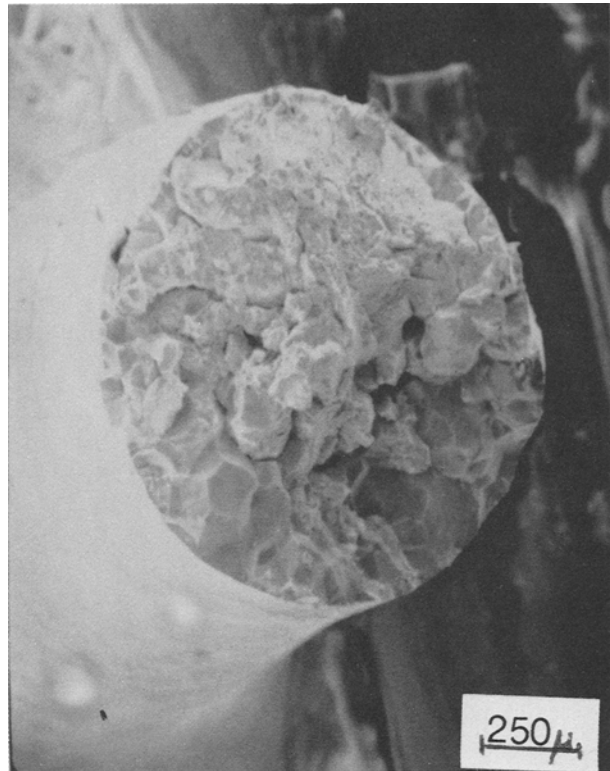
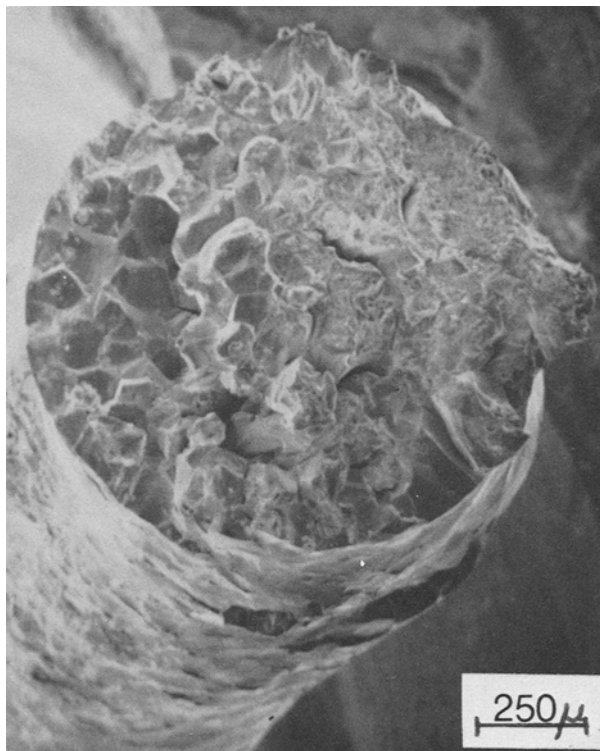
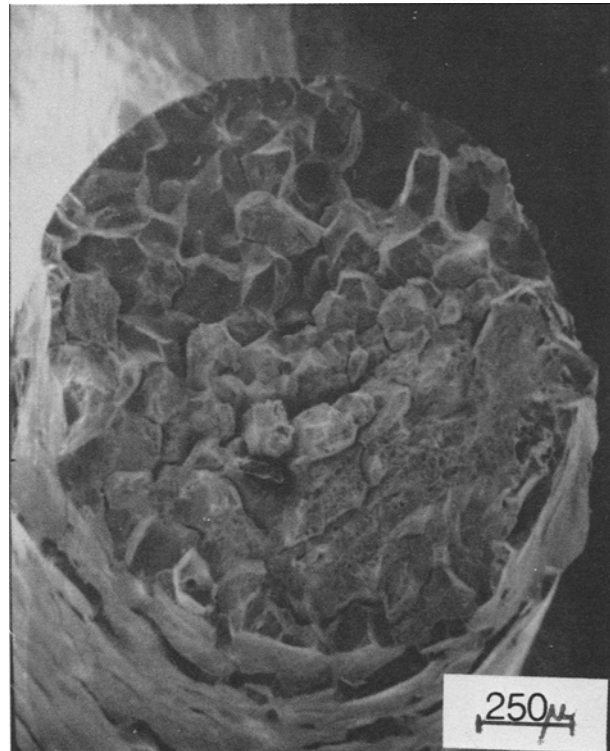
Fig. 2—The fracture surfaces of the high carbon 304 samples, sensitized at 650°C for 24 h, after cathodic charging failures. (a) The high purity heat with an initial applied stress of 379 MN/m², (b) The phosphorus doped heat held at an initial applied stress of 379 MN/m², (c) The high purity heat held at an initial stress of 250 MN/m², (d) The phosphorus doped heat held at an initial stress of 250 MN/m², (e) An example of the striated transgranular fracture observed in these samples.

Typical fracture surfaces from these samples are shown in Figs. 2 to 4. Figure 2 shows fractures of the sensitized, high carbon materials. The initial hydrogen fracture was always predominantly intergranular and the rapid fracture at the center of the sample was microvoid coalescence. In addition, a striated transgranular fracture was observed for both heats, especially near the onset of fast fracture, Fig. 2(e).

The extent of intergranular fracture depended on two factors. The primary one was the applied stress; the lower the applied stress and the longer the time to failure, the more intergranular fracture observed. Also, at any given stress which caused failure, more intergranular fracture was observed in the phosphorus doped steel, Fig. 2(a) to (d).

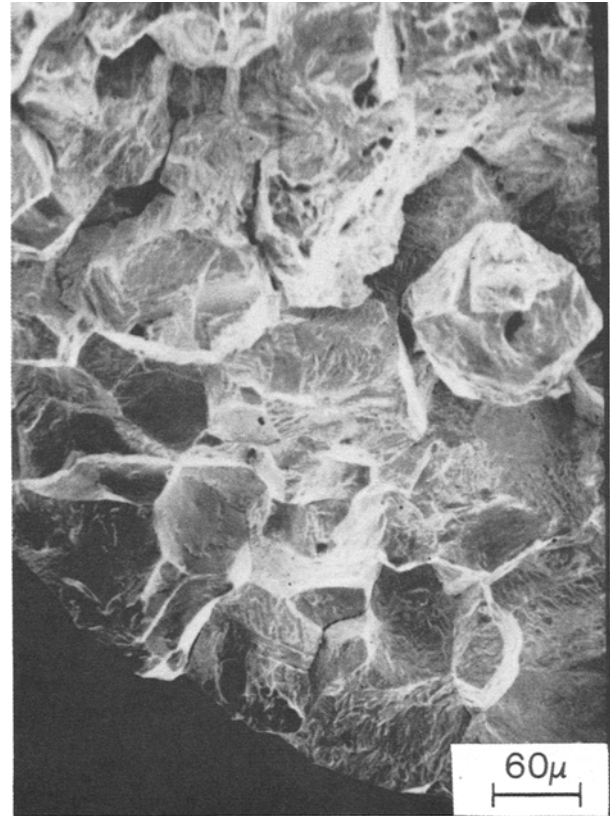
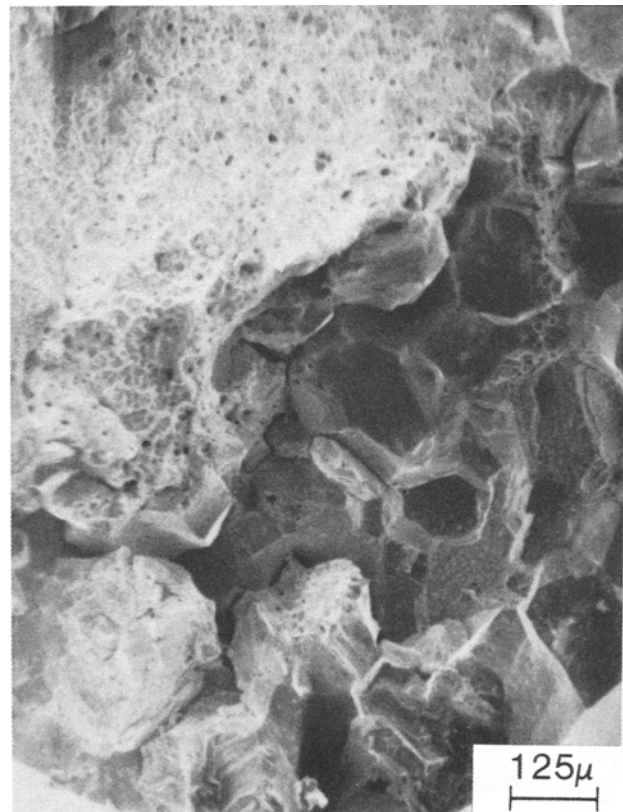
Fig. 3—The fracture surfaces of the low carbon alloys after cathodic charging failures. (a) is the high purity heat, (b) is the phosphorus doped heat.

Figure 3 shows typical fracture surfaces of the low carbon alloys. The surfaces of the solution annealed samples and samples given the additional heat treatment of 650°C for 24 h were quite similar. Over 60 pct of the grain boundaries in the high purity heat had ductile tearing on them whereas those in the phosphorus doped samples were nearly always smooth. Figure 4 shows the fracture surface of a solution annealed sample of the high carbon heat doped with phosphorus. Again it is clear that the initial hydrogen fracture is predominantly intergranular.

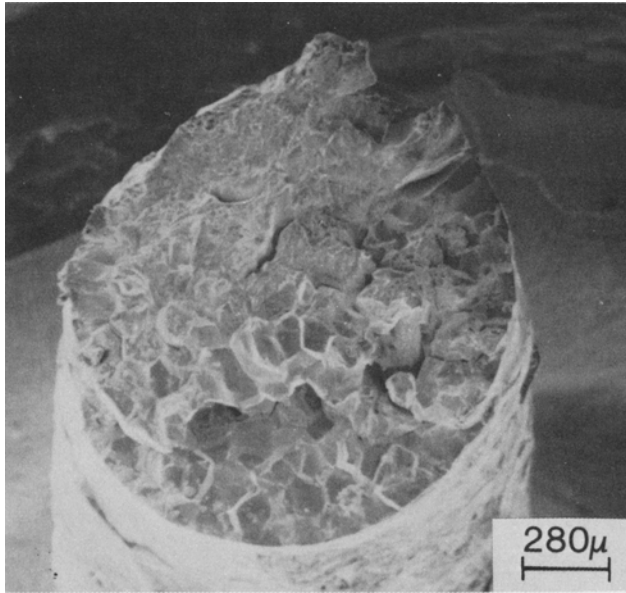
Fig. 4—The fracture surface of the unsensitized, phosphorus doped high carbon sample that failed during cathodic charging.

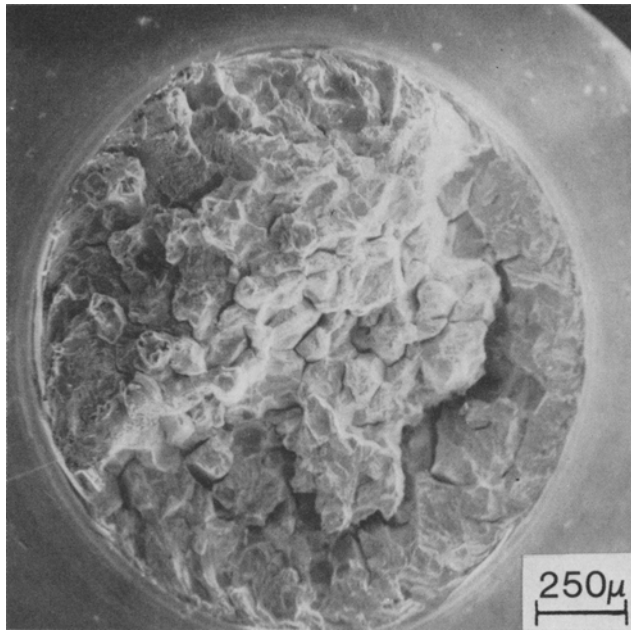
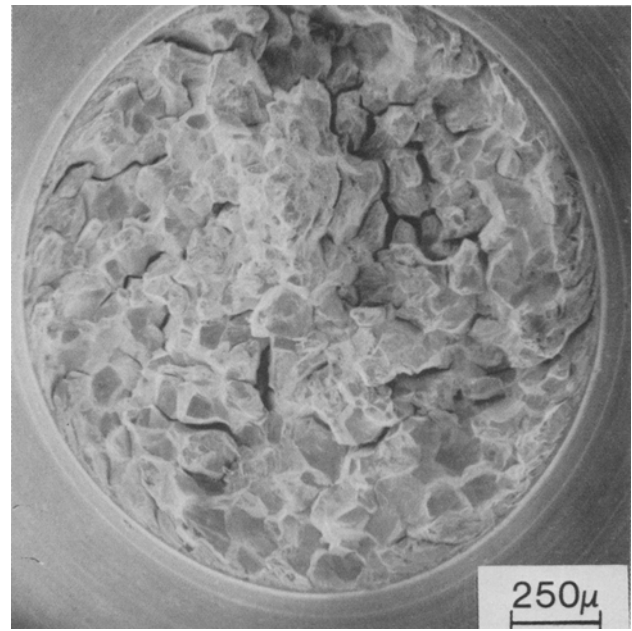
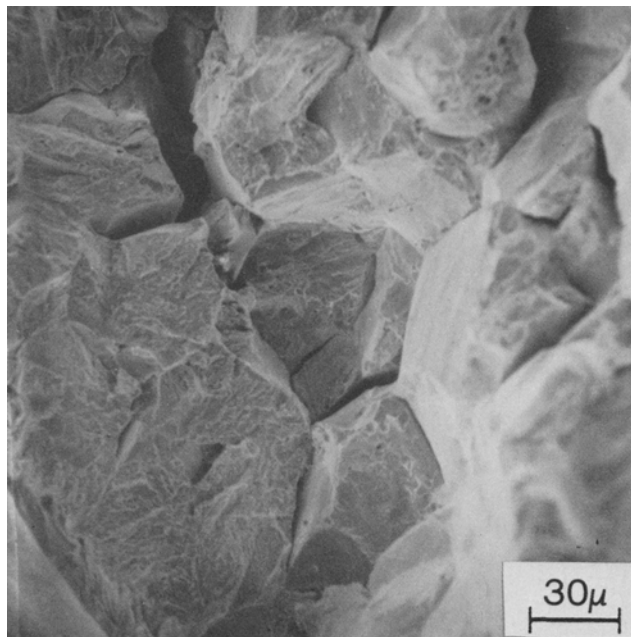
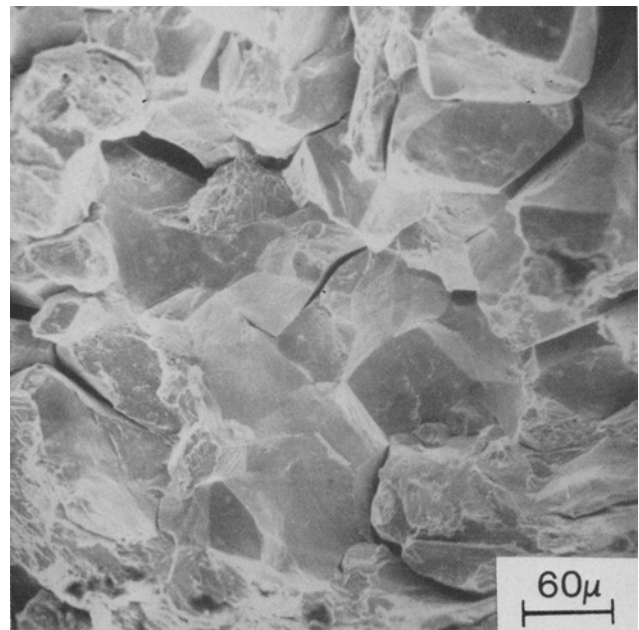
Fig. 5—Fracture surfaces of the sensitized high carbon samples pulled to failure in hydrogen gas. (a) and (b) are the high purity heat, samples (c) and (d) are from the phosphorus doped heat.

The results of these tests rank in the same general order as do those from the cathodic charging experiments. In the high carbon heats sensitized at 650°C for 24 h intergranular hydrogen assisted fracture was produced across the entire surface, Fig. 5. In the low carbon alloys some microvoid coalescence was observed in the center of the fracture surface, Fig. 6. In the solution annealed, high carbon materials microvoid coalescence was the primary fracture mode. Also the effect of phosphorus was much more obvious in these experiments, especially as the susceptibility of the material to hydrogen cracking decreased. In sensitized samples of the high purity, high carbon alloy the intergranular surfaces were often ductile; in the phosphorus doped heat they were quite smooth, Fig. 5. More intergranular fracture was observed in the phosphorus doped heats of the low carbon alloys and in solution annealed samples of the high carbon steels than in the corresponding high purity materials, Figs. 6 and 7.

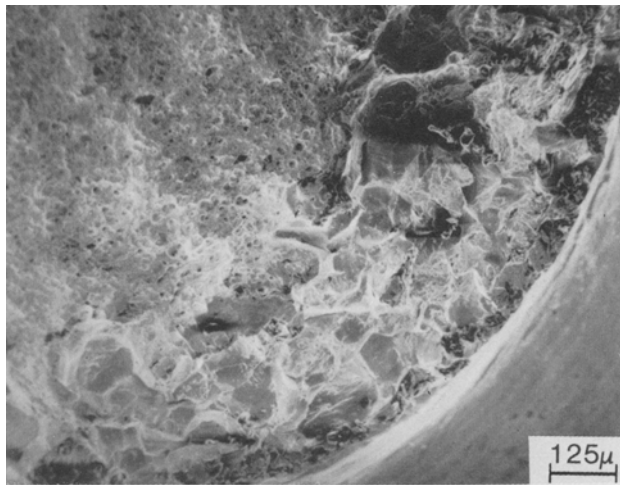
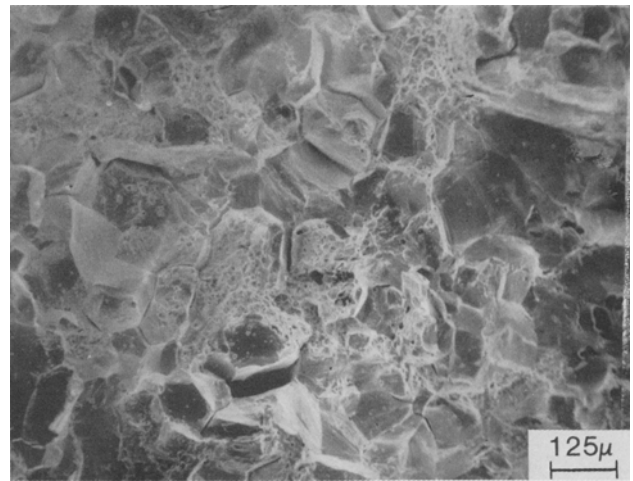
Fig. 6—Fracture surfaces of the low carbon alloy samples pulled to failure in hydrogen gas. (a) is the high purity heat, (b) is the phosphorus doped heat.

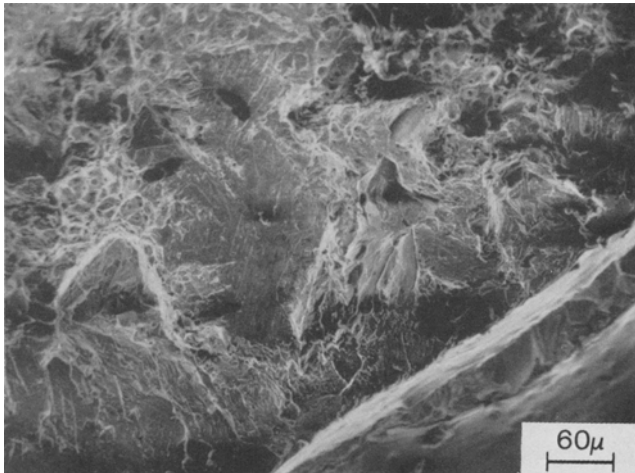
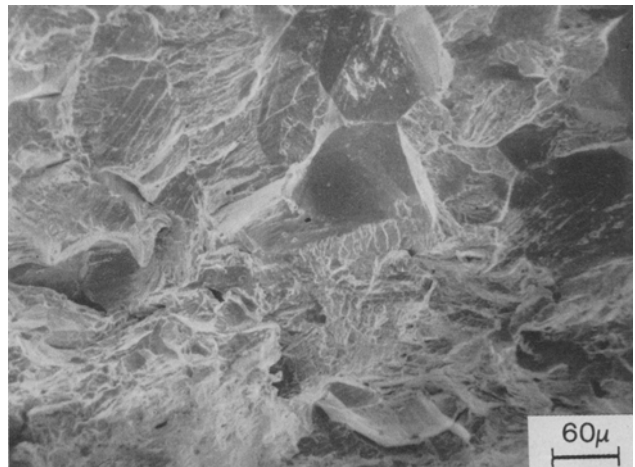
Fig. 7—Fracture surfaces of solution annealed high carbon samples pulled to failure in hydrogen gas. (a) is the high purity material, (b) is the phosphorus doped material.

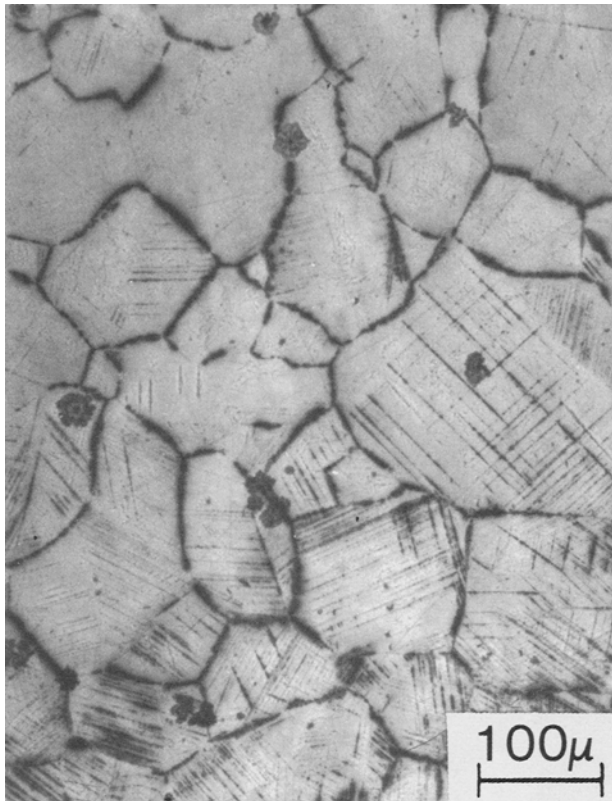
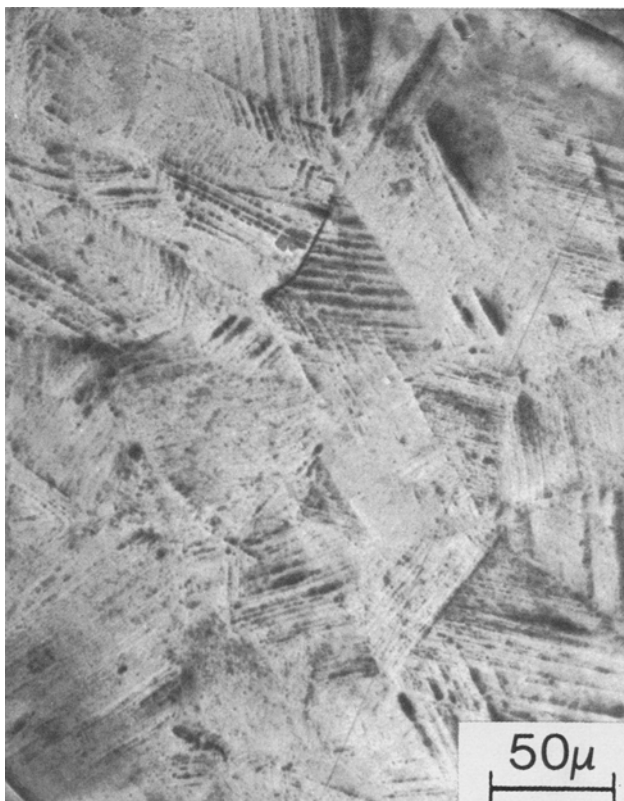
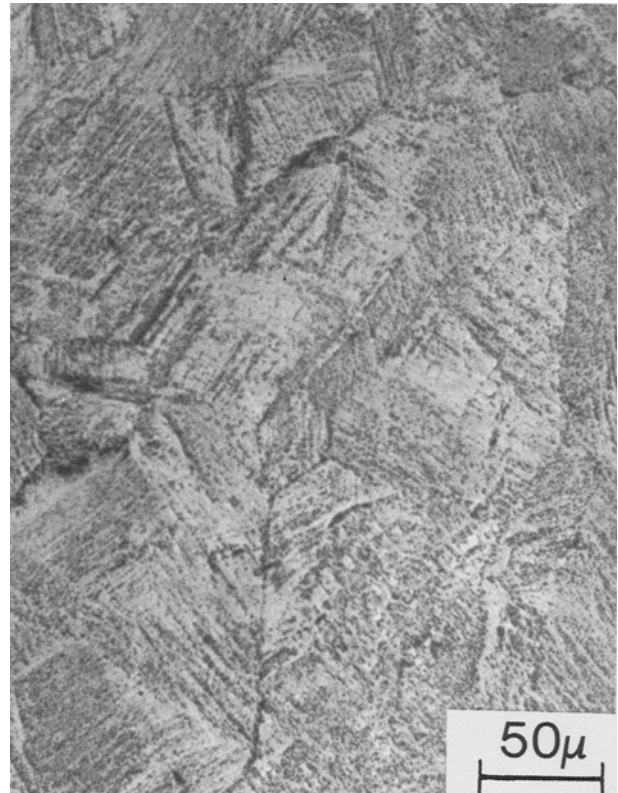
Fig. 8—Micrographs of samples covered with ferrofluid and placed in a magnetic field. (a) is a sensitized high carbon sample stressed to a level of 276 MN/m^2 . (b) is an unsensitized high carbon sample stressed to a level of 393 MN/m^2 . (c) is a low carbon alloy stressed to a level of 290 MN/m^2 . Sample C was charged with hydrogen while the stress was applied. Note that a crack had formed along one of the highly martensitic grain boundaries.

One way to check these ideas qualitatively is by the ferrofluid technique.²⁹ Ferrofluid is a colloidal suspension of iron filings. In this experiment a specimen is mounted and polished but not etched. A drop of fluid is placed on the sample and spread out with a cover glass. When a magnetic field is applied, the iron filings are attracted to the ferromagnetic regions of the material. Here, this would be the martensite, not the paramagnetic carbides or austenite.²⁹

Figure 8 shows the results of these experiments. In the sensitized high carbon materials the continuous intergranular martensite is clearly delineated, Fig. 8(a). In the unsensitized, high carbon samples only regions of maximum deformation such as the slip lines are transformed to martensite, Fig. 8(b). Also, in these unsensitized alloys the amount of martensite formation varies greatly from grain to grain. In the low carbon alloys, Fig. 8(c), martensite formation occurs in every grain. The grain boundaries, then, are not completely martensitic, but most all are partially martensitic.
