FRICTION SPOT JOINING OF HIGH STRENGTH STEEL SHEETS FOR AUTOMOTIVES

ABSTRACT

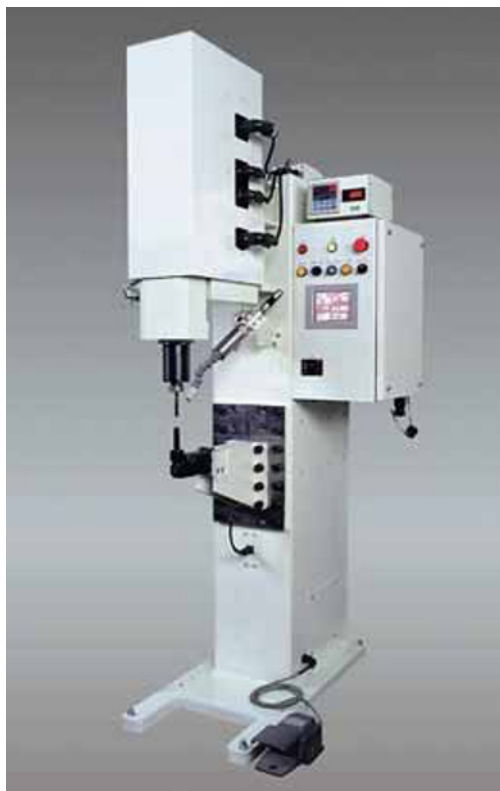
Figure 1 – Equipment used for FSJ

FSJ was applied to two sheets of DP980 steel in the lap configuration. A picture of the FSJ equipment used in this experiment is shown in Figure 1. The machine was equipped with two AC servo-motors for controlling the tool load and rotational speed precisely, developed for the FSJ process. The tool used in this experiment was made of silicon nitride (Si_3N_4). The tool had a 14 degree, concave-angled shoulder with a threaded cylindrical pin. The shoulder diameter, the pin diameter and the pin length were 10 mm, 4 mm and 1.5 mm, respectively. Two types of surface treatments on the tool were prepared for this experiment, i.e., one was left bare and the other was coated with TiC/TiN multi layer by chemical vapour deposition. The coated tool was used with Ar shielding gas during FSJ in order to prevent oxidation of the coating.

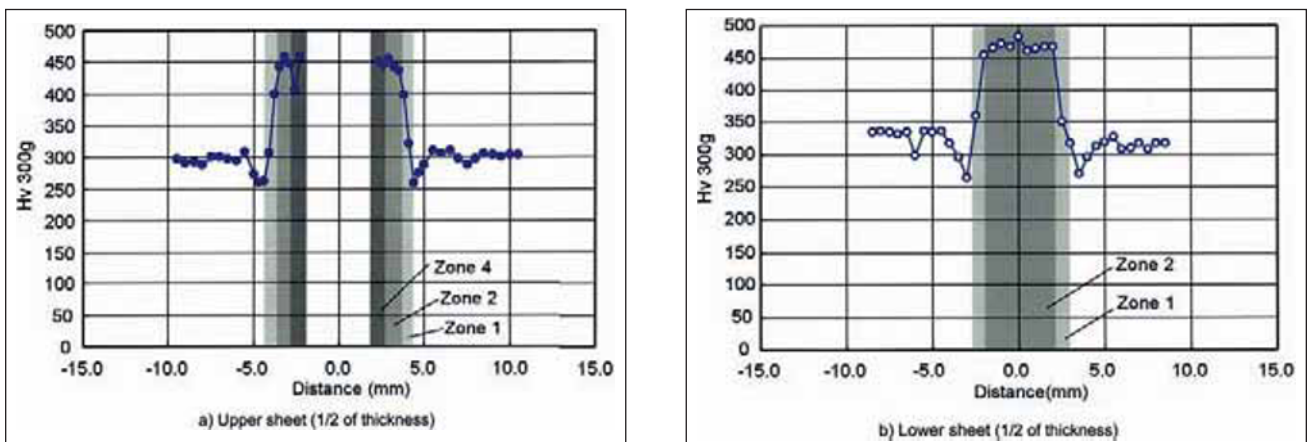
Figure 6 – Micro-Vickers hardness profile of the joint

Micro-Vickers hardness profile of the joint is shown in Figure 6. Average hardness of the base material was approximately 320 Hv. The hardness was reduced near

the outer border of Zone 1, then increased rapidly toward the tool exit hole. The maximum hardness of 450 Hv was measured in Zone 4, a value frequently found in a resistance spot weld of DP980 steel [6]. The lower hardness in Zone 1 was associated with tempering of the martensite, and the maximum hardness in Zone 4 would be due to the fine martensitic structure.

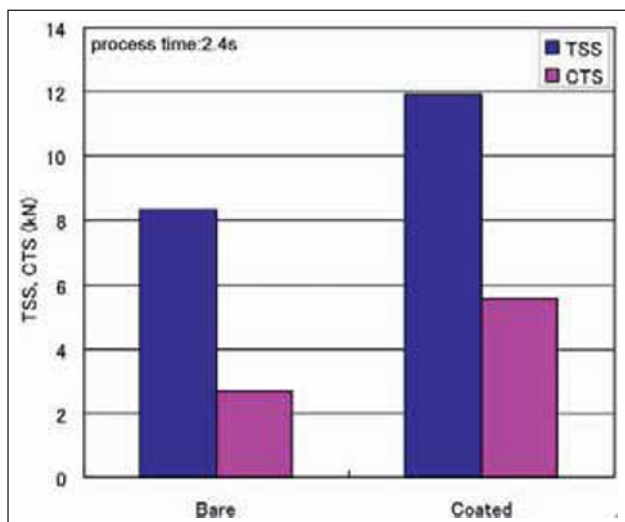
Figure 7 – Tensile shear and cross tensile strength of the joint obtained at 2.4 s

Strength of the joints in tensile shear and cross tension tests are shown in Figure 7. The strengths of the joint produced with the coated tool are also presented in this figure. The coated tool resulted in apparently a higher strength than the bare tool, especially since the effect of coating on the cross tension strength was significant.

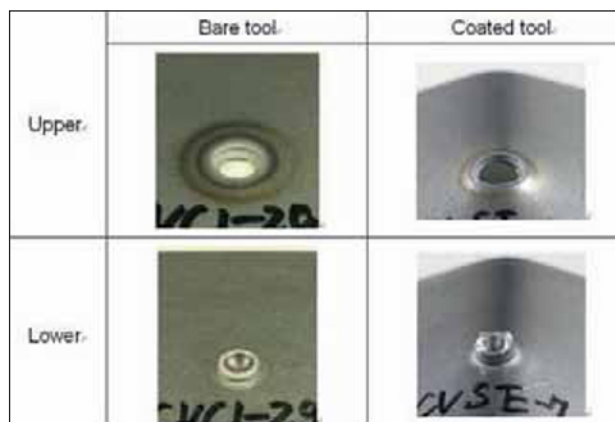
Figure 8 – Appearance of fracture parts after cross tension test

The appearance of the fractured joints produced with the bare tool and the coated tool after the cross tension test is shown in Figure 8. It was noted that there was a difference between the two in the failure mode in the cross tension test. The joint produced with the coated tool, which showed the higher strength, exhibited typical pull-out fracture, while the fracture was propagated along the periphery of the stir zone in the joint produced with the coated tool. A previous study on friction spot joining of DP590 steel showed the same results [7], but the reason for this difference remains unclear at present. Further studies on fracture mechanisms in both cases are in progress and will be reported in the near future.
