IMPROVING THE LIFE OF CONTINUOUS CASTING ROLLS THROUGH SUBMERGED ARC CLADDING WITH NITROGEN-ALLOYED MARTENSITIC STAINLESS STEEL

Madeleine Du Toit and Johan Van Niekerk

Doc. IW-2053-09 (ex-doc. IX-2303-09), recommended for publication by Commission IX "Behaviour of Metals Subjected to Welding."

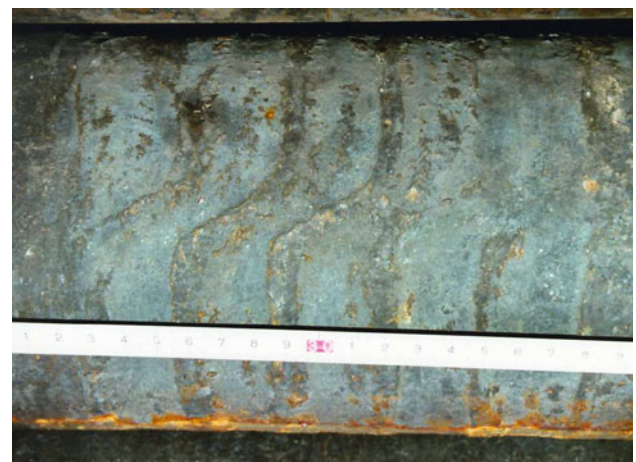
Figure 1 – Wear of a casting roll
(Photograph courtesy of Welding Alloys Ltd, UK) [6]

In the finishing stands and lower segments of the caster roll line, oxidation of the steel surface in the presence of steam produces oxides which aggravate abrasive wear. Oxidation results in an “elephant skin” surface appearance due to grain boundary oxidation of the outer clad layers, as well as cracking and spalling of the cladding. An example of the surface of a worn casting roll is shown in Figure 1. The risk of wear and oxidation failure can be reduced by ensuring that the clad layer has a high chromium content (greater than approximately 12 %), which facilitates the formation of a continuous stable oxide layer that has the ability to regenerate spontaneously. Alloying with nitrogen is beneficial due to the formation of a stable nitrogen-modified $FeO.Cr_2O_3$ spinel phase on the roll surface, which ensures a lower coefficient of friction and superior resistance to gouging and adhesive wear [5, 6].

Fluctuating stresses within the surface layers of casting rolls may give rise to fatigue failures during service. The fluctuating stresses may be mechanical, caused by cyclic loading per revolution due to the passage of the slab or by bending of the rolls [1, 4, 6]. Fluctuating thermal stresses develop due to changes in the temperature of the roll surface as it contacts the hot slab (leading to peak temperatures in the region of 600 °C), followed by water spraying as the roll revolves. A network of fine thermal fatigue cracks, known as “fire-cracking”, may develop, and is recognized as the major

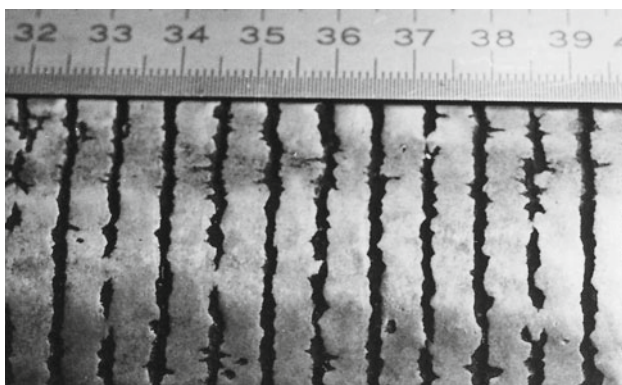
Figure 2 – Pitting corrosion of a continuous casting roll surface

Localized pitting and crevice corrosion develops as a result of exposure to aggressive acidic environments within the caster. Anodic dissolution of the steel may be accelerated within surface discontinuities, promoted by progressive acidification of the pit or crevice environment (as illustrated by Equations (1) and (2)). Extensive pitting corrosion of the surface of a caster roll is shown in Figure 2. High chromium, molybdenum and nitrogen contents increase resistance to localized corrosion [6].

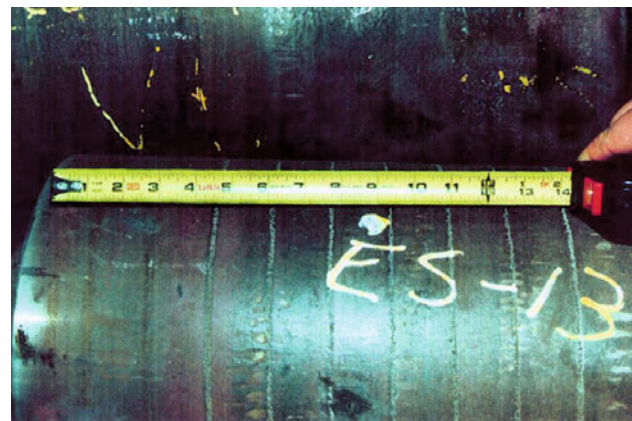
Figure 3 – Inter-bead corrosion of a continuous casting roll surface

Multiple pass welding and slow cooling after cladding promote the precipitation of chromium-rich M_{23}C_6 carbides at the prior austenite grain boundaries or martensite lath boundaries. The formation of these carbides is very difficult to prevent, especially in the reheated or inter-bead zones between runs. Resulting chromium depletion of the surrounding matrix may give rise to sensitization and preferential corrosive attack of the chromium depleted overlap regions. A reduction in the carbon content, as well as higher levels of chromium and nitrogen, are beneficial in preventing attack [2, 6]. An example of inter-bead corrosion caused by sensitization is shown in Figure 3.

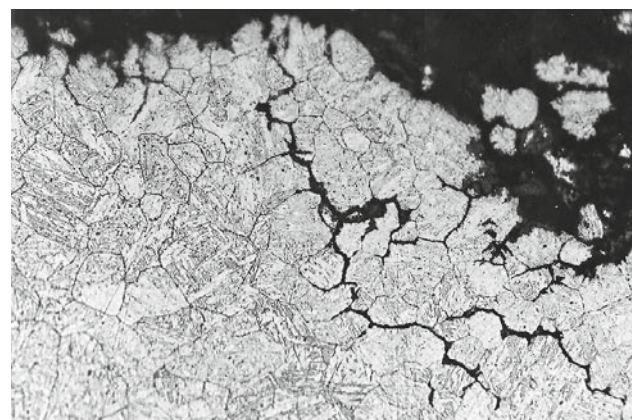
Figure 4 – Intergranular stress corrosion cracking of a continuous casting roll surface

crevices, particularly in the reheated or overlap zones of weld beads. These areas may be sensitized by the weld thermal cycle and are often prone to chromium depletion and intergranular attack. Once initiated, these cracks can propagate under the influence of applied tensile stresses which damage the passive film at the crack tip [6]. A micrograph displaying stress corrosion cracking along the prior austenite grain boundaries of a caster roll clad layer is shown in Figure 4.

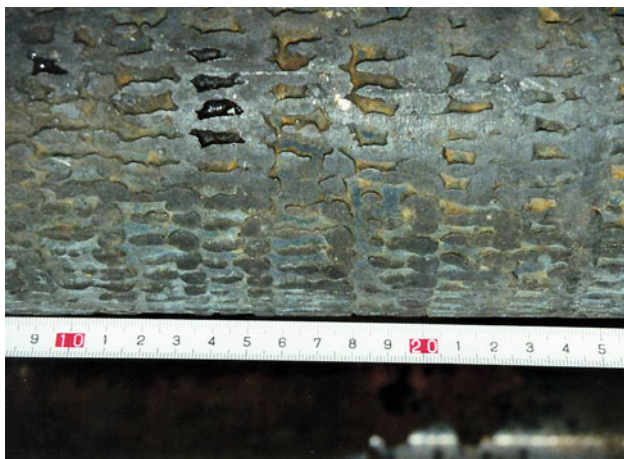
Figure 5 – Mould flux-induced corrosion of a continuous casting roll surface
(Photograph courtesy of Welding Alloys Ltd, UK) [6]

The formation of hydrofluoric acid lowers the pH of the cooling water and creates a severely corrosive environment in contact with the roll surface. An example of mould flux-induced corrosion is shown in Figure 5.

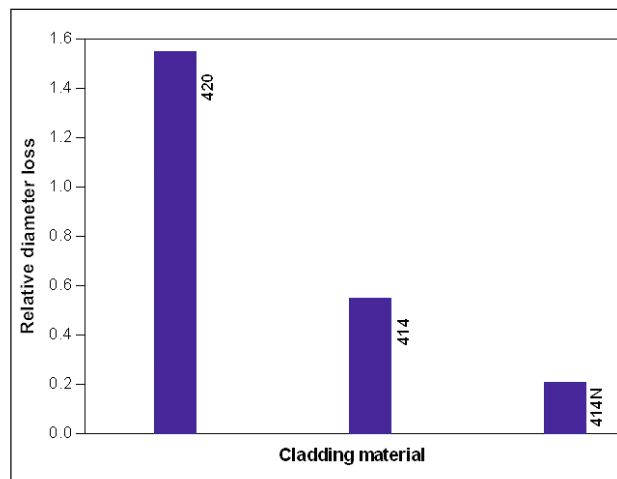
Figure 6 – Comparison between the relative diameter loss of continuous casting rolls surfaced with 420, 414 and nitrogen-enhanced 414N cladding material [7]

Further improvement can be obtained by substituting part of the carbon normally added to martensitic stainless steels with nitrogen. Nitrogen-enhanced 12 % chromium martensitic stainless steels exhibit faster repassivation kinetics, a fine homogeneous distribution of nitride precipitates which inhibit grain growth, and an increase in the stability and passivity range of the oxide film [2]. This results in improved oxidation and corrosion resistance, higher strength, improved impact toughness, enhanced temper resistance, and higher resistance to thermal and thermomechanical fatigue. These improved properties result in considerably less material loss during service, as shown in Figure 6 for unmodified 420 and 414, compared to nitrogen-enhanced 414 (labelled 414N) martensitic stainless steel.

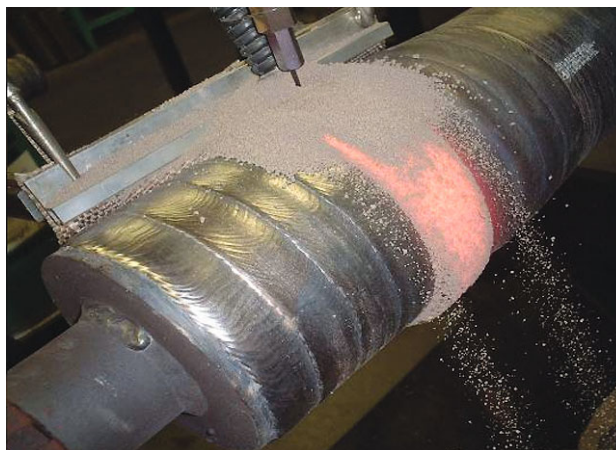
Figure 7 – Submerged arc cladding of continuous caster rolls using Chromecore 414N-S wire

Single-wire submerged arc welding utilizing neutral flux and a wide weave (25 to 30 mm) to facilitate machining and provide a more uniform deposit (resulting in a bead width of 30 to 40 mm) is used (see Figure 7). A preheat temperature of 230 °C and a maximum interpass temperature of 350 °C are specified. Cladding is usually performed above the M_s (martensite start) temperature to avoid brittle fracture and to minimize the risk of hydrogen-induced cracking.

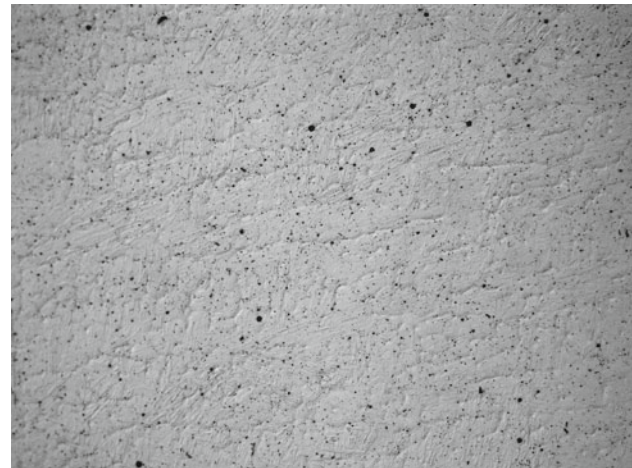
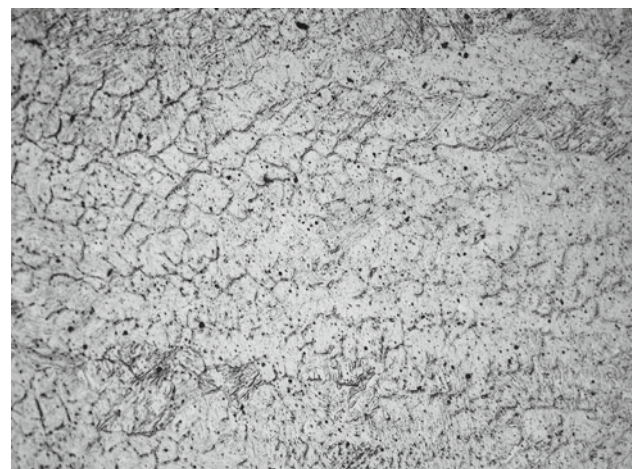
a) The third layer

b) The last layer

Figure 8 – Optical micrographs of a 414N-S deposit in the as-welded condition

Examination of the 414N-S deposit in the as-welded condition [Figures 8 a) and b)] revealed a martensitic microstructure with some δ -ferrite located at the cores of the original dendrites that formed on solidification. The observed δ -ferrite content was within acceptable limits, and no retained austenite was evident, resulting in acceptable hardness levels (Table 3). Isolated carbide particles were observed, however, the absence of continuous films of grain boundary carbide indicates that the deposit was not sensitized by the weld thermal cycle. Examination at a higher magnification (Figure 12) revealed that the observed carbide particles were not specifically associated with the δ -ferrite phase.

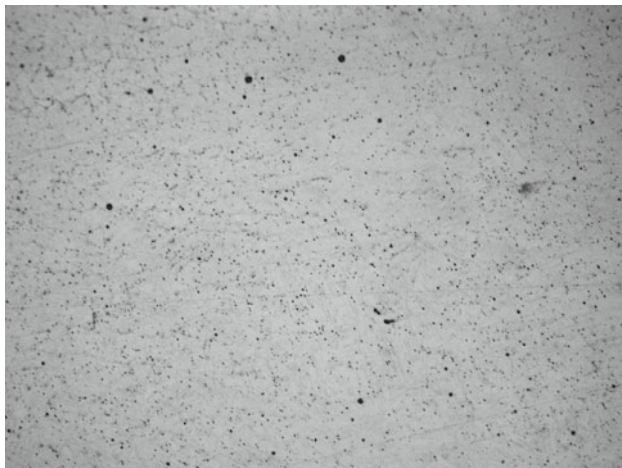
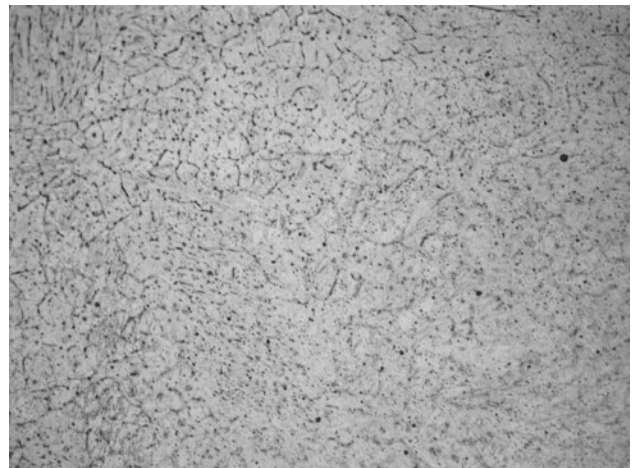
a) The third layer

b) The last layer

Figure 9 – Optical micrographs of a 414N-S deposit after post-weld heat treatment at 480 °C for 5 h

The optical micrographs shown in Figures 9 a) and b) suggest that stress relieving at 480 °C for 5 h (current practice) did not result in extensive grain boundary carbide precipitation, and the deposit microstructure appears very similar to that of the as-welded specimen. Table 3 also indicates that this heat treatment did not reduce the deposit hardness to any significant extent. Although the amount of stress relieving obtained at 480 °C is likely to be limited, this heat treatment is unlikely to cause any detrimental changes to the mechanical properties or corrosion resistance of the deposit.

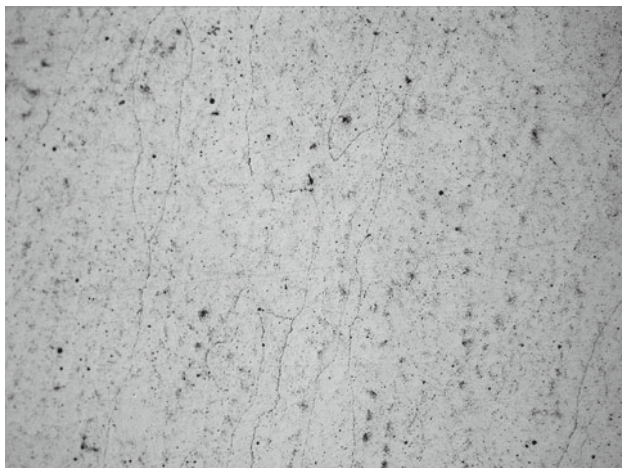
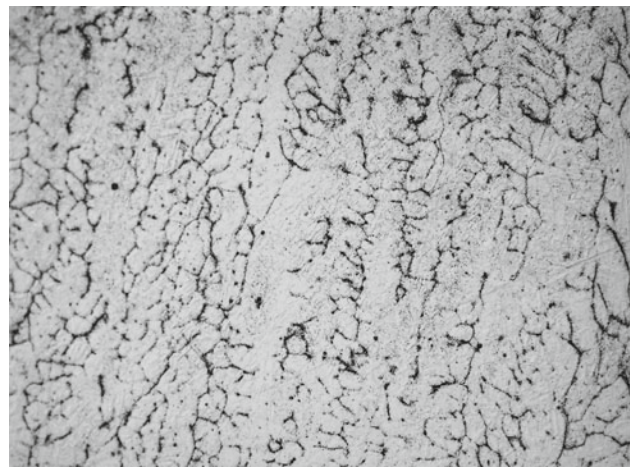
a) The third layer

b) The last layer

Figure 10 – Optical micrographs of a 414N-S deposit after post-weld heat treatment at 580 °C for 8 h

As shown in Table 3, heat treating the 414N-S deposit at 580 °C for 8 h resulted in a reduction in hardness, although the measured hardness was still within the specified range. Figures 10 a) and b) indicate that this standard heat treatment resulted in extensive carbide precipitation. Within the last layer, the carbides appeared to be associated with the δ -ferrite phase (Figure 13), whereas in the third layer the carbides seemed to outline the prior austenite grain boundaries.

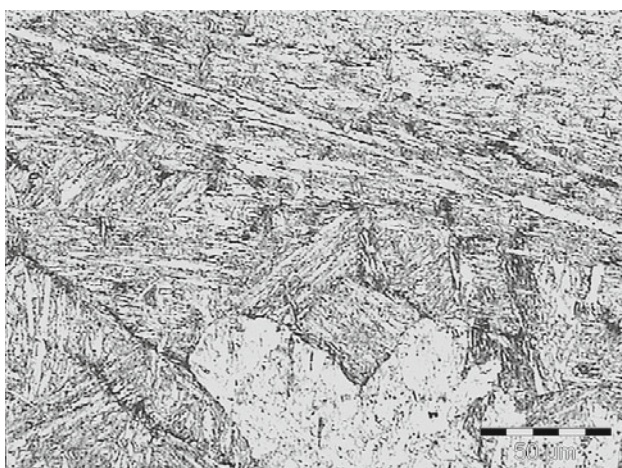
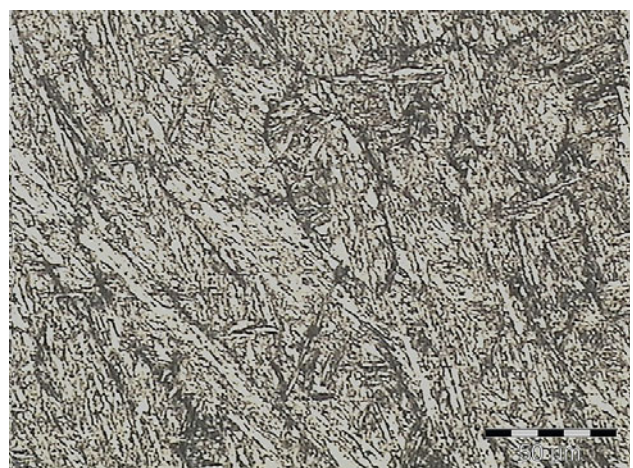
a) The third layer

b) The last layer

Figure 11 – Optical micrographs of a 414N-S deposit after post-weld heat treatment at 620 °C for 1 h

Table 3 indicates that post-weld heat treatment at 620 °C for 1 h caused an unacceptable reduction in deposit hardness below the specified hardness range for this application. This heat treatment also resulted in extensive carbide precipitation at the prior austenite grain boundaries and the martensite lath boundaries, as shown in Figures 11 a) and b). Although the extent of chromium depletion caused by the observed carbide precipitation was not evaluated during the course of this investigation, the structure is likely to be sensitized, and may exhibit increased susceptibility to localized corrosion and the initiation of stress

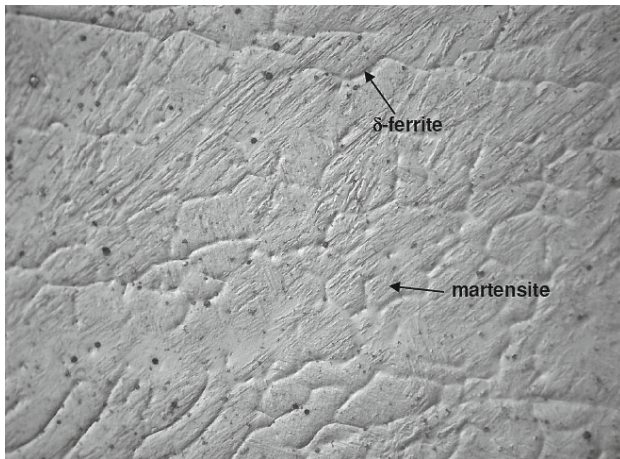
Figure 12 – Optical micrograph of the last layer of a 414N-S deposit in the as-welded condition

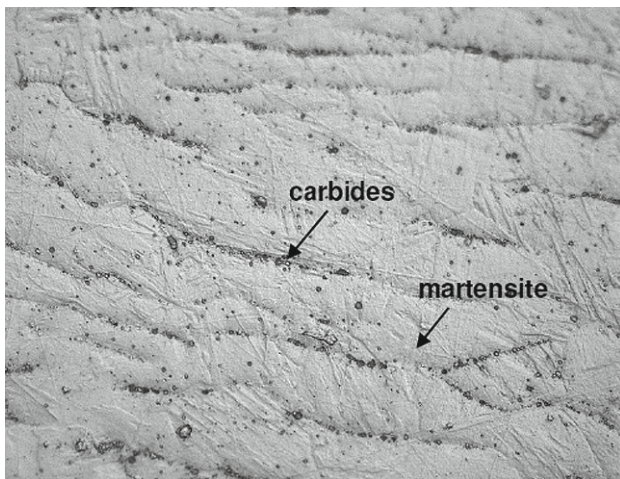
Figure 13 – Optical micrograph of the last layer of a 414N-S deposit after post-weld heat treatment at 580 °C for 8 h
