Reconstruction of Tsunami Inland Propagation on December 26, 2004 in Banda Aceh, Indonesia, through Field Investigations

Abstract—This paper presents the results from an extensive field data collection effort following the December 26, 2004 earthquake and tsunami in Banda Aceh, Sumatra. The data were collected under the auspices of TSUNARISQUE, a joint French-Indonesian program dedicated to tsunami research and hazard mitigation, which has been active since before the 2004 event. In total, data from three months of field investigations are presented, which detail important aspects of the tsunami inundation dynamics in Banda Aceh. These include measurements of runup, tsunami wave heights, flow depths, flow directions, event chronology and building damage patterns. The result is a series of detailed inundation maps of the northern and western coasts of Sumatra including Banda Aceh and Lhok Nga.

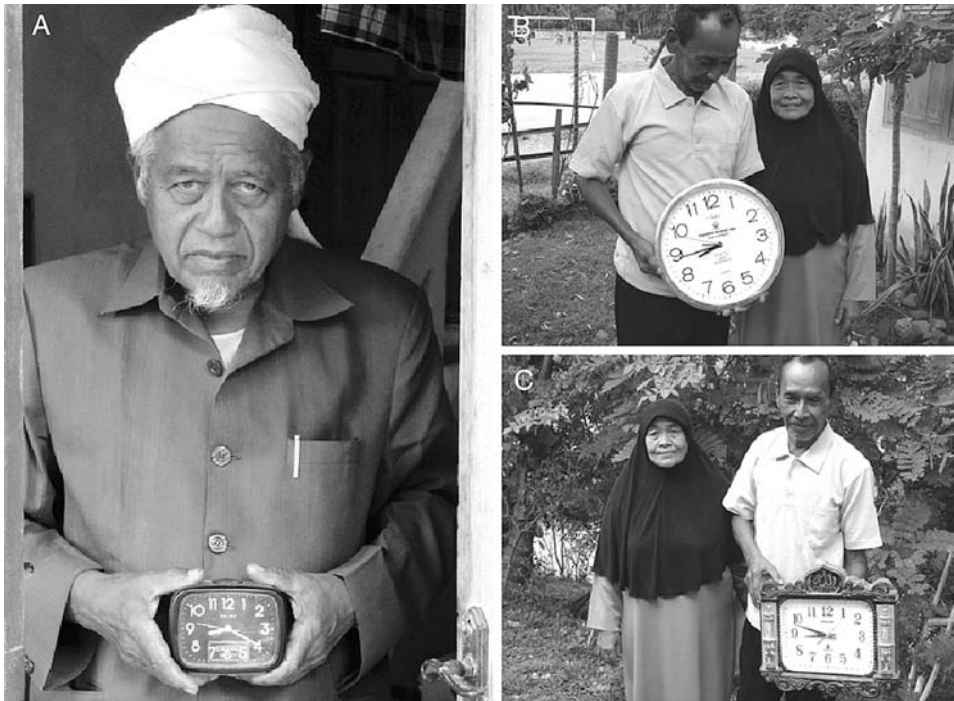
Figure 5

Clocks stopped by the tsunami waves. A: Mr. Abu Abdul Rhaffar, Imam of Lhok Nga's main mosque, carrying a clock stopped by the first tsunami wave at 8:20 LT. B and C: Two clocks stopped by the second tsunami wave at Lampulo, 1.5 km from the open ocean. Located inside the same house near the boat, they stopped at 8:44 LT and 8:49 LT, respectively. (Photos: F. Lavigne).

On the west coast, the imam of Lhok Nga’s main mosque heard people shouting “air laut naik” (the sea level raises) at 8:12 LT ($t_{EQ} + 13$ min), meaning that he heard the shouts when the sea started to return from its lowest receding level. The clock he found in his neighbor’s house was broken by the leading wave at 8:20 LT (Fig. 5a) ($t_{EQ} + 21$ min). The second wave (the main one) occurred less than 5 minutes after the

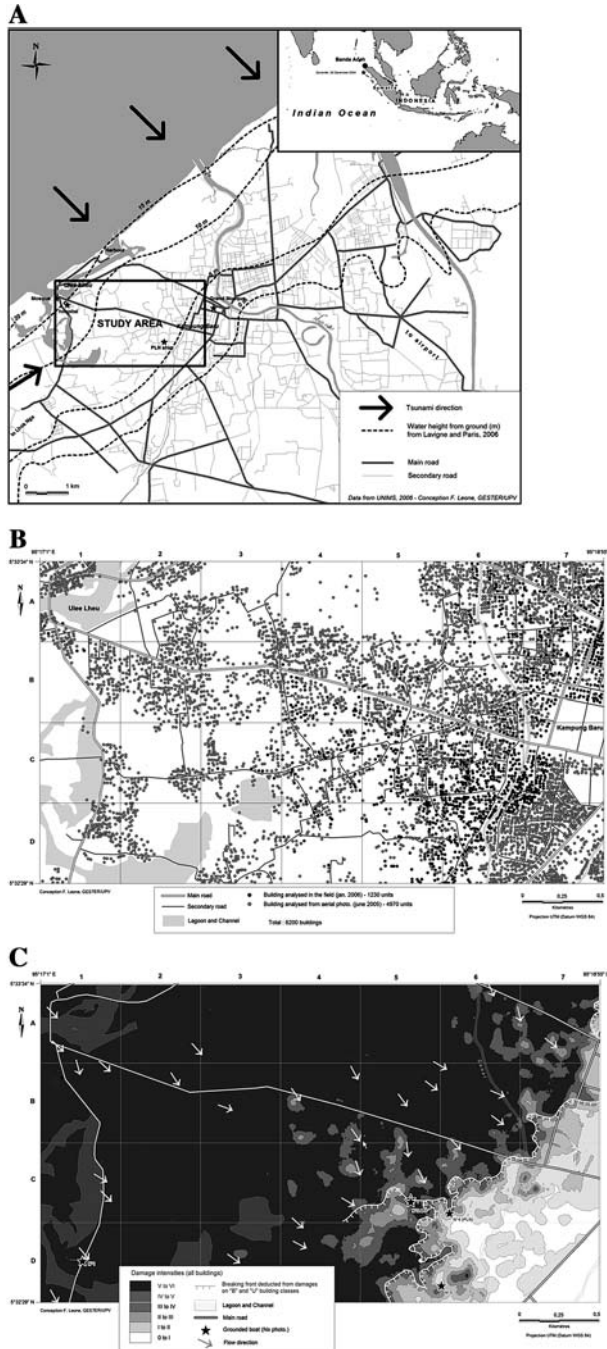
Investigation of tsunami-induced damage on building after the 26 December, 2004 tsunami. A. Studied area between Uleelheue and downtown Banda Aceh. B. Map of studied buildings. The selected area was divided in 25 ha squares. Within each square, the damaged building were precisely located using the freely available post-disaster high-resolution Quick Bird imagery (<http://www.digitalglobe.com>), and high resolution aerial photographs provided by Bakosurtanal (4970 units), from June 2005. C. Map of interpolated damage intensity for all building types (methodology and map conception: F. Leone).

The integration and interpolation of 6200 damaged buildings in a GIS enabled reconstitution of the damage gradient in the northwestern suburbs of Banda Aceh city (Table 1 and Fig. 7). Nearly all of the buildings suffered grade 5 damage (i.e., destruction/collapse) and only a few reinforced-concrete buildings (e.g., a big mosque, the hospital, and a school at Uleelheue) suffered very heavy structural damage (grade 4). No substantial to heavy damage (grade 3) has been observed. Artificial embankments collapsed, and big boulders from these embankments or from the near-shore sea floor were moved inland (e.g., 85 tons of coral boulders in Labuhan: PARIS *et al.*, 2007a). The tsunami also damaged port breakwaters, destroyed or washed away small vessels, and violently moved large vessels ashore. Figure 7c underlines a steep drop in the damage gradient around 2.7 km from the coast. Interestingly, four grounded boats are plotted exactly along the line of the bore's collapse, indicating a sudden drop in tsunami energy. This line was further refined using the Macro-tsunami intensity scale (Table 1). The final shape of the line outlines digitations that can be associated with different wave heights or roughness variations of the topography. However, such lobes that are drawn on Figure 7 are difficult to interpret owing to the complex dynamics of the tsunami within the town.
