The 11 March 2011 Tohoku Tsunami Survey in Rikuzentakata and Comparison with Historical Events

Key words: Tsunami survey, historical review, inundation, run-up, Rikuzentakata, Kesen River, Tohoku tsunami, Showa tsunami, Meiji tsunami, Chilean tsunami, tsunami control forest.

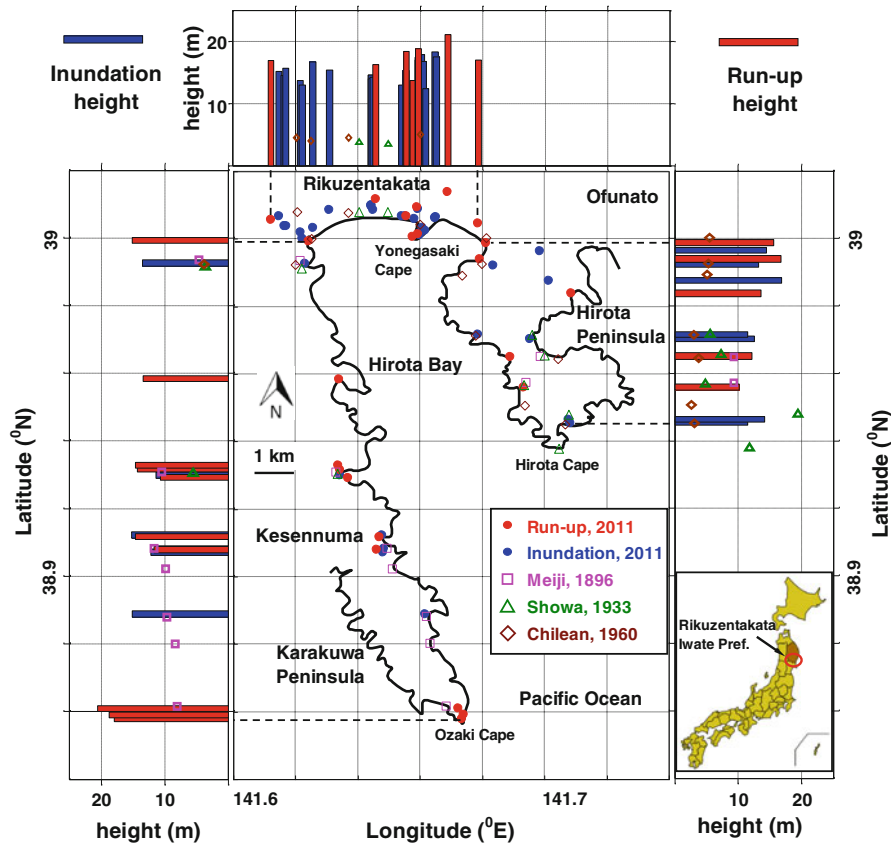
Figure 1

Tsunami survey results along the Hirota Bay. Bar graphs are for measured tsunami inundation (blue) and run-up (red) heights of the 2011 Tohoku tsunami, in which historical records of tsunami heights for the 1896 Meiji (magenta square), the 1933 Showa (green triangle) and the 1960 Chilean events (brown diamond) are also superimposed

The measured tsunami inundation and run-up heights along the shoreline of the Hirota Bay show a representative tsunami height of about 15 m (Fig. 1). Given the U-shape of Hirota Bay, the funneling effect (tsunami amplification in a V-shaped bay due to energy concentration) from the entrance to the head of the bay was widely absent. Relatively large run-up heights around rocky cape tips were detected, e.g., about 20 m at the Ozaki Cape and the Yonegasaki Cape. This is ascribed to the steep rocky coastlines and refraction effects of tsunami waves. The wave energy converged on the protruding capes, resulting in the locally high tsunami run-up.

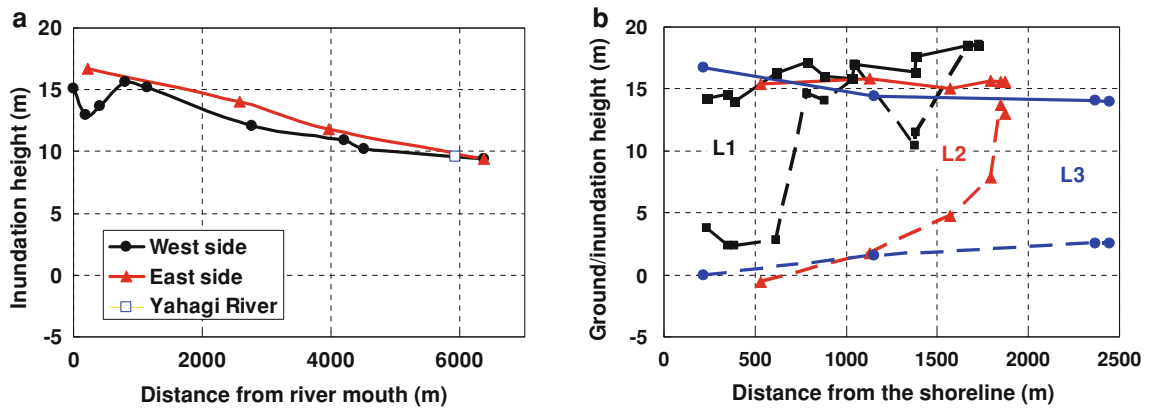
Figure 4

Overland tsunami height spatial distribution. **a** Tsunami inundation heights along both sides of the Kesen River, as well as the Yahagi River. **b** Measured tsunami height distribution (*solid lines*) and the corresponding ground elevation (*dashed lines*) along three cross-shore directional survey lines, *L1*, *L2* and *L3* indicated in Fig. 3

Figure 4a shows that the tsunami height is slightly larger on the east side of the Kesen River. The inundation height at the Yahagi River is almost the same as along the main river route in terms of the corresponding distance from the Kesen River mouth. With increasing tsunami upriver propagation, the tsunami height gradually decreases towards the river's upper reaches. The decay is almost linearly proportional to the travelling distance along the river route at a rate of 1 m/km. On the contrary, the tsunami heights gradually increase in the urban area along the survey line L1 as shown in Fig. 4b. This increase of tsunami heights from 14.5 m near the shoreline to 18.5 m at the run-up location is accompanied by an abrupt change in the topographic ground elevation. Along the survey line L2, the tsunami height remains relatively uniform at 15.5 m, while the topographic ground elevation gradually increases by 13.5 m along the survey transect. A decreasing trend is found along the survey line L3, which is adjacent to the Kesen River and follows the same trend as the tsunami height distribution along the river route (Fig. 4a). As for these three transects, the overland flow depth presented maximum values of

approximately 15 m near the shoreline, followed by landward decays. Considering the longshore variation in the inland area (more than 1,000 m away from the shoreline in Fig. 4b), the topographic ground elevations increase eastwardly from line L3 to line L1. The recorded tsunami heights also increased eastwards in accordance with the underlying topographic features along the WE direction.

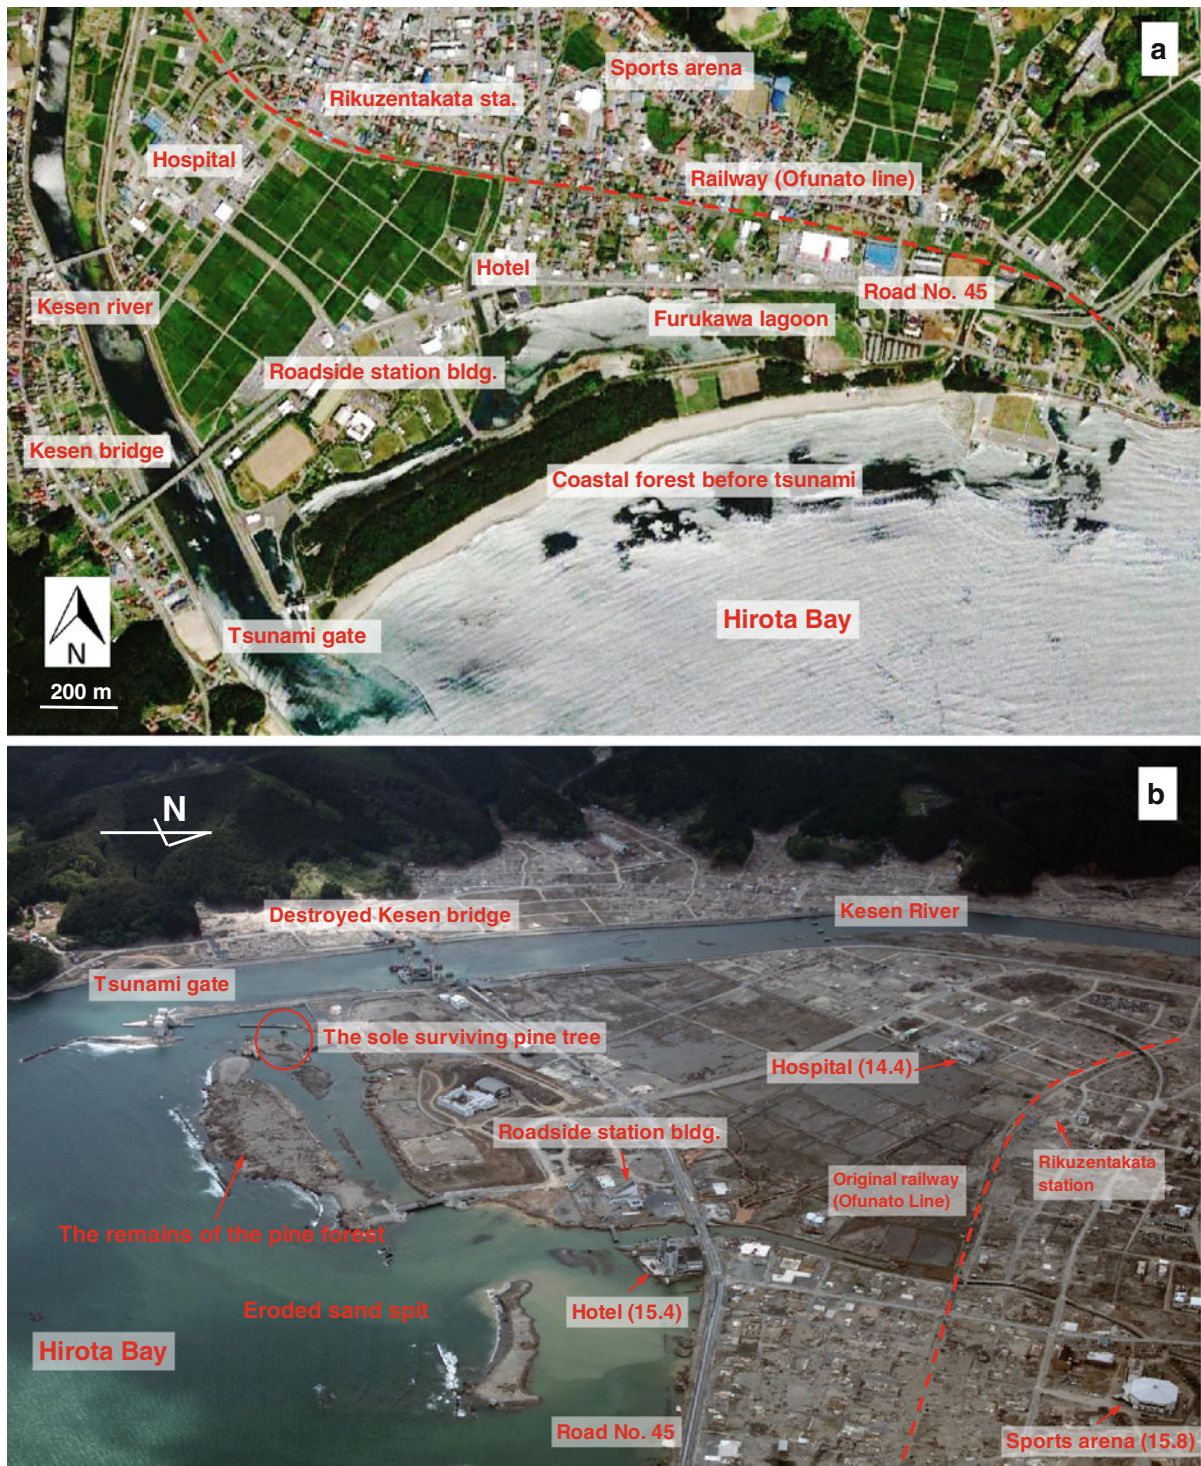
Comparison of the pre- and post-tsunami situations in Rikuzentakata. **a** Pre-tsunami satellite image of the city of Rikuzentakata. Image was recorded on 23 July 2010 (Photo credit: GeoEye). **b** Aerial photograph of the city of Rikuzentakata after the tsunami attack. Image was recorded on 25 May 2011 (Photo credit: Geospatial Information Authority of Japan). *Numbers in brackets indicate the measured tsunami inundation height at these locations. The dashed line represents the railway route of the Ofunato Line*

Figure 5 shows the pre- and post-tsunami situations in Rikuzentakata. Comparing with the satellite image recorded before the tsunami (Fig. 5a), an aerial post-tsunami photograph shown in Fig. 5b dramatically reveals the devastating tsunami destruction in Rikuzentakata. Most of the sand spit originally located at the east side of the Kesen River mouth was eroded after the tsunami attack. These sands were transported by the tsunami and may be deposited in the inland flood zone or washed into the bay by the subsequent tsunami outflow. For tsunami mitigation purposes, a coastal forest was planted and maintained over the past 300 years on the sand spit with more than 70,000 mature pine trees before tsunami onslaught as shown in Fig. 5a. This 2 km longshore tsunami control forest with a width of about 200 m was supposed to act similar to an artificial breakwater protecting the inland communities from storm waves and tsunami surges. Earlier studies pointed out the effectiveness of coastal forests at reducing coastal flooding due to the tsunami events and cyclone storm waves (SHUTO 1987; DANIELSEN *et al.* 2005; TANAKA *et al.* 2007; FRITZ *et al.* 2009). Unfortunately, the coastal forest in Rikuzentakata failed to protect the local residents this time. Almost all pine trees were washed away by the 15 m high tsunami wave and became floating debris impacting buildings as battering rams (Fig. 6d). The sole surviving pine tree highlighted in Figs. 5b and 6e, named “the tree of hope”, was regarded as a symbol of reconstruction by local residents. Accordingly, the conventional understanding of the tsunami mitigation provided by coastal forests should be re-evaluated, especially for such extreme tsunami events.

The 15 m high tsunami tore down all structures in Rikuzentakata except for several reinforced concrete buildings (Fig. 5), e.g., the seven-floor Capital Hotel, a building of the roadside station along the national road No. 45, the city's indoor sports arena and the

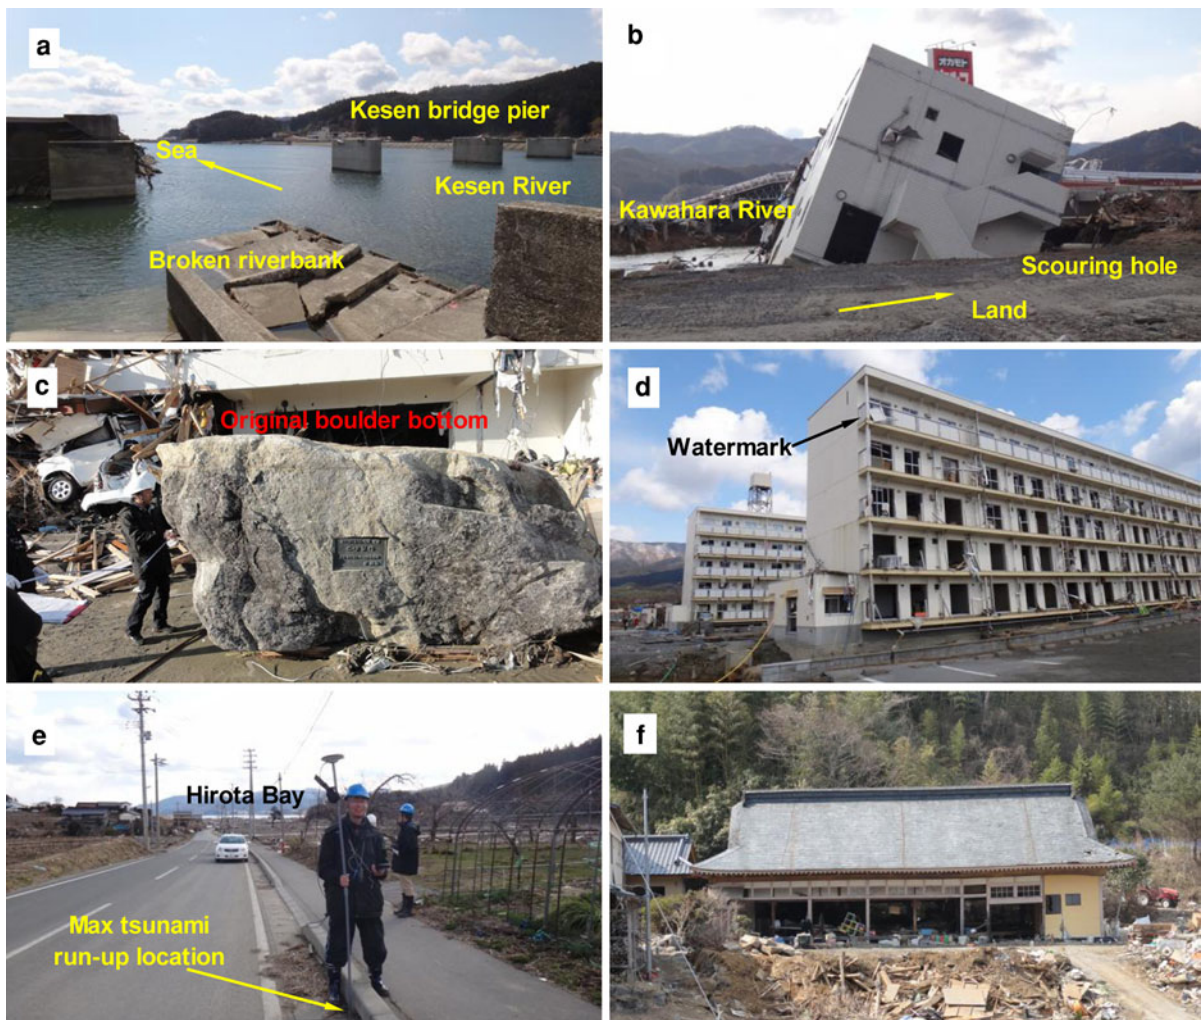
Figure 7

Post-tsunami field observation scenarios in Rikuzentakata. **a** Remaining piers of the Kesen Bridge and the broken riverbanks at location A. **b** A sunk building after tsunami outflow scouring next to the Kawahara River at location B. **c** A relocated and overturned boulder in front of the city's indoor sports arena at location C. **d** Tsunami inundation height and damages for two five-story buildings at location D. **e** A maximum tsunami run-up height at location E. **f** A damaged temple at location F (all locations are indicated in Fig. 3)

Here, we further select several representative locations to discuss post-tsunami observation scenarios in Rikuzentakata (Fig. 7). The Kesen Bridge, 0.66 km upstream from the river mouth, was completely submerged by the tsunami and destroyed with only bridge piers remaining after the event (Fig. 7a, also Fig. 5b). Overflow of the collapsed riverbanks was also confirmed. In Fig. 7b, significantly oblique subsidence of a two-story building occurred due to the tsunami outflow scouring as the water funneled to the low-elevation channels, such as the Kawahara River which has no high riverbank. Severe damage caused by the tsunami outflow was demonstrated here although earlier studies assumed small outflow velocities (IMAMURA *et al.* 2008; FURUMURA *et al.*

2011). In our field survey, a relocated and overturned boulder was found deposited in front of the city's indoor sports arena (Fig. 7c). This giant granite boulder has a dimension of 3.6 m (length) \times 2.0 m (height) \times 2.1 m (width), and was transported 35 m inland from its original location. Further landward boulder movement could be expected without impediment from the sports arena. Such boulder transport by tsunami waves has been widely reported (KATO and KIMURA 1983; NOTT 2003; FROHLICH *et al.* 2009). Figure 7d shows the post-tsunami situation of two five-story buildings located 360 m inland from the shoreline. All the balcony fences below the fifth floor of the seaside front building were broken and the measured local inundation height is 14.6 m. In contrast, damage on the landward second building was minor with even most balcony fences remaining intact. These striking differences in post-tsunami damage levels are attributed to the protective role provided by the front building. Figure 7e illustrates a detected tsunami run-up point, marked by a roadside wrackline, located 1.7 km inland from the shoreline with a local ground elevation of 18.5 m corresponding to a run-up height. Figure 7f shows that an ancient temple which safely survived aforementioned three historical tsunami disasters according to local residents, was destroyed by the 2011 event. Eyewitness interviews revealed that a number of residents attempted to evacuate to such ancient temples and shrines to seek shelter from the tsunami based on their ancestral experience, which proved to be life saving in the 2007 Solomon Islands tsunami (FRITZ and KALLIGERIS 2008). Unfortunately, the extreme tsunami caused unexpected fatalities at such tsunami shelters this time.
