Effects of Inundation by the 14th November, 2016 Kaikōura Tsunami on Banks Peninsula, Canterbury, New Zealand

Abstract—At 12:02:56 a.m. Monday, November 14 2016 NZDT (11:02:56 a.m., November 13 2016 UTC) a magnitude 7.8 earthquake struck near Kaikōura on the north-eastern coast of the South Island of New Zealand. This earthquake caused a tsunami along New Zealand's east coast that was recorded on a number of sea level gauges. Outside of the Kaikōura region, north facing bays along Banks Peninsula were most affected by the tsunami. Of these, Little Pigeon Bay experienced extensive inundation and an unoccupied cottage was destroyed by the wave run-up. We report on the inundation extent and (inferred) flow directions at Little Pigeon Bay, including a study on temporal changes in the field evidence of this inundation. Preliminary modelling results indicate that the waves may have excited resonance in the bay. We also present results from inundation surveys of nearby, north-facing bays on Banks Peninsula. The excitation of resonance in Little Pigeon Bay provides an explanation for the more severe inundation and damage there in comparison to these nearby bays.

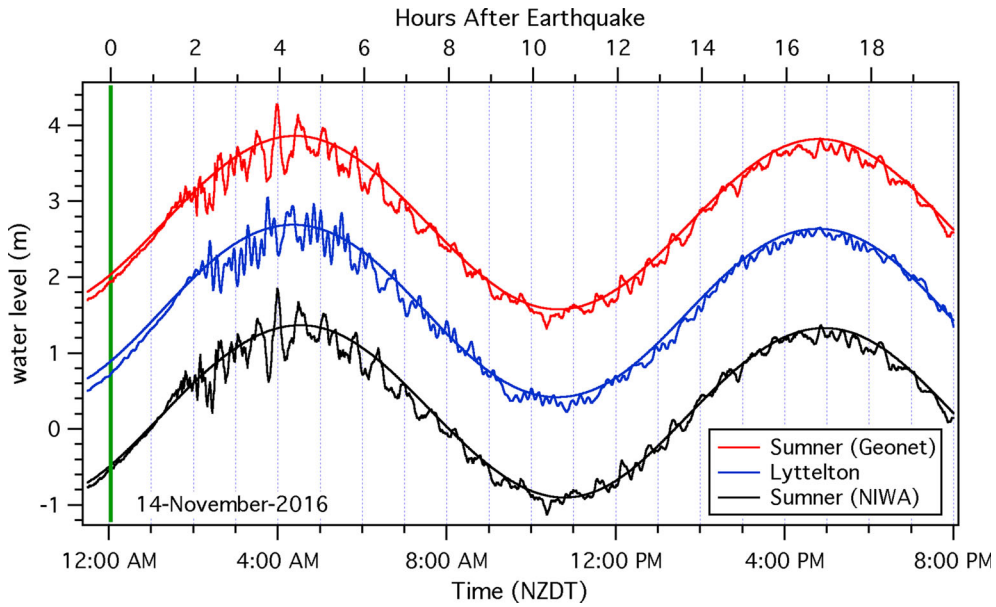
Figure 2

Predicted tide (*smooth curve*) and recorded raw water levels on the three Christchurch area tide gauges showing the effects of the Kaikōura tsunami. The NIWA Sumner gauge zero is LVD37 (0.41 m below NZVD2016), the Lyttelton and GeoNet Sumner gauges have been offset for plotting. *Vertical green line* is the earthquake origin time

Inspection of the raw data from the Sumner gauge (Fig. 2) shows the first signs of the tsunami around 1 h 15 min after the earthquake (around 1:15 a.m.) approximately midway through the rising tide. Prior to the tsunami, the water level at the Sumner gauge was close to the predicted tide level, with no measurable storm surge effect. The raw tide gauge data show a prolonged first surge lasting around 30 min before more rhythmic water surface fluctuations appear ultimately culminating in the largest oscillations between 3:00 a.m. and 5:00 a.m. (3–5 h after the earthquake). The highest absolute water level reached during the tsunami was +1.85 m relative to the Lyttelton Vertical Datum 1937 (LVD37) at 3:59 a.m. (+1.44 m above New Zealand Vertical Datum 2016 (NZVD2016)), approximately 30 min before high tide. Over the next several hours, regular oscillations continued as the amplitude gradually diminished.

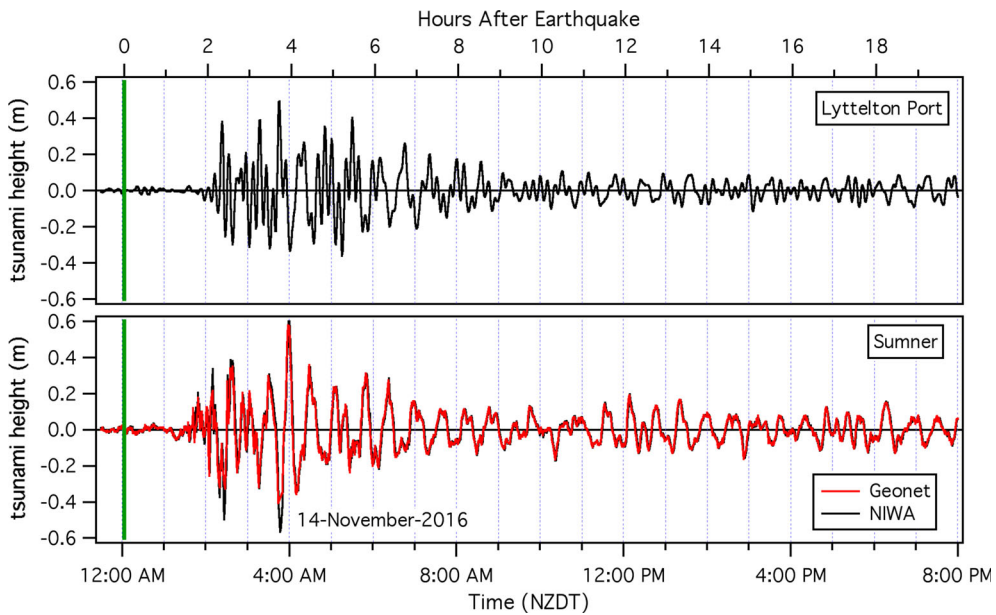
Figure 3

Filtered tide gauge records for Lyttelton Port (*top*) and Sumner (*bottom*) gauges

To obtain a clearer picture of the tsunami signal, the raw tide gauge record was filtered to remove the effect of tide and other factors (i.e., wind and pressure effects) that cause fluctuations in the water surface. Data from the three tide gauges were processed identically using methods described in Goring and Henry (2007) and Goring (2008) and presented in Fig. 3. In this filtered record, the prolonged first surge seen on the raw Sumner record is not as prominent. The delay in arrival of the first surge between the Sumner gauges and the Lyttelton one is evident and occurs as a result of the additional travel time necessary for the tsunami to propagate up Lyttelton Harbour. From the Sumner records it is apparent that the two instruments recorded nearly identical water level data with the NIWA gauge recording slightly larger peaks and troughs. The maximum wave amplitude (Zero to Peak) at Lyttelton was +0.49 m around 3:45 a.m., while at Sumner it was +0.63 m at 3:59 a.m.

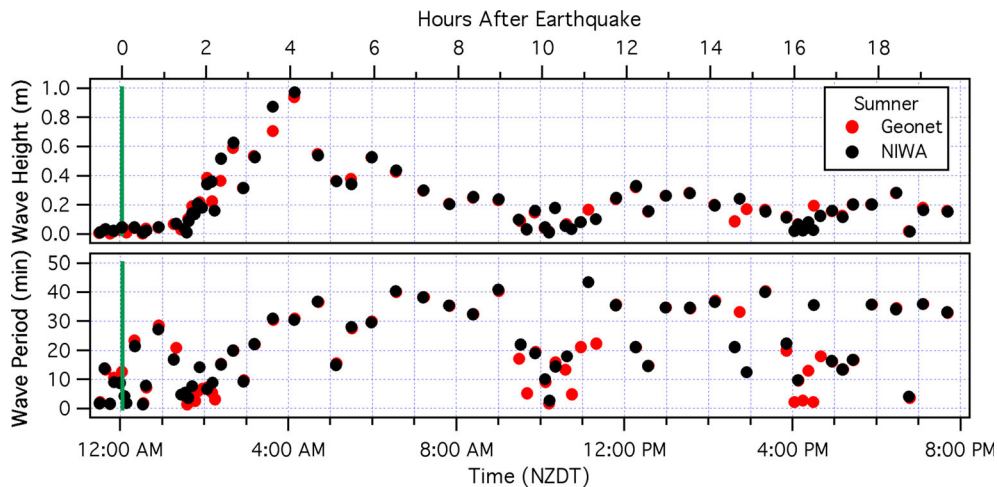
Figure 4

Wave height (peak-to-trough) (*top*) and wave period (*bottom*) of individual tsunami wave cycles from the two Sumner gauges. Vertical green line is the earthquake origin time

2007) on the filtered long-wave record was then used to determine the height and period of individual wave oscillations (Figs. 4, 5). On both the

Sumner and Lyttelton gauges there was some long wave energy present prior to the tsunami arrival—apparent from the presence of waves with 10–30 min periods seen on all three records. However, the heights of these wave cycles were small, on the order of <math>< 5\text{ cm}</math>. As the tsunami arrived (at approximately 1:15 a.m. at Sumner and 1:30–2:00 a.m. at Lyttelton Port), the wave heights steadily increased along with the wave periods peaking at approximately 4:00 a.m. NZDT.

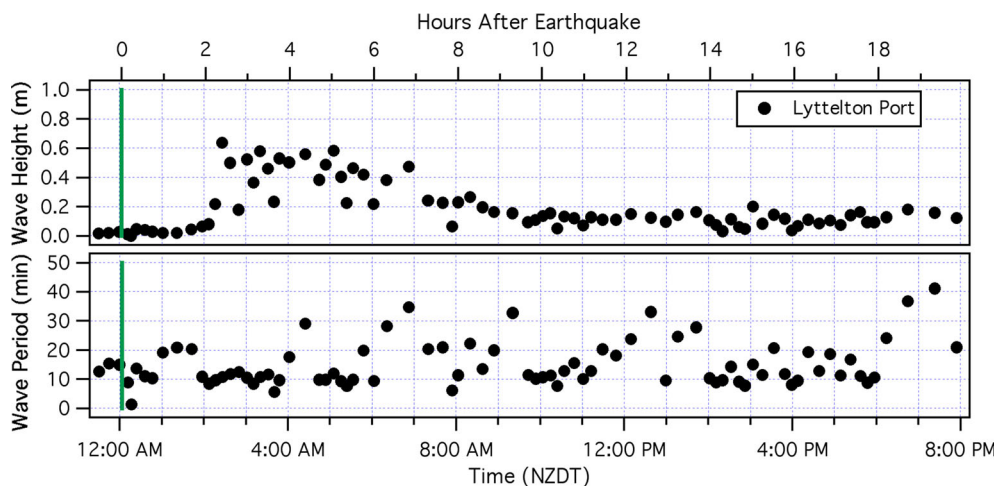
Figure 5

Wave height (peak-to-trough) (*top*) and wave period (*bottom*) of individual tsunami wave cycles from the Lyttelton Port gauge. Vertical green line is the earthquake origin time

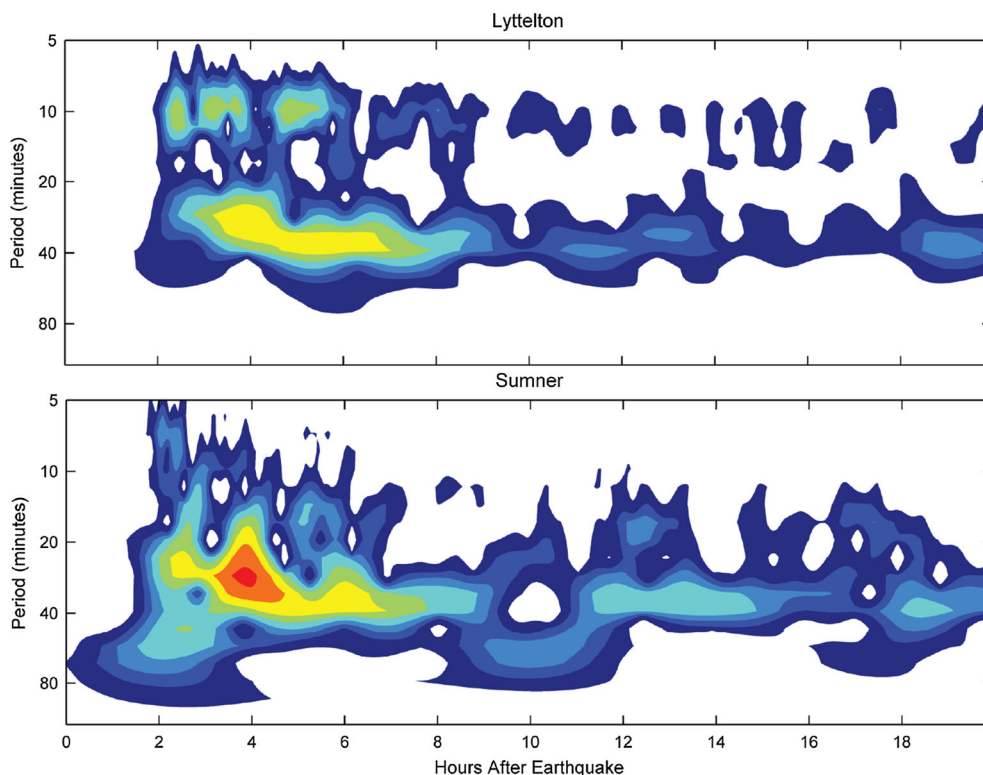
Figure 6
Wavelet spectrogram of the filtered Lyttelton (*top*) and Sumner (*bottom*) tsunami time series

The wavelet spectrogram presented in Fig. 6 shows the presence of both the longitudinal (~ 40 min) and transverse (~ 10 min) Lyttelton Harbour seiche and confirms the zero crossing analysis presented above. The peak in tsunami energy can be clearly seen approximately 4 h after the earthquake (around 4:00 a.m.). Notably, this local Kaikōura tsunami did not excite the Pegasus Bay seiche which is the fundamental mode of shelf resonance in the Canterbury Bight with a period of 205 min (Goring and Henry 1998). While there was some energy at this frequency on 14 November 2016,

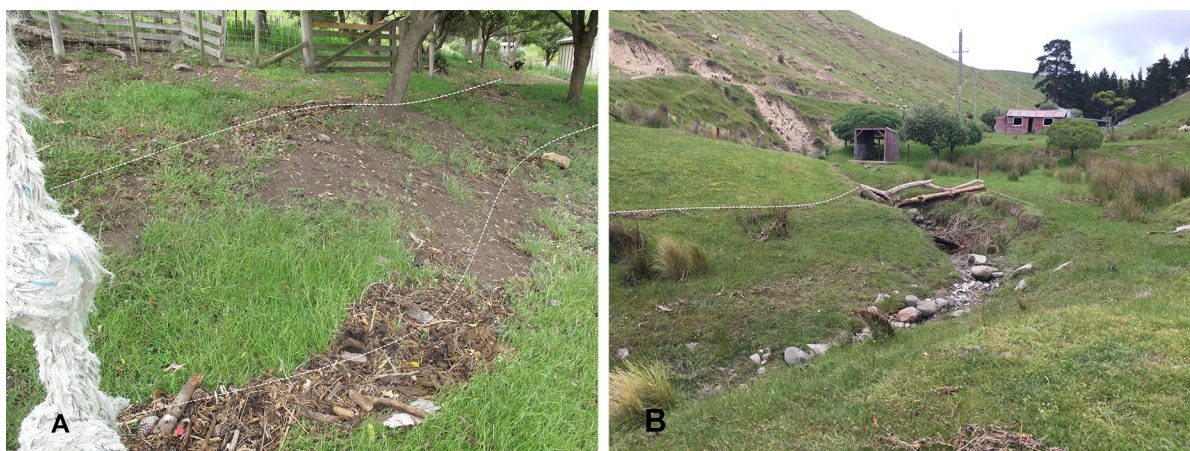
Figure 7

Inundation indicators (*white dashed lines*): **a** upper and lower inundation lines indicated by organic debris (16 November 2016, photo: William Power). **b** Logs at the bend in the stream were transported upstream by the tsunami. The inundation line can be seen on the far side of the stream (14 November 2016, Photo: Penny Aitkens)

On Wednesday 16 November, two inundation lines were visible, as outlined by rafted seaweed and organic debris (Fig. 7). Dead fish, crayfish (*Jasus edwardsii*), kina (*Evenchinus chloroticus*) and paua (*Haliotis iris*) shells were scattered over the grass. Seaweed was caught up in trees, fences and the house foundations. The macrocarpa (*Cupressus macrocarpa*) wind-break showed a clear inundation line of small seaweed floats, twigs and debris caught up in the branches as the water strained through it. The front and sides of the house were covered in tsunami “speckle” (small pieces of seaweed and organic material spattering the walls). On the seaward side of the house it reached the underside of the veranda roof (approximately 5 m above NZVD2016). As the day progressed and the sun warmed the building, the “speckle” fell off the newer weatherboards but remained attached to the cooler sides of the house that were sheltered from the sun.

Large cut sections of tree trunks that had been lying on the beach were transported inland by the tsunami. One came to rest after pushing in the door of the shed behind the house (Fig. 8), while others hit the house or were washed out into the bay by the backwash. One large tree trunk was lodged in seafloor sediments partway out into the bay. A power pole was also picked up and deposited 5 m inland from its original position (Fig. 8). The veranda was ripped off the side of the house and deposited on the beach, floating away on the subsequent high tide. It was retrieved and moored to nearby trees by the land-owners. Two logs with diameters of 20 and 40 cm

were also deposited in the streambed up to 120 m inland (Fig. 7).

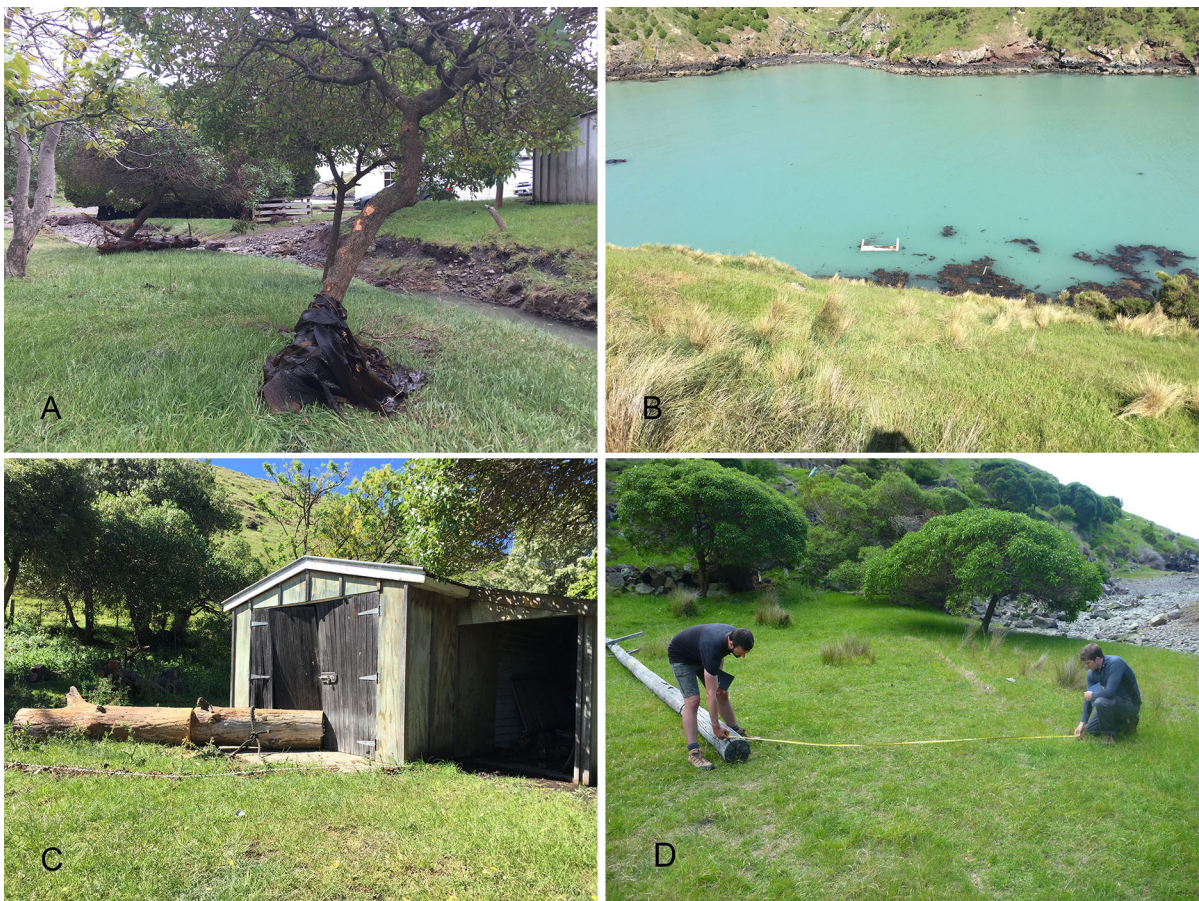
Figure 8

Inundation indicators: **a** logs and seaweed deposited by the tsunami (14 November 2016, Photo: Penny Aitkens). **b** Veranda and other tsunami debris floating in the bay after the tsunami (14 November 2016, Photo: Penny Aitkens). **c** Log battering ram (in photo it has already been cut in two for transporting, and had been moved by the time of the first survey). The *lower inundation line* (see also Fig. 9) can be seen below the log (*white line*) (14 November 2016, Photo: Penny Aitkens). **d** Power pole that was moved by tsunami (16 November 2016, photo: William Power)

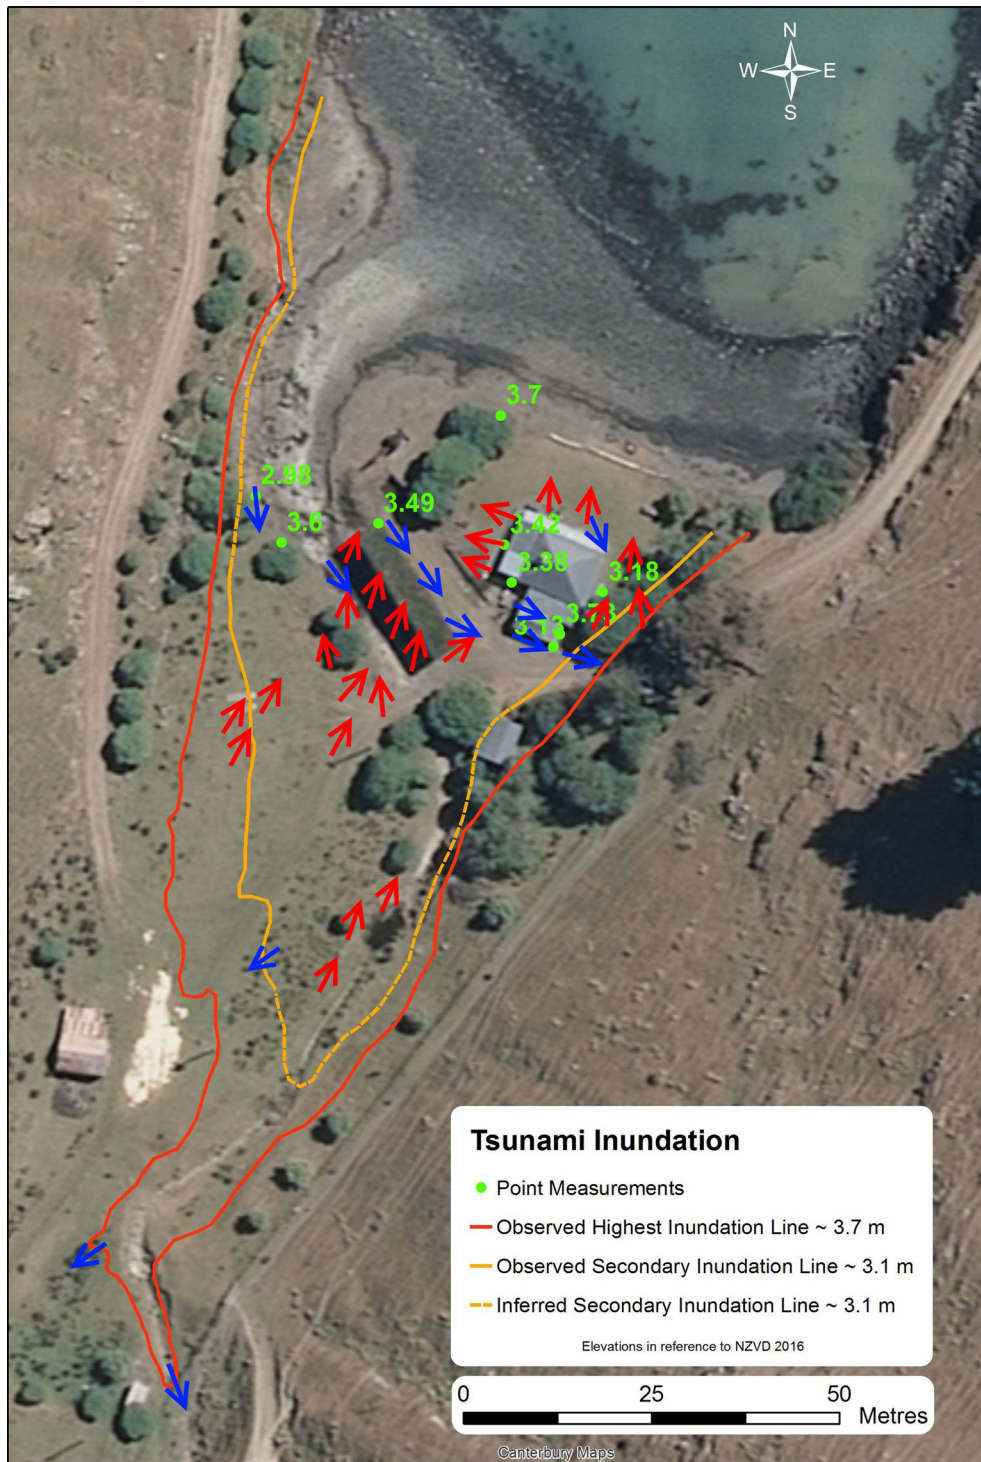
Map of tsunami inundation lines; point measurements of minimum tsunami inundation heights, relative to NZVD2016 and flow indicator directions (*blue* as inferred uprush and *red* inferred backwash). Note that the run-up distance in the streambed is at the fence, where seaweed was found—seawater may have inundated slightly further inland but no debris evidence was apparent as it was strained out in the fence.

Figure 9 shows the two inundation lines, in addition to point measurements of minimum inundation heights inferred from seaweed, inundation lines on outside walls of the cottage and other debris markers. The highest run-up distance/maximum limit of inundation is 140 m inland with a run-up height of 3.7 m above NZVD2016. This is approximately 28 cm above current mean sea level at the nearby Sumner sea level gauge (Reeve and Bell 2013). A second inundation line reached about 100 m inland, with a run-up height of 3.1 m above NZVD2016. Both of these inundating waves would have affected the cottage and the lower wave necessarily came after the first that would have removed evidence for any earlier, smaller waves.

Imbricated rocks, flattened grass, rafted material, seaweed and other debris caught in fences, trees and house foundations indicated several flow directions. Arrows show these flow directions in Fig. 9; blue arrows denoting inferred uprush and red arrows denoting inferred backwash. Imbricated rocks in the streambed near the macrocarpa wind-break indicate that water travelled up the streambed

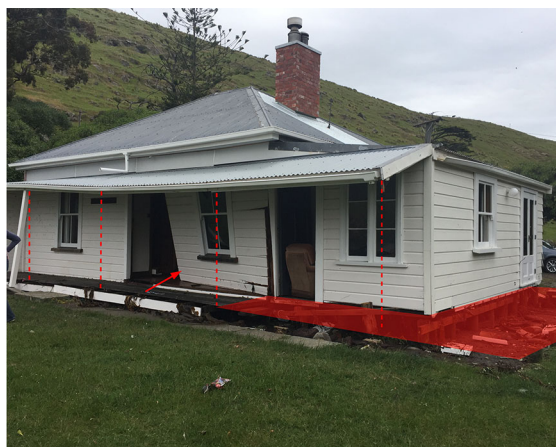
Figure 10

Damage observations from the northern (seaward) side of the cottage, showing the deck removed by the uplift forces (*shaded area*), the veranda poles removed or displaced (*dotted lines*) and the location of debris impact on the wall and door (*arrow*) (14 November 2016, photo: Penny Aitken)

The cottage at Little Pigeon Bay sustained heavy damage during the tsunami. The three primary causes of damage were uplift forces, debris impacts and sediment deposition. Uplift forces completely removed the veranda along the western side of the cottage, and part of the northern veranda (this was never recovered). The western end of the cottage was also lifted approximately 5 cm from its foundations. Debris impacts destroyed veranda posts on the seaward side of the cottage, removed the front door and displaced several of the walls inwards. The maximum wall displacement due to debris impact was approximately 70 cm adjacent to the front door. The tsunami deposited sediment on the floor of every room of the cottage, with finer material plastered on the walls providing a clear indication of internal inundation (and/or splash) levels. Damage on the northern (seaward) side of the cottage can be seen in Fig. 10.

The water marks and damage to the cottage provide useful data to support the inundation height and direction observations obtained from the inshore debris deposits. Figure 11 shows a water mark measured in the bathroom of the house. However, depending on their location, the water marks were also caused by splashing (where the water met a vertical wall) or sloshing (in some of the rooms). The external water marks were measured at 3.42, 3.38, 3.13 and 3.73 m above NZVD2016 (see point measurements in Fig. 9). These inundation height observations are supported by the survey of the upper debris line further inland, approximately 3.7 m above NZVD2016. Based on the observed damage (and local topography) the tsunami appears to have impacted the cottage from the north (seaward side—the shortest path to the cottage) and west (following the streambed onshore). The largest debris impacts were sustained from these two directions. The eastern side of the cottage also sustained debris impact during backwash.

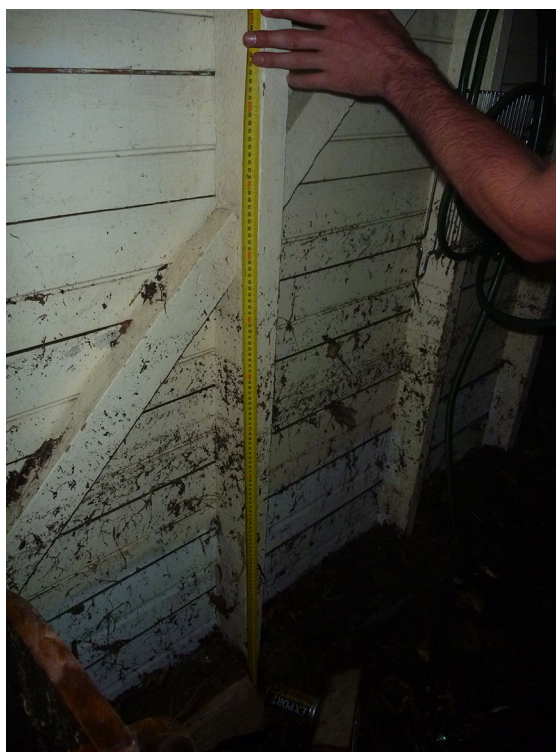
Figure 11

Internal water mark in the bathroom approximately 1.0 m above the floor, along with significant sediment deposition on the floor (photo: James Williams)

The tsunami deposited sediment and fine debris on the walls and floors of every room. Although the most severe damage was caused by uplift forces and debris impacts, the wetting and sediment deposition ruined most of the furniture within the house. Detailed observations of the damage to the cottage will support the calibration of physical and numerical models of the event, in addition to contributing to research on the development of fragility curves for wooden buildings under tsunami inundation. These

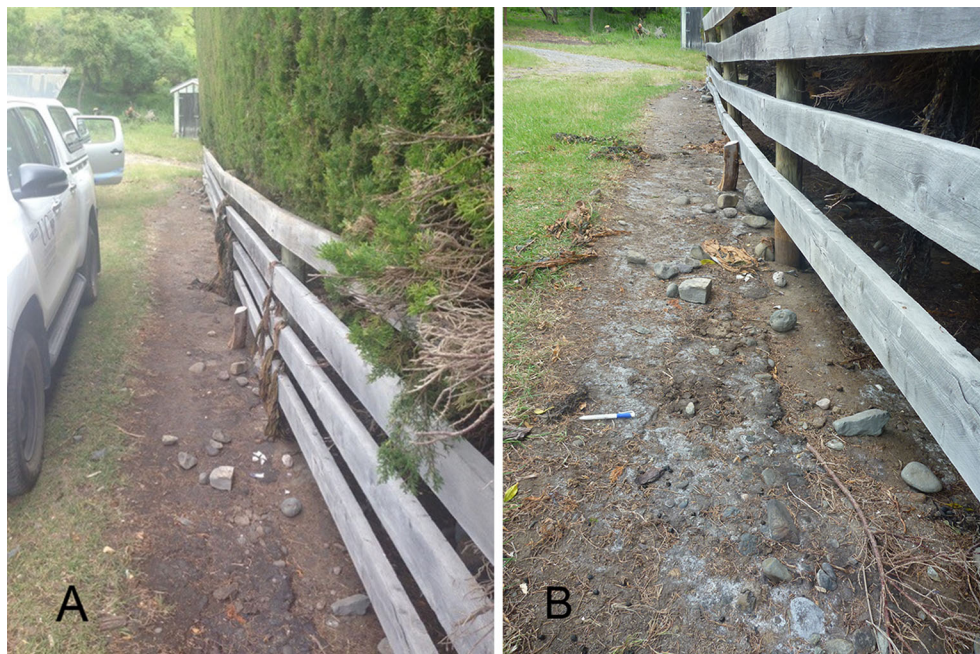
Figure 12

Comparative pictures of bare earth in front of the macrocarpa wind-break. **a** Taken on 19 November 2016. **b** Taken on 30 November 2016. The larger rocks and wooden post can be used as reference points as they have not moved between the two photos. The salt crust was not visible directly after the tsunami (**a**) but is clearly visible 16 days after the event (**b**) (photos: Jose Borrero and Emily Lane)

The most striking change over the visits to the site was the occurrence of salt crusts on the third visit (16 days after the event). They were observed in front of, and under the macrocarpa wind-break (Fig. 12), on the streambank and walls of the streambed (Fig. 13). These salt crusts had not been observed during the first two visits, and are attributed to evaporation and capillary action due to temperature and/or wind. Similar crusts have been previously reported following large tsunamis (e.g., Chagué-Goff et al. 2012). In Japan, extensive salt crusts were observed, two months after the 2011 Tohoku-oki tsunami, despite being subject to 60 mm of precipitation (Chagué-Goff et al. 2012); or one year later in areas that were inundated by seawater for 3 months (Chagué-Goff et al. 2014). Here, the high

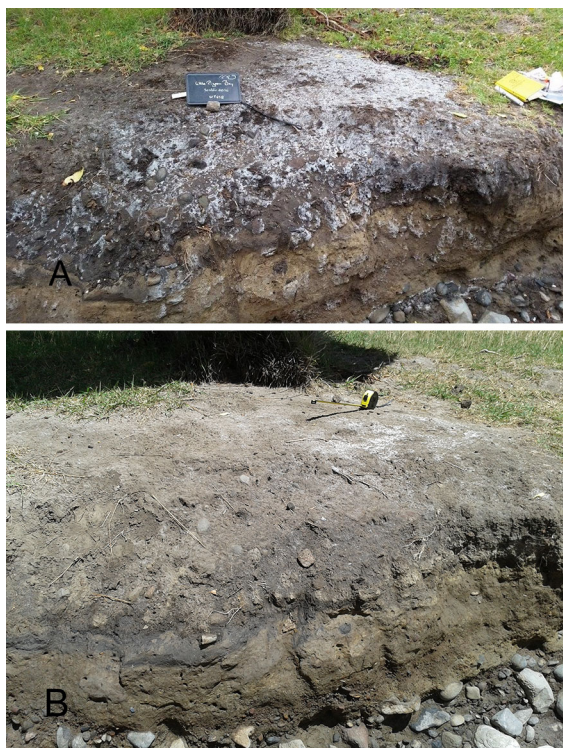
Figure 13

Salt crust on the bank and side of the stream. **a** 30 November 2016 (photo: Catherine Chagué-Goff). **b** 15 January 2017 (photo: Emily Lane). Note that the salt crust was observed in areas partly protected from rainfall by the tree canopy. By mid-January all the salt crust on the side of the stream had washed away, and only a poorly defined crust was still visible under the tree (**b**)

the vertical face (Fig. 13b). Likewise it was visible underneath the macrocarpa wind-break where it was sheltered from the rain but not around the more exposed front section. In both places it was far less striking in colour and extent. While there was still some evidence of tsunami inundation, the extent was harder to determine.

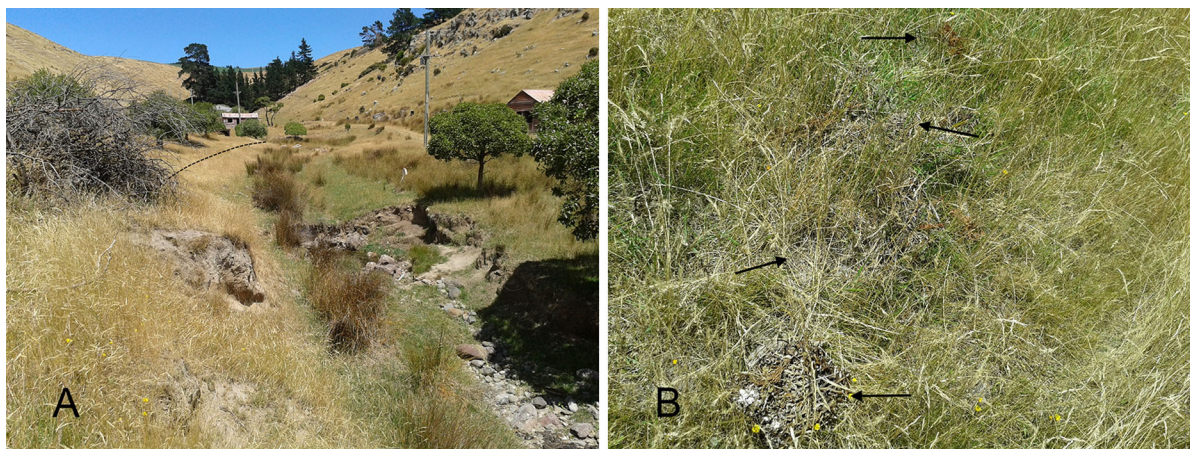
Figure 14

15 January 2017. **a** Any grass die-back that might have occurred was masked by the long golden grass seed heads (*Rytidosperma clavatum*) equally apparent above and below the inundation line (black line). **b** Tsunami debris (black arrows) hidden in the long grass (*Rytidosperma clavatum*) (photos: Emily Lane)

By 15 January 2017 (62 days after the tsunami), while the grass was noticeably sparser than observed on previous visits, there was no marked difference between the grass that had and had not been inundated. This was likely due to heavy summer rains (the Akaroa gauge measured 137 mm of rain since the tsunami—mostly in 3 events) and the growth of long golden grass seed heads (*Rytidosperma clavatum*) masking any further grass die-back that might have been observed. Tsunami debris was still visible in the grass, especially around the house. While individual debris piles could still be seen along the inundation line, they were no longer obviously a linear feature demarking the inundation limit, again in part due to the long grass with dried seed heads (*Rytidosperma clavatum*) that had grown up (Fig. 14). The salt crust that had been so apparent on 30 November 2016 was still weakly visible directly under a tree on the streambank but not on

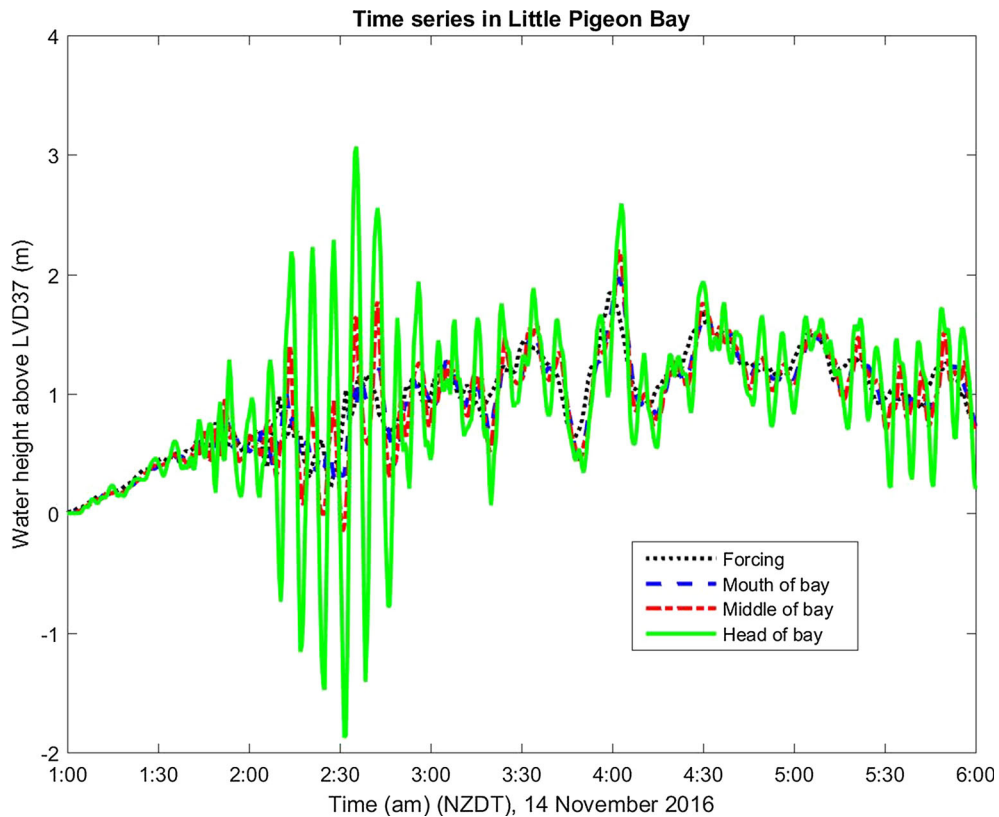
Figure 16

Preliminary modelling of Little Pigeon Bay showing tsunami forcing (Summer tide gauge from 1 a.m. to 6 a.m., 14 November 2016—cf. Fig. 2) and response at the mouth, middle and head of the bay. A strong resonance at the fundamental mode can be seen at the middle and head of the bay

tide gauge reading from the Sumner gauge starting at 1 a.m. when the gauge crossed 0 m above LVD37 (0.4 m below NZVD2016). This modelling revealed a strong fundamental resonance signal along the bay between the head and the small peninsula on the western edge at a period of about 400 s (Fig. 16). This resonance was particularly noticeable between 2:15 a.m. and 3:00 a.m. In the model output, the two waves that arrived around 2:30 a.m. inundated further than the later waves at 4:00 a.m. and 4:30 a.m. The latter were the largest waves measured at the Sumner gauge. Interestingly these later waves did not excite a strong resonant response. The zero-crossing analysis in Fig. 4 shows waves with periods of around 7 min coming in around 2:00 a.m. while later waves tended to have longer periods. Approximating the expected period of the signal following Rabinovich (2009), and assuming a triangular bay with a linearly sloping bottom (see Table 9.3 in Rabinovich 2009) with a length of 1500 m and a depth at mouth of 16 m, gives a wave period of 396 s. Likewise calculation of the modes based on cross-sections along the thalweg of the bay (Wilson 1972) give a fundamental mode of 403 s. These both correlate strongly with the modelled oscillation period. Figure 17 shows snapshots from the maximum modelled water excursion around 2:30 a.m. and the fundamental mode oscillation. The maximum water level predicted by the model (Fig. 17c) reproduces well the observed inundation. Water draining out the stream can be seen during the water minima (Fig. 17a, d) and an eddy off the small headland can be seen in Fig. 17d.
