## The 8 September 2017 Tsunami Triggered by the $M_w$ 8.2 Intraplate Earthquake, Chiapas, Mexico

**Key words:** Post-tsunami survey,  $M_w$  8.2 intraplate earthquake, Mexican subduction, runup, tsunami early warning.

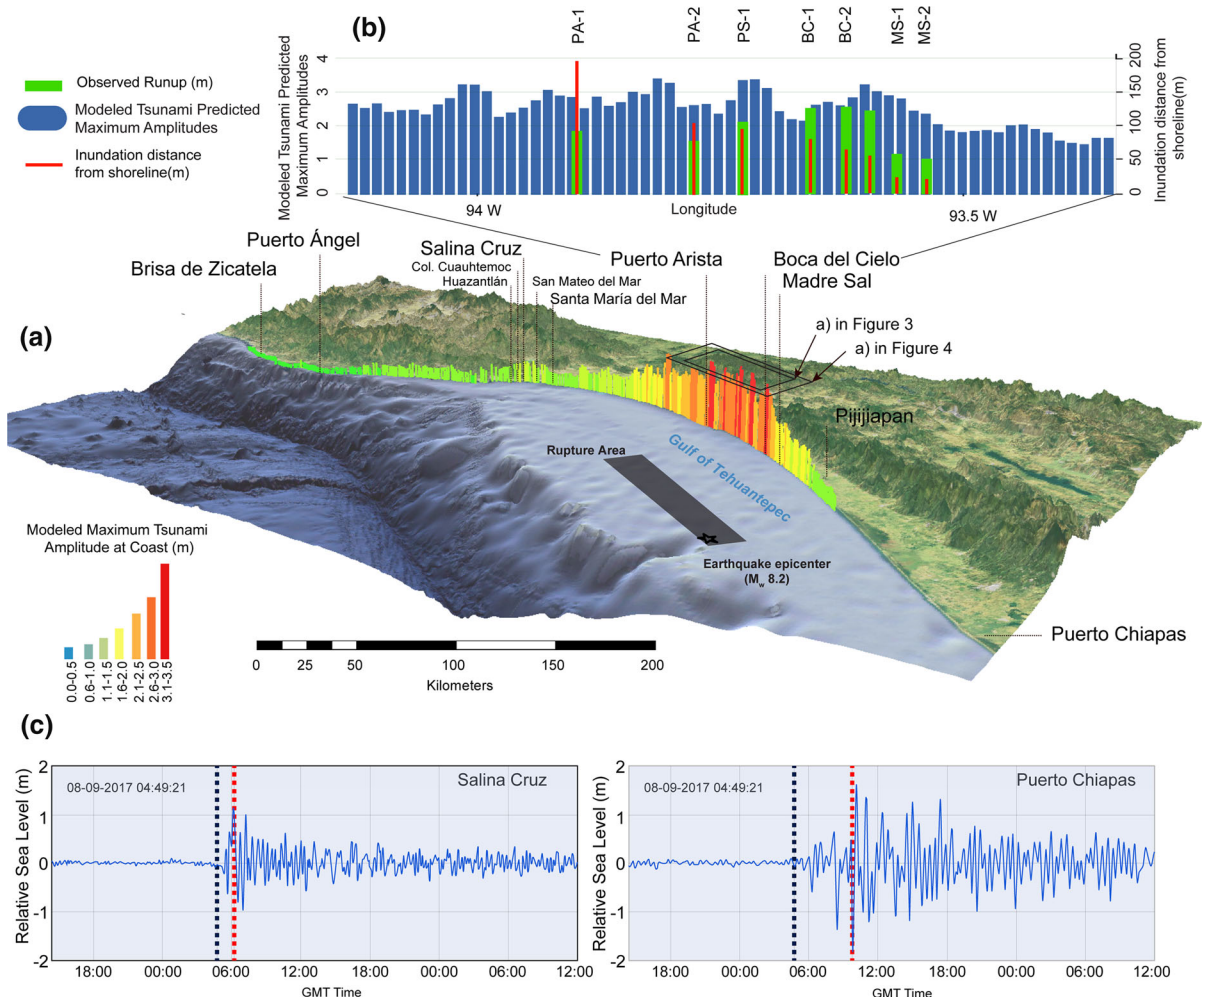
Figure 2

8 September 2017 observed tsunami runup, inundation distance, and modeled maximum amplitude at Chiapas coast. **a** 3D-bathymetry of the subducting Cocos plate and the North America plate along the trench; colored columns show maximum modeled tsunami amplitudes at coast; **b** surveyed sites show observed runup (green), inundation distances (red) and maximum modeled tsunami amplitudes at coast (blue); **c** tide gauge data at Salina Cruz and Puerto Chiapas stations (tidal signal removed); time of earthquake—dashed black line; time of maximum amplitude at stations—dashed red line

that the maximum amplitudes of the tsunami were between  $-94.5$  and  $-93.0$  W (Fig. 2). Following this tsunami model, we selected sites for measurements.

The associated tsunami wave propagated radially away from the source and was recorded first at Salina Cruz tide gauge station at 05:13 (GMT) and at 05:25 (GMT) at Puerto Chiapas (Fig. 2).

Tide level at SC and PCh before the arrival of the first tsunami wave was low 0.37 m below sea level at 5:14:2 (GMT) and 0.42 m at 5:27 (GMT), respectively, on 8 September 2017. It is noteworthy mentioning that low tide was present ( $-0.39$  m average of SC and PCh stations) at the time of the first tsunami arrival. The maximum measured runup using debris marks was  $\sim 3$  m at Boca del Cielo, and maximum inundation distance measured from the shoreline (as shown in Fig. 3f, Table 1) was 190 m in Puerto Arista, corresponding to the coast opposite the epicenter and in the central sector of the Gulf of Tehuantepec (Fig. 2). Runup values tended to decrease toward the southeast, except for PCh, where the first waves were not the highest and the maximum amplitude was reported by tide gauge data as 2.34 m (Fig. 1). In general, our field data agree with the predicted results from the preliminary tsunami model. However, tide gauge signal suggests 2.38 m above mean sea level maximum wave level at 09:50 (GMT), i.e., 5 h later than the arrival of the first tsunami wave, at the PCh station (Fig. 2). The tsunami event and related sea perturbations lasted nearly 48 h.

We collected information regarding the tsunami early warning system as part of eyewitness interviews during the post-tsunami survey. We asked locals in each town of the surveyed area (8 villages, Fig. 2) about their reaction during and after the earthquake and if they received an official warning of evacuation prior to the tsunami.

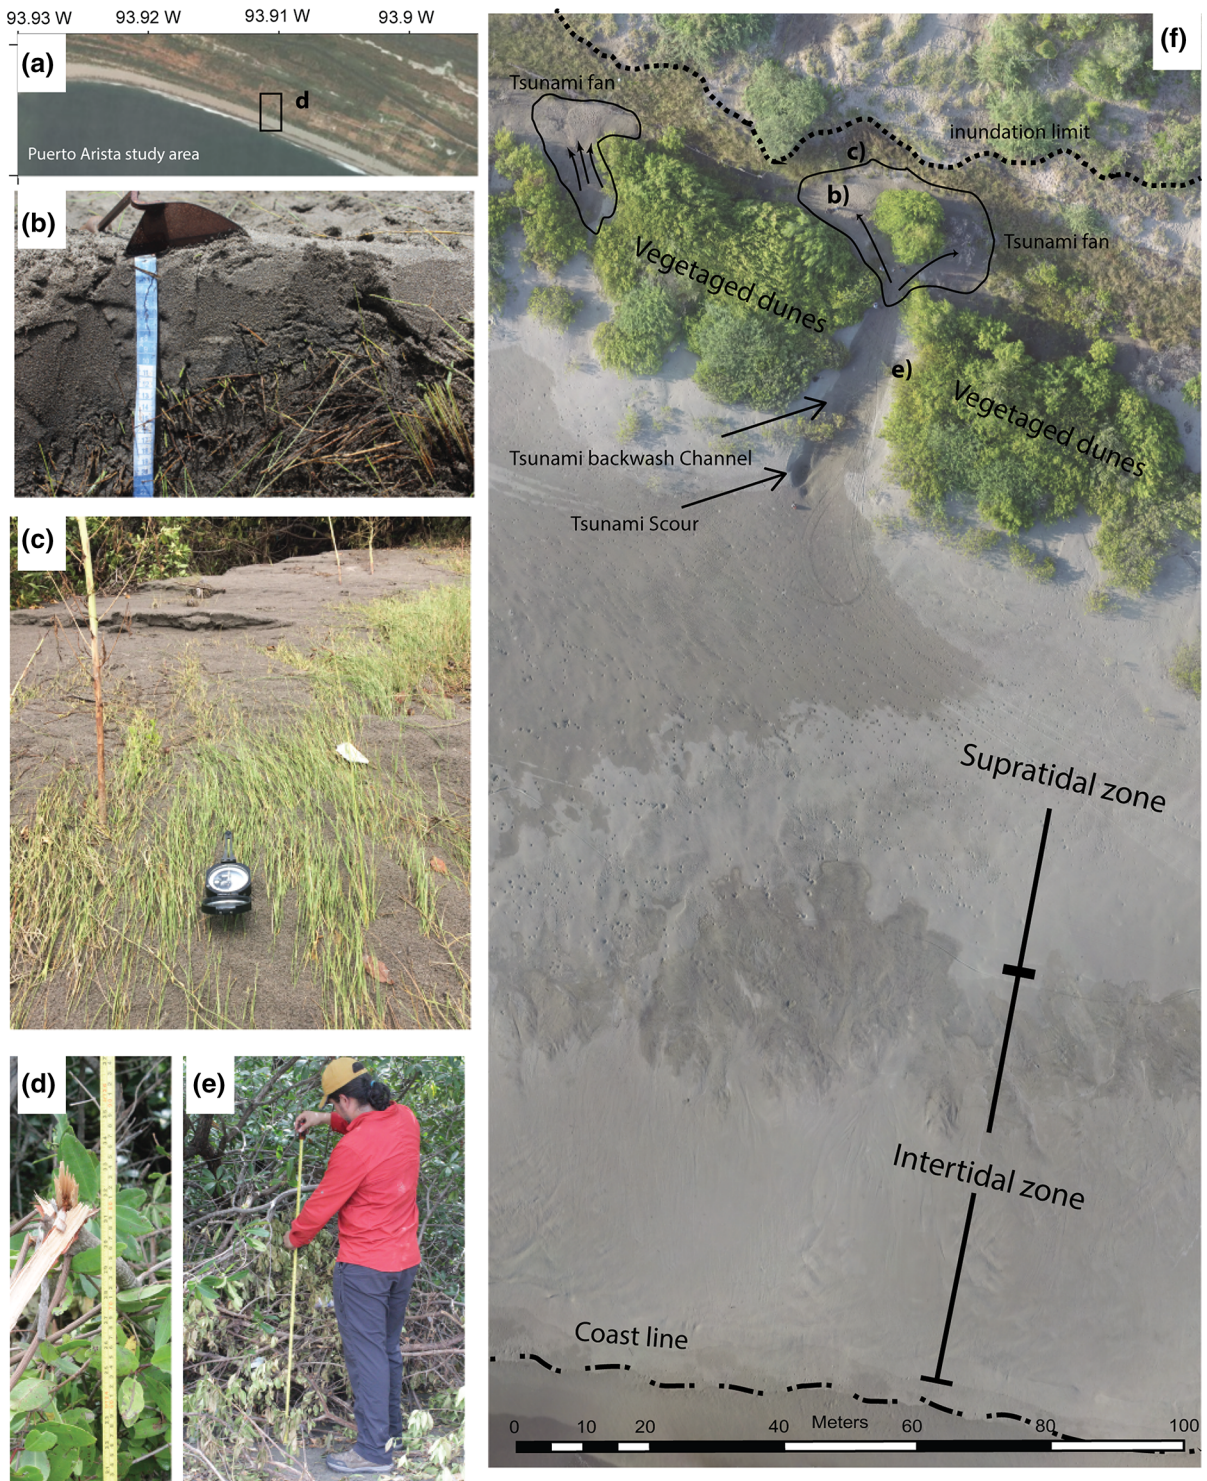
◀Figure 3

Post-tsunami survey observations, Gulf of Tehuantepec, Chiapas. **a** Puerto Arista study area. **b** Evidence of grass covered with sand. **c** Evidence of grass partially covered with sand and vegetation indicating tsunami flow direction (from S to N). **d** Broken mangrove tree branch. **e** Flow depth marked by broken branches and debris on tree. **f** Drone-captured digital elevation model of tsunami effects at site PA2 (location shown in **a**). The tsunami inundation limit (dotted line) is marked by dry, dead vegetation (due to saltwater inundation). Geomorphic features are labeled; letters indicate the location of features shown in detail in **e–g**

Tsunami scour and erosion were evident near the backshore behind a berm at Punta Arista (Fig. 3f), while tsunami deposits, mainly a sand unit with a sharp basal contact, showing laminations within the sand unit, at the beach face reached up to 32 cm thickness thinning landward up to 172 m inland (Figs. 3b, c, 4c, d, e). We distinguished tsunami deposits from other extreme storm deposits by different means such as tsunami eyewitness reports, still greenish grass and other vegetation that was recently buried by sand transported by the tsunami, buried debris and trash, and sand deposited in houses and fields (Figs. 3, 4). We also revised the NOAA-NHC (2017) database for recent storms near the coast of Chiapas and there is no record of a storm hitting this coast on the previous months of the 8 September tsunami. At Boca del Cielo, minor fractures and minor slumps occurred on the lagoon side of the sand bar, most probably related to the ground shaking

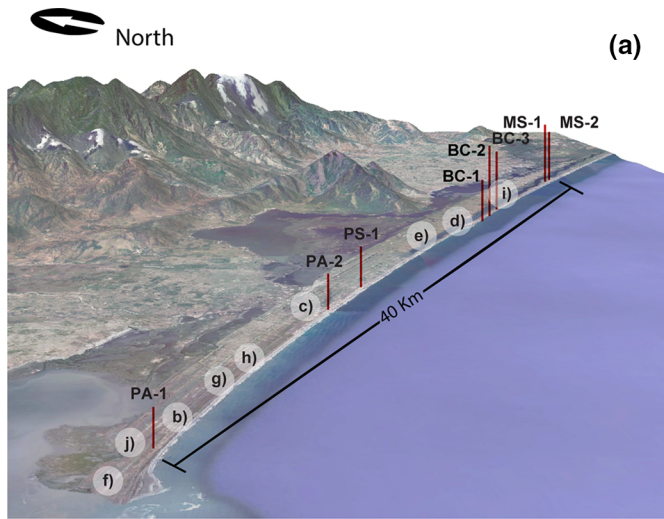
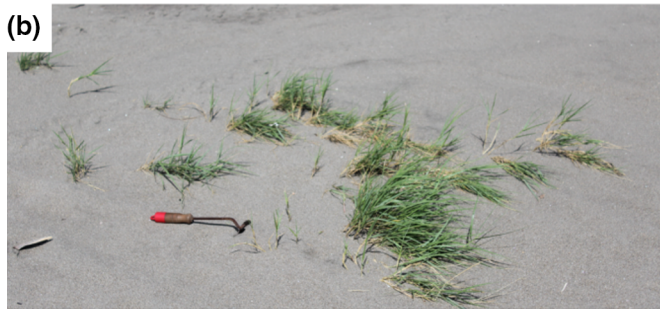
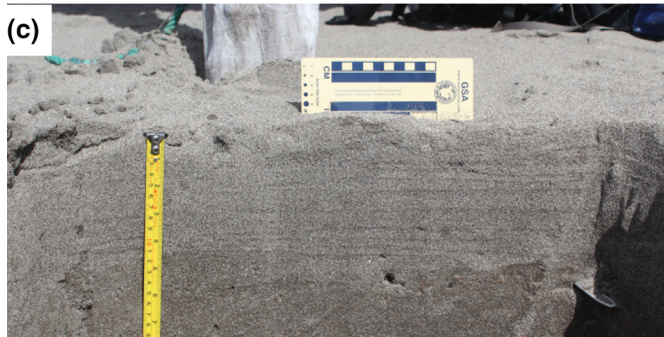
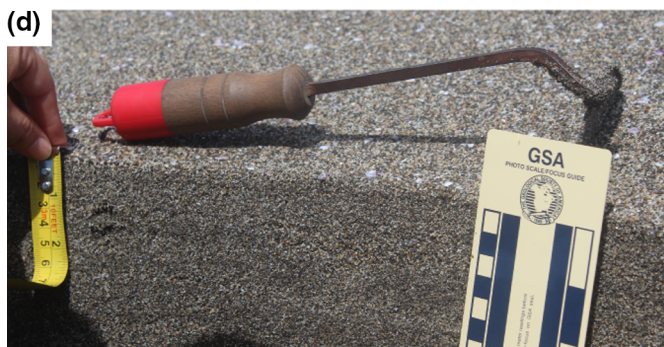
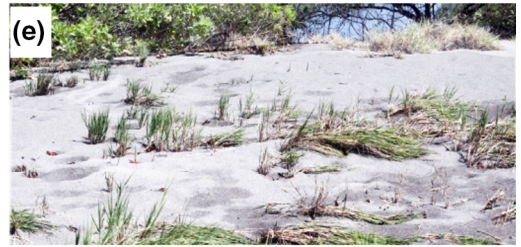
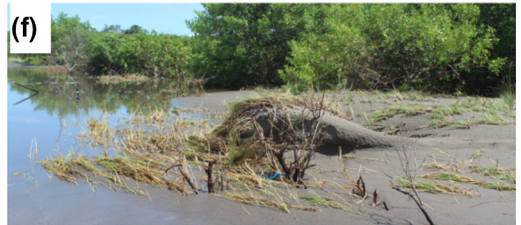
## ◀Figure 4

Physical observations of the 8 September 2017 tsunami. **a** Chiapas coastal plain and **b–j** the approximate location of the photographs. **b** Evidence of grass covered with sand in the vicinity of point PA-1. **c** Sand deposit on the beach approximately 100 m from the sea at Puerto Arista town (please see text for description of tsunami deposit). **d** Sand deposit located on the beach, near point PS-1 (please see text for description of tsunami deposit). **e** Sand deposit covering grass in the vicinity of PA-1. **f** Pedestals, evidence of erosion in sand dunes next to an estuary. **g** Pedestals, at the interface of the beach and the beach ridges, also exposed roots of mangroves detached from the ground. **h** Area with evidence of tsunami inundation showing a protruding trunk and detached vegetation by the tsunami. **i** Overview of the beach between points BC-2 and BC-3 shows traces of vegetation debris transported by the tsunami beyond the high tide mark (latest not shown in picture). **j** < 1-m-high grasses that were bent in the direction of the tsunami flows in the vicinity of PA-2

produced by the 8 September 2017 earthquake. A 1.8 m erosional scarp emerged on the beach at Boca del Cielo estuary and across the estuary mouth. It is unclear whether this scarp was formed because of tsunami erosion or a slump. It is also likely that lateral spreading produced this scarp. Figure 4 shows evidence of tsunami flooding, grass buried by tsunami deposits, detached vegetation such as mangrove trees, trees branches broken, debris transported by the tsunami flood and trapped on trees, trash transported by the tsunami and buried by sand, water and debris inundation marks on walls at houses and on trees, swimming pools filled with marine water and sand, and erosional geomorphic features such as pedestals, canals, and fans produced by the tsunami.
