Inhibited wood degradation of cement-coated beech Laminated Veneer Lumber (LVL) for temporary in-ground applications

Sebastian Hirschmüller¹ · Roman Marte² · Johann Pravida³ · Michael Flach⁴

Received: 27 November 2017 / Published online: 19 June 2018
© Springer-Verlag GmbH Germany, part of Springer Nature 2018

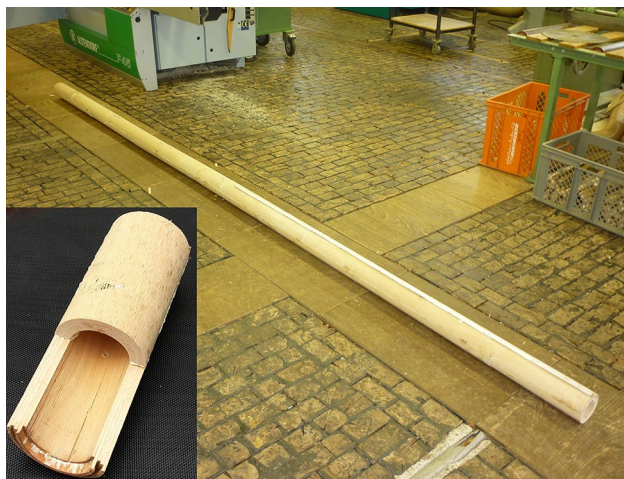
Fig. 1 4000 mm LVL hollow cross section with 100 mm outer diameter

The possibility of substituting temporary steel anchors by laminated veneer lumber (LVL) hollow cross sections (Fig. 1) manufactured from European beech (*Fagus sylvatica* L.) is being investigated in a research project aimed at

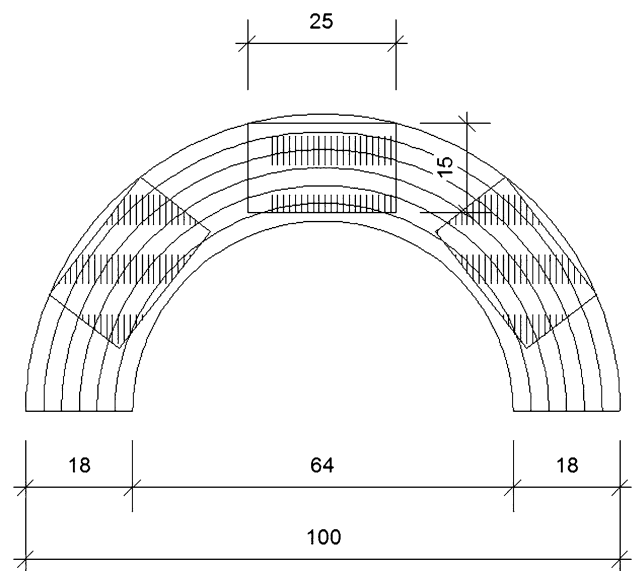
Fig. 2 Schematic cross-section of a tubular half-pole with marked LVL strips; dimensions in millimetre

BASF Kauramin® 683 melamine formaldehyde resin with Kauramin® 688 hardener was used to produce tubular half-poles, whereby the pressing parameters had been developed in preliminary investigations. To provide realistic geometrical conditions (i.e. to exclude any influence of veneer curvature on fungal attack), hollow cross sections were produced. Unidirectionally adjusted, 6 × 3 mm thick veneers were used to produce tubular half-poles with an outer diameter of 100 mm and a wall thickness of approximately 18 mm. The grain direction of all veneers was adjusted to the tube axis; no transverse layers were used. After the adhesive curing process, all tubular half-poles produced were stored again in NC for 7 days prior to further manipulation. After at least 7 days of storage in NC, all LVL tubular half-poles were sized to a length of 600 mm and subsequently cut into 25 mm wide strips, to ensure tensile tests without geometrical influences. Three 25 mm wide and 15 mm thick strips were obtained from one tubular half-pole (Fig. 2). After that, the samples were symmetrically planed to a similar thickness of 15 mm to avoid the influence of sample size effects on material strength and stiffness. To perform tensile tests parallel to the grain, a dog-bone shaped sample based on D 3500-90 (2003) with 10 mm width in the mid-area was developed in several preliminary tests (Fig. 3). To ensure exactly the same geometry of 10 mm width (b) and 15 mm height (h) within the test length for each sample, a CNC-manufactured model was taken as the basis for milling the specimens. Within the 15 mm high testing cross section at least four 3 mm thick veneers were located with a radial orientation of annual rings due to the peeling process of the veneer sheets (Fig. 4).

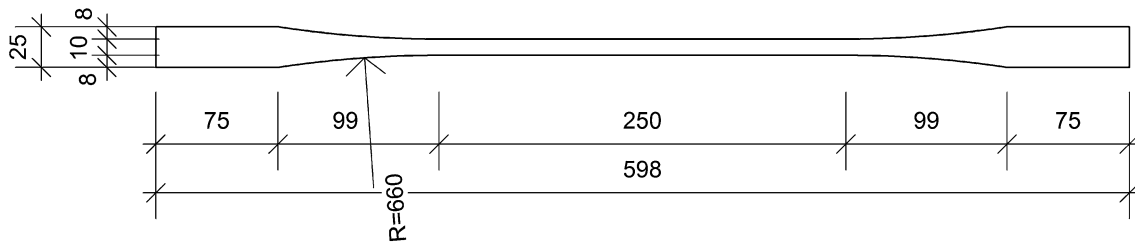
Fig. 3 Tensile test specimen; dimensions in millimetre

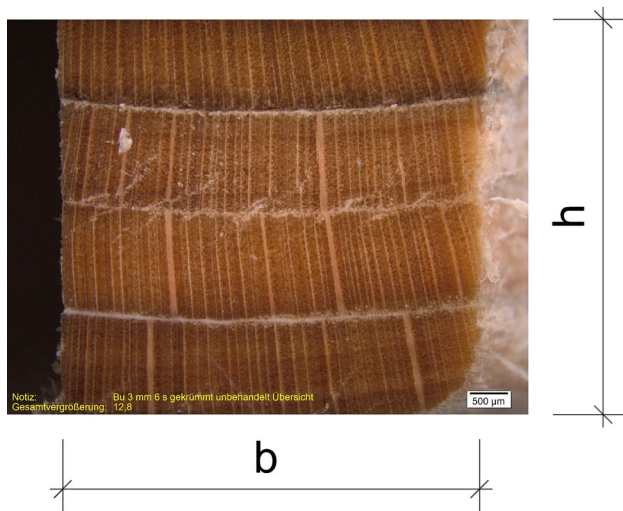
Fig. 4 Tensile test specimen cross section at 12.8x magnification

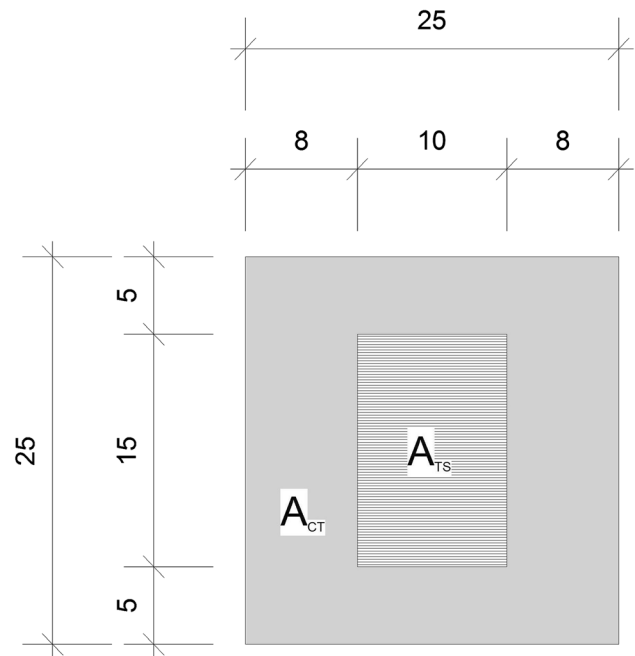
Fig. 5 Schematic cross-section with surrounding cement body (A_{CT}) and embedded tensile test sample (A_{TS}); dimensions in [mm]

and one tensile test sample was subsequently completely embedded in each piece of formwork. The geometrically necessary cross-sectional area of the cement body was therefore slightly higher ($A_{CT} = 475 \text{ mm}^2$) with a CW ratio of 3.16 (Fig. 5). After one day of initial cement hardening, the formwork was carefully removed and a 600 mm long cement-coated test specimen was produced (Fig. 6). The thin cement coating at the widened cross section (25 mm width and 30 mm width of the formwork) of the bone-shaped test specimens at the clamping area failed immediately after stripping the formwork. The cement coating missing from the enlarged cross-section of the clamping area was replaced using an epoxy resin coating.

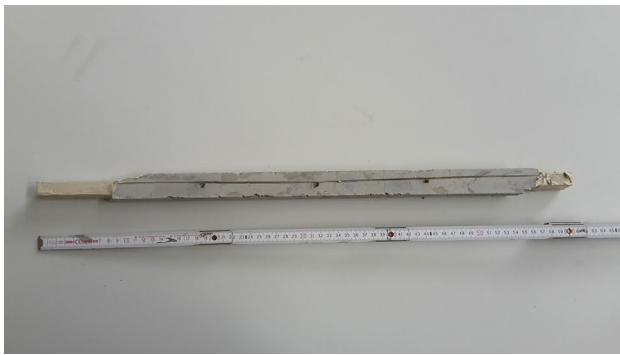
Fig. 6 Cement-coated test specimen from the CEM batch with epoxy resin protection at the clamping area

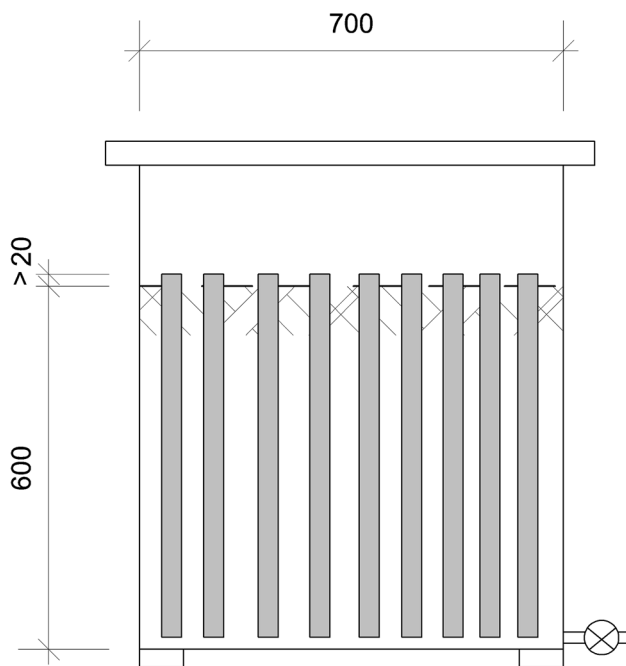
Fig. 7 Schematic longitudinal section of a compost container with vertically loaded test specimen and drainage opening at the bottom; dimensions in millimetre

807 (2001) process. Untreated and non-sterilized compost, consisting of brush cuttings and garden waste, was filled 600 mm high in two 700 mm wide circular plastic containers (Fig. 7). Both containers were stored for 12 months in the material testing laboratory at Rosenheim University of Applied Sciences with a climate in the range of 22–26 °C and relative humidity between 35 and 45% in the room. Air circulation at the upper surface of the compost was ensured by ventilation openings in the top cover of the box. A drainage opening was located at the bottom of each container. After filling the containers with compost, both were loaded with test specimens in a vertical configuration. Ninety unprotected test samples were placed in container I and 90

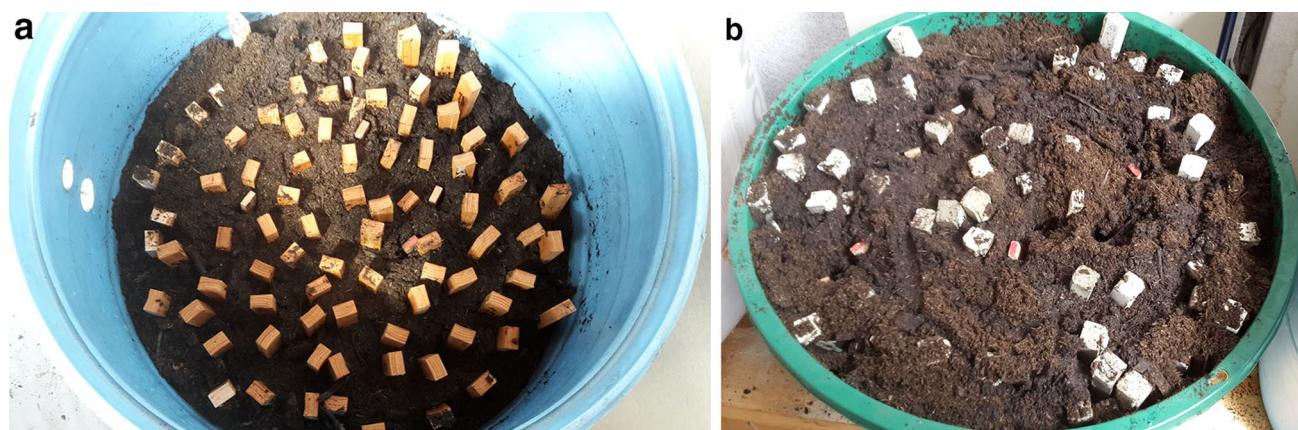
Fig. 8 Container I and container II with inserted test samples. **a** Box I, filled with 90 unprotected test specimens and 12 control specimens, **b** Box II, filled with 90 cement-coated test specimens and 12 control specimens

cement-coated test samples (after 3 days of cement hardening) in container II (Fig. 8). The top end of each sample was at least 20 mm below the compost surface. Additionally, 12 pieces of solid beech control sticks (100 mm long, 20 mm wide and 10 mm thick) were inserted upright in the compost across the entire surface in each container. Six control sticks were used for moisture control; the remainder was used to control fungal attack (virulence control sticks compliant with ENV 807 2001). Prior to installation of the control sticks, the initial dry weight m_0 of each stick was determined by oven drying (EN 322 1993). Moisture control sticks were renewed monthly due to the fungus-induced WL, whereby WL of the wood specimens was calculated compliant with ENV 807 (2001) and EN 113 (1996) as WL of the exposed sticks after oven-drying relative to the initial dry weight.

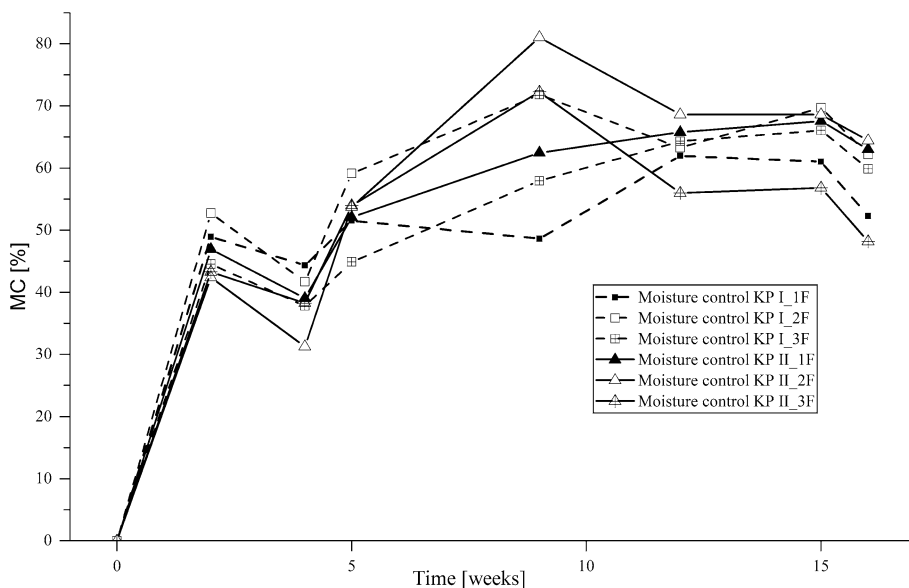
Fig. 9 MC (% of dry weight) of control sticks in container I (KP I_F) and container II (KP II_F)

Monitoring of the control sticks was stopped after an exposure time of 26 weeks due to failure of all virulence control sticks caused by massive deterioration. At a soil moisture content of 100% WHC, the moisture control sticks in both containers reached a more or less constant moisture level (Fig. 9) between (50 ± 5%) and (80 ± 5%) as required in ENV 807 (2001). WL of the six virulence control sticks in

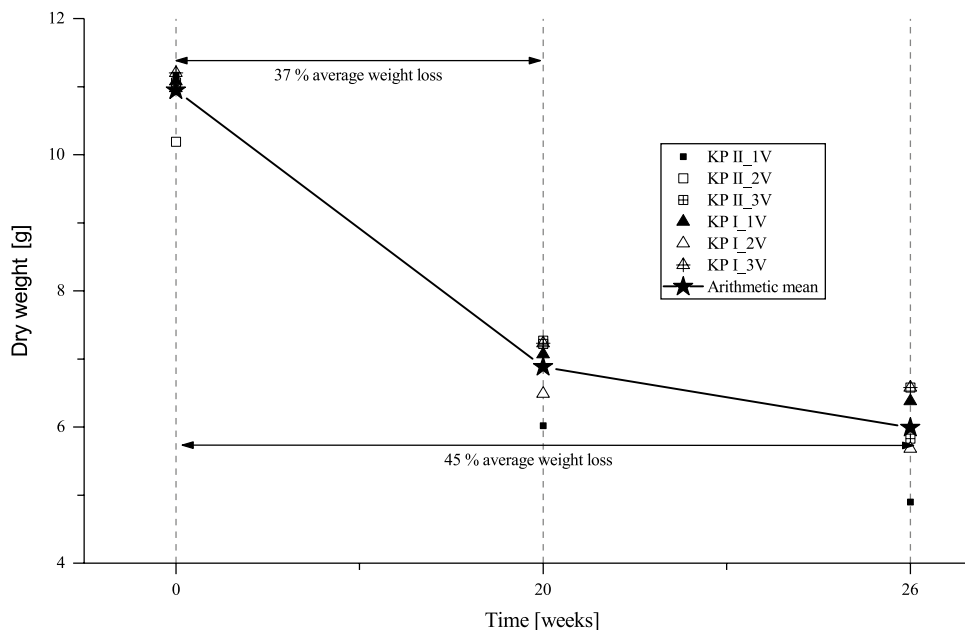
Fig. 10 Time-dependent dry weight of virulence control sticks in container I (KP I_V) and container II (KP II_V)

container I (KP I_V) and container II (KP II_V) after 20 and 26 weeks exposure time was calculated following Eq. (1). As shown in Fig. 10, the control sticks in both containers had 37% WL after 20 weeks of exposure, which indicates a severe fungal attack.

WL of 45% at the second control measurement after 26 weeks of exposure was moderate compared to WL within the first 20 weeks. Oven drying of the control sticks at a temperature of (103 ± 2) °C after 20 weeks of exposure influenced the fungal activity afterwards and therefore, reduced the rate of WL. Nevertheless, fungal wood deterioration was detected in both containers.

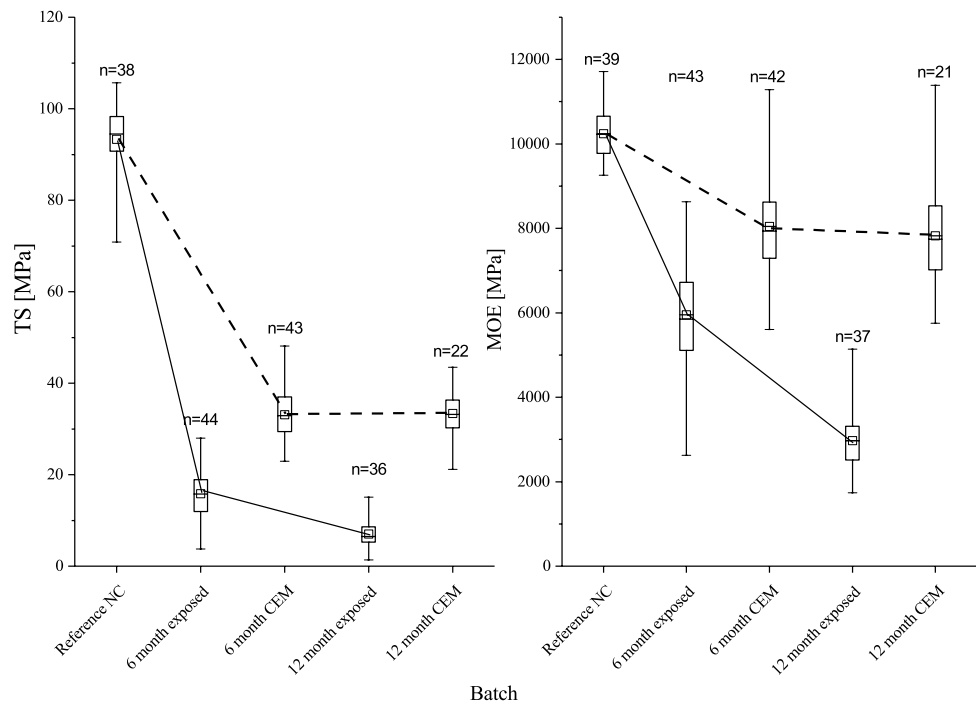
Fig. 11 TS of LVL batches (left) and related MOE (right) with mean connection line. Whiskers minimum and maximum values, box Q_{25} and Q_{75} quartile, square in box arithmetic mean, n number of samples and horizontal line median

As anticipated, in the case of exposed samples without cement coating, TS and MOE decreased significantly with ongoing exposure, whereby the strength dissipation was higher in the first 6 months of exposure. Contrary to a review given in Wilcox (1978), in case of uncoated samples, TS (82% strength reduction) was found to be more affected by fungal deterioration than MOE (42% stiffness reduction) after 26 weeks of exposure. A decrease in strength was proportionally greater compared to WL, which correlates well with findings published in Curling et al. (2002). However generally, the determined ratio between WL of control specimens after 26 weeks of exposure (WL=45%) and tensile strength reduction is considerably higher than values for a strength reduction determined in bending tests (Wilcox 1978).

Cement-coated batches also displayed strength loss, but the residual TS and MOE were significantly higher (test power $P=1$) compared to exposed batches without cement coating. The strength reduction of cement-coated batches could be traced back to an alkaline degradation of wood. Results of TS and MOE were in good agreement with results of previous investigations, where similar cement-treated beech LVL showed a severe tensile strength and stiffness decrease due to alkaline attack (Hirschmüller et al. 2018). The reduction in TS and MOE was therefore assumed to be predominantly affected by wood hydrolysis due to the high alkalinity of the cement coating and not by fungal degradation. In the cement-coated batches, no significant difference in tensile properties was identified for exposures between 6 and 12 months, neither in TS nor in MOE. Hence, cement coating displayed a positive effect on specimen durability. Coated samples also lost strength, but the decrease in material properties stagnated with time. However, although the statistical comparison between cement-coated batches with 6 and 12 months exposure delivered no significant difference, the low test power ($P=0.10$) of the t-test (including a

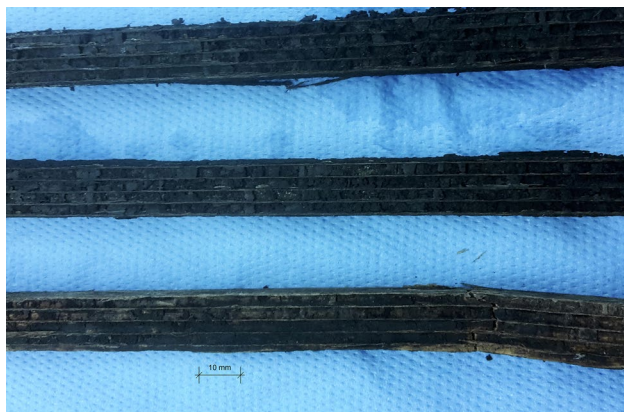
Fig. 12 Side view of “12 months exposure” samples

All samples displayed massive deterioration throughout their lengths. During compost removal and cleaning, eight samples were destroyed due to the destruction of their complete cross-section (Fig. 12). A molecular diagnostic fungal determination was therefore neglected. It is assumed that these samples were infested by the same fungal species as the 6 months exposed samples due to the sample storage in the same vessel.

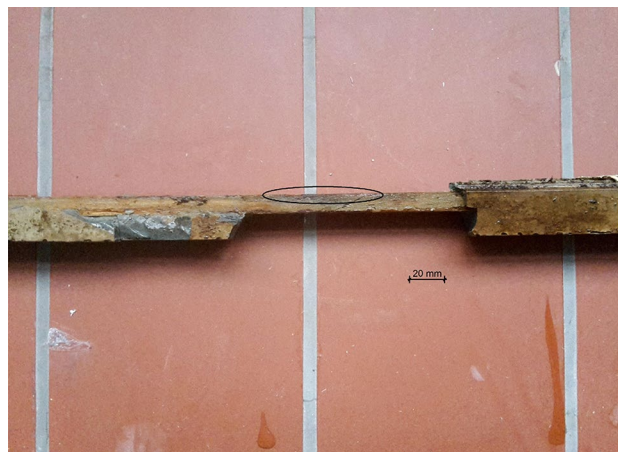
Fig. 13 Top view of the “12 months CEM” sample with initiating deterioration in regions with low cement covering (elliptical marker)

After 12 months of compost storage, all samples showed severe destruction in places of the epoxy-resin-covered clamping area. 13 samples were destroyed in the clamping area during compost removal, and in 13 samples, deterioration initiation was recognized in regions with a thin cement coating due to eccentric embedment in the framework during production (Fig. 13). The remainder of the samples had no visible fungal infestation but a fibrous surface caused by rough cement removal in combination with wood degradation caused by the cement, a well-known effect of alkaline wood destruction (Mašura 1982; Glaus et al. 1999; Knill and Kennedy 2003). The pH of the extracted cell water was determined to be 8.99. The molecular diagnostic fungal determination of a randomly selected sample without visible deterioration using DNA chip technology revealed an infestation with *Schizophyllum commune*, a common white rot fungus.

The fungal attack observed in sections with low cement coating thickness and the moderate pH of wood cell water (pH 8.99) measured after 12 months of cement contact (pH 13) led to the assumption that cement coatings work as a physical barrier against fungal infestation, whereby the impact is related to the coating thickness. A possible explanation for this dependence on thickness is the interaction between white rot fungi and cement, because the fungi produce CO_2 as a result of their metabolic activity and therefore, increase the carbonisation reaction of cement (Goodell et al. 1997). After a carbonisation-induced decrease of the cement pH, the physical cement barrier may lose its efficiency with subsequently increased fungal deterioration due
