Cyst formation 4 years after ACL reconstruction caused by biogradable femoral transfixation: a case report

Abstract We present a case with an unusual and late cyst development after use of a biogradable femoral transfixation for ACL reconstruction.

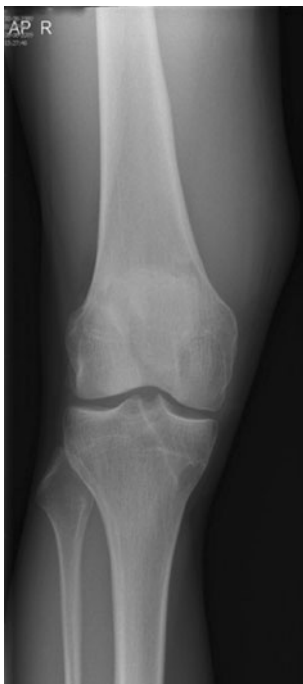
Fig. 1 Radiograph of the knee indicating a large soft tissue swelling at the medial side superior of the knee and a still visible transfemoral canal

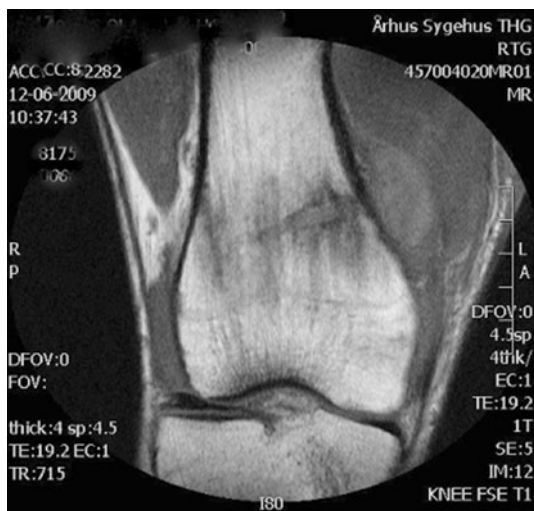
A subsequent MRI revealed a cyst formation originating from a cortical defect of the medial aspect of the femur communicating with a widened tunnel from the inserted transfix system. Furthermore, a solid degradation product from the Biotransfix implant inside the cyst is seen. (Figs. 2 and 3).

Fig. 2 MRI of the knee with cyst formation at the medial aspect of the knee, originating from the inserted transfemoral fixation

An incision posterior to the head of vastus medialis was made, and the cyst was identified and removed. The cyst was filled with gelatinous liquor, and several products with up to a length of 5 mm from the now degraded Transfix pin were found.

A guide pin was placed transfemoral through the tunnel of the former fixation device and a 6-mm drill was used in order to remove remnants from the Transfix pin.

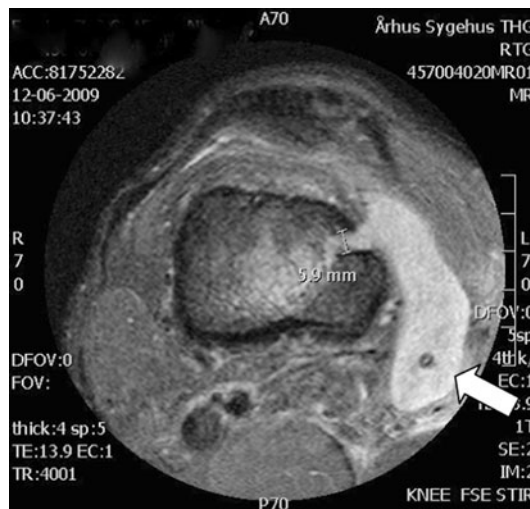
Fig. 3 Cyst formation at medial side of femur. A part of the degraded Biotransfix is seen in the cyst

Inside the cyst, we found several pieces of the degraded and now broken Transfix pin, and based on the history of this patient we believe that the cyst is caused by the degradation products.
