MRI injury patterns in surgically confirmed and reconstructed posterolateral corner knee injuries

Abstract

Purpose The posterolateral corner (PLC) of the knee is anatomically complex with similarly complex MR imaging findings in acutely injured knees. The purpose of this study was to define the MRI pattern of injury in cases of PLC disruption requiring surgery because of clinical instability.

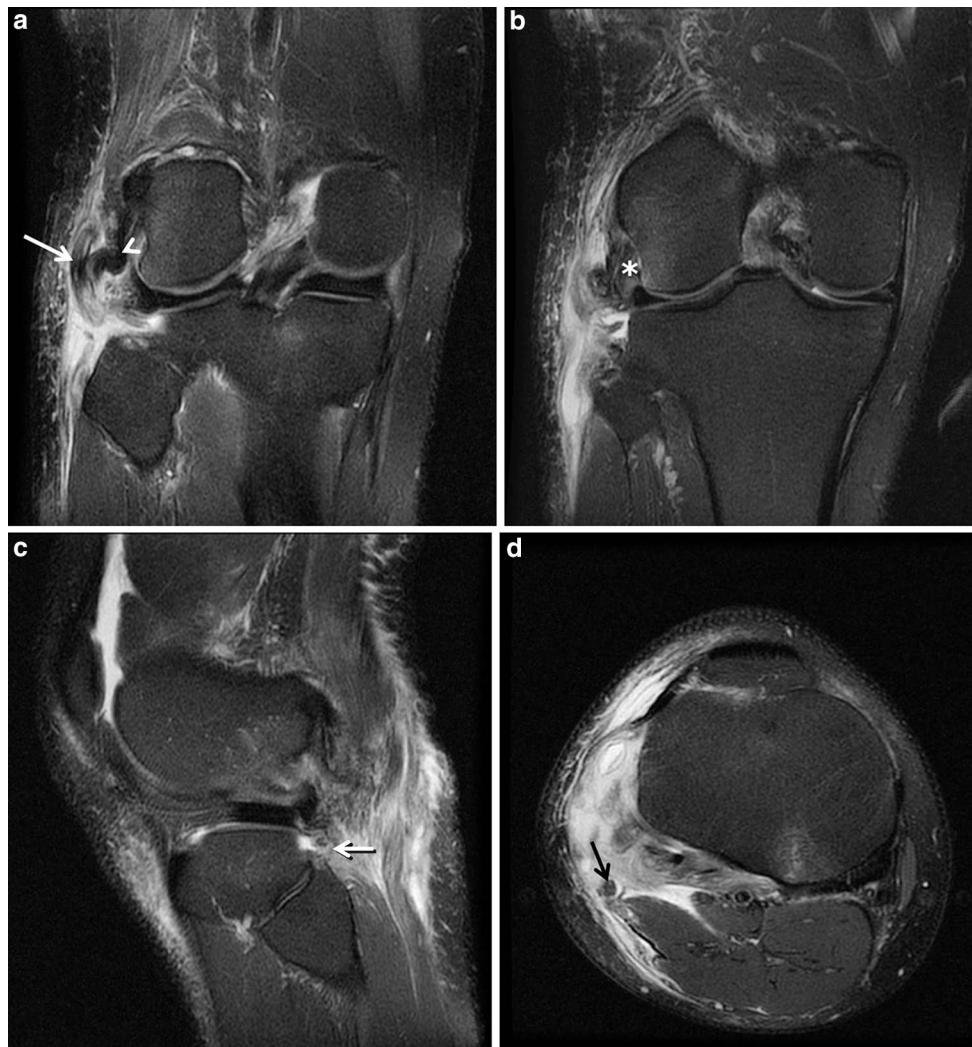
Fig. 1 27-Year-old male involved in a moderate speed motorcycle accident. Coronal T2-weighted images (**a**, **b**), demonstrate complete avulsion of the BF (*white arrow*) and FCL (*white arrowhead*) off of the fibula, and high-grade partial tearing of the PT at its femoral insertion (*asterisk*). The conjoint tendon is retracted several mil-

limetres proximally. Sagittal (**c**) and axial (**d**) T2-weighted images demonstrate high-grade partial tearing of the PFL (*white arrow*) and thickening of the peroneal nerve (*black arrow*) with extensive postero-lateral soft tissue oedema

Notably, at least two of the three structures, the FCL, popliteus, and BF, were abnormal in all of the study patients (Fig. 1).
