Study on laser cladding remanufacturing process with FeCrNiCu alloy powder for thin-wall impeller blade

Abstract The centrifugal compressor impeller is widely used in petroleum, chemicals, and other fields and is liable to failure in complicated working environment. Laser cladding as an advanced technology was used to remanufacture the failure impeller. And, remanufacture quality and service safety should be considered. In this paper, simulation and experiments were applied to study the remanufacturing process of failure thin-wall impeller blade. Firstly, a sequentially uncoupled 3D thermo-mechanical finite element (FE) model was developed to calculate temperature distribution and conduct mechanical analysis. Secondly, the impeller blade of repair region quality was studied based on microstructure analysis, microhardness, and tensile property tests. Finally, dynamic-balancing experiment, over-speed test, and dye penetration inspection were used to assess the security of remanufactured impeller. Numerical simulation showed that high temperature (about 1521 °C) and high residual stress (about 300 MPa) were distributed surrounding heat-affected zone (HAZ). And, experiments showed tha

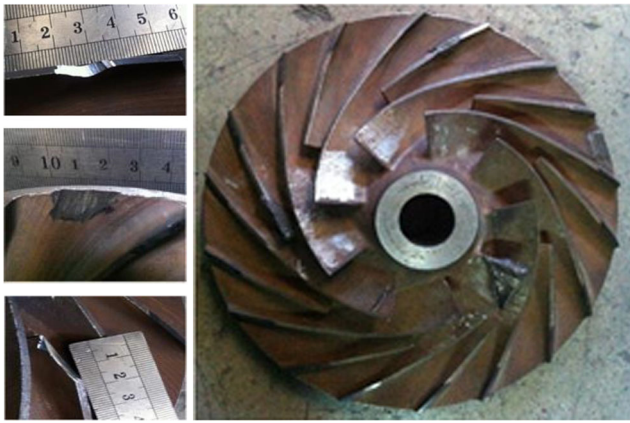
Fig. 1 Failure open impeller

The centrifugal compressor impeller is widely used in petroleum, chemicals, military, and other important fields [1]. The impeller, the key component of turbo machines, often has failure due to complicated working environment (centrifugal force, unstable gas flow, etc.) [2, 3]. Failure impellers and blades not only cause significant economic losses to enterprises and society but also threaten people's lives [4]. With the development of technology, laser cladding technology is used extensively in the process of remanufacturing failure parts [5], which makes the remanufacture of failure impeller possible. As the remanufacture impeller has a very high demand for remanufacturing quality and safety, the laser cladding process and remanufacture quality should be studied.

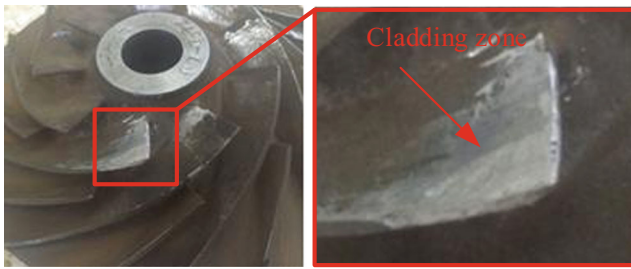
The failure impeller was remanufactured successfully by laser cladding. Figure 7 shows the remanufactured impeller; the cladding is fine, uniform, and free of crack. In the next section, forming mechanism, microstructure, and remanufactured impeller quality will be discussed in detail.

Fig. 7 Remanufactured impeller

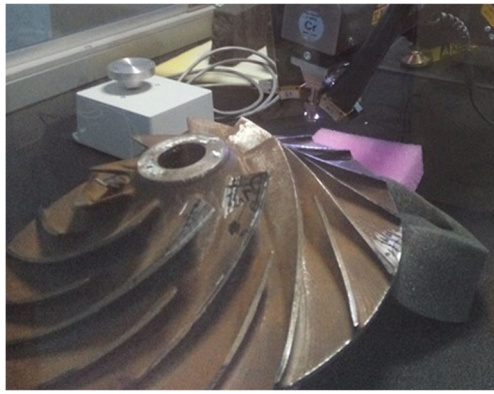
Fig. 10 Residual stress measurement by XRD

stress is 303 MPa. It is concluded that the residual stresses are generated after laser cladding in cladding coatings; the max stress is about 300 MPa. In order to validate the simulation model, the residual stress was tested by X-ray diffraction (XRD), as shown in Fig. 10. The experimental results show good consistency with simulation results. A reasonable heat treatment could be conducted to

improve the quality of remanufactured impeller by relieving residual stress.

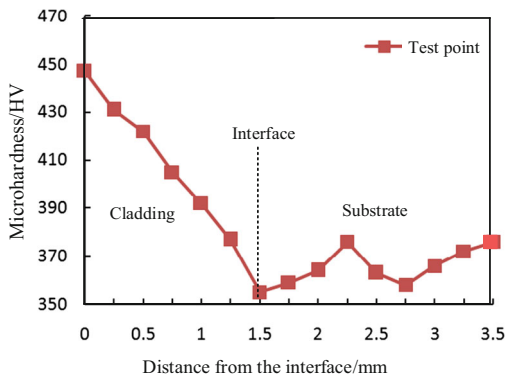
Fig. 13 Microhardness of cladding and substrate

The microhardness of cladding cross section was tested by DSZF-1 digital microhardness tester. In the thickness direction of a cladding layer, 15 points were selected. The microhardness of every point was calculated by taking the average of the remaining 4 points in horizontal line apart 0.3 mm. The microhardness is shown in Fig. 13. The surface microhardness of the cladding layer is the highest, and the average value is 443 HV. As a lot of strengthening phases (M_7C_3 , NbC) decarbonized in the cladding layer, the microhardness is increased. From the top to the interface, the microhardness decreased gradually, and the hardness decreased to 361 HV. As the crystal microhardness is transformed from the equiaxial grains to the dendrite, the microhardness is decreased slightly. The average value of cladding layer

is 398 HV. From the interface to substrate, the microhardness increased gradually and remained relatively stable; the average microhardness is 360 HV. The substrate was diluted with cladding layer in laser cladding, and the microhardness is remained stable.
