Tool wear by dissolution during machining of alloy 718 and Waspaloy: a comparative study using diffusion couples

Abstract

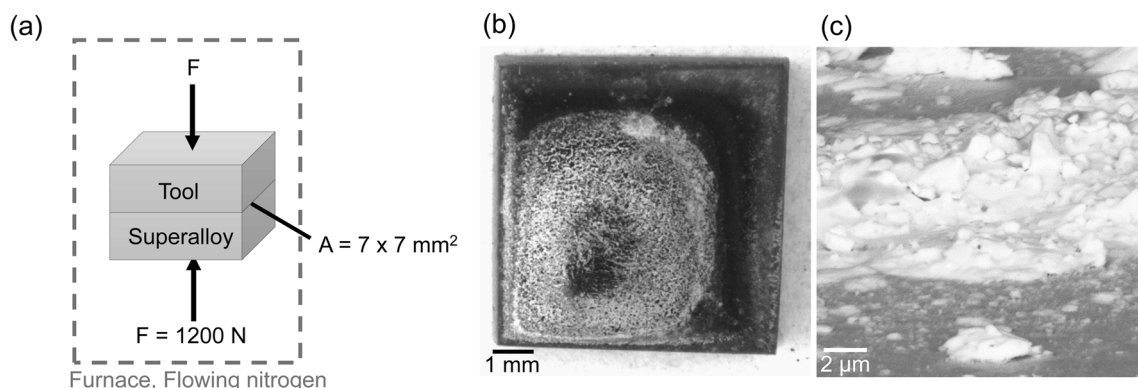
Fig. 1 Schematic setup of the diffusion couple tests with contact surface (“A”) and applied force (“F”) indicated (a); separated diffusion couple of Waspaloy after testing at 1000 °C shown in top-view (b), and tilted view

using SEM (c). Locally, several micrometer thick layers of tool material (bright particles are WC) are bonded to the Waspaloy sample

For each experiment, one diffusion couple comprising one of the two superalloys and a sample of the tool material was tested under controlled conditions. Tool and superalloy were brought in contact so that the mating surfaces were square-shaped with 7 mm side length. Furthermore, to achieve good contact during the tests, the contact surfaces were ground and polished with 1 μm diamond suspension as the final step. In that way, a total of four samples were prepared (two for each superalloy) and tested in accordance with Table 2. For each test, the sample was held together by applying a force of 1200 N corresponding to a pressure of ~ 24.5 MPa in compression for 90 min at two test temperatures. Flowing nitrogen was used as protective gas to prevent oxidation of the samples during the tests. A schematic of the experimental setup can be seen in Fig. 1a.

After testing for the set time and subsequent cooling to room temperature, the contact pressure was released from the samples. It was found that firm bonding between the tool material and the corresponding superalloy samples had occurred in all cases except for Waspaloy tested at 1000 °C. Here the vast majority of the tool material had broken off. It is believed that during cooling down, differences between the thermal expansion coefficients of the tool material and the respective superalloys lead to build-up of stresses which resulted in the debonding. However, closer examination by optical microscopy and SEM revealed that pieces of tool material were left adherent to the Waspaloy surface in contact with the tool during the test (Fig. 1b and c). Therefore, bonding had occurred during the test.

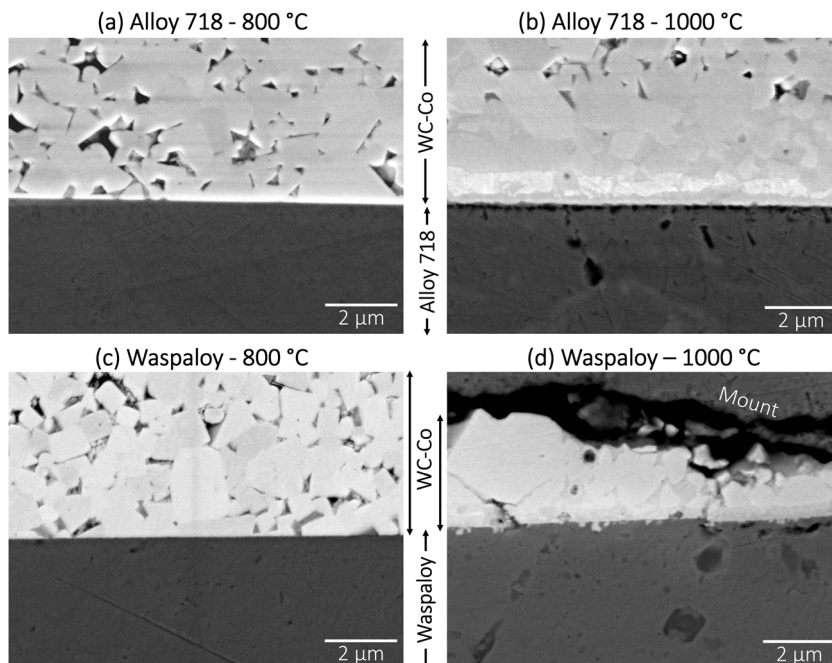
Fig. 2 Cross-sectional SEM micrographs of the tool–superalloy interfaces for the diffusion couples containing Alloy 718 (a, b) and Waspaloy (c, d) tested at the two temperatures. Note the parts of sample mounting resin in the upper part of d

In Fig. 2, the general appearances of the bonded workpiece–tool interfaces are presented for the four tests. When looking at the interface after exposure to 800 °C, see Fig. 2a and c, no obvious microstructural changes of either the superalloy or of the tool are visible close to the interface. The WC skeleton (bright) is clearly distinguishable. The holes appearing in-between the WC skeleton are areas of the Co-binder, subjected to preferential removal during metallographic sample preparation.

After the tests at 1000 °C however (Fig. 2b and d), the WC–Co microstructure within the area of about 3.5 μm from the interface appears to have changed. Both the WC skeleton and Co-binder are not clearly distinguishable any more. Instead, there are zones of slightly darker contrast in-between the bright appearing WC grains. Furthermore, it can be observed that a band has formed consisting of interrupted bright areas in very close proximity to the diffusion interfaces of the alloy 718 sample tested at 1000 °C (Fig. 2b). The band is approximately 0.5 to 1 μm thick and stretches all along the investigated interface.

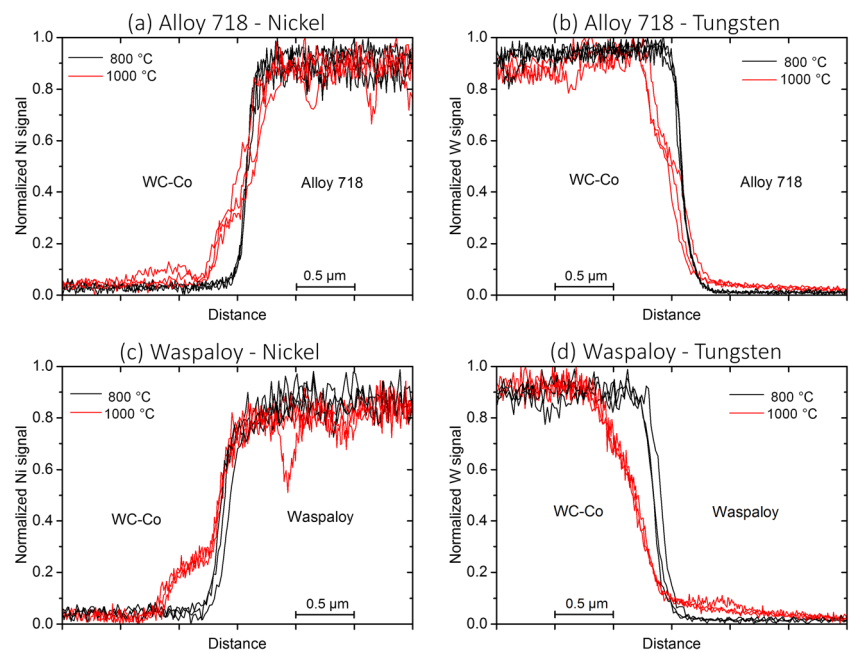
Fig. 3 Qualitative comparison of EDS line scans across the workpiece–tool interfaces after the four tests. Shown are normalized signals of Ni (**a, c**) and W (**b, d**)

For qualitative comparison of interdiffusion between the materials, at least five EDS line scans were taken across each tool–workpiece interface. Three of these line scans from each sample are presented in Fig. 3. Shown are the normalized

signal intensities of nickel and tungsten across the diffusion couple interfaces after the tests. In all graphs, a steep decrease or increase of X-rays originating from tungsten and nickel, respectively, can be seen in close vicinity of the tool–superalloy interface (the interface is approximately at the center of the x -axis). When comparing the line scans corresponding to the tests at 800 °C with the ones obtained after 1000 °C, a clear difference can be observed. The higher test temperature yielded in a more shallow increase and decay of tungsten and nickel, respectively. This can be connected to increased inter-diffusion between the tool and superalloys which increased the respective element's X-ray signals within about 0.5 μm distance from the interface. This is the case for both the alloy 718 and the Waspaloy containing sample and no significant differences can be observed between the two alloys. Furthermore and as can be seen in Fig. 3a and b, it should be noted that the EDS line scans of the alloy 718 diffusion couple tested at 1000 °C show no significant change in the X-ray intensities at the location of the bright phase.

Concerning the diffusion of workpiece atoms into the tool, it was observed that superalloy elements are present in a narrow region of the tool after the diffusion couple tests conducted at $1000 \text{ }^\circ\text{C}$ (see Figs. 3 and 4). Additionally, significant carbon depletion and formation of tungsten within the tool material were observed in the diffusion couple containing alloy 718 (see Figs. 2 and 5). In the corresponding Waspaloy containing diffusion couple, these phenomena were less pronounced and no significant carbon depletion and formation of tungsten were observable using the employed characterization techniques. A possible explanation for the different responses of the tool material during the diffusion couple tests is that the two superalloys contain different types and quantities of carbide forming elements. Of the present alloying elements, niobium has the strongest tendency to form carbides, followed by titanium [34]. Alloy 718 contains about 5.5 wt% niobium and about 0.9 wt% titanium, whereas Waspaloy contains no niobium and about 3.1 wt% titanium (see Table 1). Due to its chemical composition, alloy 718 should therefore have higher affinity to carbon which could explain the observed carbon depletion of the tool material in close vicinity to the diffusion interface.

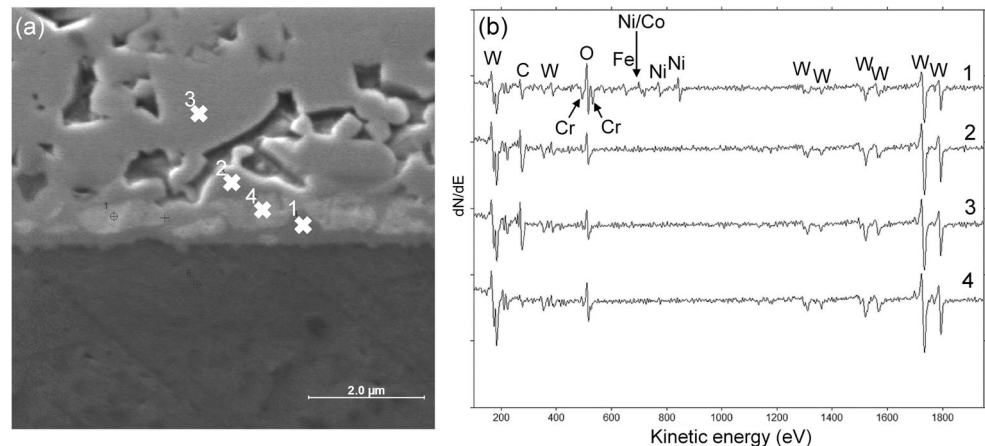
Fig. 4 AES survey scans taken in close vicinity of the interface of the alloy 718 diffusion couple tested at 1000 °C. **a** SEM image with points of analysis. **b** Differentiated AES spectra with peak designations

Complementary to EDS, additional analysis by means of AES was carried out for the samples tested at 1000 °C. As compared with EDS, AES offers higher spatial resolution and higher sensitivity on the orders of 10 nm and 0.1 at.%, respectively [31]. Figure 4 shows derivatives of AES survey spectra obtained for the diffusion couple which contains alloy 718. Characteristic Auger peaks are marked with the corresponding elements. Spectrum 1 shows presence of nickel, iron, and chromium in the tool, confirming diffusion of elements from the superalloy into the tool. At further distance from the

interface (spectra 2 and 3), no elements from the superalloy were detected, which can be seen by the absence of the corresponding peaks in the AES spectra. Spectrum 4 was obtained on the bright phase formed in close vicinity to the diffusion interface (see also Fig. 2b). As can be seen, solely tungsten, carbon, and oxygen are present in the spectrum. The presence of oxygen in all spectra is likely to be the result of air which was entrapped between the mating sample surfaces. Even though these surfaces were polished for improved contact during the tests, remaining small-scale surface roughness can lead to small gaps between the mating surfaces. The entrapped air then caused diffusion of oxygen into the diffusion couples and can explain the oxygen peaks in the shown spectra. Similar to the alloy 718 sample tested at 1000 °C, diffusion of elements of the superalloy into a narrow region of the tool adjacent to the diffusion interface was also confirmed for the corresponding Waspaloy sample.

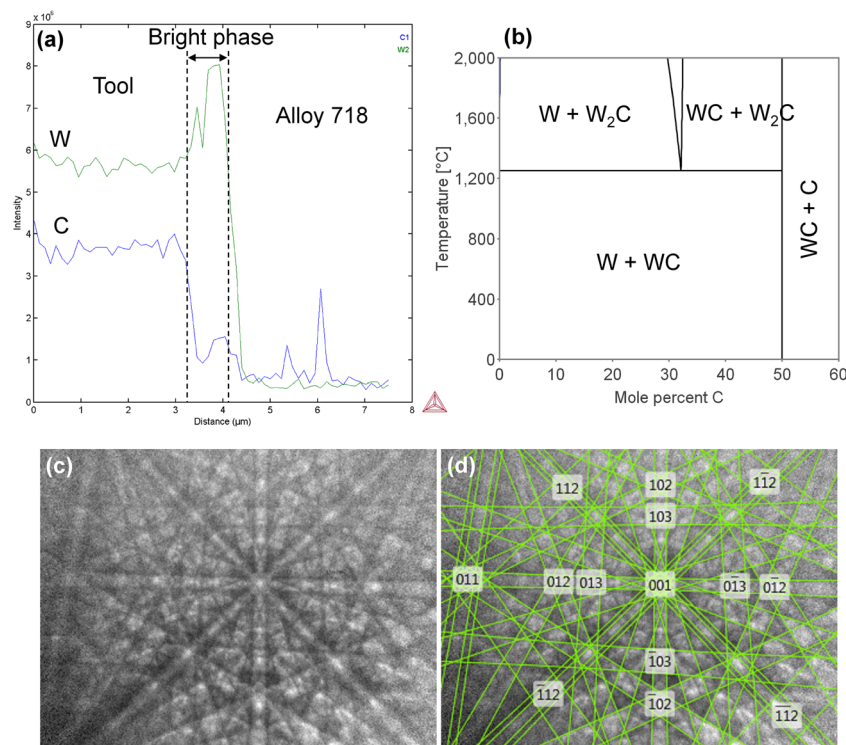
Fig. 5 Analysis of bright phase formed in diffusion couple containing alloy 718. AES line scan showing peak intensities of tungsten and carbon across bright phase (a); part of binary tungsten-carbon phase diagram (b); EBSD pattern obtained on bright phase (c) and with overlaid reference pattern of tungsten (d)

Results of detailed analysis of the bright phase formed in the diffusion couple containing alloy 718 which was tested at 1000 °C are shown in Fig. 5. AES peak intensities of tungsten and carbon across the bright phase are shown in Fig. 5a. The relative peak intensities are a measure of the relative concentration of the respective elements at the locations. As compared with WC (left side of graph), the bright phase is depleted in carbon, shown by the low intensity of the corresponding peak at this position. The bright phase was found to be mainly tungsten. This was done by identifying candidate compounds from the carbon-deficient part of the tungsten-carbon binary phase diagram (Fig. 5b) followed by analysis of EBSD

patterns acquired on the bright phase (Fig. 5c). Figure 5d shows the match of the EBSD pattern of the bright phase with the reference pattern of tungsten. The bright phase also contains some carbon, which could be explained by the fact that small amounts of WC remain within the bright zones which were not resolved by the EBSD analysis.

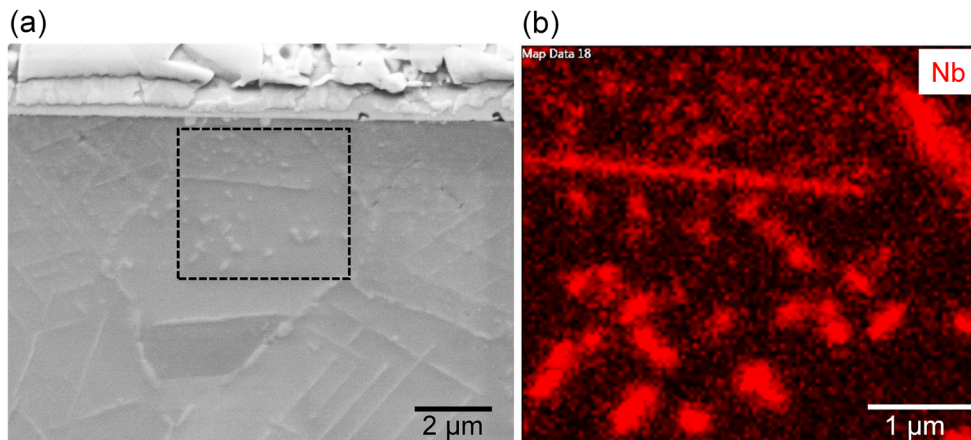
Fig. 6 Niobium-rich precipitates in alloy 718 in close vicinity to the diffusion interface after testing at 1000 °C. a SEM micrograph. b EDS map showing the distribution of niobium

Furthermore, niobium-rich phases were found to form in alloy 718 in close proximity to the diffusion interface (see Fig. 6). The shown appearance is characteristic for the entire length of the diffusion interface for the alloy 718 diffusion couple tested at 1000 °C.
