Cutting edge control by monitoring the tapping torque of new and resharpened tapping tools in Inconel 718

R. Polvorosa¹ · L.N. López de Lacalle¹ · A. J. Sánchez Egea²

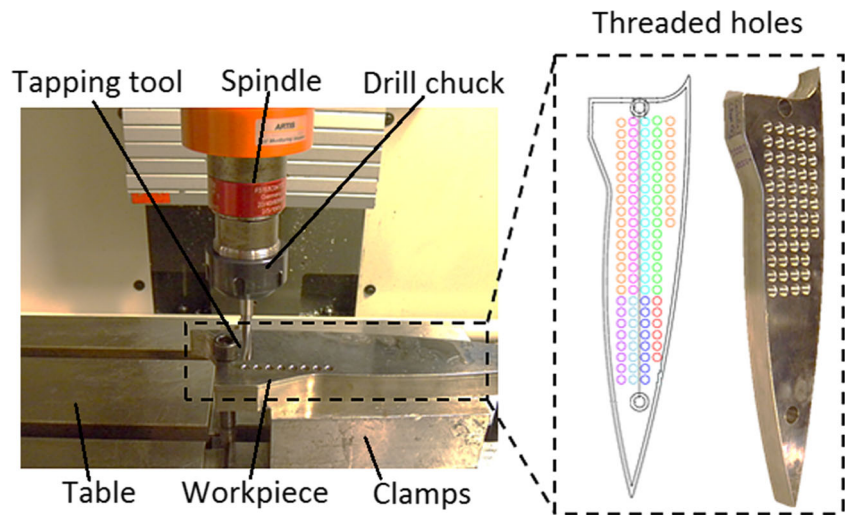
Fig. 1 Tapping setup in a 3-axis machining center, hole strategy, and the final workpiece

tests of drilling and tapping that were carried out in a 3-axis moving table vertical machining center, model: Kondia A6.

The strategy which was adopted for making threads consisted of the following steps: drilling, countersinking, re-drilling, and, finally, tapping. In particular, the first drilling operation was performed with tungsten carbide drills up to a depth of cut of 14.2 mm and a diameter of 4.5 mm. External coolant system was used to fill blind holes with crude oil, and, after that, the holes were blown with compressed air to remove the metal debris from drilling. Then, a countersinking operation was performed with a tungsten carbide tool with a diameter of 6.1 mm and a chamfer angle of 120°. Later, a re-drilling operation was carried out with a tungsten carbide end-mill tool with a diameter of 5.1 mm to thread the optimal geometrical dimensions of the holes. A maximum of five holes were done with the end-mill tool to avoid wear. In this case, the fracture failures were reduced, and the thickness of the heat affected layer in the re-drilling was lower than in the first drilling operation, because of a lower friction at the material-tool interfaces. Consequently, this smaller friction coefficient affected the cutting force, tapping torque, and the surface integrity, as described in the result section. Finally, the last step in the process was the tapping operation with a plug tap reference EG UNF 10–32, Tolerance 3B, and a diameter of 0.2306 in (ref. ID 148008 at DC SWISS SA). The material of the tap contains 8% of cobalt, which enhances such mechanical properties, as strength, toughness, and wear resistance. Different tap configurations were tested in this superalloy, particularly geometrical modifications, coating layer, and resharpening operations were modified to analyze their impact on tapping. Table 2 exhibits the main characteristics of the tested taps and the number of tap configurations used. Table 3 presents the operational conditions for the threading process.

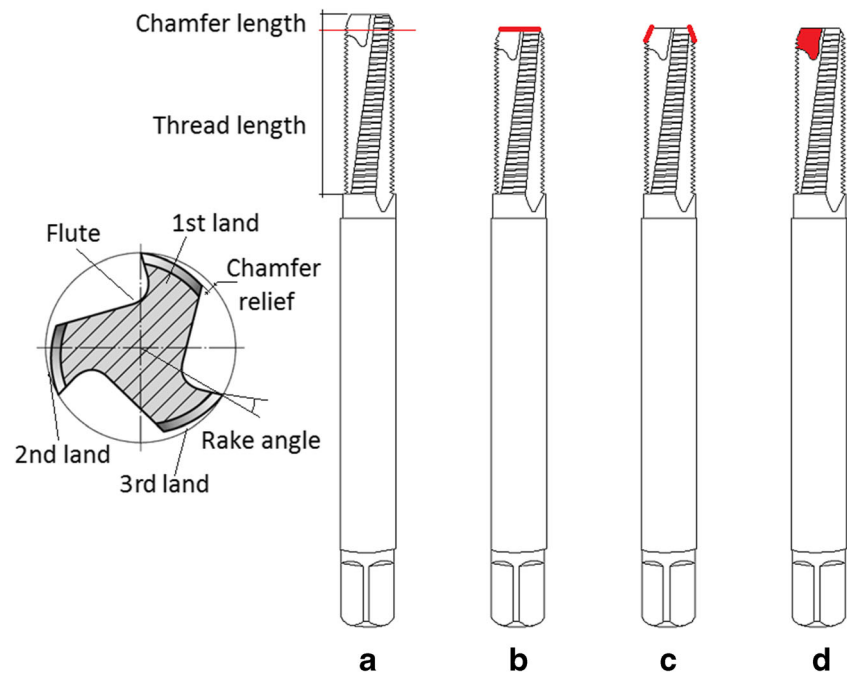
Fig. 2 Tap characteristics and different steps in a resharpening process: (a) as-received tap, (b) tap cut in length, (c) chamfer regeneration, (d) spiral point formation

The completion of resharpening depends on the employee's experience, where the outer peak of the cutting edges and the nominal flute diameter play a key role to perform an accurate tapping operation. These cutting edges of the tap are responsible for removing material, where the rake angle, chamfer length, and relief angle, as well as the number of lands are important parameters to take into account during tapping [6]. In this work, C spiral-flute taps with three cutting lands involved in thread formation were investigated, as shown in Fig. 2a. The tool wear was the main reason to carry out a resharpened process of a worn cutting tap. The steps to resharpening a worn tool are the following ones: the first step consisted in cutting the initial part of the chamfer length, as shown in Fig. 2b. The second step consisted in making a tap chamfer regeneration, defining a longer and sharper chamfer of the thread, as described in Fig. 2c. In this way, the tap can gradually penetrate into the material [10]. This operation was also very important to define the right chamfer clearance angle of the tap that depends on the material to cut [11]. The chamfer angle helps to shear off the chips when threading a hole, and the chamfer regeneration was achieved with a helical grinding

operation, as described by Liao et al. [12]. Besides, Karpuschewski et al. [13] described a method for searching the wheel position in helical flute grinding. Finally, the third step consisted in the cutting edge reinforcement operation, see Fig. 2d, which was a grinding operation in the rake face, also called spiral point. This resharpening operation brings two aspects associated: (1) the tap exhibited a higher negative rake angle which makes the cutting edges stronger; (2) the reinforcement operation helped to finishing the cutting edges by creating new cutting edges which maximize the chamfer length of the tap.

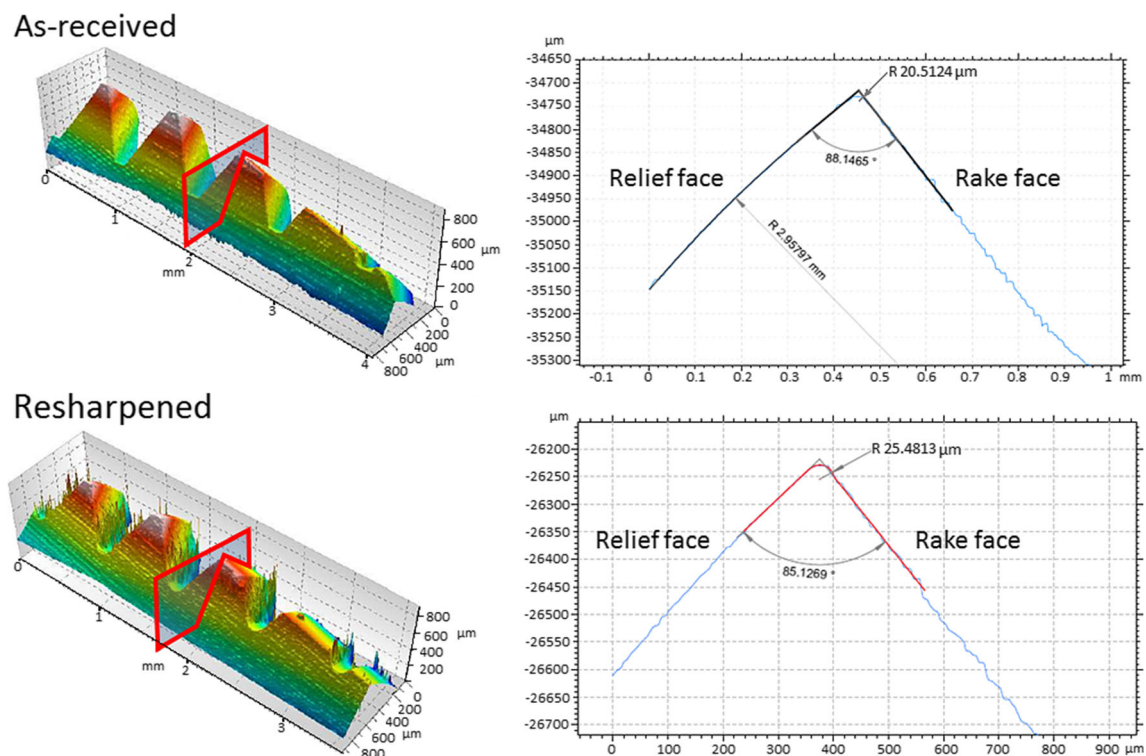
Fig. 3 Topographies of the cutting edges and tool tip radius characteristics for an as-received tap and a tap resharpener once

The evaluation of the cutting performance of the different tap configurations presents some difficulties, because of the low number of threaded holes that each tap can perform in this superalloy before their failure. During the tapping operation in this hard-to-cut alloy, it is common to have broken or flaked edges, which sometimes even happens during the first threaded hole. Determining the wear evolution of the cutting edges is a complex task to assess, where notches and worn edges are limiting factors in the service life and cutting capabilities of these cutting tools. Consequently, surface topographies and profiles of the different tap configurations are repetitively measured to analyze the wear evolution and surface damages. Figure 3 exhibits the cutting edges topographies and the profiles of the tool tip radius for an as-received tap and a tap resharpener once.

The surface topographies in both taps present similar geometrical dimensions, although the angle between the relief face and the rake angle changes a few degrees depending on the tap configurations. The resharpener taps present a sharper cutting edge compared with the as-received ones, as expected

from the removal material process of tool resharpener. Additionally, the tool tip radius is also different between both taps. The as-received tap exhibits a radius of 20.5° , while the radius of the resharpener tap is about 25.5° . These few degrees will make a great difference during tapping, due to a higher contact area between tool-workpiece interfaces. A bigger geometrical difference is observed when comparing these two taps with a worn tap after its service life. The radius value of the worn tool tip is noticeably blunt than the as-received tap. Besides, notches and material adhesion are commonly found at the worn cutting edges. These higher values of tool tip radius and flaked cutting edges have been proved to affect the thrust force and torque during tapping [15, 16]. Figure 4 shows an as-received tool at the end of its service life with a tool tip radius of 41° and a notch in the first cylinder teeth after the chamfer clearance. Note that the tip radius is twice the value of the radius of an as-received tap. This higher value of tool tip radius increases the contact area between the interfaces of the tapping tool and the material to cut. As a consequent, higher friction coefficient is expected in tapping. This higher friction coefficient will bring higher values of cutting force and tapping torque, greater wear of the cutting tool, and poorer quality of the thread of the final workpiece.

around 7 times sharper than a resharpened tool, both after achieving the 8th thread. Note that the resharpening process is performed to the worn cutting edge to achieve similar tool tip radius and rake angle than the as-received tap (see Fig. 3). In this sense, it is expected to weaken the cutting edges due to the rake angle decrease with the resharpening process.

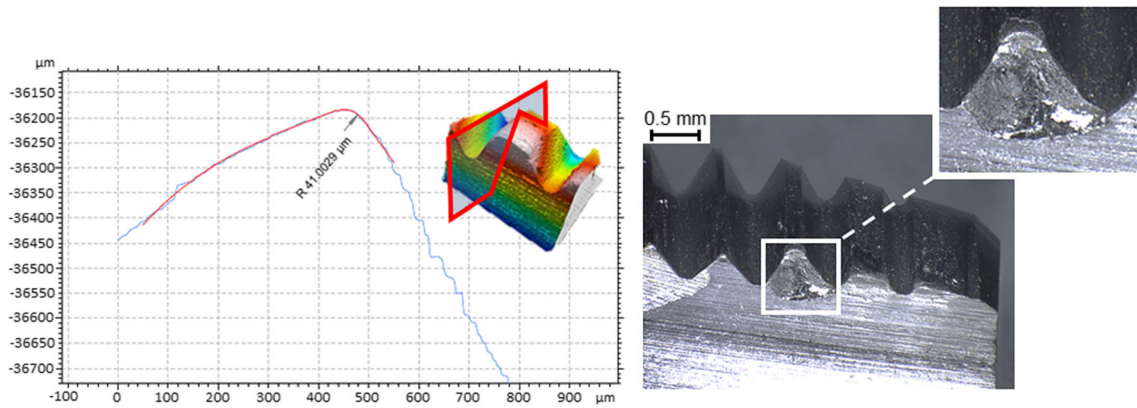
Fig. 4 Typical value of a worn cutting edge and a notch commonly found in these cutting tools at the end of its service life

The test stop criterion and, subsequently, tool replacement was defined for three different circumstances. The first stop criterion is defined by the quality of the thread, which is the most common stop criterion in industry. This quality is tested by using Go/No-Go gauges. The second stop criterion was due to high values of tapping torque, particularly higher values than $12\ \text{Nm}$. Accordingly, high values of torque are associated with a high level of tool wear; breakages or notching in several edges of the tap; or the catastrophic failure that sometimes could happen, due to the high demands in the machining of Inconel 718. For these worn cutting edges with low cutting capabilities, undesired findings during tapping can be found, such as unremoved metal debris and notches. Finally, the third stop criterion is to analyze the wear degradation of the tapping tool in a microscope. In particular, notches of about $0.25\ \text{mm}$

in a cutting edge of the tap are considered as a stop criterion for replacing the tapping tool.

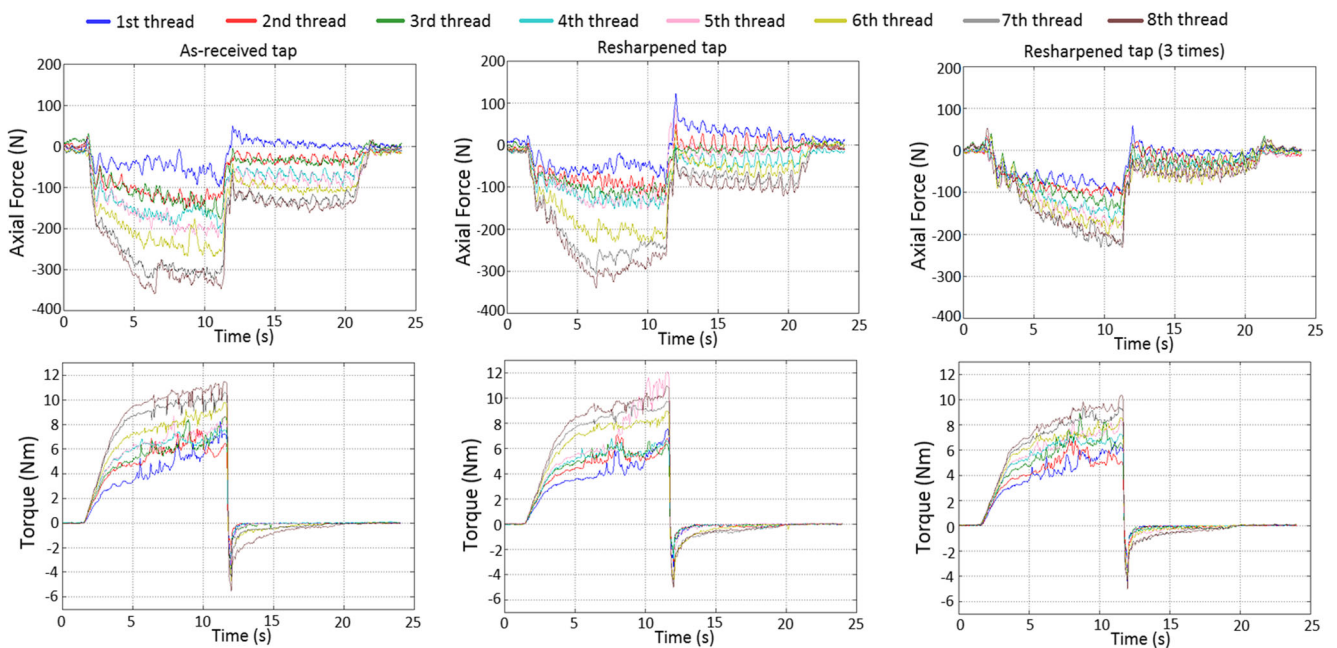
Fig. 5 Axial force and tapping torque of the different threads performed in Inconel 718 with an as-received tap, a tap resharpener once, and a tap resharpener three times

Inconel 718. The magnitudes of the axial force and torque are measured to describe the cutting capabilities of each tap configurations. Thus, Fig. 5 exhibits the axial force and torque of the eight threads performed in Inconel 718 with an as-received tap, the same tap resharpener once and resharpener three times.

Firstly, it is denoted that the axial force increases with the number of threads. The 1st thread exhibits the lowest cutting forces, and the 8th thread needs a higher cutting force for tapping, independently of the tap configurations. The maximum values of axial force in 8th thread were about -350 N, -300 N, and -220 N for an as-received tap, a tap resharpener once, and a tap resharpener 3 times, respectively. Regarding the tapping torque, the maximum values of torque 8th thread were about 11.6 Nm, 12 Nm, and 10 Nm for an as-received tap, a resharpener tap, and a 3 times resharpener tap, respectively. Subsequently, the

resharpener cutting tools decrease the required axial force and torque in tapping, which seems to be associated with the lower angle between the relief and rake faces. This lower angle decreases the contact area between tool and workpiece and, consequently, promotes a decrease of friction between the interfaces of the tap and the material to be threaded. Figure 6 shows the required tapping torque versus the number of threads performed in Inconel 718 with an as-received tap, a tap resharpener once, a tap resharpener and recoated, and a tap with 2° extra of chamfer clearance angle. In this sense, wear capabilities of these tap configurations are analyzed according to the number of threads achieved following the same procedure. The average value of torque per thread is calculated with the area under the curves divided by the total time taken to tap the hole, rotate the tap in reverse to take them out of the hole, and clean the metal shavings from the threaded hole. Each

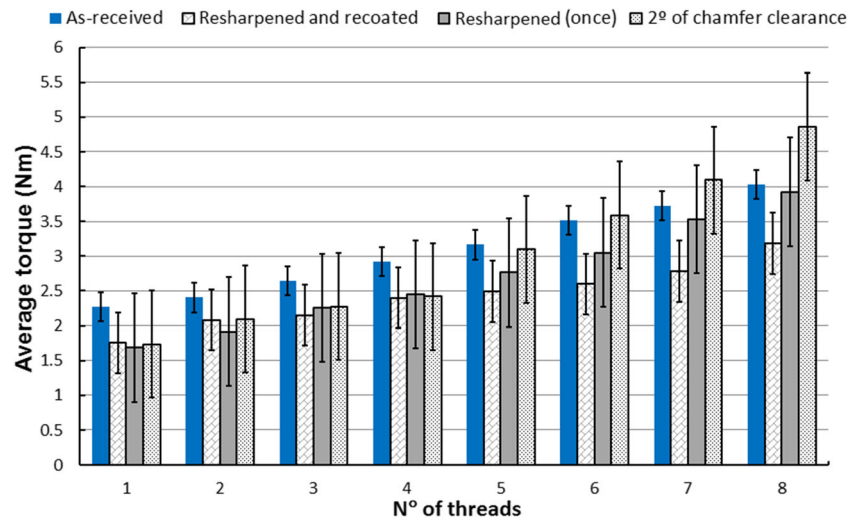
Fig. 6 Evolution of the average torque for the tested tap configurations as a function of the number of threaded holes. Note that the average torque is represented by the average of three measurements and the error bars correspond to a standard deviation

experimental value is the average of three measurements and the error bars correspond to the standard deviation. The tapping torque tends to increase with the number of threads, due to the wear of the tool that affects the cutting capabilities of the taps [17]. Accordingly, the as-received taps show the highest torque values of 2.2 Nm and 3.2 Nm in average for the 1st and the 5th thread, respectively. For the last threads, the cutting tool with 2° extra of chamfer clearance angle exhibits the highest torque values of 3.6 Nm and 4.8 Nm in average for the 6th and the 8th thread, respectively. On the contrary, the tap resharpended once and recoated exhibits the lowest values of torque of about 1.7 Nm, 2.5 Nm, and 3.2 Nm in average for the 1st, the 5th, and the 8th thread, respectively. Regarding the resharpended taps with and without recoating, they present similar torque values than the tap with 2° extra of chamfer clearance angle up to the 5th threaded hole. Similar results were reported by Lorenz et al. [18], where a reduction of torque is found for 7/16–20 UNF taps with a greater chamfer relief. Oezkaya and Biermann [19] also compared numerically and experimentally uncoated and coated tapping tools. They found lower average torque values for the coated tools independently of the metric thread. When comparing the results from the 5th to the 8th threaded holes, noticeable torque differences are found between the resharpended taps with respect to the resharpended and recoated taps. In particular, lower torque values are observed for the recoated taps, due to the excellent wear capabilities of TiCN which helps to enhance the service life by reducing tool wear. Finally, the worst scenario is found for the tap with 2° extra of chamfer clearance with values of torque of 4.8 Nm, when performing the 8th threaded hole. This high value of torque is likely attributed to the higher surface degradation observed in the first cylinder teeth after the chamfer clearance modification, as can be seen in the surface integrity subsection.

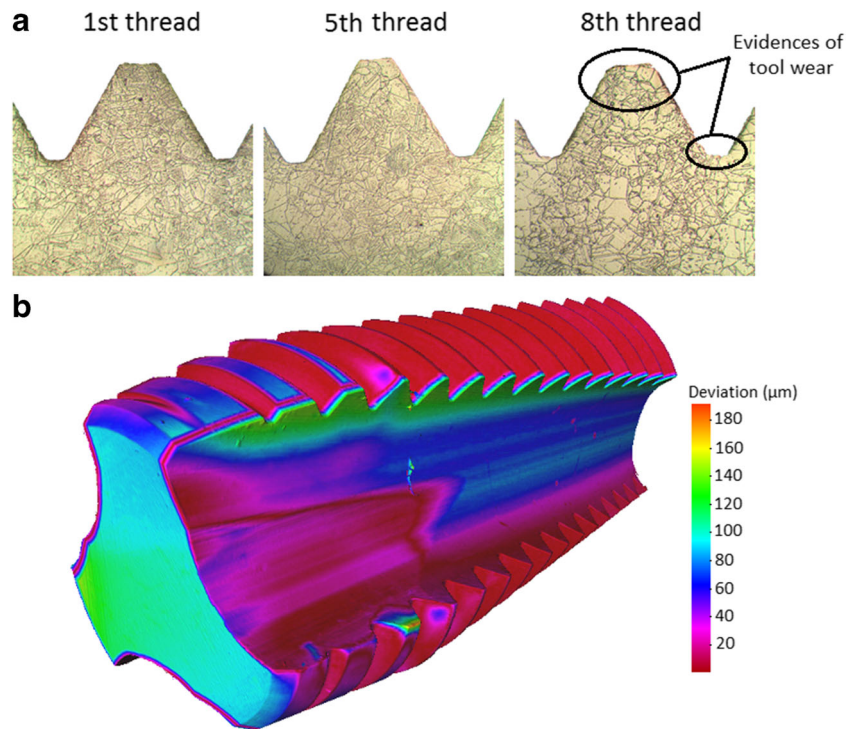
Fig. 7 (a) Surface integrity of a tapping hole with an as-received tap in the 1st, 5th, and 8th threaded hole. (b) Worn progression tool tip radius and surface damage at the valley after performing the 8th tapping hole with respect the as-received tap

The surface analysis of the different tested taps is carried out after performing different number of threaded holes (from one to eight threads). For this purpose, the threaded samples were cut from the end part and encapsulated in Bakelite. After that, they were grinded with a series of grits in a rotating wheel, polished by using several cloths with diamond suspensions spray up to 1 μm and etched with Kalling's reagent n° 2 (5 g CuCl_2 , 100 ml HCl, 100 ml ethanol). Then, the material's microstructure was analyzed as recommended by the ASTM standard E407 [20]. Following this procedure, the edges of the cutting tools are observed with the aim to describe surface damage, material adhesion, microcracks, laminations' effects, and worn of the tool tip radius. These undesired findings are aggravated right at the end of the chamfer length, which defines the finished size of the desired thread. All these surface defects will affect the quality and lifespan of these tapping tools. Sometimes microcracks, material adhesion and lamination can be found in the first threaded hole, even for threads generated with a brand new cutting tap. Figure 7a shows the surface integrity of the specimens threaded with an as-received tap in the 1st, 5th, and 8th threaded hole. Additionally, Fig. 7b exhibits the surface deviation after performing the 8th threaded hole compared with respect to the as-received tap. An evident worn progression of 180 μm is denoted at the tool crest after performing the 8th threaded hole.

No noticeable surface differences are found at the tool crests and valleys of the taps between the 1st and 5th thread. Similar results were found when comparing equivalent threads for as-received and resharpended taps. Evidences of worn of tool tip radius or the threaded material are denoted in the 8th threaded hole. In particular, flatted edges with higher radius are found, but not micro cracks, material adhesion, or deformed grains. Higher tool tip degradation and cutting

forces were found in the crest of the first full thread of the cutting tool, right after the chamfer length, which is referred to a maximum load distribution across the cutting teeth and chip formation. Similar results were described by Axinte et al. [21] when investigating the surface integrity of different polished methods in Ti6AL4V. Figure 8 shows the profiles of the cutting edges for an as-received tap, an as-received tap in the 8th thread, and a resharpened tap without coating in the 8th thread. The profile measurement is performed at the first full thread, where higher tool degradation is observed. Resulting that the tool tip radius of an as-received tap is around 2.5 times sharper than the same tool after performing the 8th threaded hole. Also, the radius of the tool tip for an as-received tap is

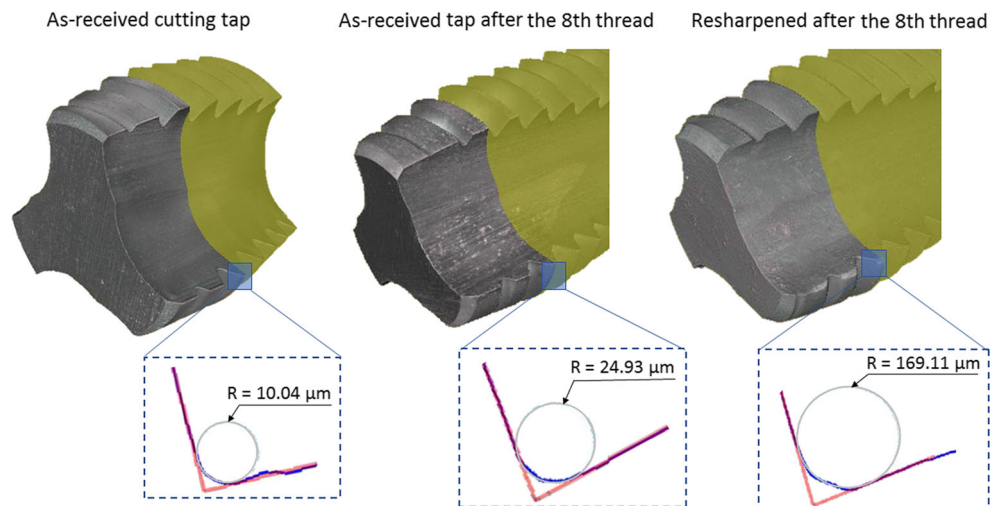
Fig. 8 2D profiles of the cutting edge for an as-received tap, an as-received tap after the 8th thread, and a resharpened tap after the 8th thread

Despite of the roundness differences at the tool tip radius, all the threads were correctly assessed without deformed grains, cracks, or material adhesion in the threaded holes, independently of the tap configurations. Regarding the surface deviation of the cutting tool when performing the 8th threaded hole, crest edge smoothness evidences up to 25 μm are denoted right at the end of the chamber length, particularly at the

first full-thread teeth. In this first full thread is expected to bear the higher cutting force [22]. The resharpened and uncoated taps showed higher radius of the tool tip after the tapping process, which is associated to higher cutting force deviation and worse quality of the surface integrity. Furthermore, the surface deviation in average is found to be 180 μm along the tap's flute (see Fig. 7b), due to the interaction between the cutting tool with the metal shavings. Similar values of wear of the as-received tap are found for resharpened and recoated taps. This is because recoating the helical flute facilitate firstly to remove the metal chips and secondly to reach the lubricant the cutting teeth. Therefore, resharpening and recoating taps have shown the best machining performance in tapping Inconel 718, because of reducing adhesion which was the main wear mechanism. Hence, resharpening and recoating taps could be the right choice for improving the tapping operation and saving expenses of tool replacement and manufacturing downtime.
