Renaissance patinas in Úbeda (Spain): mineralogic, petrographic and spectroscopic study

Abstract Different analytical techniques were used for microstructural and compositional analysis of the ochre-coloured patinas that appear on the calcarenite substrate of monuments in the historical settings of Úbeda and Baeza (Spain). Optical microscopy, scanning electron microscopy–energy dispersive x-ray spectrometry (SEM-EDX), x-ray diffraction, Raman spectroscopy and attenuated total reflection–Fourier transform infrared spectroscopy (ATR-FTIR) were employed and a critical comparison of their experimental requirements, strengths and weaknesses is presented. The study focussed on two churches in Úbeda where patinas were widespread in ornamental elements. These films contained calcite as the principal component, and traces of dolomite and feldspars. Clear identification of calcium oxalate, mainly in the form of whewellite, was achieved by infrared and Raman spectroscopic studies. Results from texture, distribution and composition of the patinas in ornamental elements suggest that ancient treatments were applied for protection of Renaissance façades and consolidation of weathered older façad

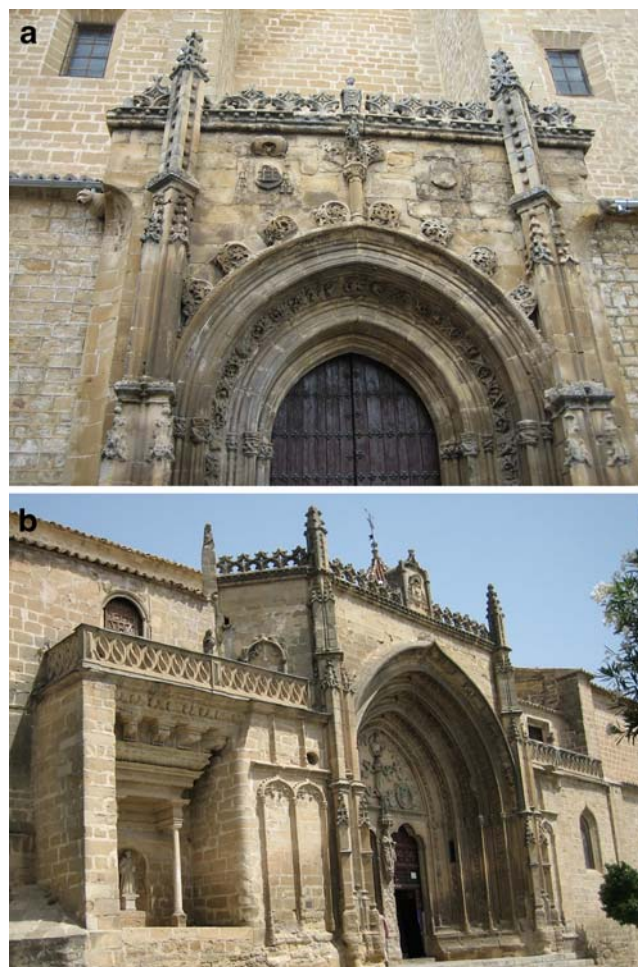
Fig. 1 Southern façades of San Isidoro (a) and San Pablo (b) churches in Úbeda (Spain)

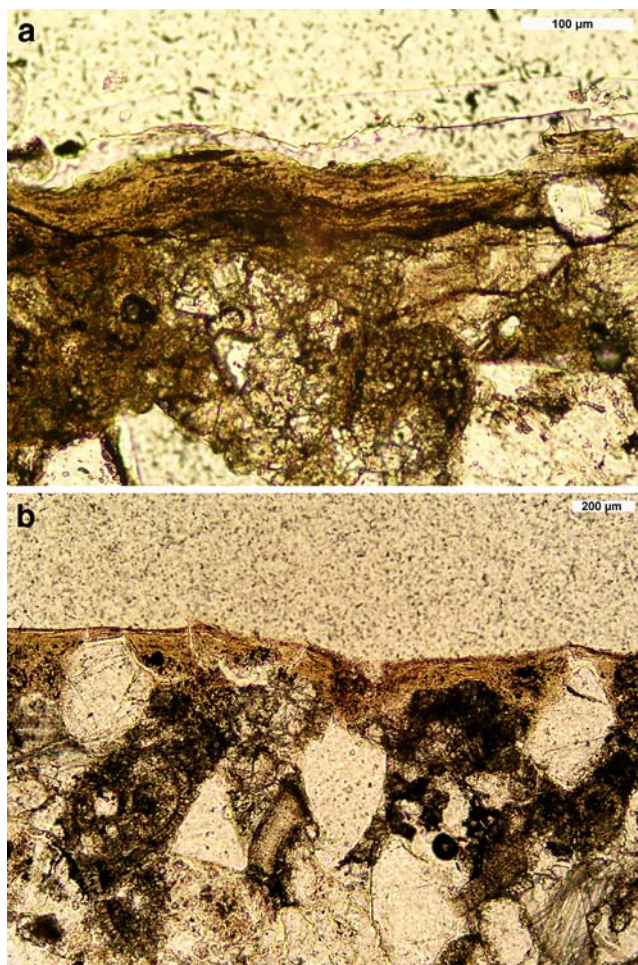
Fig. 2 Ochre-coloured patinas covering ornamental elements in the southern façades of (a) San Isidoro's church (SIU-17) and (b) San Pablo's church (SPU-27). Plane-polarised light. (a) Patina is homogeneous, shows a slight lamination and covers a nonweathered surface. Scale bar 100 µm. (b) The patina is homogeneous, cryptocrystalline and slightly polystratified. The layer–stone contact is sharp but some microfissures can be observed. Scale bar 200 µm

The samples from the southern façades of San Isidoro (SIU) and San Pablo (SPU) churches showed a thin continuous superposition of ochre-coloured layers perfectly adhered to the stone surface (Fig. 2). The layers were very homogeneous and 30- to 70- μ m thick. In addition to small grains of calcite, patina appears to be composed (in plane-polarised light) of a micritic matrix in which minerals could not be identified because of their tiny size. Some ferruginous stains could be also distinguished inside. These iron oxides contribute to give the patinas their characteristic ochre colour.

Microfissures were sometimes found perpendicular to the surface of the patinas (see Fig. 2b). The substrate under the layer is a partially cemented Franca stone with traces of gypsum. No traces of biological growth were found.

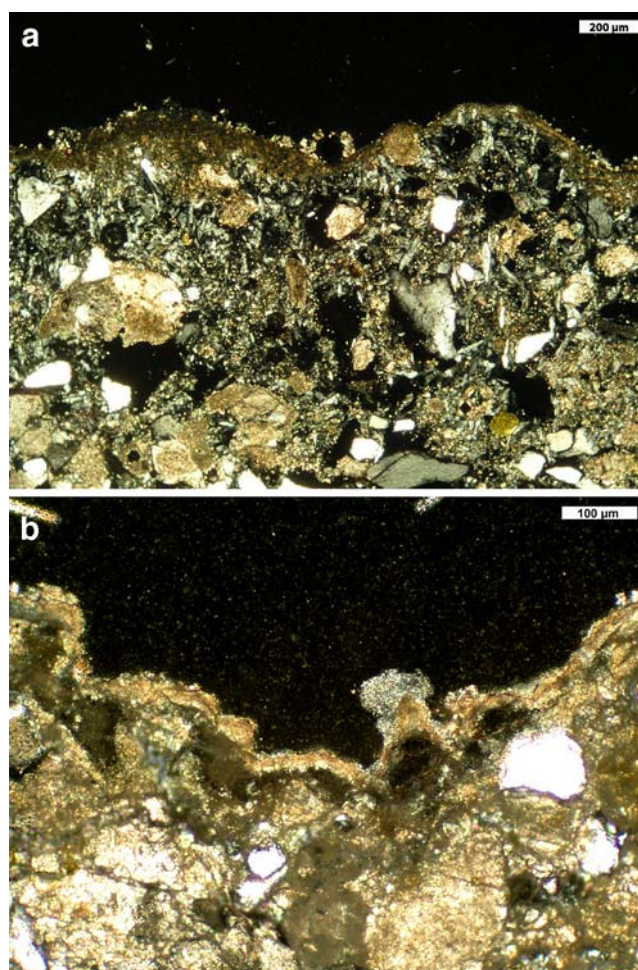
Fig. 3 Patinas (a) SPU-73 and (b) SPU-55 from San Pablo's church. Cross-polarised light. (a) Thin and discontinuous patina covering an ornamental element (northern façade). The stone substrate is completely grain disaggregated and the calcitic cement has been substituted by neoformed acicular crystals of gypsum. Scale bar 200 µm. (b) Irregular patina covering a weathered supporting ashlar on the western façade. The outer stone surface is altered and it shows an increment of porosity and a decrease of calcitic cement. Scale bar 100 µm

The patina from the northern and western façades of San Pablo's church showed diffused levels and an irregular borderline as it penetrates inside microcracks and irregularities of the stone (Fig. 3). In these cases, stone substrate was always altered; see for example Fig. 3a where a clear crystallisation of acicular gypsum is observed. Discontinuities between the layer and the stone substrate were detected. Although patinas were mainly found over ornamental elements, few mortars and ashlar seem to be coated by an ochre layer in the northern and western façades (Fig. 3b).

In sheltered areas of both churches, especially in San Pablo's, patinas seem to be covered by an acicular gypsum layer containing dust and small fragments of calcite and

quartz (see Fig. 3). All these components formed a typical black crust [26] caused by atmospheric weathering.

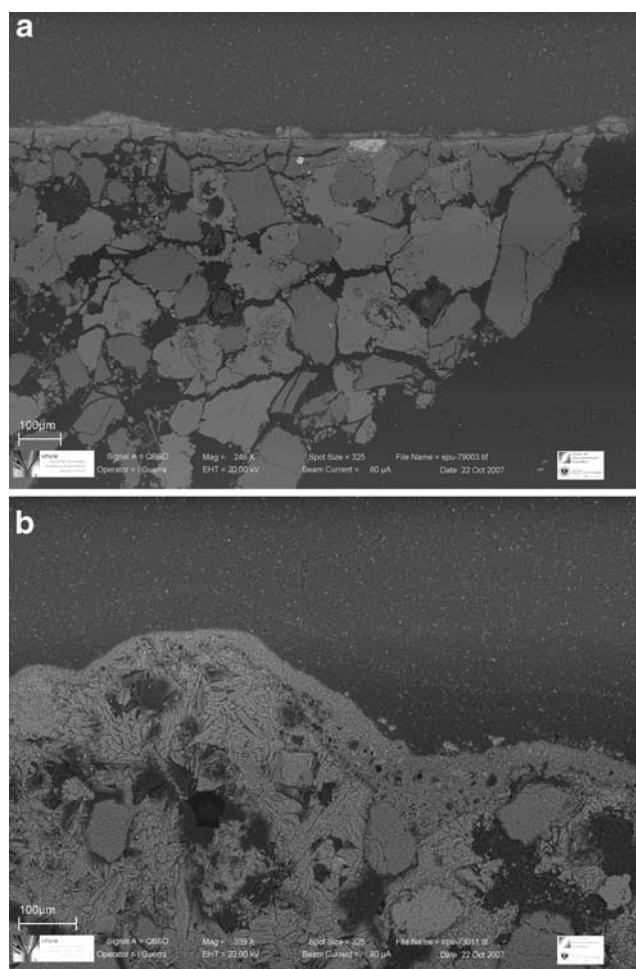
Fig. 5 SEM-BSE (backscattered electron mode) image of thin sections of patinas in ornamental elements. Scale bar 100 μm . (a) SPU-31: thin and regular patina develops on calcarenite, in which an ochre micritic layer can be seen in direct contact with the rock. The ochre layer appears microlaminated. (b) SPU-73: the patina covers the surface and adapts to the irregular underlying surface. Gypsum fills underlying pores and cavities

The morphology of the patinas has been previously discussed and our SEM images showed similar results. Figure 5 shows that the outer surface of the patinas was relatively homogeneous and smooth. EDX results (see Fig. 6a) showed that the major component, calcium, was accompanied by minor amounts of aluminium, silicon and iron. This result pointed to calcite being the essential component of the patina. Aluminium and silicon indicated the presence of clay minerals. Iron was attributed to Fe oxides and clay minerals, although it can also appear as atmospheric particulate matter together with bromine, zirconium and lead.

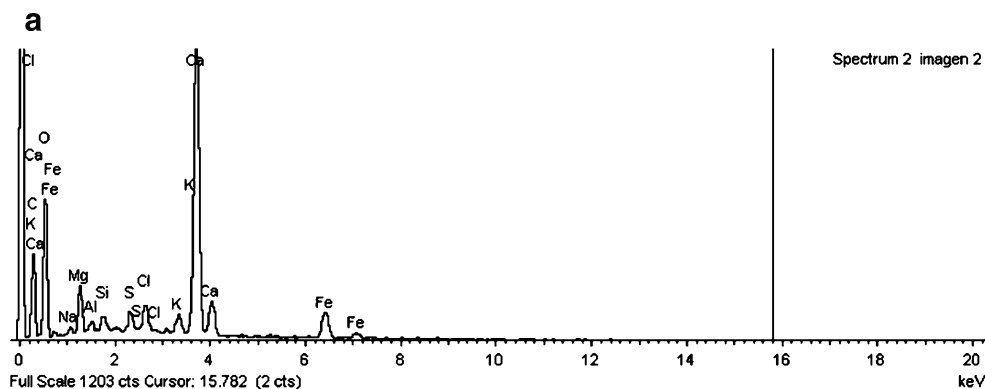
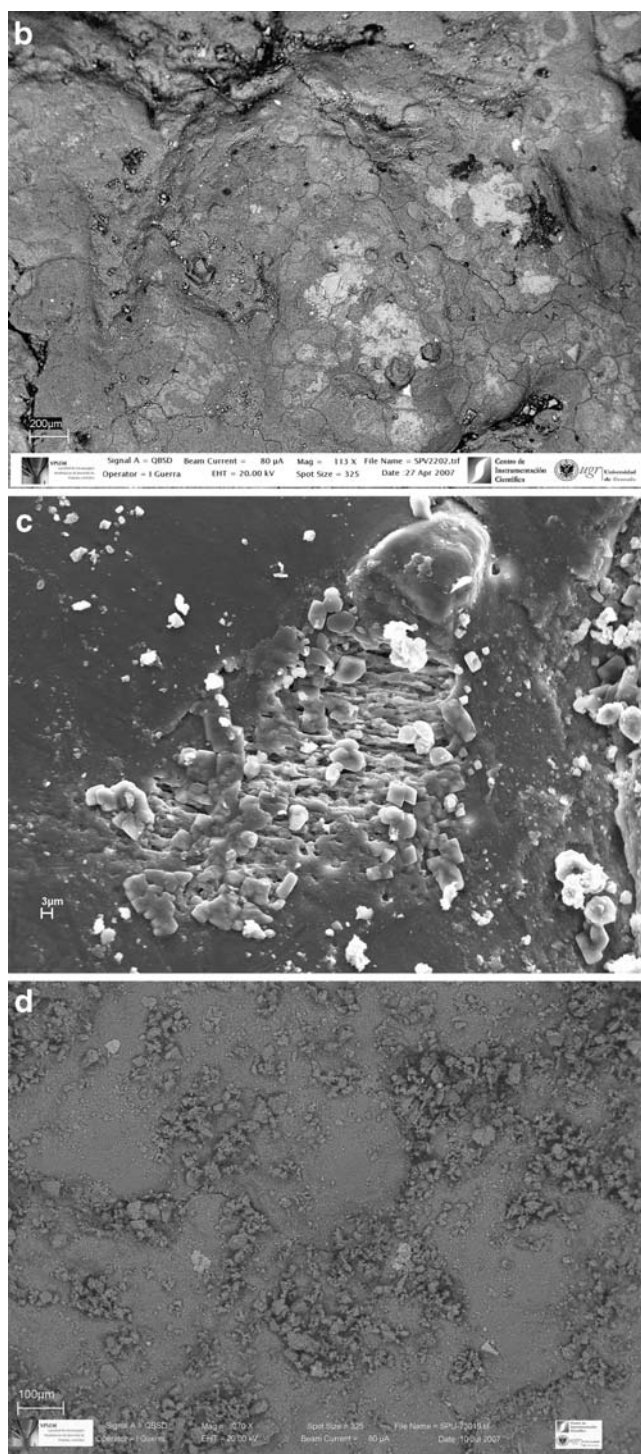
Fig. 6 (continued)

Fig. 6 Typical EDX-SEM analysis of the surface of a patina sample (a). SEM-BSE images of the surface of samples (b) SPU-22 showing retraction microcracks. Scale bar 200 μm ; (c) SIU-17. Small crystals of Na/K chloride crack the continuity of the patina as efflorescences. Scale bar 3 μm ; and (d) SPU-73. The surface of patina shows chloride and sulfate efflorescences. Scale bar 100 μm

The surface of the patinas was occasionally cracked by microfissures. Perpendicular microfissures (Fig. 6b) which

seem to be produced by retraction of the original paste and parallel microfissures produced by the growing of crystalline salts (e.g. gypsum, halite, sylvite, mirabilite or hexahydrite) (Fig. 6c). EDX microanalysis provided information about their constituents being the more important sodium, potassium, magnesium, calcium, sulfur and chlorine. Soluble salts, especially Na–K chloride and Ca–Mg sulfates, crystallise as subflorescences and cryptoefflorescences. Most of these ions came from adjacent mortars and were distributed by the high capillary rise. The efflorescences promoted the loss of calcitic cement and the grain disintegration of the underlying calcarenite (Fig. 6d).

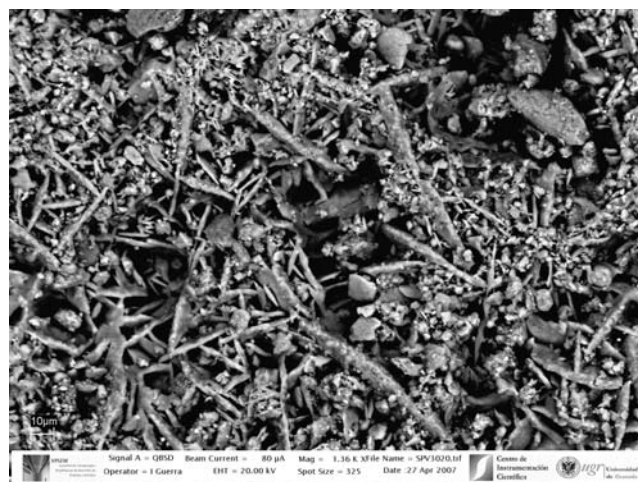
Fig. 7 SEM-BSE image of the surface of a typical black crust of lenticular gypsum crystals (with dust particles trapped in the network) on the patina SPU-29. Scale bar 10 μm

Sometimes, patinas were covered by black crusts of gypsum (see Fig. 7). These crusts had already been observed by OM and also contained dust particles (calcite, quartz, carbonaceous particles). EDX microanalysis also allowed the detection of metallic particles which reveals atmospheric pollution. The fact that San Pablo's church is located in an area with a busy road helps to explain the presence of black crusts overlapping the patinas [1] in ornamental elements sheltered from washout [13, 23]. Due to gypsum aggressiveness, patinas were altered because it crystallises and penetrates into microfissures contributing to the scaling of the patina.

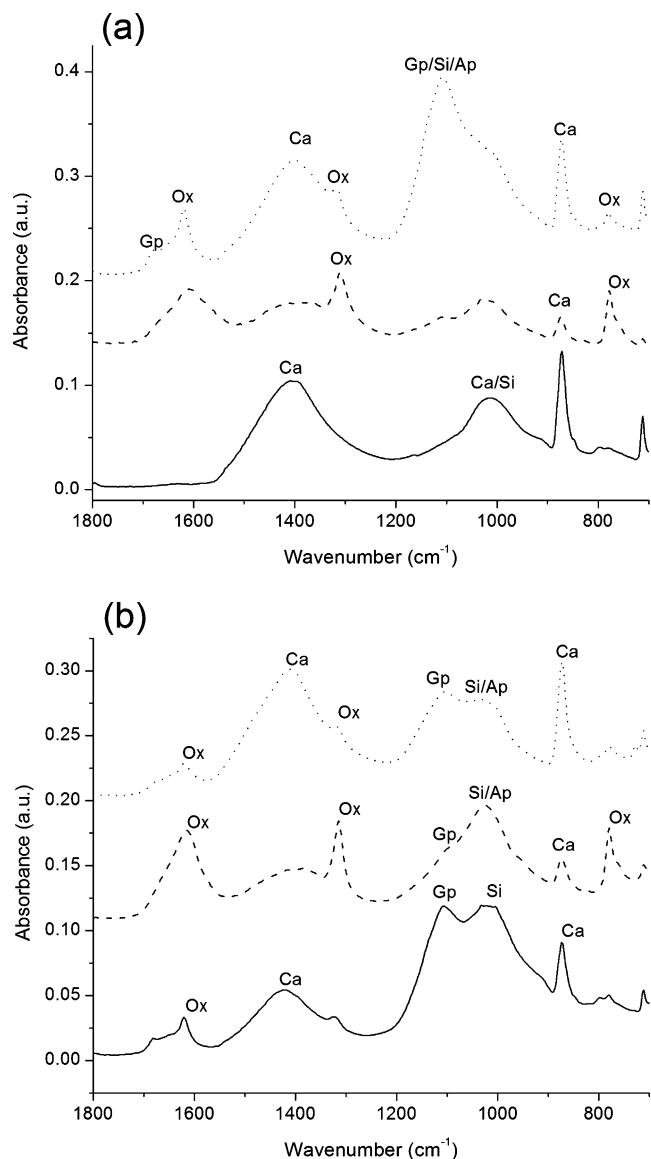
Fig. 9 Recorded Infrared spectra of (a) “Franca substrate” (black) and two samples from ornamental elements SIU-17 (red) and SPU-73 (green); and (b) samples from supporting elements SPU-55 (black), SPU-61 (red) and SPU-68 (green). *Ca* calcite, *Gp* gypsum, *Ap* apatite, *Si* silicate, *Ox* oxalate

Infrared spectra were obtained in attenuated total reflection (ATR) mode. The short penetration of the radiation when using the ATR technique is an advantage for the study of patinas because the underlying substrate does not interfere in the recorded spectra. The application of high pressure was necessary to achieve an intimate contact between the sample and the ATR element due to the hardness and the irregular surface of the samples. This was only possible using a single-reflection diamond crystal. Typical ATR-FTIR spectra of unaltered Franca substrate and patinas are shown in Fig. 9. The spectrum of the substrate is dominated

by typical bands of calcarenite: two broad absorption bands centred at about 1,400 and 1,000 cm^{-1} due to carbonates and silicates, respectively, and two sharp spectral features located at 872 and 712 cm^{-1} due to calcite.

Infrared spectra of the patinas revealed the presence of different amounts of calcium oxalates and calcite in all the samples studied (Fig. 9). The distinction between the two

forms of calcium oxalate using IR is more difficult than using Raman spectroscopy, because it is based on the slightly shifted symmetric O–C–O stretching vibrations of whewellite, and weddellite, located at 1,317 and 1,324 cm^{-1} , respectively [13, 36]. Thus, although the characteristic absorption peak of whewellite was mainly detected, slight shifts of the band can indicate the presence of weddellite. The identification of other compounds is more complicated due to the overlapping of broad spectral features in the region 900–1,200 cm^{-1} . However, the use of the second derivative allowed discrimination between overlapping bands [13]. In this way, gypsum with an antisymmetric stretching band of SO_4^{2-} at 1,111 cm^{-1} [37] and apatite with PO_4^{3-} antisymmetric stretching at 1,029 cm^{-1} [29] could be identified in some samples.
