The Bangudae Petroglyph in Ulsan, Korea: studies on weathering damage and risk prognosis

B. Fitzner · K. Heinrichs · D. La Bouchardiere

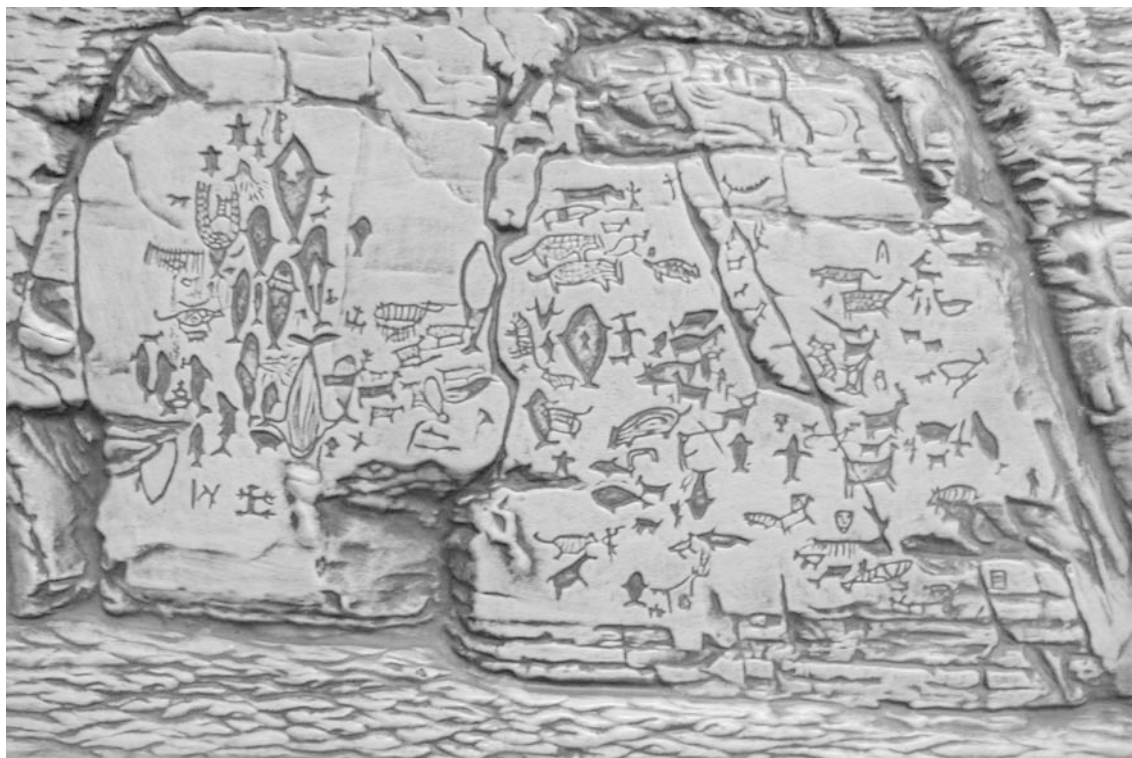
Fig. 1
Model of the Bangudae Petroglyph

Korean National Treasure (No. 285). The petroglyph shows about 200 carvings including land animals, sea animals and hunting scenes (Figs. 1, 2, 3, 4). The carving techniques are classified into Myeonjjogi—chiselling out completely the inside of the object, and Seonjjogi—chiselling just outlines. The petroglyph was carved on a cliff, which is composed of sedimentary rocks—sandstone, siltstone, sandy shale—of the Silla Series/Cretaceous. The bedding planes incline with 12.5° in direction of NW. The cliff is affected by a considerable number of structural discontinuities. The petroglyph is protected against rain by protruding rocks above it.

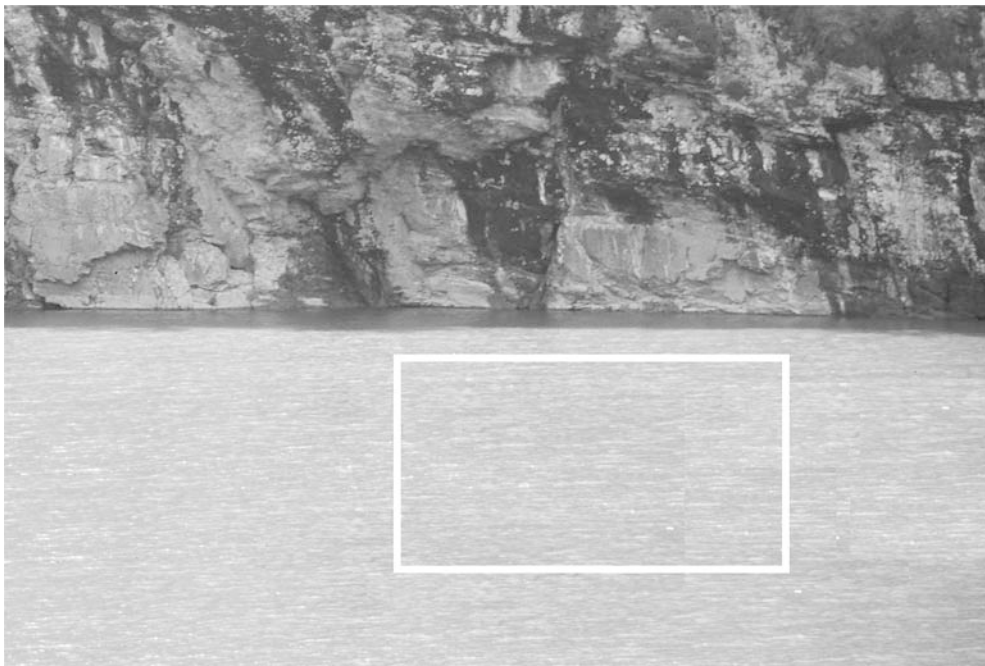
Fig. 6
The Bangudae Petroglyph
(location indicated by the *white frame*) submerged by the Sayeon reservoir water

The Bangudae Petroglyph is situated at the Daegok River, a tributary of the Taehwa River (Fig. 5). In the period between 1962 and 1965, the Sayeon dam was built on the Daegok River establishing a water resource for Ulsan Metropolitan City. Since the construction of the dam, the Bangudae Petroglyph is submerged for about 8 months/year—from early spring to autumn—by the Sayeon reservoir (Fig. 6). The consequent danger of increasing stone deterioration and, thus, ir retrievable loss of most important cultural heritage, has resulted in intensive efforts to prevent damage and to protect the petroglyph for future generations.

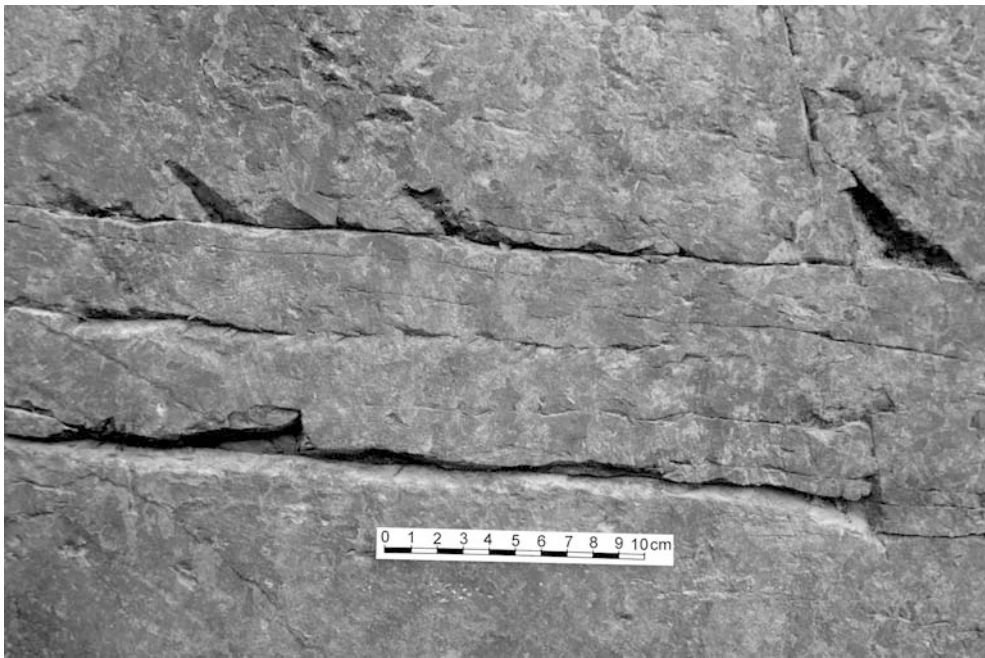
Fig. 10
Weathering form “splitting up
(Xv)”

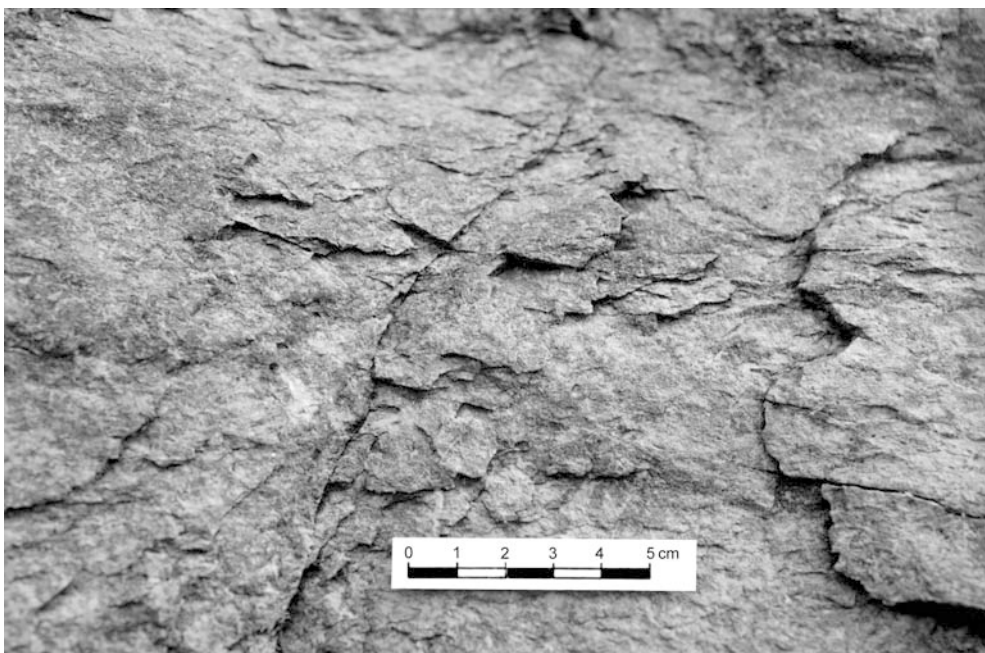
Fig. 11
Weathering form “multiple
flakes to crumbling (mF-Pu)”

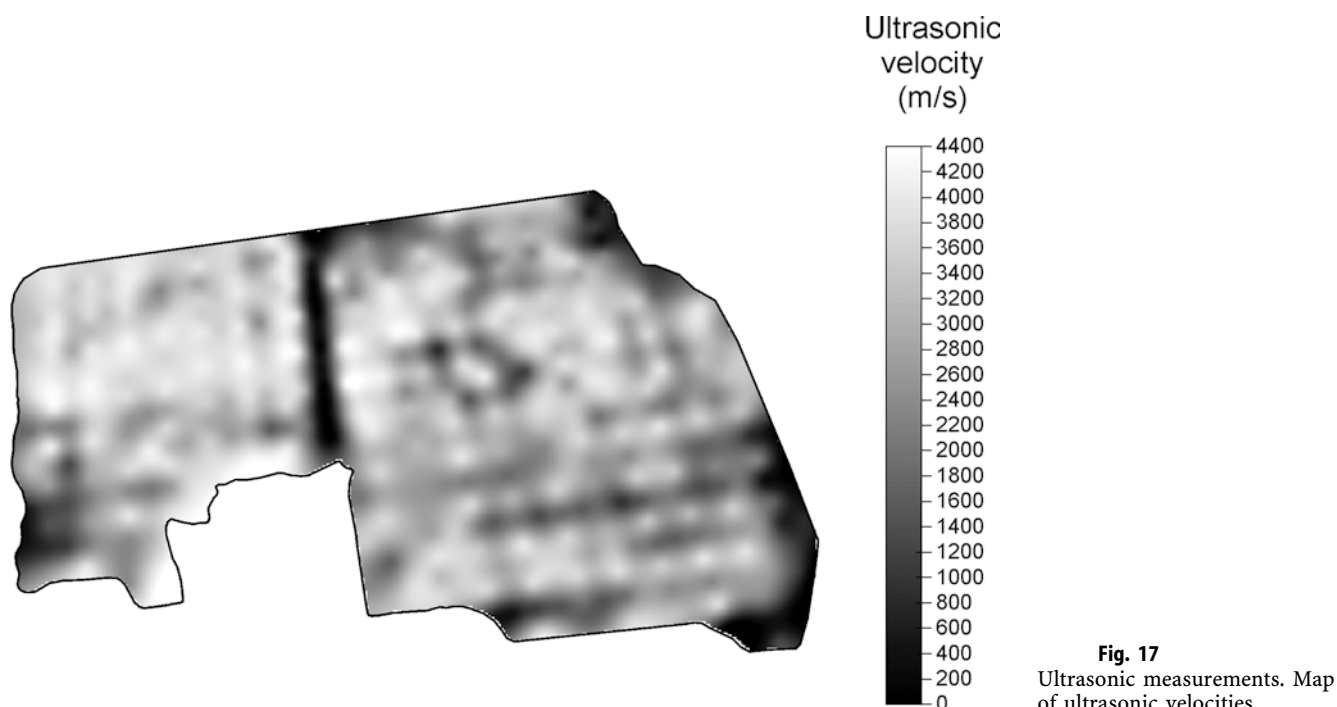
Ultrasonic velocities were used to quantify the weathering state of the rocks, especially with respect to disintegration/detachment of stone material and discontinuities/fissures. They are mapped as isolines in Fig. 17. Their

intensity of disintegration/detachment of stone material and the dimension of discontinuities (depth, width) increase. In Fig. 17 the transition from unweathered rocks to increasing deterioration of rocks correlates with the transition from light grey to black colour. The colour pattern clearly reflects and quantifies a significant network of individual or intersecting discontinuities and the map is an important supplement to the fissure map (Fig. 12). High to very high ultrasonic velocities (3,500–

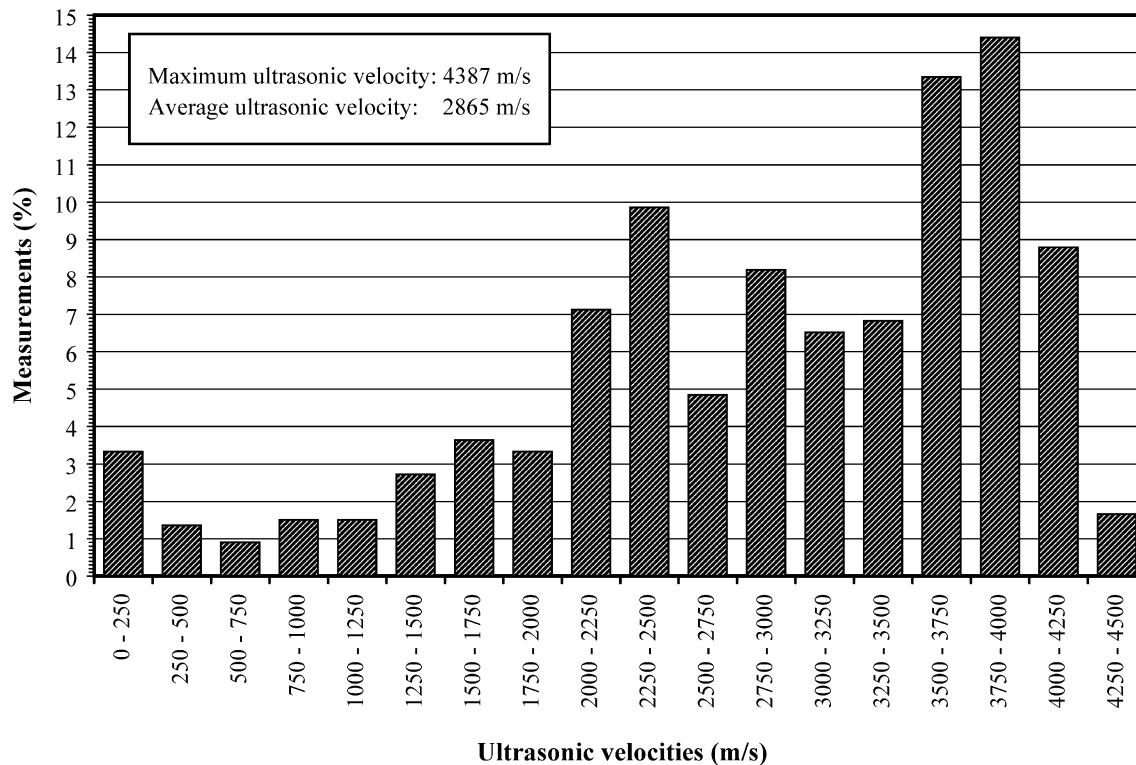
Fig. 18

distribution is classified in Fig. 18. The highest ultrasonic velocities of about 4,400 m/s correspond to the ultrasonic velocities determined for the unweathered parts of the analyzed samples. Ultrasonic velocities decrease as the

Classification of the ultrasonic velocities

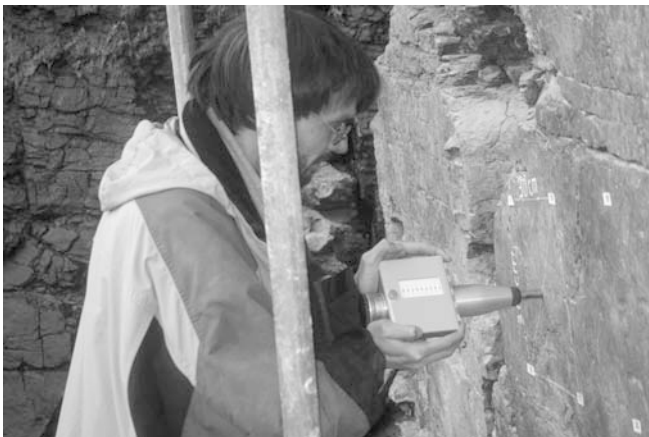
Rebound hardness measurements with a Schmidt hammer

The rebound hardness measuring procedure is illustrated in Fig. 19 and the distribution of the rebound hardnesses is classified in Fig. 20. The registered rebound hardnesses range between 19 and 56. The rebound hardness for non-carved areas without any detachment of stone material ranges between 45 and 56 (average: 49). It is striking that the rebound hardness for carved areas without any visible stone deterioration is considerably lower. It ranges between 34 and 46 (average: 41). This indicates a weakening of the grain-bond due to the carving procedure. With respect to detachment of stone material, the lowest rebound hardnesses were stated for stone surfaces affected by intense crumbly disintegration. Considering the rather high average rebound hardnesses related to other types of detachment of stone material, it can be deduced that the detaching stone pieces are still well-connected to the stone beneath. Therefore, a rapid loss of stone material in the near future is not very probable. Results obtained from the evaluation of weathering forms and from the in situ measurements (ultrasonic measurements, rebound hardness measurements) were combined for the characterization and quantification of damage zones.

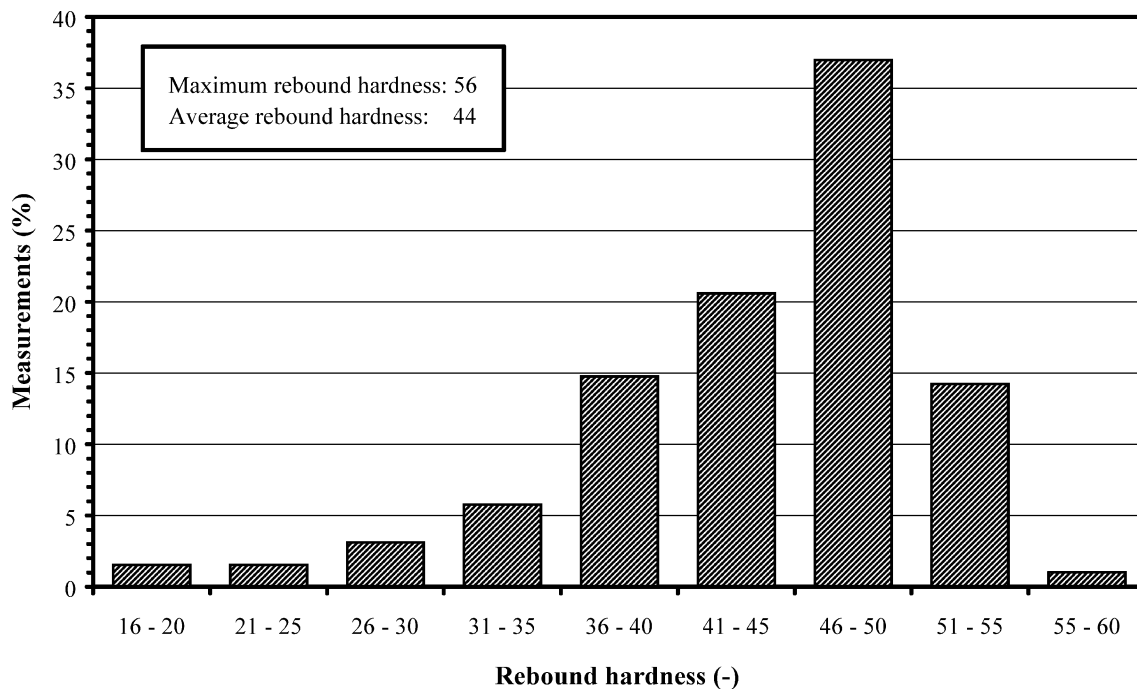
Fig. 20
Classification of the rebound hardnesses

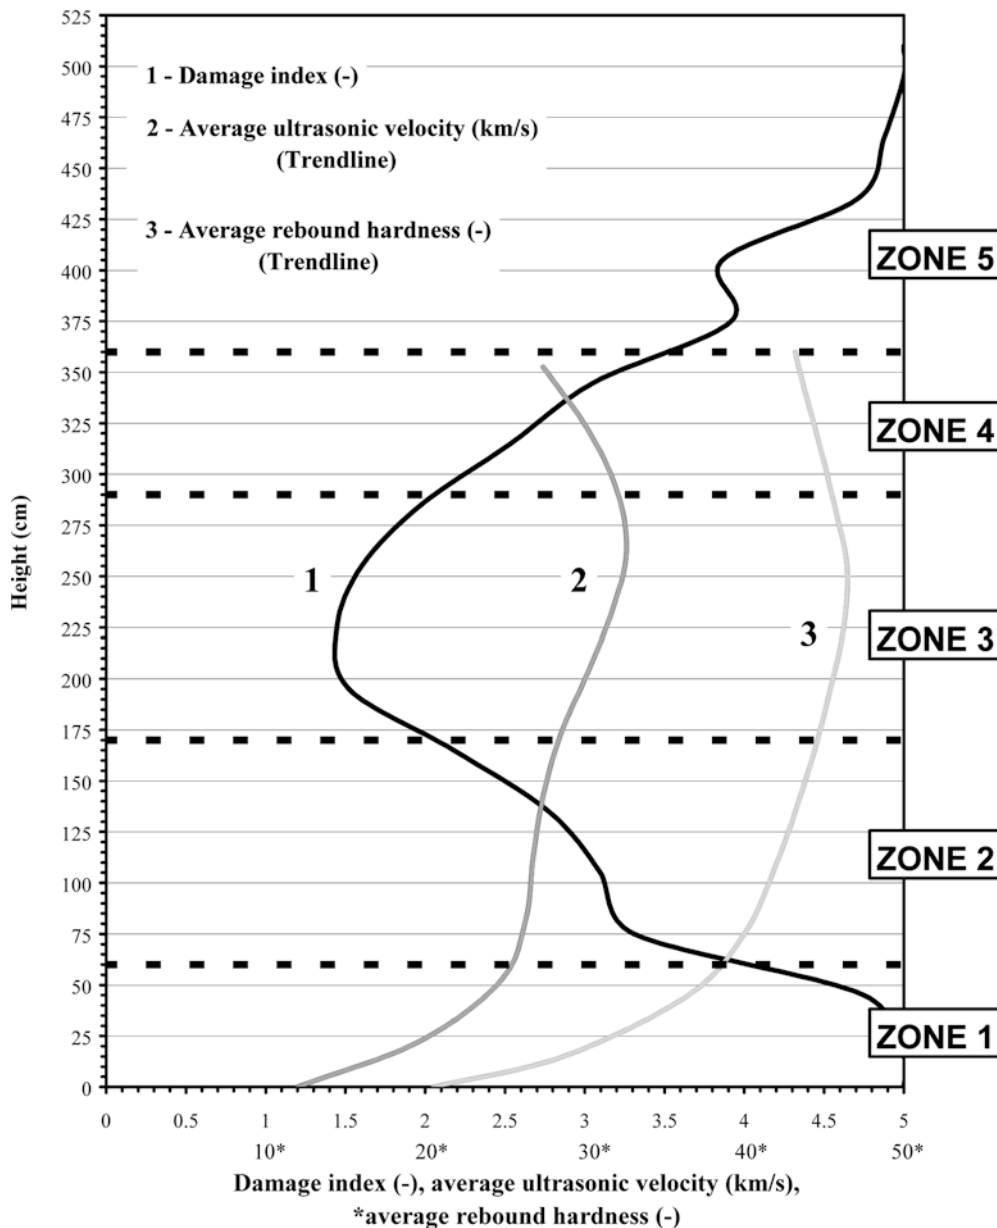
Based on monument mapping, a vertical profile of the damage index was determined for the investigation area. Additionally, ultrasonic velocities and rebound hardnesses were evaluated with respect to a vertical profile (Fig. 21).

The profile of average ultrasonic velocities correlates with the profile of average rebound hardnesses, whereas these profiles are inversely proportional to the profile of damage index.

Fig. 21
Zonation of damage – vertical profile

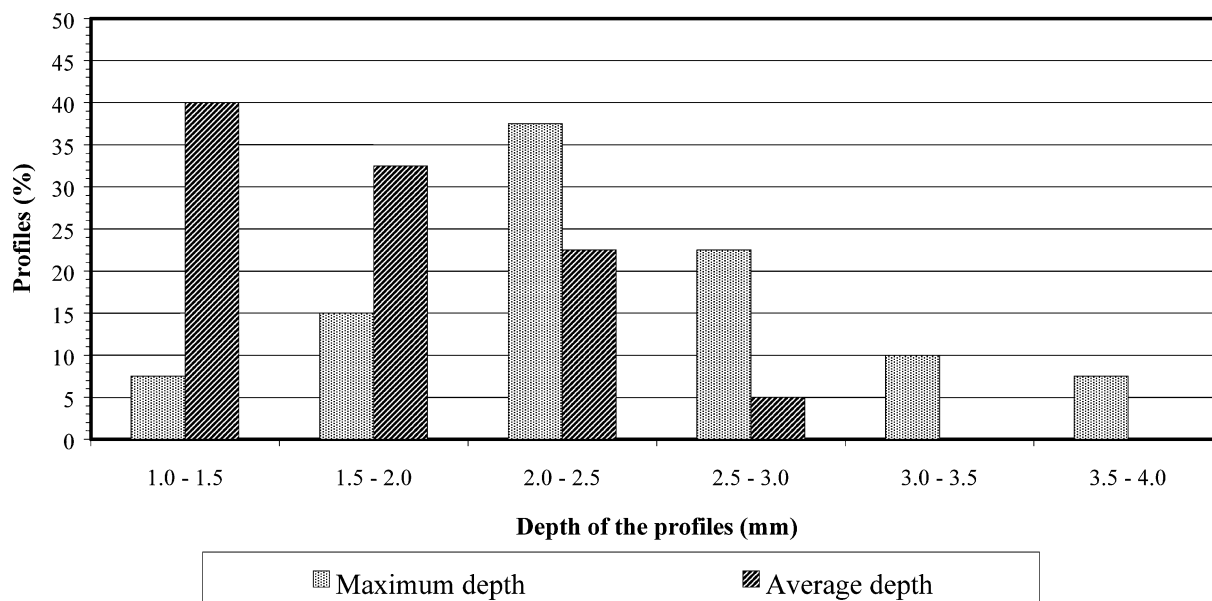
profiles represent the stone material removed by carving, the grey areas the remaining stone material. Fig. 25 shows the evaluation of all profiles with respect to the maximum depth and the average depth. All profiles show a maximum depth of less than 4 mm. The maximum depth of most of the profiles is between 2 and 3 mm and average depth is between 1 and 2 mm. This quantitative evaluation of the profiles was used for a risk prognosis (Fig. 26). For example, if the stone surface were to recede 2 mm, at least 20% of the carvings would be lost. If it were to recede 3 mm, almost 80% of the carvings would be lost. This prognosis is alarming, considering the recent stone detachment—described by weathering forms such as granular disintegration, flaking, contour scaling and crumbling—and structural/textural weakening of the rocks indicated by the lower ultrasonic velocities and rebound hardnesses.

Profile measurements. Classification of maximum and average depths

The profile measurements at carvings have shown that the maximum depth of the carvings is between 2 and 3 mm. Macroscopic detachment of stone material at the carvings is rather rare. The actual low relief of many carvings is considered as a result of erosion provoked by non-visible detachment of finest particles. The low relief of the carvings means that the high historical and cultural importance of the petroglyph is limited to a stone surface zone of only few millimetres. So, even slightest erosion will result in the disappearance of carvings. This prognosis is alarming.

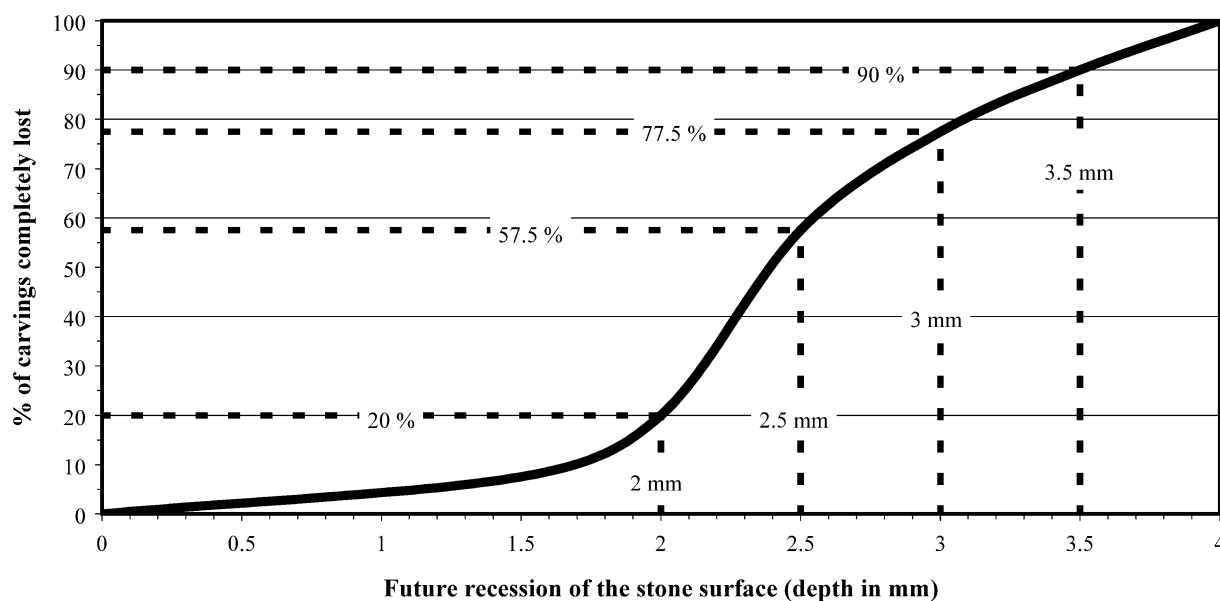
Fig. 26

Risk prognosis derived from profile measurements

Preservation measures—especially preventive measures—are advisable. The presented results of damage diagnosis will be combined with information from other disciplines such as rock mechanics, hydrology/hydrogeology, climatology and engineering sciences. Then an appropriate preservation strategy will be decided. At present, the continuous monitoring of the Bangudae Petroglyph is recommended in order to recognize any
