Structural and geomorphological aspects of the Kat landslides (Tokat—Turkey) and susceptibility mapping by means of GIS

Abstract Kat County, which is located in a slope of hilly region and constructed in the side of a mountain along the North Anatolian Fault Zone, is frequently subject to landslides. The slides occur during periods of heavy rainfall, and these events cause destruction to property, roads, agricultural lands and buildings. In the last few decades, a lot of houses and buildings have been damaged and destroyed. Settlement areas have remained evacuated for a long time. The slope instabilities in the study area are a complex landslide extending from north to south containing a lot of landslides. Field investigations, interpretation of aerial photography, analyses of geological data and laboratory tests suggest that some factors have acted together on the slopes to cause the sliding. In the wet season, the slopes became saturated. As the saturation of the earth material on the slope

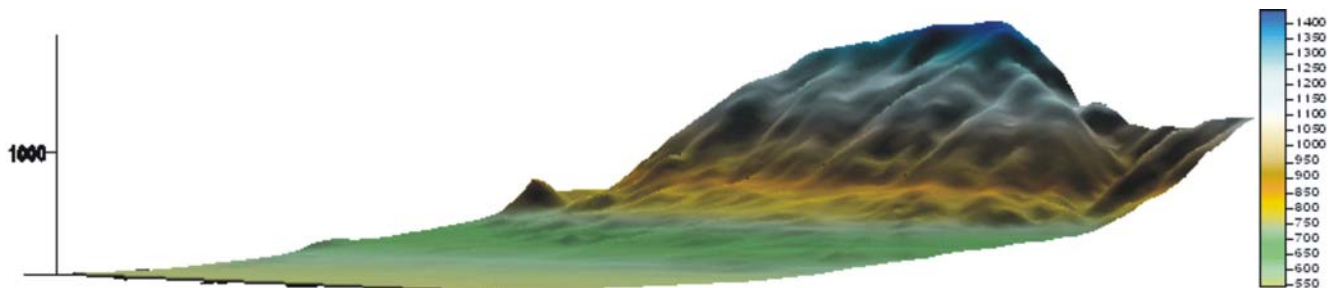
Fig. 2 Topography of the study area

The study area was divided into the two parts, namely, down Kat County and upper Kat County. Upper Kat County is nearer the hills, and down Kat County is located in the plains of the Yesilirmak river, having slopes ranging between 0 and 5%. In the upper Kat, the slopes change from 5 to 45%, and have very steep topography, especially in the northern part of the county (Fig. 2).

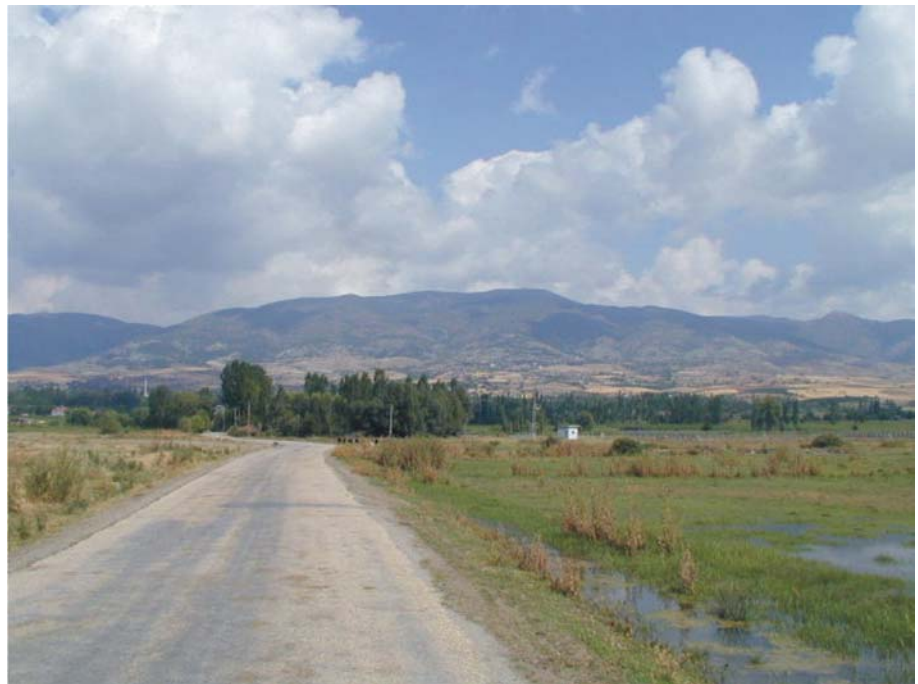
Fig. 5 General view from landslides

It has been recognized that the Kat County is frequently subjected to landslides (Fig. 5). The slides occur during

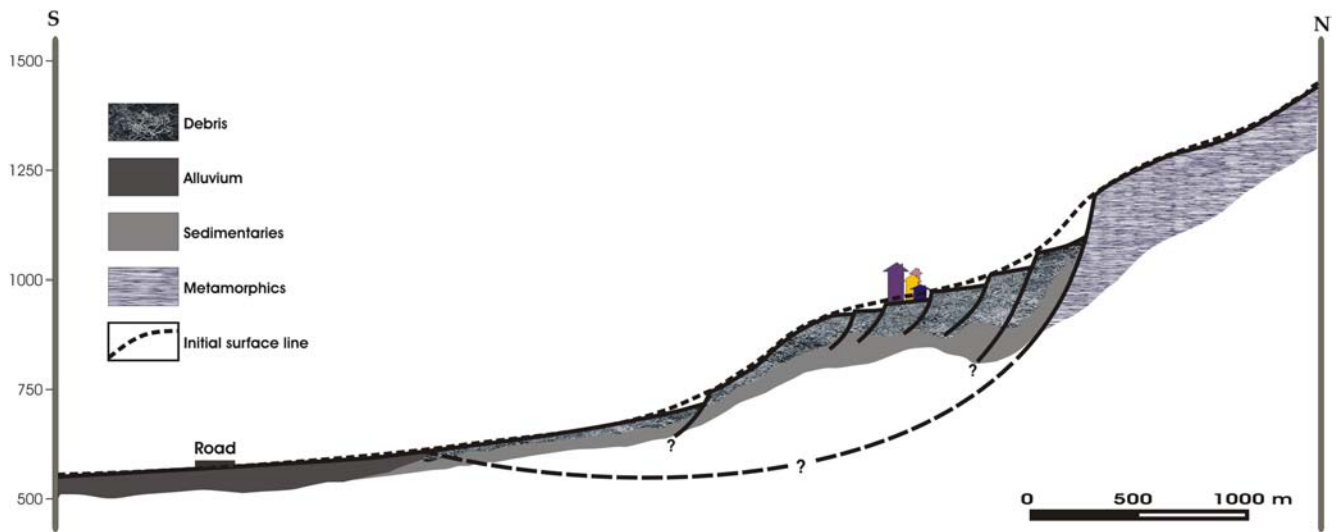
Fig. 6 Cross-section from north to east

the periods of heavy rainfall. The events cause destruction to property, roads, agricultural lands and buildings. In the last few decades, a lot of houses and buildings have been damaged and destroyed. Settlement areas have remained evacuated for a long time. Constructed cross-section from north to south by the continuous surface investigations and borehole works had shown that there were a lot of landslides connected to each other (Fig. 6).

The analyses showed that the potential slope instabilities are in the main directions of NW–SE, NE–SW and N–S, these directions are the same with the dominant slope directions in the study area. All of the landslides in the study area were observed between the Dökmetepe fault in the south and the Mercimekdagi-Çamdere fault set in the north. It is possible to explain that the slope instabilities in the study area are a complex landslide extending from the north to the south containing a lot of landslides (Fig. 6).

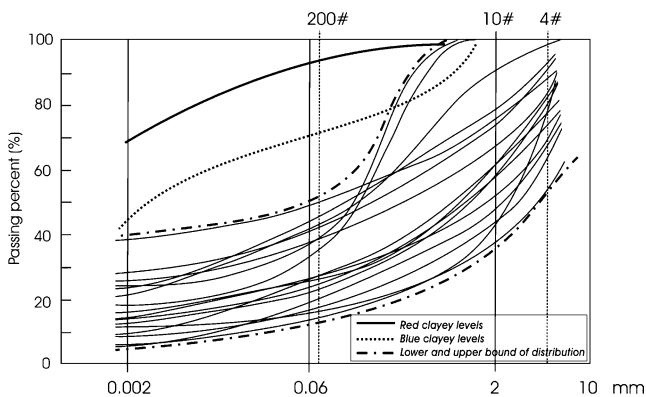
Fig. 7 Grain size distribution of the soils from landslide materials

Soil mechanic tests were carried out on samples collected from the debris material in accordance with the American Standards Testing of Materials standards (Bowles 1992). Conventional coarse sieve, fine sieve and hydrometer methods were used for grain size analyses. These analyses revealed that the soils are composed of 5% block, 25% gravel, 40% sand, 10% silt and 20% clay size material. The range of grain size is shown in Fig. 7. Most of the clays tested were of low plasticity, and according to the plasticity chart, 100% of the samples are of the CL group (low plasticity, inorganic clay) soils (Fig. 8). The soils of the debris material possess low to medium swelling potentials according to the Williams and Donaldson's (1980) swelling potential chart modified from Van Der Merwe (1964) (Fig. 9).

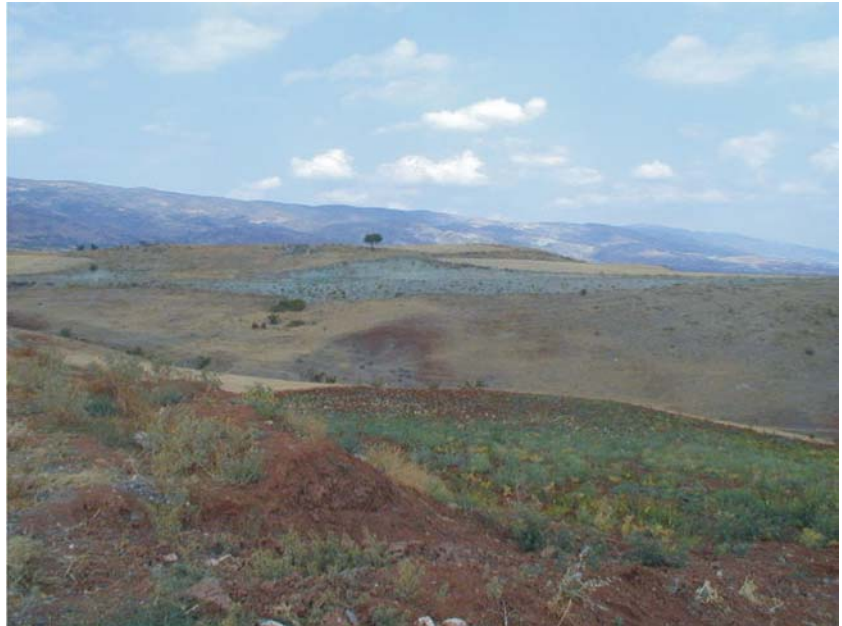
Fig. 10 Views from the red and blue clayey levels of the landslide area

Also, red-coloured clays were observed in the contact of the sedimentary series and debris material, and blue clays were observed between the metamorphics with sedimentary series where there was a widespread occurrence of the landslides (Fig. 10). Both of those clays were of the CH group (high plasticity, inorganic clay) soils (Fig. 8), and have high swelling potentials (Fig. 9). Clays in the contacts of the units reduce the friction and driving forces. Thus, the sliding was to be easy and fast especially in the steep slopes. In the rainy season, an increase in the saturation degree of the sliding material facilitated the landslide. Water could be

reached to the clayey levels because of the permeable characteristic of the debris and the jointed structure of the rocks.

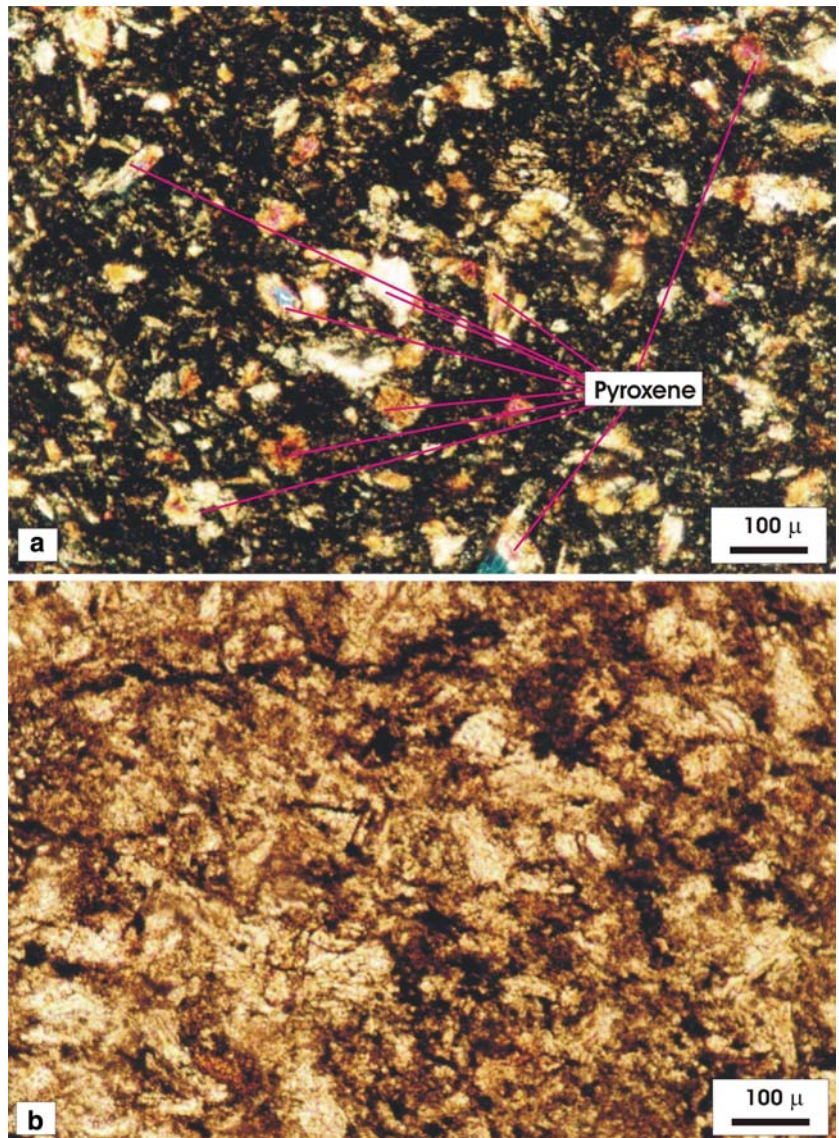
Fig. 11 Thin sections of the metamorphics

Basementrock in the landslide area is metabasalt. Pyroxenes were observed as phenocrysts, and in some samples, there were transformations to tremolite and amphibole. In all the samples, chloritization after groundmass is common and epidote group minerals were observed. Although cataclasm was not observed in the thin sections, sometimes a non-clear cataclasm and orientation were observed (Fig. 11). As the result of thin-section determination, it was determined that the basementrock has basic characteristic and metamorphized in the green-schist facies.

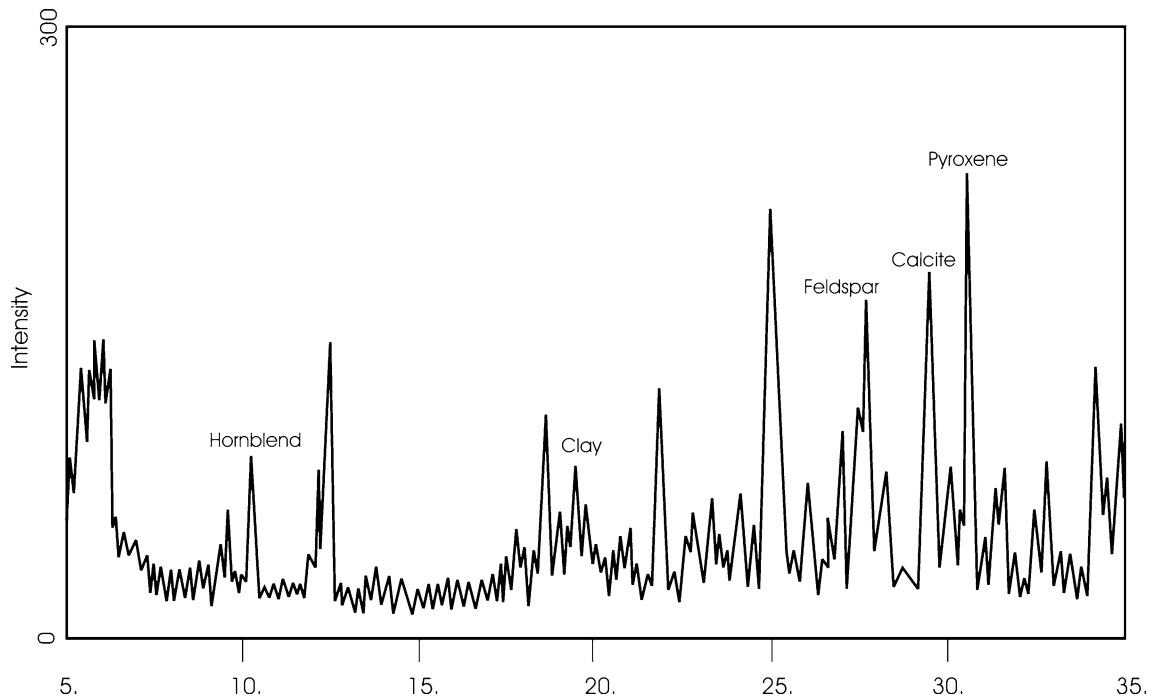
Fig. 12 Characteristic X-ray diffraction diagram of whole-rock powder

Mineralogical determinations were carried out in two stages, which included whole-rock powder diffraction determination and oriented samples of clay-size fraction by X-ray diffraction. Quantities of the minerals were calculated as proposed by Yalçın and Bozkaya (2002). The results of the mineralogical determinations showed that the soils were composed of clay, calcite, feldspar, pyroxene and hornblende minerals, the average semi-quantitative quantity of clay minerals being 48.8% (Fig. 12, Table 2). The mineralogical content thus ob-

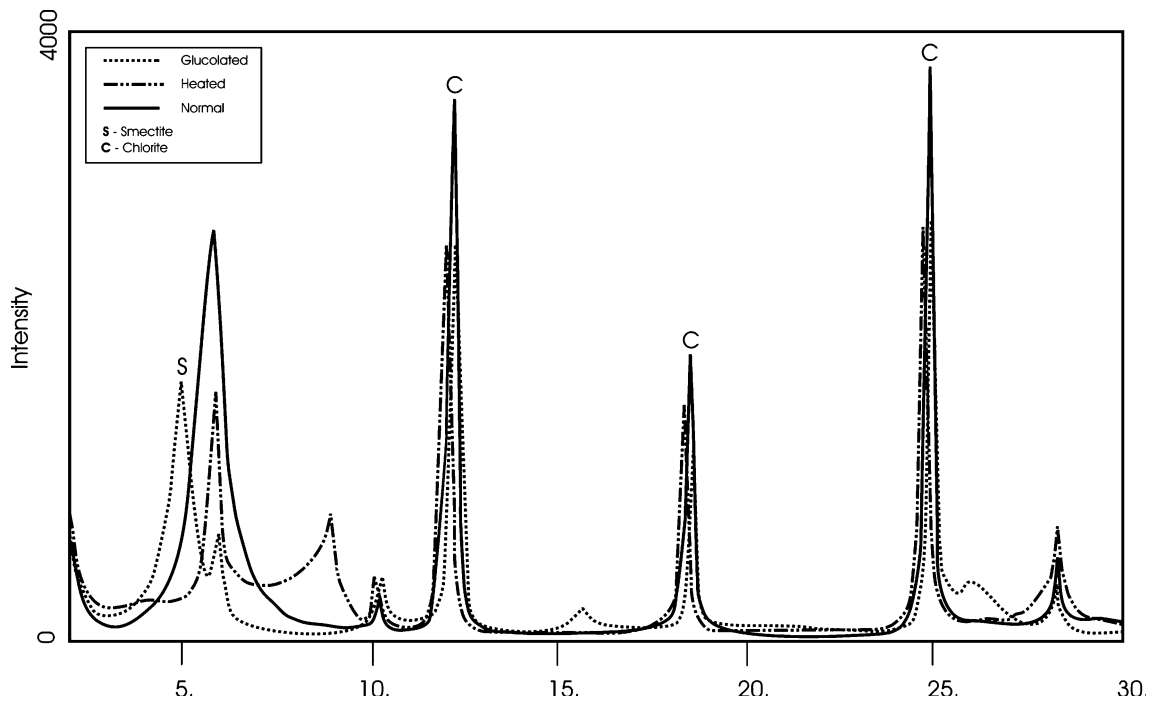
Fig. 13 Characteristic X-ray diffraction diagram of oriented clay-size material

tained largely supports the fact of the source rock of metabasalts. Chlorite and smectite appear to be the dominant clay minerals (Fig. 13, Table 2).

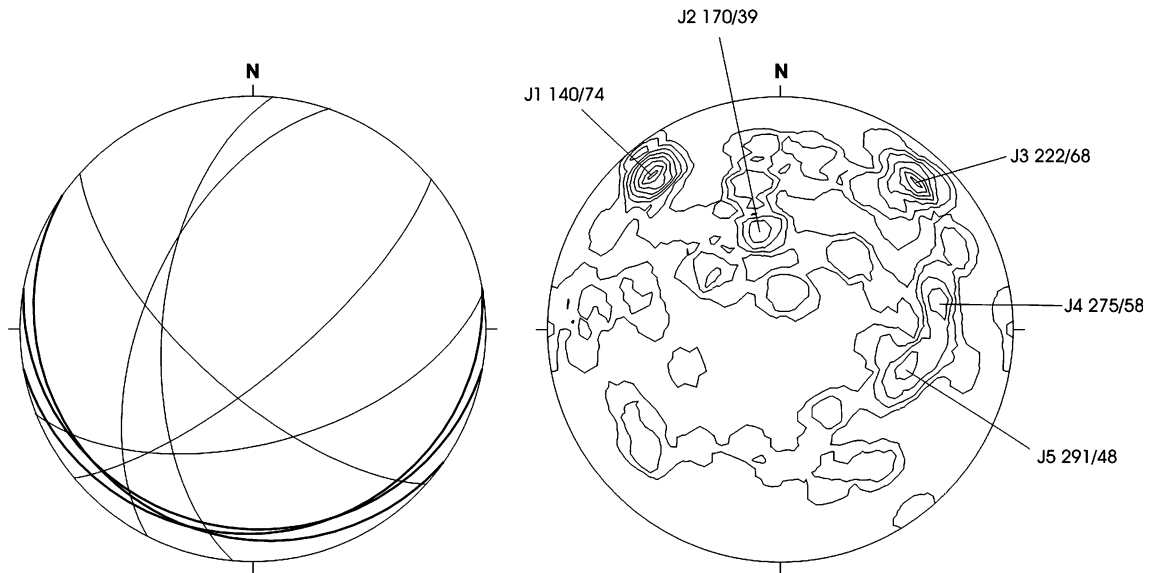
Fig. 14 The significant pole concentrations, and their great-circles (sedimentary series)

Discontinuities have been described according to I.S.R.M. (1978); their orientations as well as slope faces have been plotted on equatorial equal-area diagrams (Figs. 14, 15). The obtained projection implies that a

number of significant pole concentrations are present and indicates the range of strikes and dips of the joints as well as their mean directions.

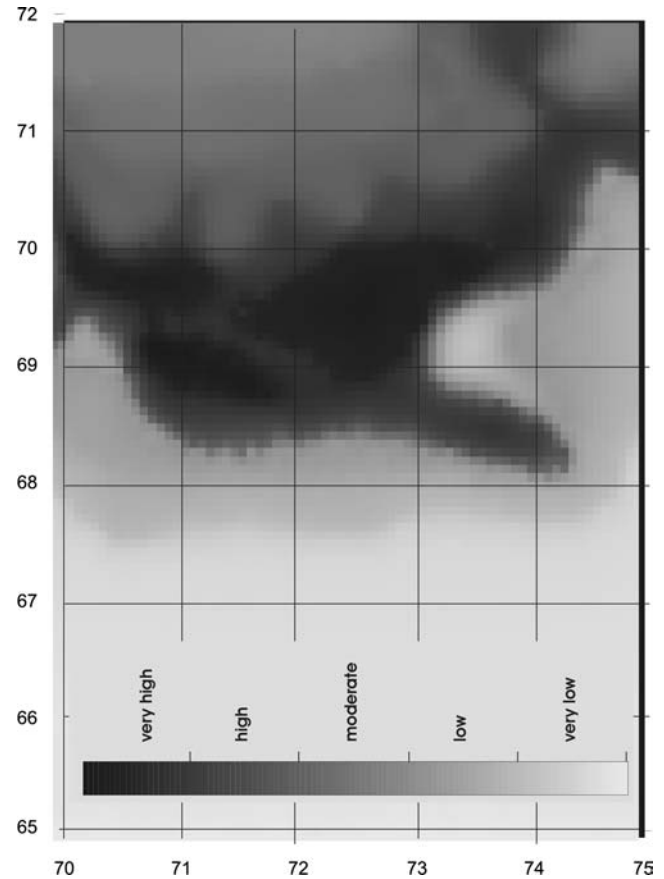
Fig. 17 Landslide susceptibility map of the study area

Finally, the susceptibility map was produced by using the matrix method. The first matrix was the area of each of the combinations of classes of factors that determine each type of movement. The second one was the area of each of the combinations occupied by the rupture zones for the different types of movements. And, the third matrix was established from these data as the matrix of susceptibility (Fernández et al. 2003). The susceptibility map of the study area can be seen in Fig. 17.

The landslide susceptibility map obtained by using the GIS showed that a large area is susceptible and prone to landslides in the northern part of the study area.
