Failure characteristics of rainfall-induced shallow landslides in granitic terrains of Shikoku Island of Japan

Ranjan Kumar Dahal · Shuichi Hasegawa ·
Atsuko Nonomura · Minoru Yamanaka ·
Takuro Masuda · Katsuhiko Nishino

Abstract Soil slips, debris slides, and flow occurrences on hill slopes of particular areas are closely related to the mode of rainfall. Because of geological, geomorphological, and climatic settings, Japan is highly prone to rainfall-induced landslides. In 2004, Shikoku, the smallest island of Japan, faced extreme events of typhoon rainfalls and suffered huge losses of life and property because of floods and landslides. This paper deals with the synoptic descriptions of failures that occurred in the granitic terrain of northeast Shikoku Island, Japan, along with rainfall and failure relationships during the typhoon 0423 (Tokage) of 2004. Examples of typical failures that occurred in Moriyuki and Monnyu of northeast Shikoku are taken into consideration in this study. Data from laboratory and field were used to perform sensitivity and stability analyses with respect to varying slope angles, strength parameters, and thicknesses of saturated residual soil. This stud

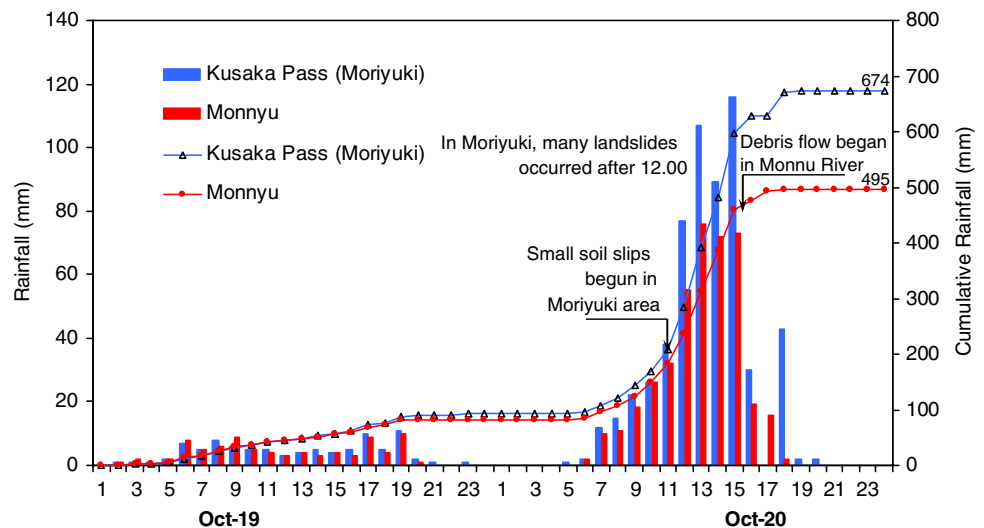
Fig. 2 Rainfall pattern and time of failures in Moriyuki and Monnyu catchments during typhoon 0423

Moriyuki and Monnyu, situated in the eastern part of the Kagawa Prefecture (Fig. 1), were hardest hit by the typhoon 0423 (Tokage) in 2004. From 19 through 20 October 2004, typhoon 0423 produced 674 and 495 mm of rain in a 48 h period on Moriyuki and Monnyu of eastern Kagawa, respectively. On 20 October, a rain-gauge station in the Kusaka pass (located within 1 km aerial distance from Moriyuki) recorded 582 mm of rain in 24 h with a maximum 116 mm/h rainfall intensity. Likewise, Monnyu area has a reservoir for irrigation water supply in east Kagawa and has a rain gauge station close to the failure sites. In this rain gauge station, on 20 October, 412 mm of rain was recorded in 24 h with a maximum 76 mm/h rainfall intensity (Figs. 1, 2).

Likewise, the maximum 1 h rainfall in Moriyuki and Monnyu areas on 20 October 2004 was 117 and 76 mm, respectively (see Fig. 2 also). Evaluating from the minimum value of permeability, it was understood that within 5 h of continuous percolation of water into the masa soil of Moriyuki, water could enter more than 20 cm of soil depth. This suggested that extensive failure occurred in masa soil of northeast Shikoku because of a high rate of infiltration and high intensity of rainfall.

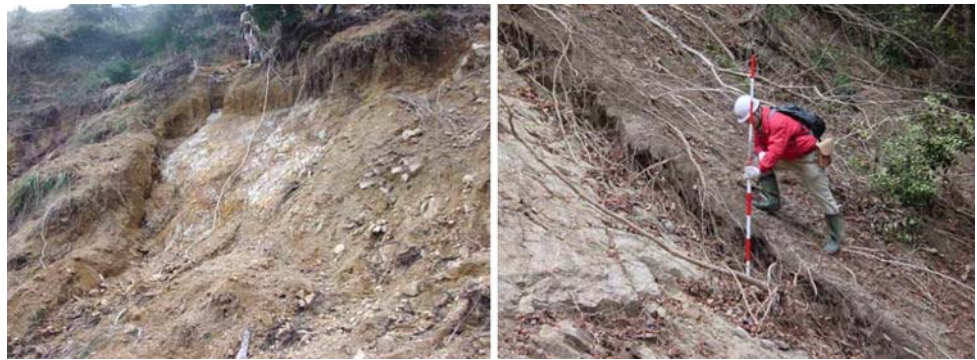
Fig. 5 Translational failure in weathered granite

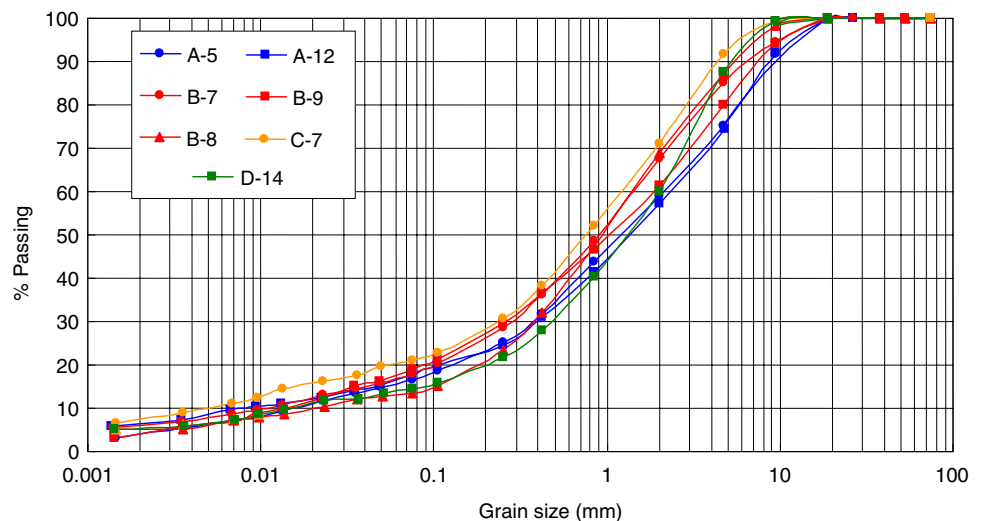
Fig. 6 Grain size distribution curve of soils at selected seven landslides

The grain-size distribution curves of samples from the selected seven landslides of Moriyuki are given in Fig. 6. The distribution curve clearly shows the very narrow range of variation in soil types in the selected landslides.

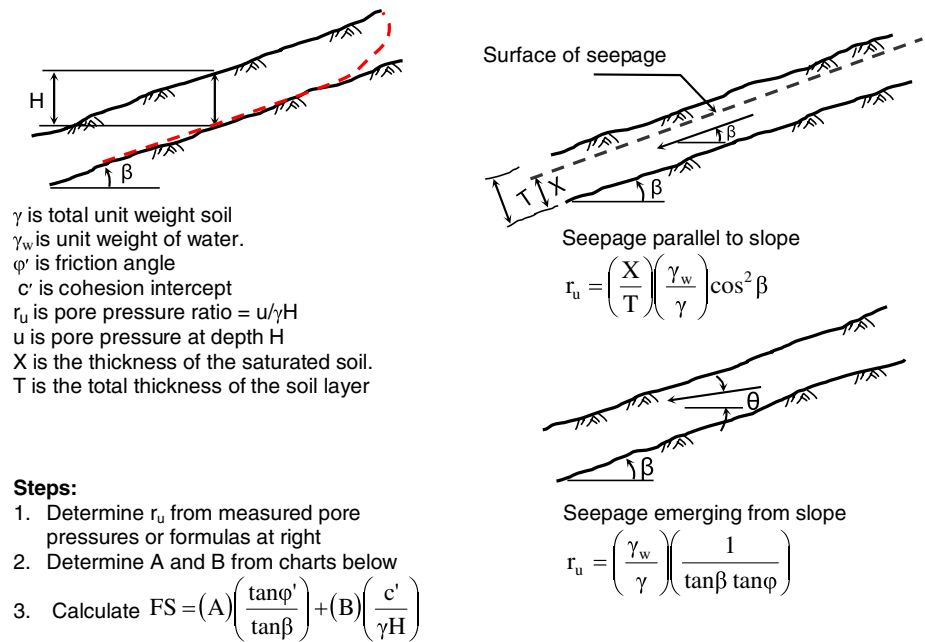
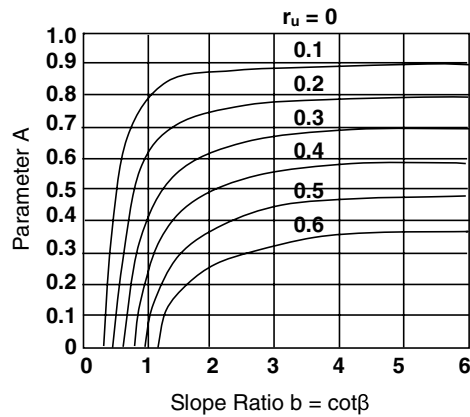
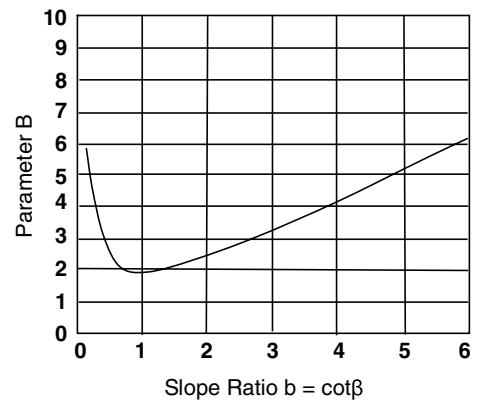
Fig. 7 Infinite slope stability analysis, method described by Duncan (1996), redrawn from Turner and Schuster, 1996

The infinite slope stability analysis method developed and described by Duncan et al. (1987) and Duncan (1996) was used for stability and sensitivity analysis. Figure 7 provides the necessary information for the application of this method including the factor of safety equation and the charts for determining parameters A and B used in the factor of safety equation. This method has been already used by some researchers for the stability analysis of translational slides (Shakoor and Smithmyer 2005). In this research, the method is employed on residual soil slopes of granitic terrain.

which have high potentiality of translational slides. This method considers that the length of failure surfaces is high in comparison to the depth. It also ignores the driving force at the crown part of the sliding mass and the resisting force at the toe part. In fact, the resisting force is usually high during failure; so, in engineering practice, the infinite slope stability analysis is considered to be slightly conservative (Duncan 1996). Duncan (1996) also described two possible seepage conditions, seepage parallel to the slope face and seepage emerging from the slope (see Fig. 7). In this study, on the basis of field investigation, seepage is considered to occur parallel to the slope face. Duncan (1996) described the following three steps of procedure in the analysis method (see Fig. 7 also).

2. Determination of parameters A and B , is necessary for the calculation of factor of safety and can be obtained from Fig. 7. However, the following equation is also useful for estimation of the value of A and B (Duncan 1996). $A = 1 - \left(\frac{r_u}{\cos^2 \beta}\right)$, $B = \frac{1}{\sin \beta \cos \beta}$ where A corresponds to the pore pressure acting normal to the sliding surface, and B corresponds to the shear resistance along the sliding surface.

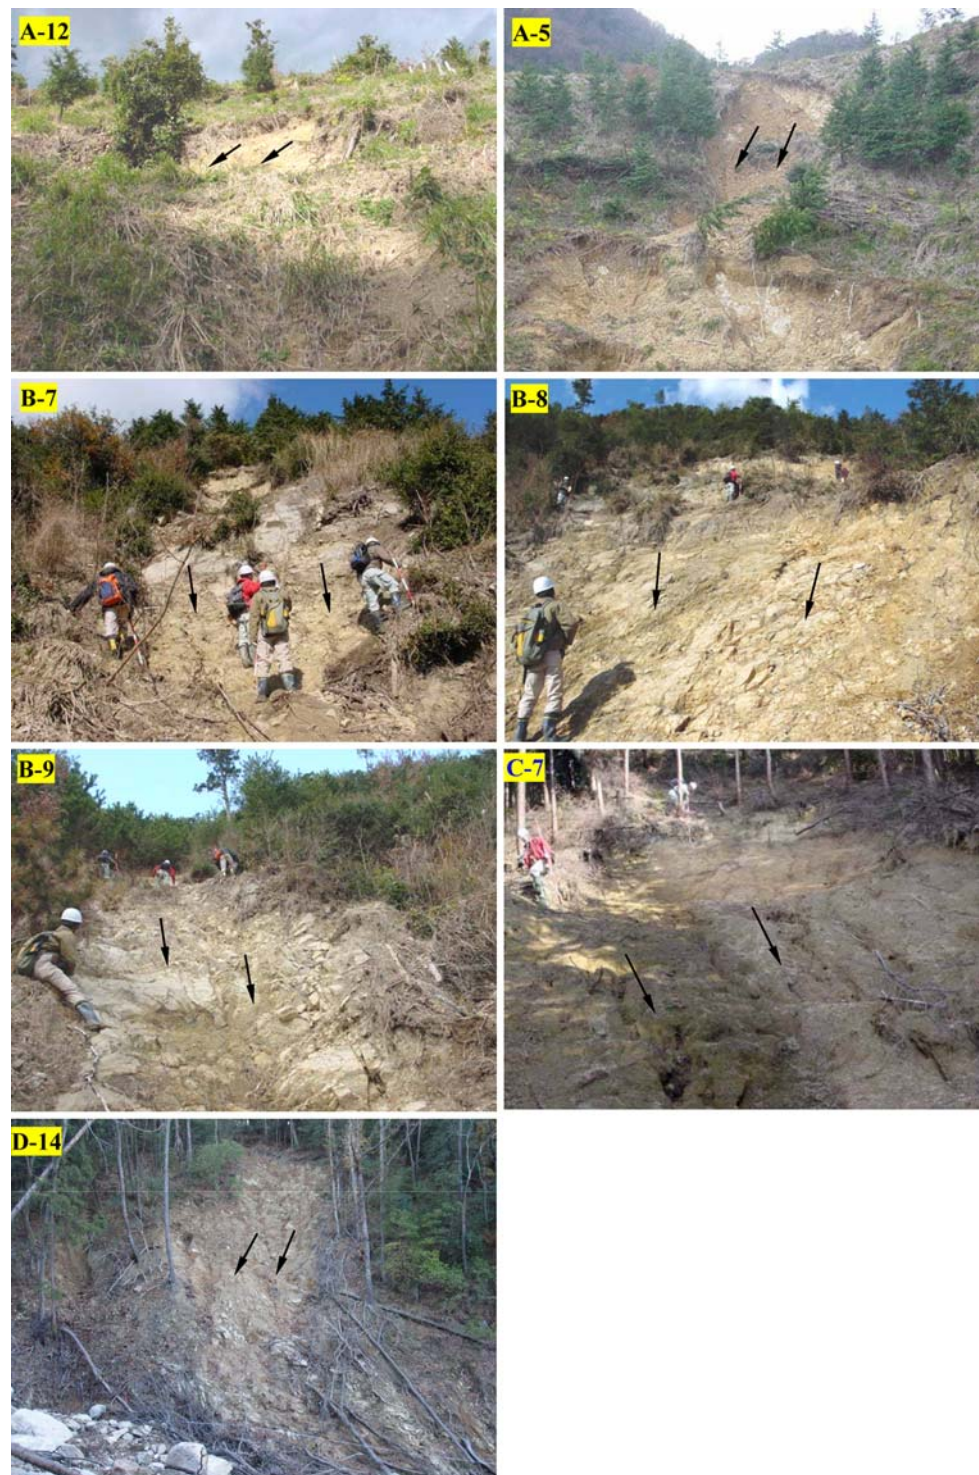
Fig. 8 Photographic representation of selected seven landslides

the residual soil and the underlying less weathered granite or granodiorite. Indeed, colluvial materials and fractured bedrocks were also involved in about 20% failure (see Fig. 4f), but for sensitivity and stability analyses, they were excluded in this study and attention given only to the stability of thin residual soils (<1.5 m found in more than 70% of failure) over less weathered granite and granodiorite. For the sensitivity and stability analyses, the residual soil layer was also assumed to be uniform throughout the slope. The depth of soil on each selected slide ranged from 0.7 to 1.1 m. Moreover, investigation of the sense of movement in a total of 116 landslides of Moriyuki and Monnyu showed that more than 60% of the slides had perfect translational sense of movement and about 30% of the slides had semi-translational (having slight curved surface of failure) sense of movement. In this sense, only in Moriyuki, about 90% of slides can be categorized as translational slides. This is another reason that seven landslides of Moriyuki (Fig. 8, Table 2) were taken into

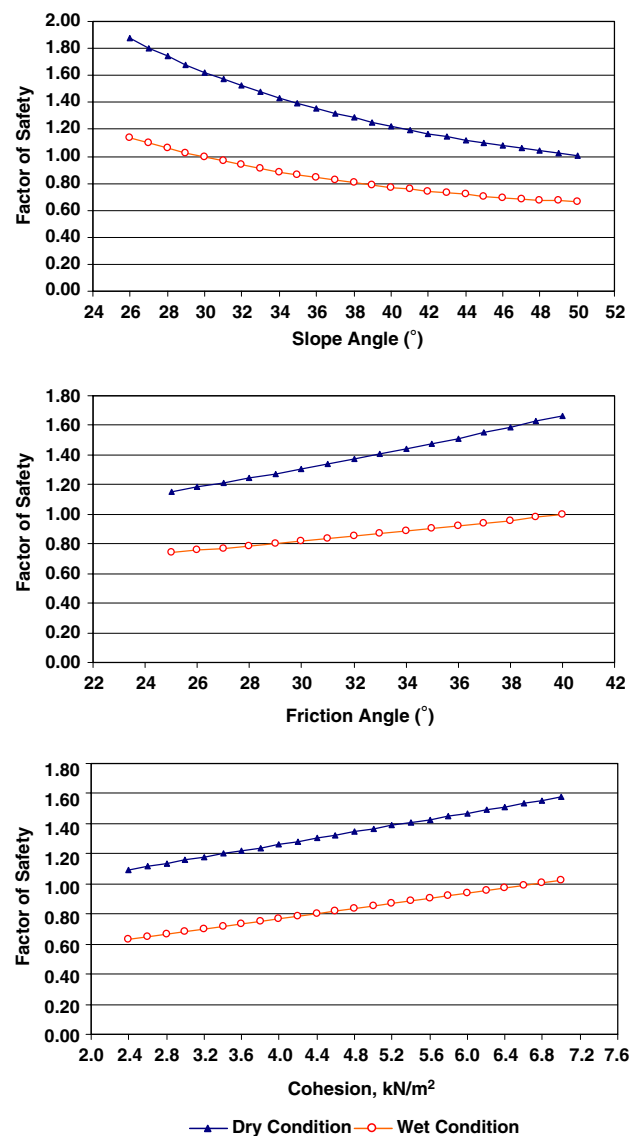
Fig. 9 Variation of factor of safety with respect to slope angle, friction angle, and cohesion for landslide A-5 for both dry and saturated condition of soil

Sensitivity analysis is a heuristic analysis, which examines the dependency of various parameters used in a calculation. Therefore, before stability analysis, sensitivity analysis was carried out to assess the variations in the factor of safety with respect to changes in engineering parameters such as inclination or slope angle (β), cohesion (*c*), friction angle (φ), and unit weight (γ). The infinite slope analysis method (Duncan 1996) was used for sensitivity analysis by keeping each variable constant, except the input parameter that was needed for estimation. The values of slope angle, unit weight, friction angle, cohesion, and thickness (measured normal to slope) of soil were used for each site as the fixed parameters. This heuristic analysis was carried out using both best (dry condition) and worst (saturated condition) cases of unit weight for failure. Field measurements indicated that the slope angle in seven sites ranged from 32° to 44°. Therefore, a range of 26°–50° was chosen to cover any deviation. Likewise, average friction angle values for the study sites also ranged from 27.3° to 35.3° and thus a range of 25°–40° was used. Value of cohesion ranged from 2.9 to 6.5 kN/m², and so in this analysis, value of cohesion from 2.4 to 7.0 kN/m² with increment of 0.2 kN/m² was used. The value of soil depth was used as per the field measurement (ranged from 0.7 to 1.1 m). Figure 9 shows an example of sensitivity analysis for site A-5. Similar plots were generated for all seven cases.

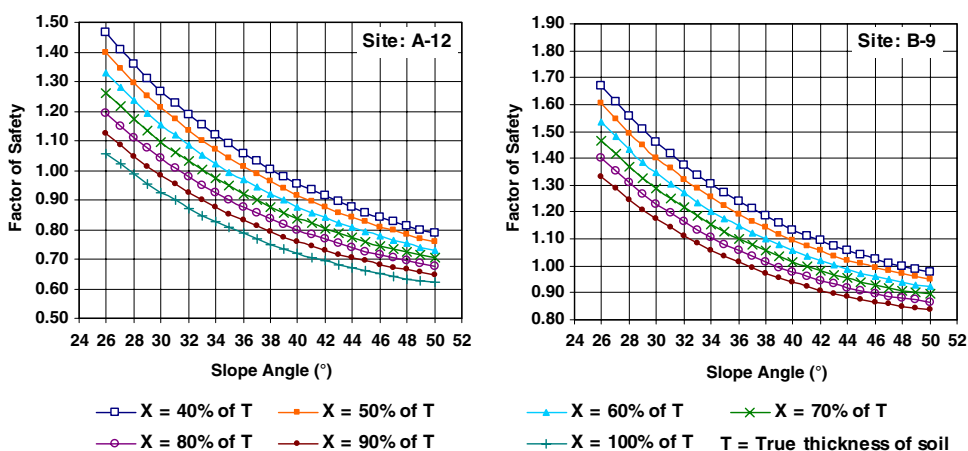
Fig. 10 Relationship between saturated soil fraction, slope angle, and factor of safety for landslides A-12 and B-9

40 to 100% of soil thickness (T) of each slide. Similar to the process employed in sensitivity analysis, 25 (26°–50° with interval of 1°) slope angle values were examined for each site and plotted. An example of the results of stability analysis for landslides having minimum thickness (A-12) and maximum thickness (B-9) are shown in Fig. 10. It illustrates the relationship between slope angle and factor of safety for various values of saturated fraction of soil layer (X). It is obvious that as soil saturation increases, the factor of safety decreases for a given slope angle. Results of stability analysis are listed in Table 3 and it was understood that masa soil of northeast Shikoku has high potentiality of translational slide even in 40% saturation of soil layer. If soil thickness is high, more saturation is needed.

The calculated factor of safety for each landslide site is illustrated in Table 4. Site B-7, B-8, and B-9 had higher slope angle value and also factor of safety of 1.18, 1.38, and 1.32, respectively for dry conditions. Data show that landslide C-7 failed at 100% saturation during typhoon 0423 (Tokage), whereas the others failed at 40–80% saturation.

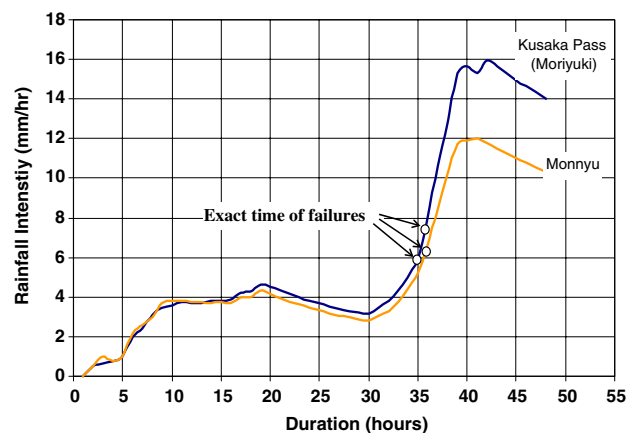
Fig. 11 Temporal pattern of rainfall intensity vs. duration for the 2004 rainfall event of Moriyuki and Monnyu areas. The left of the graphs represent initiation of rainfall. Symbols indicate the occurrence of landslides in Moriyuki and Monnyu during typhoon 0423 (Tokage)

temporal pattern of rainfall intensity vs. duration conditions during the typhoon 0423 (Tokage) in the study areas. The continuous lines represent rainfall intensity vs. duration in Kusaka Pass and Monnyu rainfall gauging stations, whereas the time of occurrence of landslides is shown as circular symbols.

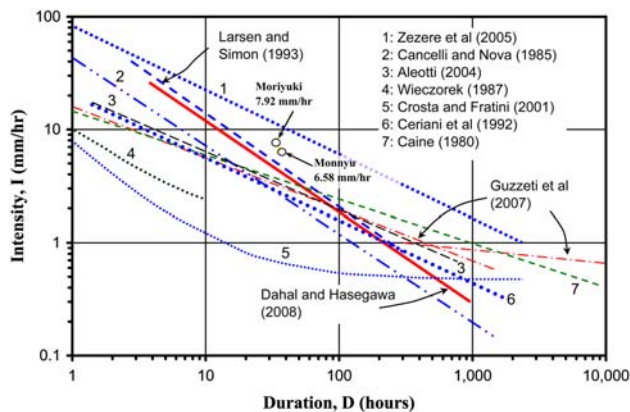
The value of effective temporal rainfall intensity to create landslide was plotted with rainfall duration in a log–log graph to analyze the empirical rainfall thresholds. In the same log–log paper, rainfall threshold curves proposed by various researchers were also portrayed (Fig 12). The plot revealed that the rainfall intensity in northeast Shikoku (Moriyuki and Monnyu) during 2004 typhoon 23 event was slightly higher than the threshold of storm-triggering landslides proposed by Larsen and Simon (1993) for Puerto Rico (humid tropical region) and by Dahal and Hasegawa (2008) for the Nepal Himalaya (tropical monsoon region). Similarly, it is slightly lower than the rainfall threshold of landslides in Portugal, western Europe (Zezere et al. 2005). The curve proposed by Cancelli and Nova

Fig. 12 Rainfall intensity and duration associated with slope failures during typhoon 0423 (Tokage) in northeast Shikoku, Japan, and curves proposed by various researchers for a similar case. From the data of 2004 landslides events, threshold rainfall intensity for northeast Shikoku is slightly higher than the threshold lines for rainfall triggering landslides proposed by Larsen and Simon (1993) for Puerto Rico (humid tropical region) and by Dahal and Hasegawa (2008) for the Nepal Himalaya (tropical monsoon region). Similarly, it is slightly lower than threshold for landslides in Portugal, western Europe (Zeze et al. 2005)

(1985), Ceriani et al. (1994), Crosta and Frattini (2001), Aleotti (2004) and Guzzetti et al. (2007) for the Alps could not cover the average rainfall intensity of the study area. The curves proposed by Wieczorek (1987) and Cannon and Ellel (1985) for the Rockies also do not have any similarity with the data of the study area. However, the full disaster history needs to be understood for more accurate prediction of the threshold. In this study, only data of 2004 failure events were used to correlate threshold with already established threshold curves and to obtain a glimpse of landslide threshold for the granitic terrain of northeast Shikoku.
