# Testing the durability of limestone for Cathedral façade restoration

**Abstract** This research aimed to specify an optimum replacement stone for Truro Cathedral. A variety of petrographically and visually similar material to the original Bath stone was initially selected. The stones were subjected to three different durability tests; Sodium sulphate crystallisation and large scale testing with both accelerated and climatic freeze-thaw cyclic loading. The most suitable stone was determined as the one with the best performance characteristics overall.

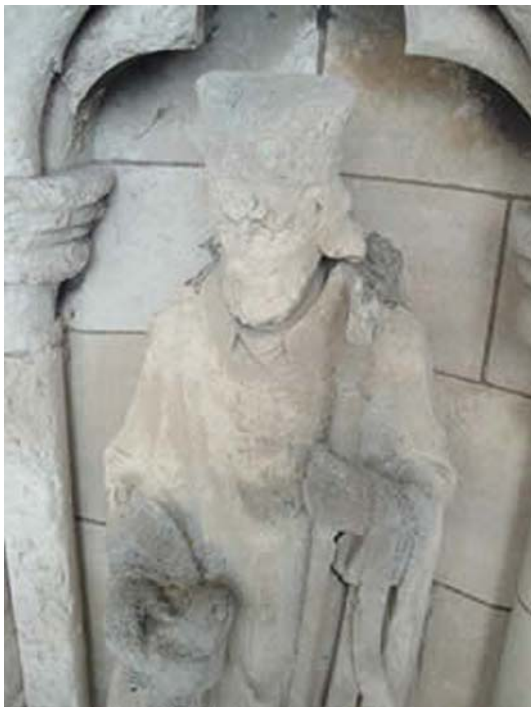
**Fig. 2** Weathered statue (TRURO CATHEDRAL 2005)

The Bath stone in this building were weathered variably. Some parts of the fabric appeared to be in very good condition, whilst others have disintegrated completely (Fig. 2). Investigation of the fabric by Jefferson Consulting for English Heritage concluded that there was no apparent correlation between the degree of exposure and decay levels and it was concluded that there was probably a wide variation in the durability of the stone itself. This latter hypothesis was further investigated through much more detailed examination of a selection of six stones in 1999. The stones conformed to the typical visual and petrographic description of Bath Stone although there were variations in the sizes and composition of the clastic and matrices of the stones. However an obvious reason for selective decay was not discerned (Jefferson 2001).

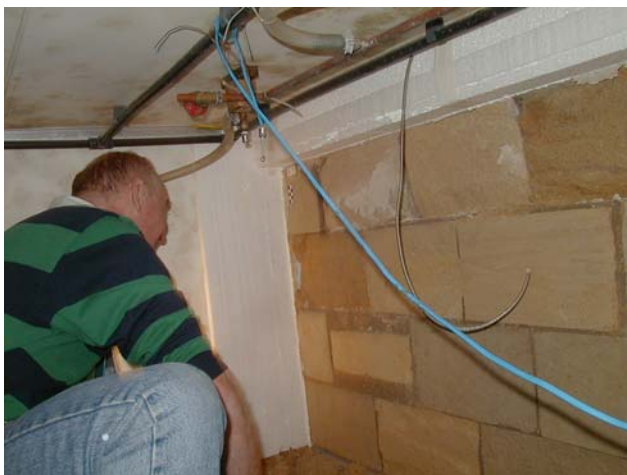
**Fig. 3** Inspection of test wall in CERAM test chamber

Research Ltd) research chamber, which is 1.9 by 2.0 m on plan and 1.2 m high (external dimensions) with the outer skin having 80 mm of insulation between external (ambient) and internal conditions. Two sets of two stone panels, where each panel had a length of 560 mm and a height of 740 mm, were constructed at one end of the chamber (Fig. 3). The panels were isolated thermally from the laboratory. The standard test, first described by Peake and Ford (1984), lasts for 100 cycles (10 days). The elements of each cycle are given in Table 3. In general, a durable brick (e.g. an Engineering class brick) can be expected to be undamaged after 90 cycles (Peake and Ford 1984), however it is anticipated that the Cathedral replacement stone would be substantially undamaged even after the end (100 cycles or 10 days) of the standard test. Here, the standard test was continued to a total of 200 cycles (20 days) to monitor any progressive decay.

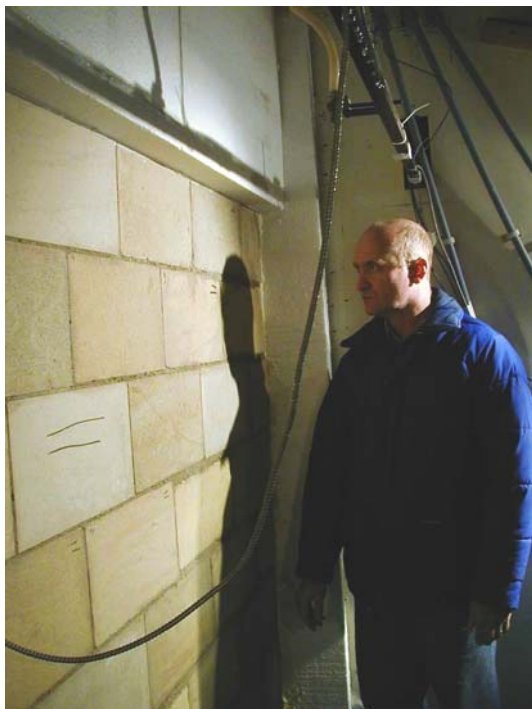
**Fig. 4** Inspection of test wall in climatic simulation test chamber

The climatic simulation chamber at Sheffield Hallam has been fully described in the literature (Taylor-Firth and Laycock 1998, 1999; Laycock 2002) and gives control over both interior and exterior conditions to more closely mimic likely weathering elements. The simulator itself is composed of two chambers each of dimensions 4 m long, 3 m wide and 2.6 m in height. A wall was constructed which separated the two chamber halves and contained eight samples of each of the stone types to be tested, a total of 64 blocks (Fig. 4). The sample sizes were 350 mm × 200 mm × 200 mm for full blocks and 170 mm × 200 mm × 200 mm for half blocks and a mortar joint of 6 mm was used. Typically, the stone supplied from the North Porch of the Cathedral was of more irregular shape and variable in size, averaging approximately 350 mm × 190 mm × 150 mm and thus required the use of a larger mortar joint to keep coursing level.

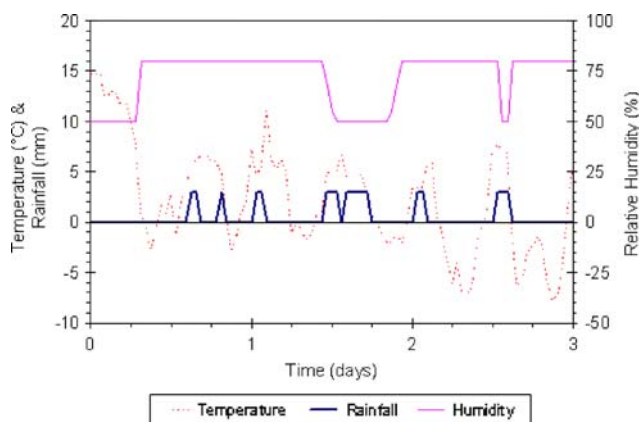
**Fig. 5** Applied 3-day weather cycle; climatic simulation chamber

The weathering conditions on one side, denoted as the external face, are shown in Fig. 5, whilst the other internal face was maintained at 5°C. Driving rain is created by

Winter simulation involved a cycle of weather Fig. 5, based on 30 years of weather data from the Meteorological Office St. Mawgan site approximately 25 km to the NNE of Truro. Conditions were generated for a 3-day cycle repeated initially for 100 days, and then, as little degradation had occurred, for a further 100 days, giving a total of 800 events below freezing. At intervals the climatic simulator wall was subjected to driving rain conditions as described previously.

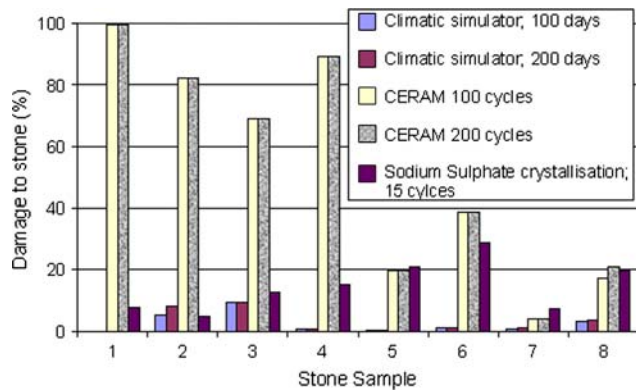
Fig. 6 Mean damage to stone for different test apparatus

Figures 6 and 7 compare the overall block damage of the materials in both freeze-thaw testing regimes to those of the salt crystallisation test. It can be seen that the CERAM chamber causes significantly more damage than the climatic simulation. Extending the test from 100 to 200 cycles in the CERAM test seems largely unnecessary as little change in both mean and standard deviation of damage occurred.

The CERAM test consistently causes the greatest amount of damage in the materials tested with about half the samples suffering significantly more damage than the salt crystallisation test. Where a high level of damage

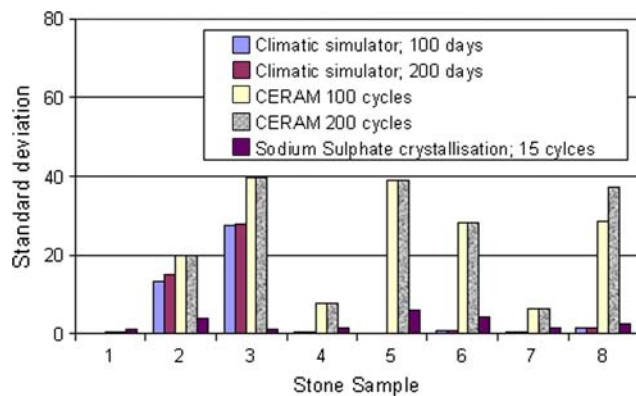
Fig. 7 Standard deviation of mean damage to stone for different test apparatus

occurs in the salt crystallisation test, this correlates with similar levels of frost damage in the CERAM test although the standard deviation in the latter is much higher. A high standard deviation (Fig. 7) indicates selective weathering and differences in the stone samples within a type which were not evident prior to testing. While this does not conclusively prove the poor durability of the material it may throw doubt onto the performance of a high percentage of the blocks tested and therefore their use in a large restoration project. Testing at full scale enables such differences in performance to be identified.

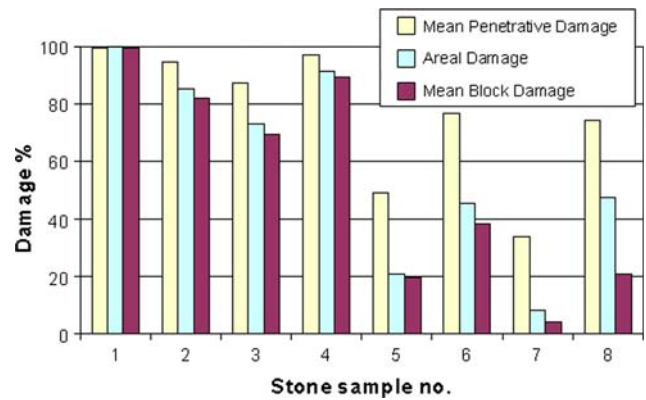
Fig. 8 Summary of the lateral extent and penetrative nature of damage generated during testing in CERAM apparatus after 200 cycles

Further insight into performance can be gained for frost damage through comparison of the areal extent of damage and mean depth of penetration of the damaged areas. The CERAM test method causes damage which is both widespread and to considerable depth (Fig. 8) notably for samples 1 to 4. In comparison, the climatic chamber (Fig. 9) causes much less areal damage and generally lower penetrative decay.

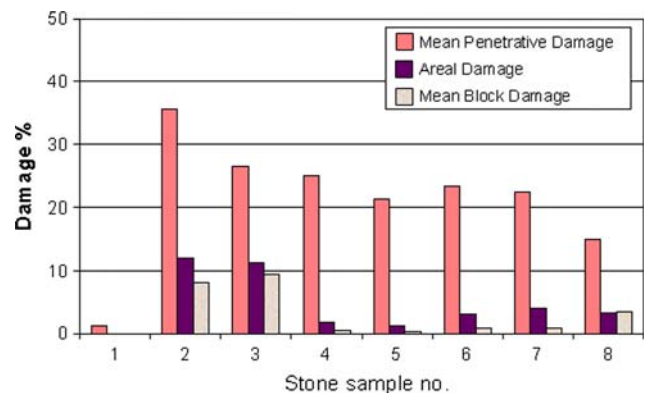
Fig. 9 Summary of the lateral extent and penetrative nature of damage generated during testing in climatic simulation chamber after 200 days
